Costa Concordia

Anatomy of an organisational accident

Capt. Antonio Di Lieto

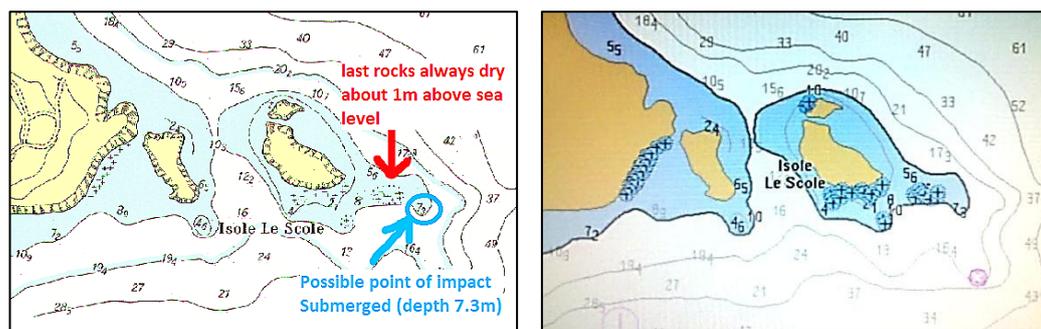
The safety margin initially established by the Captain was of 0.5 nautical miles (about 1 kilometre) from the furthestmost point of a group of small islands (*Le Scole*), just south of the main port (*Giglio Porto*) of Giglio Island. From that point on, a *touristic navigation* should have gone parallel to the coast, saluting the islanders and sounding the ship's horn. However, the Costa Concordia got as close as 100 meters from the furthestmost point taken as reference by the Captain, striking an underwater rock with a charted depth of 7,3 meters (fig.4).

Fig.4 – Le Scole Islands and the possible point of impact with an underwater rock at 7.3 meters of depth. Screenshots captured from paper chart IIM 74 (left) and Electronic Navigation Chart IT50074B (right).

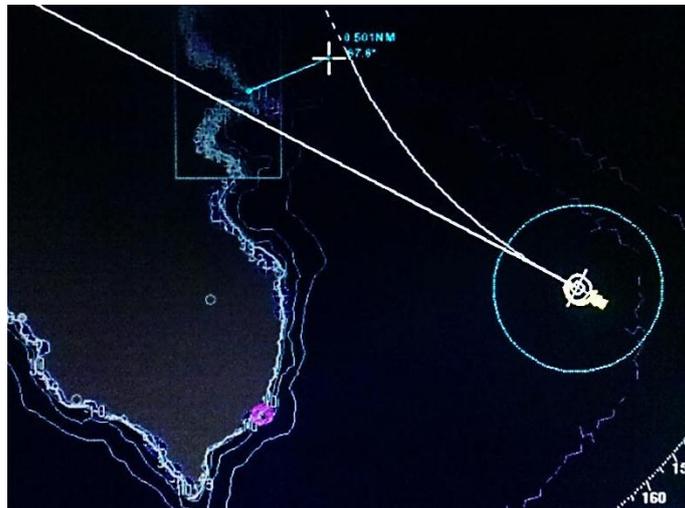
This initial error and the lack of challenge by the planning officer, led to an *Undesired Ship State* (see fig.7). In the specific case, the situation of unnecessary risk is determined by planning a sail-past with a safety margin of 0.5 nautical miles (about 1 km). Moreover, given the intrinsic limitations of the ship in term of list (as a function of course alterations with high rate of turns), the approach almost perpendicular to the coast would have not left room to recover from shiphandling errors. The undesired state was recognized by the Senior Officer of the Watch (SOOW)⁷, who tried to alter course to starboard (fig.8), but five other significant errors were made, exacerbating the situation until all the available defences were breached.

Fig.8 – Costa Concordia position at 9.37pm, extracted from the presentation of the Italian Maritime Investigative Body at the 90th IMO Maritime Safety Committee (MSC) meeting in May 2012. The course alteration meant by the SOOW has been simulated on a Sam Electronics INS NACOS (Chart Radar mode, night display, display category “standard”), with a radius of turn of 2 nautical miles, at a speed of 15.4 knots. It results that at 9.37pm it would have been still possible to keep the safety margin within the established limit of 0.5 nautical miles. The straight line represents the ship’s heading during the hypothetical turn, whereas the curved line represents the projected path of the ship if the alteration had been carried out. The circle around the ship is a Variable Range Marker (VRM) of 0.5 nautical miles.

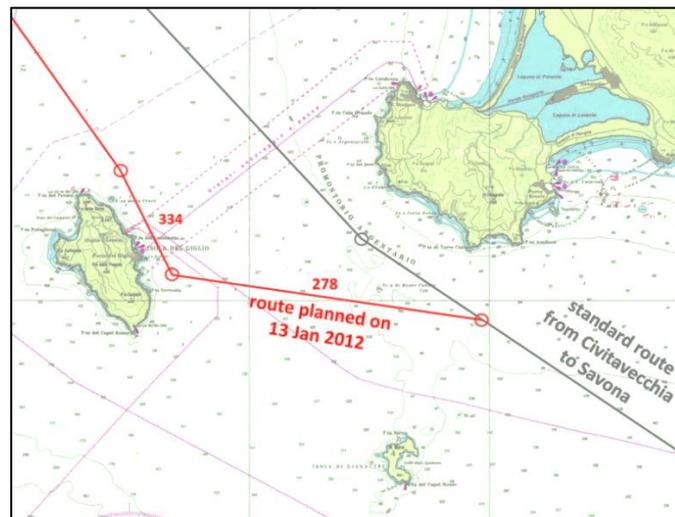
The second error was a shortfall in voyage planning. According to the Safety Officer⁸ - who arrived on the bridge just after the impact with the rock – only the original route was drawn on the paper chart, a few miles off the island. Most likely, he saw the paper chart n.6 (scale 1:100.000) of the Italian Hydrographic Office (fig.9), which seems to be the one used to plan the deviation towards Giglio Island (Italian Ministry of Infrastructure and Transport, 2012). He also noticed an isolated position fix placed well south of that route, which confirms the improperly planned navigation towards Giglio Island. Even though the new route was uploaded on the Integrated Navigation System (INS)⁹, the voyage plan had to be reported with priority on all relevant paper charts¹⁰. In fact, chart n.119 (scale 1:20.000) and chart n.74 (scale 1:5.000) were available for detailed planning. This is a specific duty of the planning officer, who follows the Captain's directives on the subject¹¹. They met before departure from Civitavecchia to discuss about the sail-past, but the intentions were not translated into a formal route planning on all available paper charts. During that meeting, the safety margin of 0.5 nautical miles was established by the Captain, under suggestion of the planning officer¹². Its definition is a critical decision for each route of the voyage, especially in proximity of navigational hazards. The events demonstrated that the safety margin was not established from the limit of the no-go area - the 10 meters bathymetric line – and not even from the furthestmost emerged rock, but from a generic point of *Le Scole Islands*, barely visible on the 1:100.000 scale chart. The voyage plan is regulated by specific guidelines of the International Maritime Organisation (IMO, 1999), and most likely by specific company's procedures.

Fig.9 – Chart n.6 IIM (scale 1:100.000) used for voyage planning

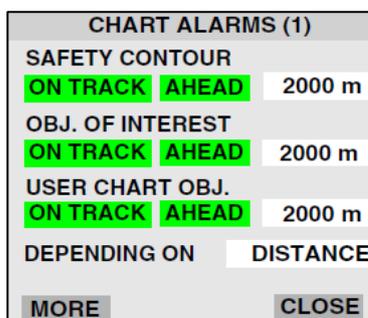
The fourth error also relates to route monitoring. In contrast to the third error, this involved the INS, to be officially used only as an aid to navigation. The equipment was operated by the SOOW, who used the radar distances and the electronic chart overlay to monitor the approach to the island. The error consisted in assessing the distance from the furthestmost radar echo of *Le Scole* rocks, and not from the limit of the *no-go area*, that is the 10 meters bathymetric line. Such line is also known as a *safety contour*, and the INS provides a functionality to set a warning zone ahead of the ship's bow in order to generate a *chart alarm* (fig.10). Nobody within the team realised that between the furthestmost echo radar used as reference, and the limit of the safety contour, there were two significant navigational hazards not detectable by the radar: a small rock about 1 meter above the sea level, and an underwater rock with a shallowest depth of 7.3 meters (fig.11). The dry rock was sighted by the Captain only when it was too late.

Fig.10 – Chart Alarm settings on Sam Electronics INS “NACOS” (ref. Multipilot operator manual)

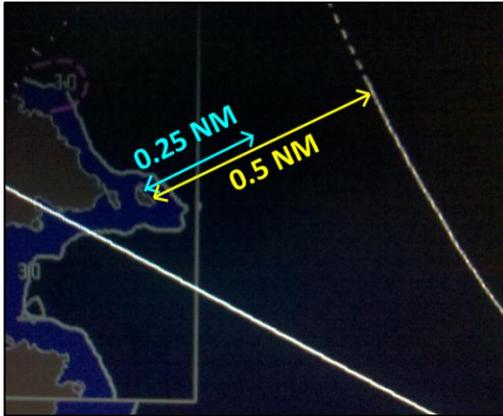
Fig.12 – Reduction of safety margin from 0.5 to 0.25 nautical miles, still enough to pass clear of Le Scole islands.

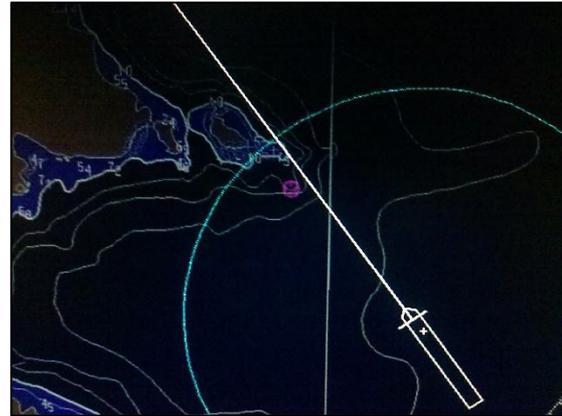
0.28 nautical miles¹⁷. At 9.44pm – one minute before the ship was turning with a safety margin reduced to less than 0.25 nautical miles (fig.13). The Captain probably relied more on his visual perception than on INS information, and initially altered course with a too small rudder angle. Only when he sighted the furthestmost rock of Le Scole on his port bow, he ordered the rudder hard to starboard. The stern sectors of the hull most probably struck the underwater rock with a charted depth of 7.3 meters (see fig.4). As a result of a tight coupling of all the previous errors, and of a number of latent conditions, the underwater rock was never taken into consideration, neither in route planning nor in route monitoring. This is confirmed by the interview released by the Captain the morning after the accident, who considered the possibility of an uncharted rock¹⁸.

Fig.13 – Simulation of ship's position at 9.44 pm, Course Over Ground (COG) 323, speed 16 knots, on Sam Electronics INS "NACOS" (range 0.5 NM, safety contour 10m). The blue Variable Range Marker (WRM) shown in blue is set to 0.28NM, which is the value mentioned by the Captain.

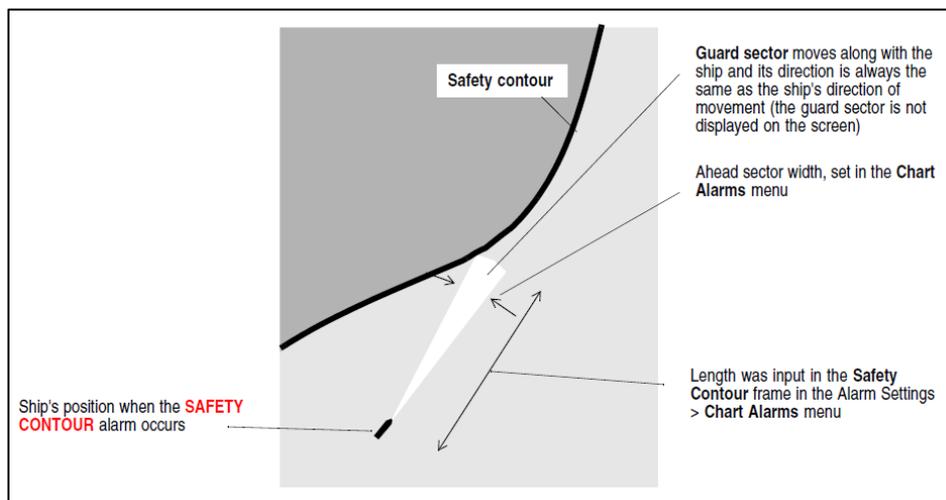
With regard to *chart alarms* for example, a potential usability issue might arise from the guard sector defined by the operator. The guard sector opens out from the ship's position in direction of the ship's actual course (fig.14), and once it intersects particular cartographic features – such as *safety contours*, *land areas*, and *objects of interest* with a depth value less than the selected safety contour – it triggers an alarm. But once defined, the guard sector is not displayed on the screen – differently from the guard sectors for automatic radar target acquisition – making it difficult for operators to remember its parameters, especially when many others have to be kept in mind.

Fig.14 – Invisible guard sector of chart alarms for Sam Electronics “NACOS” (*Multipilot and Chartpilot*).

Correct chart alarm management may have alerted the SOOW to the presence of both the 10 meters safety contour and the 7.3 meters spot sounding off *Le Scole*.

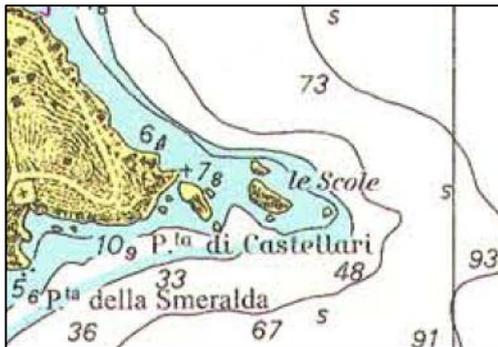
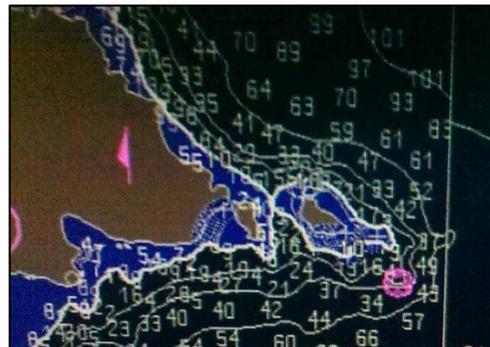
effort. In the worst cases important features becomes unreadable, compromising the situational awareness of the OOWs. Comparing the paper chart with the vector chart of Giglio Island (fig.16 a, b), it appears evident that the *art of cartography* got lost in translation from paper to vector charts. Aesthetics plays a functional role in design (Norman, 2002) and *aesthetic integrity* is also one of the fundamental principles behind the most successful software interfaces of main stream packages.

Fig.15a – Chart IIM 119 (Italian Hydrographic Office), scale 1:20.000. The chart is used as a source for the compilation of the ENC cell IT400119 (compilation scale 1:12.000).

Fig.15b – ENC cell IT400119 displayed on Sam Electronics NACOS (Chart Pilot), in night display, display category "ALL", range 0.75NM (correspondent to a compilation scale of 1:12.000).

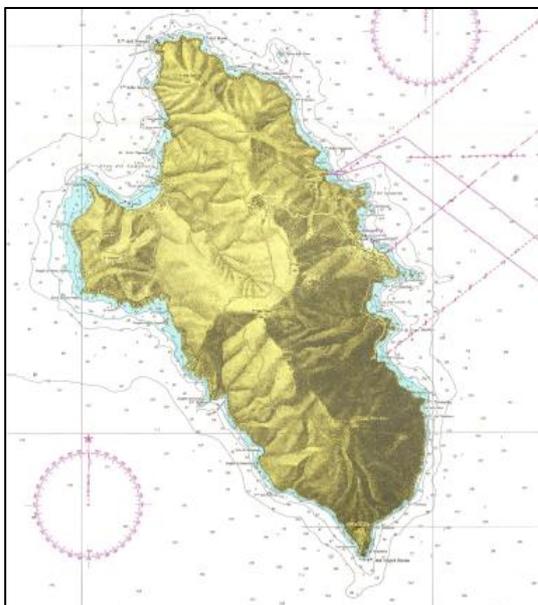
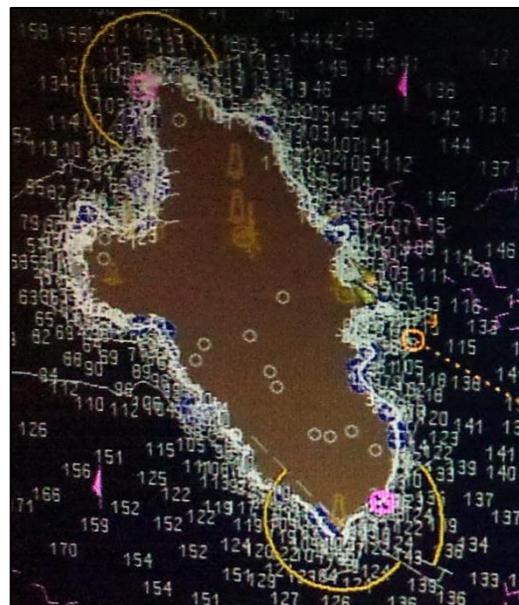
Fig.16a – Chart IIM 119 (Italian Hydrographic Office), scale 1:20.000. The chart is used as a source for the compilation of the ENC cell IT400119 (compilation scale 1:12.000).

Fig.16b – ENC cell IT400119 displayed on Sam Electronics NACOS (Chart Pilot), in night mode, display category "ALL".
