**MARINE INVESTIGATION REPORT
M13N0001**

LOSS OF TOW

**TUG *CHARLENE HUNT* WITH
PASSENGER VESSEL *LYUBOV ORLOVA*
OFF CAPE RACE, NEWFOUNDLAND AND LABRADOR
24 JANUARY 2013**

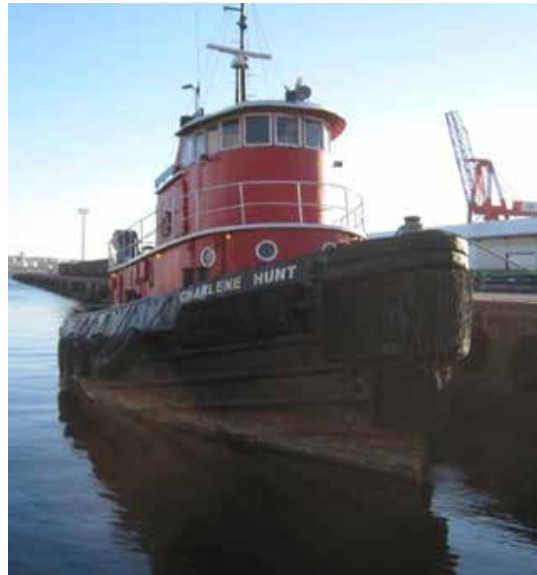
Photo 1. *Charlene Hunt* (photo: Alan Knight)

The *Charlene Hunt* was approaching the end of its normal life cycle and had been out of service for the majority of the 2 years prior to this voyage. It had a number of deficiencies that had not been rectified prior to the voyage, including the following:

- an inadequate towing winch that was unable to stow the minimum recommended length of tow line;
- no load line certificate;
- a lack of structural and watertight integrity, as identified during vessel inspections; and,
- several inoperable pieces of lifesaving equipment and lifesaving equipment that was missing.

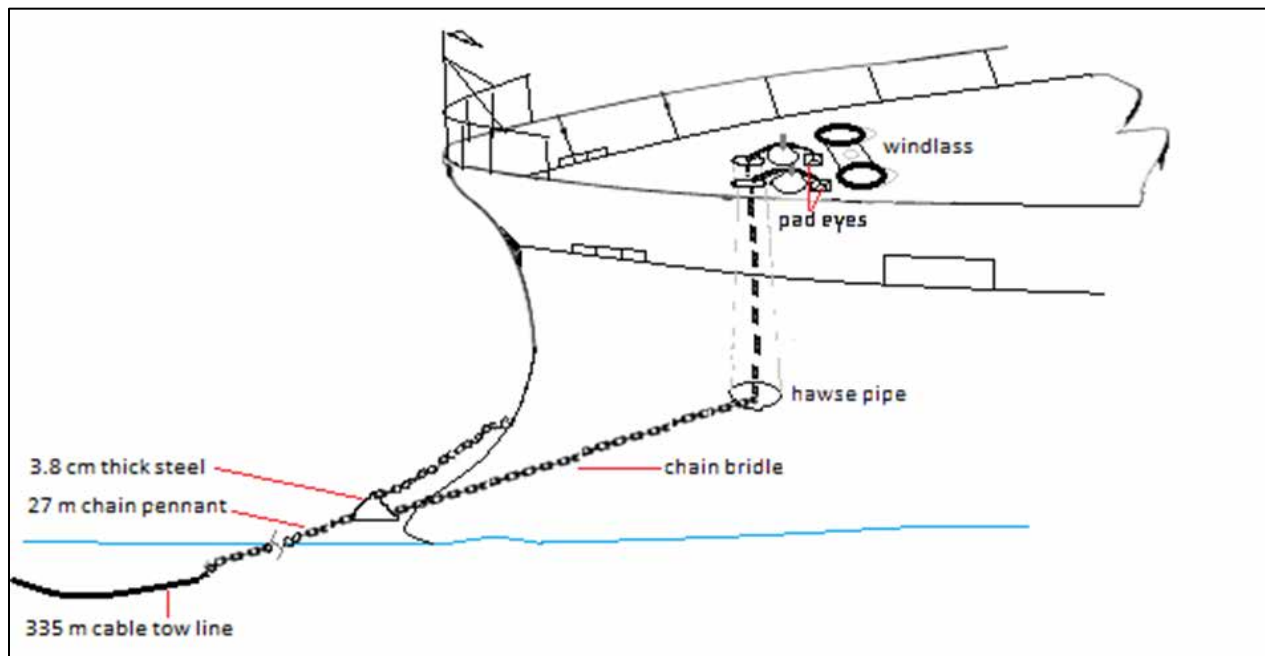
Figure 1. Diagram of the towing arrangement on the *Lyubov Orlova*

The towing arrangement in this occurrence had been constructed mostly using materials salvaged from the *Lyubov Orlova*. The crew selected pieces of used anchor chain with the least wear to construct 2 towing bridles, each long enough to clear the vessel's bulbous bow (Figure 1).

The end of each bridle connected to the forward deck of the *Lyubov Orlova* via shackles and pad eyes that were welded to the deck between the windlass and the hawse pipes.²⁶ From each pad

eye, the bridles passed through an arrangement that secured them on the guide roller and then down corresponding hawse pipes. The used anchor chain failed at the point where the bridles passed through the guillotine/chain stopper²⁷ securing them on the guide roller located on the foredeck of the *Lyubov Orlova*. From the bottom of each hawse pipe, the bridles extended to a 3.8 cm-thick triangular steel plate. Another 27 m piece of salvaged anchor chain shackled to the steel plate served as a pennant. New shackles, each with a 45-ton safe working load, connected all of the towing arrangement components.

After leaving the protective lee of the Newfoundland shore and rounding Cape Race, the tug and tow encountered heavy seas. The *Charlene Hunt* had no additional tow line to pay out to soften the shock load and reduce the strain of the towing arrangement. This strain likely created chafing of a chain link on the guillotine/chain stopper. In addition, the available shock line had not been installed. Subjected to increased forces caused by the combined 40 knots winds, 5-6 m seas, and the course change to starboard into the wind, the chain link eventually failed at the guillotine/chain stopper.

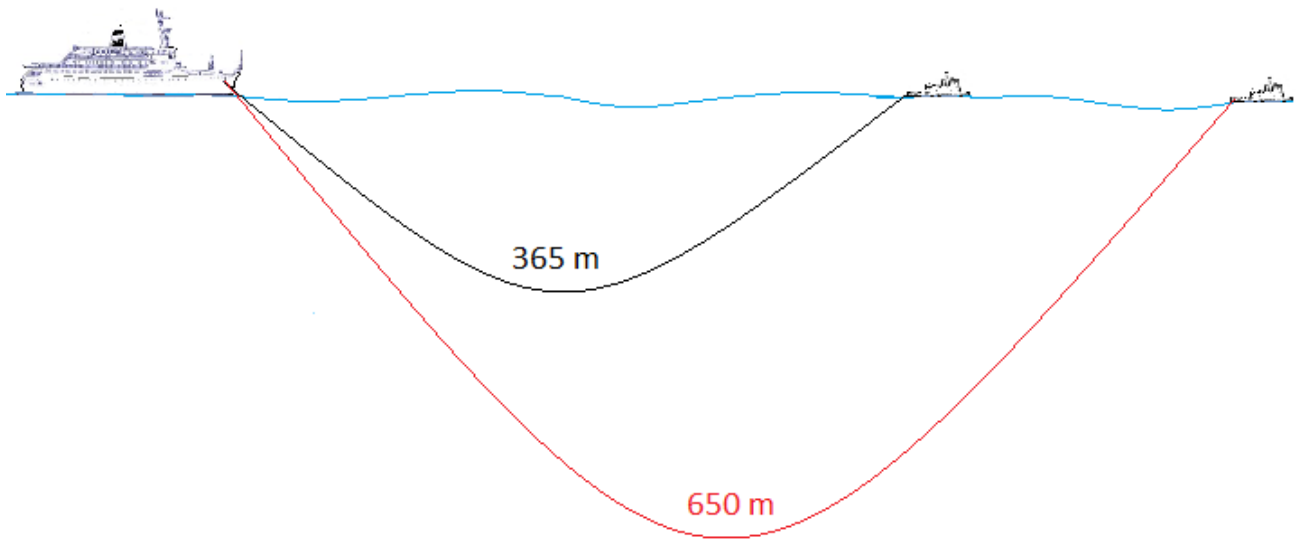
Appendix C – Catenary between tug and tow

In this occurrence, the relief master did not have additional tow line to pay out when the sea conditions increased and was therefore unable to generate the additional catenary necessary to soften the shock load acting on the towing arrangement (Appendix C). Furthermore, although the relief master had identified the need for a shock line and ordered one prior to departure, the crew had difficulties attaching it and the tug and tow left without the shock line becoming a working part of the towing arrangement.

This diagram illustrates how the catenary changes as the length of the tow line increases. A tow line of 650 m absorbs more peak shock loads than a tow line of 365 m.
