MARINE INVESTIGATION REPORT M13C0071

STRIKING AND SUBSEQUENT GROUNDING

**GENERAL CARGO SHIP *CLAUDE A. DESGAGNES*
IROQUOIS, ONTARIO
06 NOVEMBER 2013**

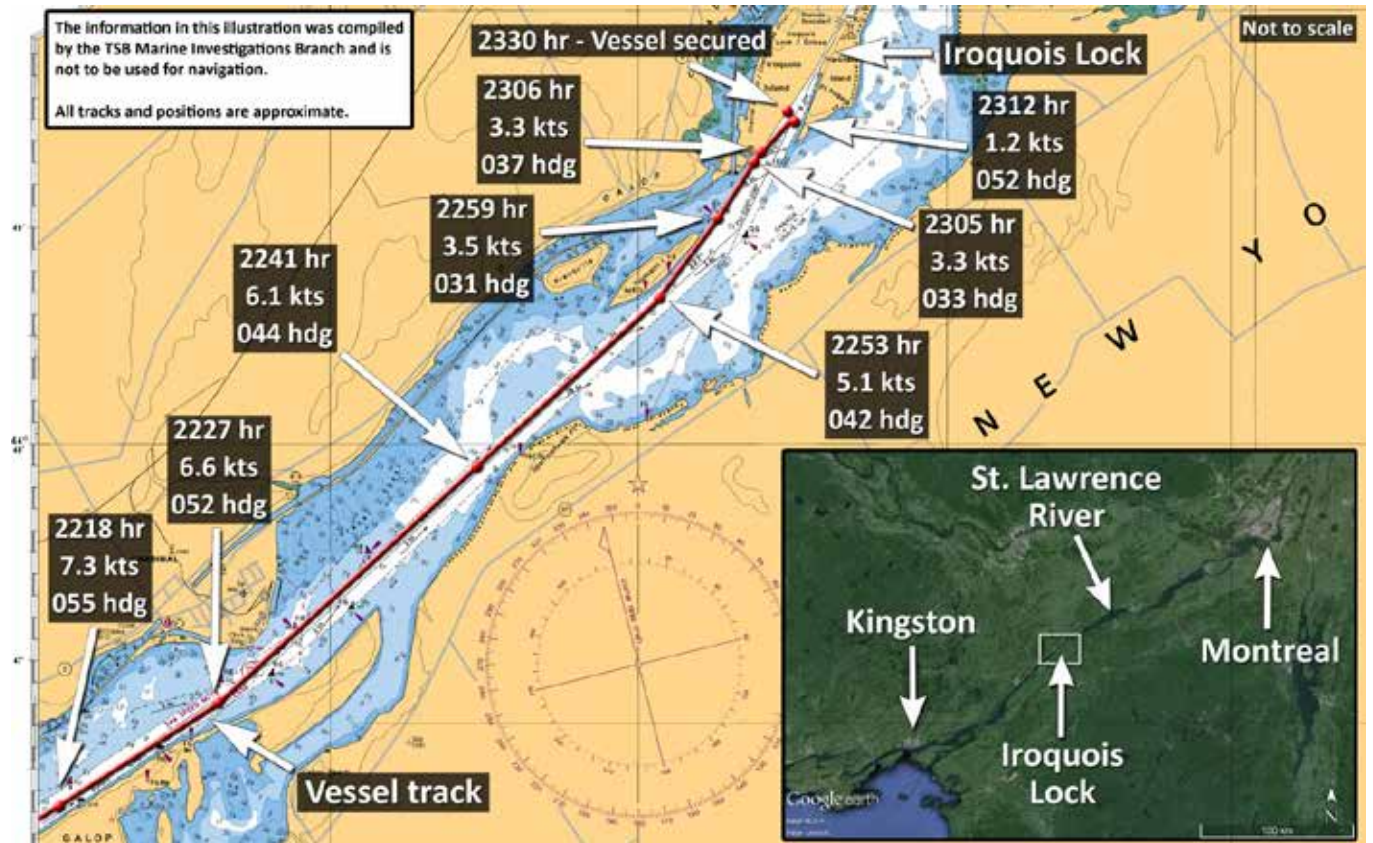
Appendix A – Vessel's route to Iroquois Lock

As the vessel proceeded downriver, the master and pilot spoke, but did not develop a shared understanding of the manoeuvre to be used in the approach to the Iroquois Lock. While the pilot had explained his plan to dredge the anchor to the officer of the watch (OOW) earlier in the voyage, the details of the plan were not relayed to the master when he arrived on the bridge. Although the pilot later informed the master of his intention to carry out the manoeuvre in broad terms, the master did not confirm that he understood or agreed with the manoeuvre. Neither the master nor the pilot discussed the plan further as the vessel approached the lock entrance. When the master ordered that the vessel's speed be reduced, the pilot advised against this due to the direction and force of the current at that time. Although the pilot requested the forward anchors be deployed, each time, the master declined.

When the vessel reached a critical point, close to the lock, the pilot once more requested the use of the anchor to slow down the vessel, but the master did not initiate the pilot's orders. The anchor was not dredged, nor was any other means of slowing down the vessel employed; therefore the vessel continued on its path and struck the upper approach wall. Following the striking, the master and pilot attempted to realign the vessel; however, they were unable to regain control due to the vessel's momentum, the wind, and the current. The vessel crossed the channel and ran aground.

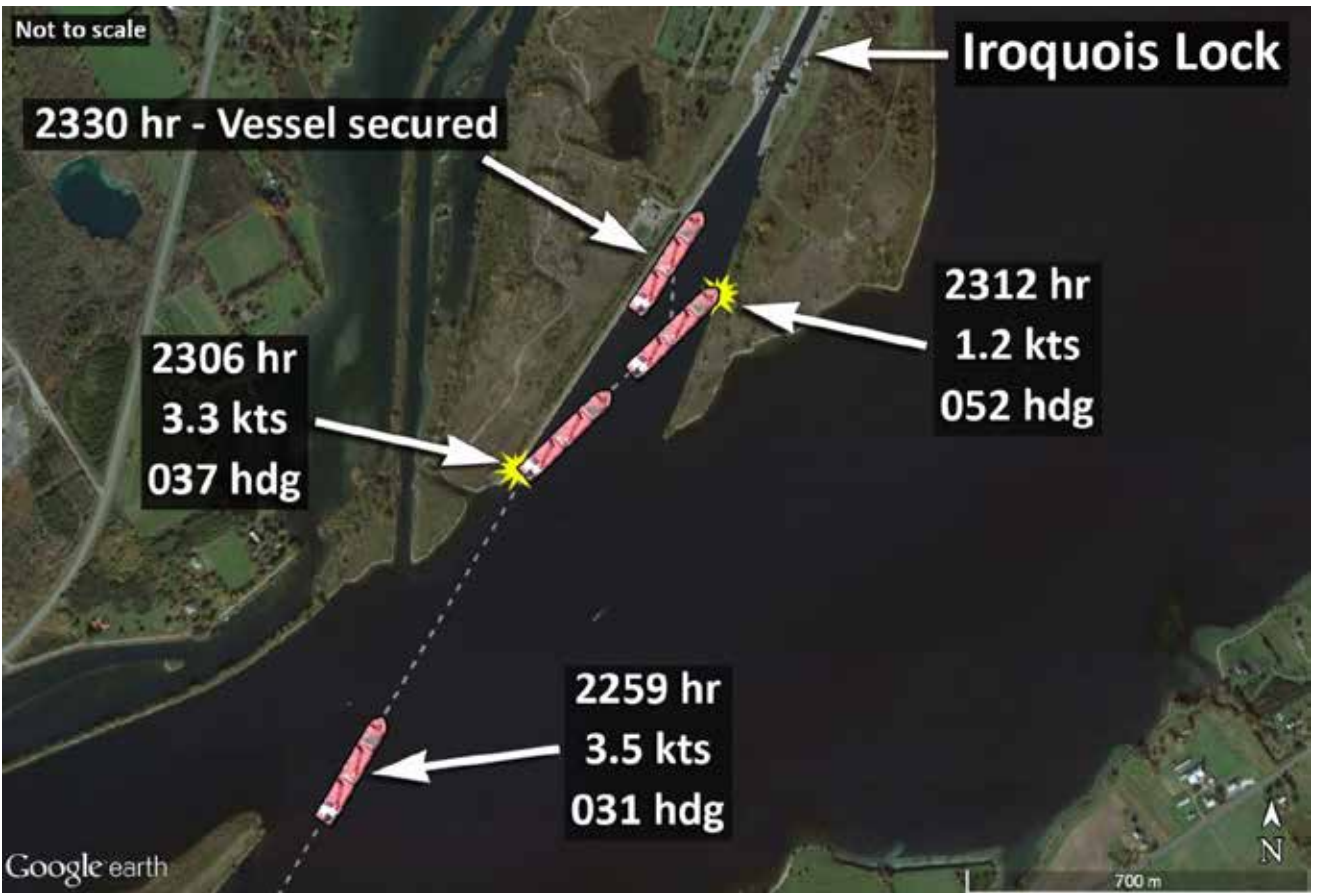
Appendix B – Occurrence location

2306 - Vessel strikes Iroquois Lock upper approach wall

2312 - Vessel runs aground

2330 - Vessel reported secured at Iroquois Lock upper approach wall
