# National Transportation Safety Board

## Marine Accident Brief

### Sinking of Towing Vessel *Nalani*

<b>Accident no.</b>	DCA15LM011
<b>Vessel name</b>	<i>Nalani</i>
<b>Accident type</b>	Sinking
<b>Location</b>	About 1.5 miles west of Barbers Point, Honolulu, Oahu, Hawaii 21° 18.5' N, 158° 09.4' W
<b>Date</b>	January 22, 2015
<b>Time</b>	1510 Hawaii standard time (coordinated universal time – 10 hours)
<b>Injuries</b>	None
<b>Damage</b>	Total loss of vessel, valued at \$200,000
<b>Environmental damage</b>	Oil sheen observed
<b>Weather</b>	Clear skies, winds about 10 knots, 6–8-foot seas, water temperature 77.2°F
<b>Waterway information</b>	Pacific Ocean, about 1.5 miles west of Barbers Point Harbor, water depth about 2,200 feet

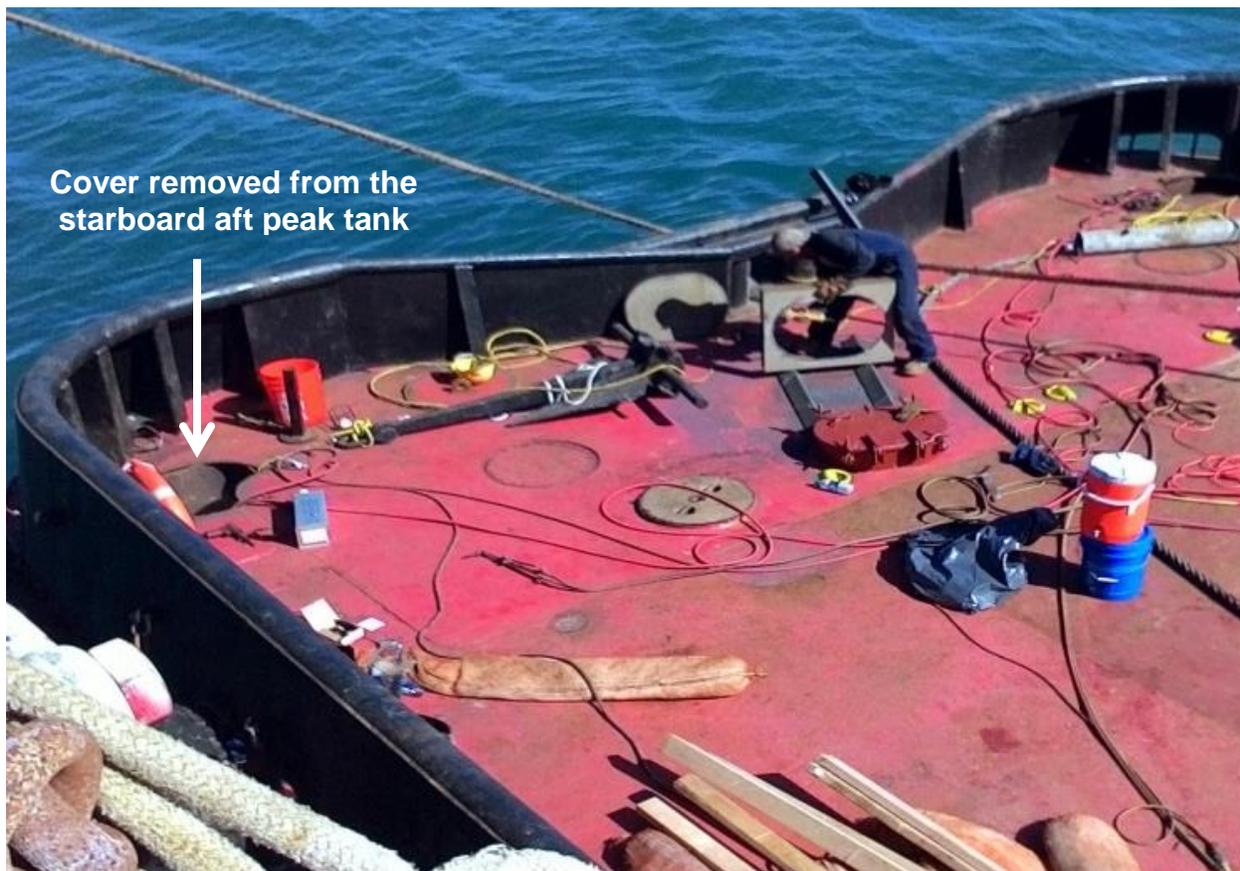
A 30-minute sea trial of the autopilot system was scheduled for 1500 on January 22, 2015, the day before departure. A Hawaii state pilot was requested to join the sea trial, and he arrived about 1415. Earlier that same morning, an owner’s representative directed a shipyard worker to cut out a 20-inch-diameter welded steel plate cover from the starboard side of the stern deck above the starboard aft peak tank. (Steel plates had been welded in place of bolted hatch covers the previous year due to water leakage into the aft peak tanks.) The shipyard worker was told to replace the 20-inch plate with a raised-combing hatch cover, which had threaded bolts for securing.

**Stern of the *Nalani* with its starboard aft peak cover removed. (Photo by *Nalani* crewmember)**

After the steel plate was cut and removed, the shipyard worker went ashore to drill the new cover, but when he returned about 1435, the *Nalani* had already departed for the sea trial. The crew on board the vessel temporarily placed a piece of gasket material over the 20-inch hole in place of the steel cover. This remedy, however, left the starboard aft peak tank vulnerable to

water intrusion and progressive downflooding. The captain told investigators that he was aware of the unsecured opening but decided to get under way for the sea trial anyway.

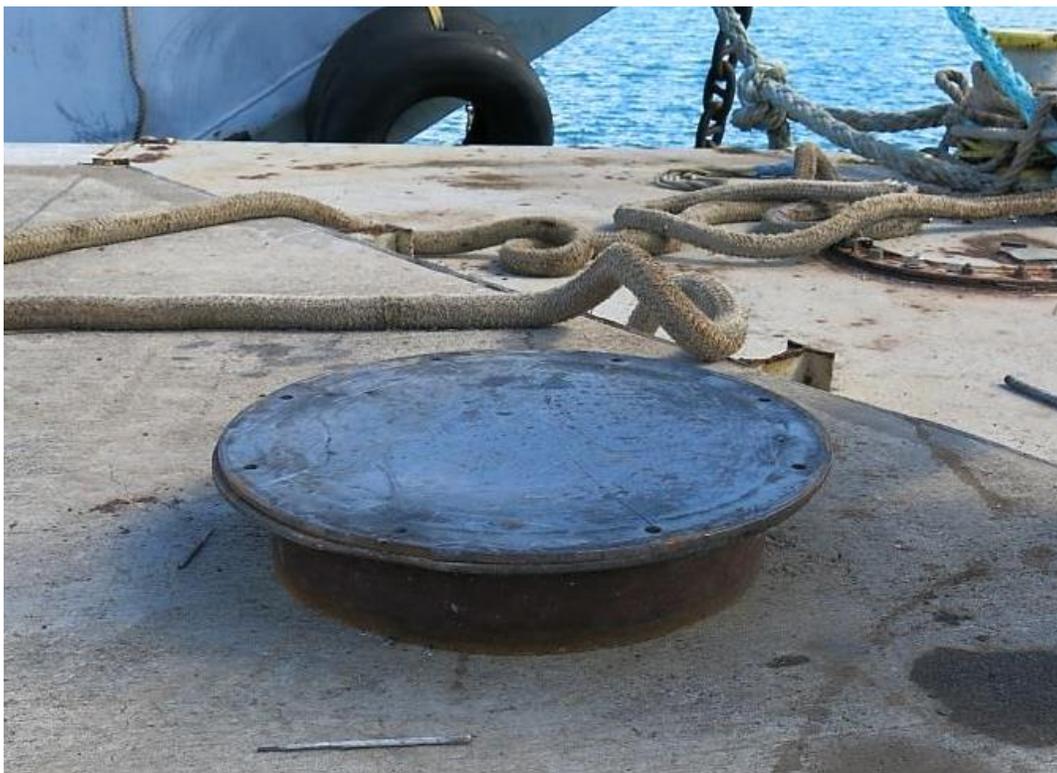
**The replacement cover that was to be installed on the starboard aft peak tank.**

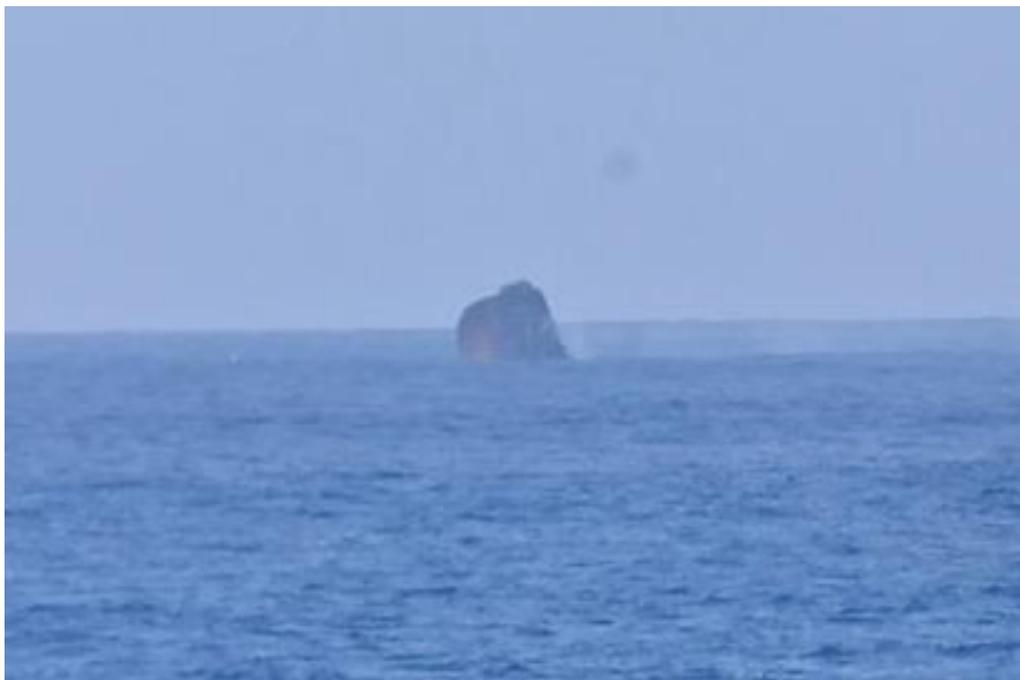
Less than a minute later, the *Nalani* suddenly began listing heavily to port, and the captain sounded the general alarm. The pilot ordered the engines to be stopped, the crew to move to the high side of the vessel, and then to abandon ship. All 11 persons entered the water; the pilot counted everyone and notified the Coast Guard via handheld radio that all persons were off the vessel. Some of the crewmembers were able to board the inflatable auxiliary boat and a liferaft that released from the vessel. About 1531, the *Nalani* listed 45 degrees to port and, about 2 minutes later, 90 degrees to port. About 1533, the stern sank beneath the waves, the bow pointed toward the sky, and the vessel slid beneath the surface and sank at a water depth of about 2,200 feet.

The skyward-pointing bow of the *Nalani* just before the vessel sank. (Photo by *Clean Islands* crewmember)
