**Mooring line failure resulting in serious injury to a
deck officer on board
Zarga
alongside South Hook LNG terminal,
Milford Haven
on 2 March 2015**

MAIB SAFETY BULLETIN 1/2015

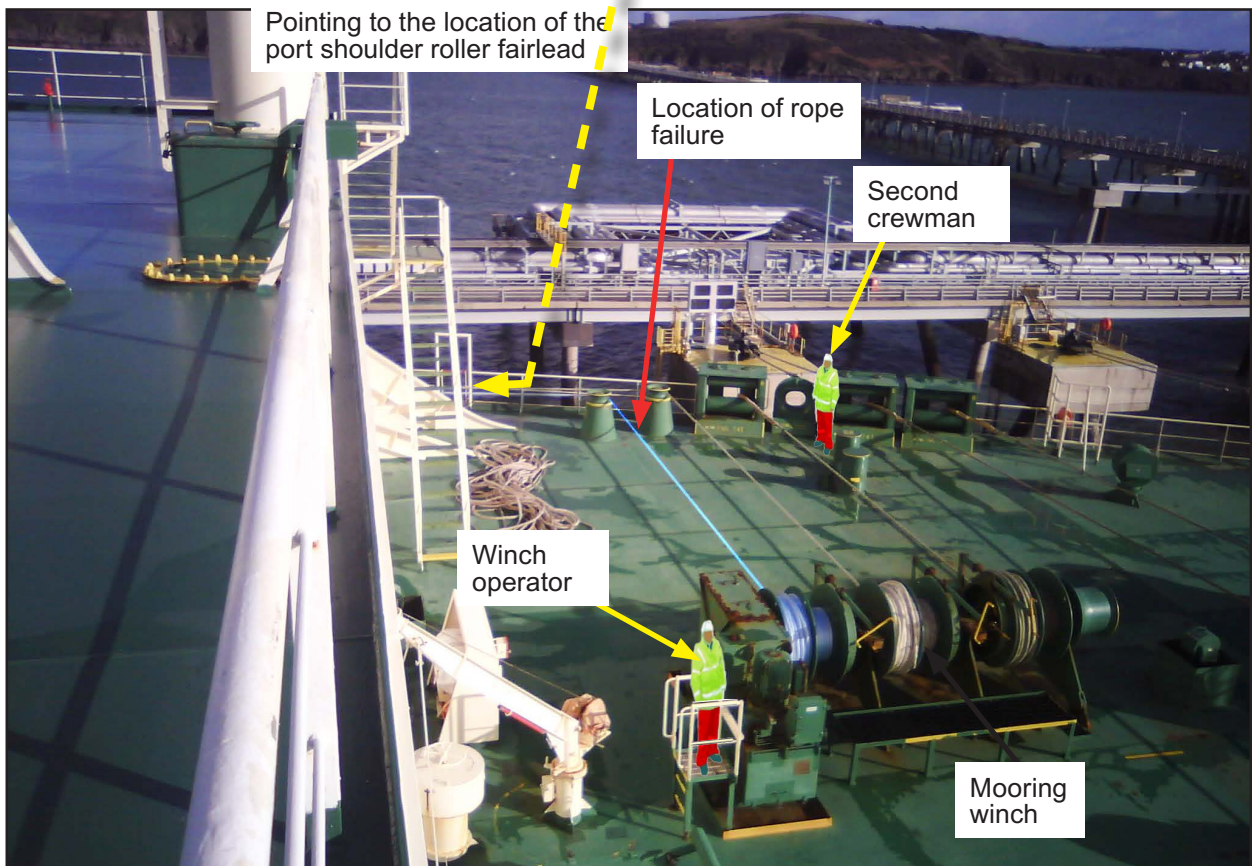
Figure 4: Port side forward mooring deck

- Mooring lines led around roller pedestals and fairleads can lead to potentially complex snap-back zones. Ship operators and masters should conduct their own risk assessments to ensure potential snap-back zones are identified, and are reviewed at regular intervals.
