Bahamas Maritime Authority

Report of the investigation into the loss of
the Bahamian registered tanker "Prestige"
off the northwest coast of Spain
on 19th November 2002

Report of the investigation into the loss of the
Bahamian registered tanker "Prestige" off the
northwest coast of Spain on 19 November 2002

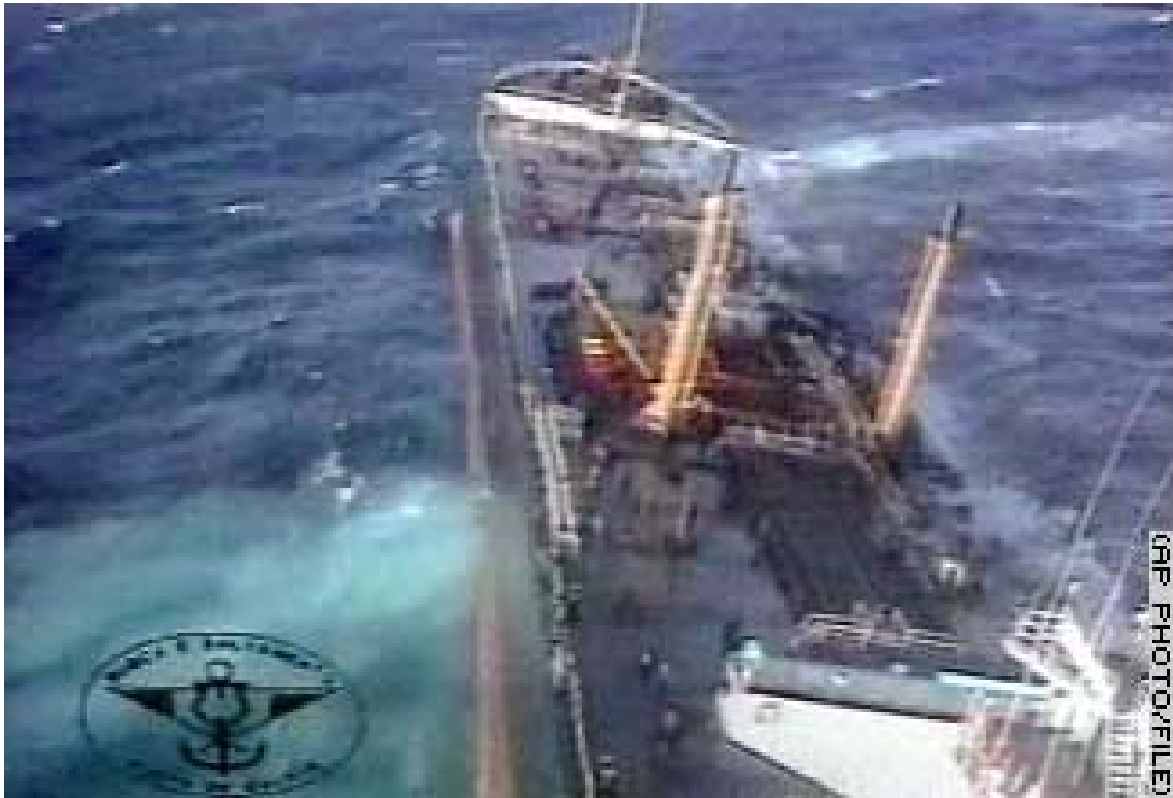
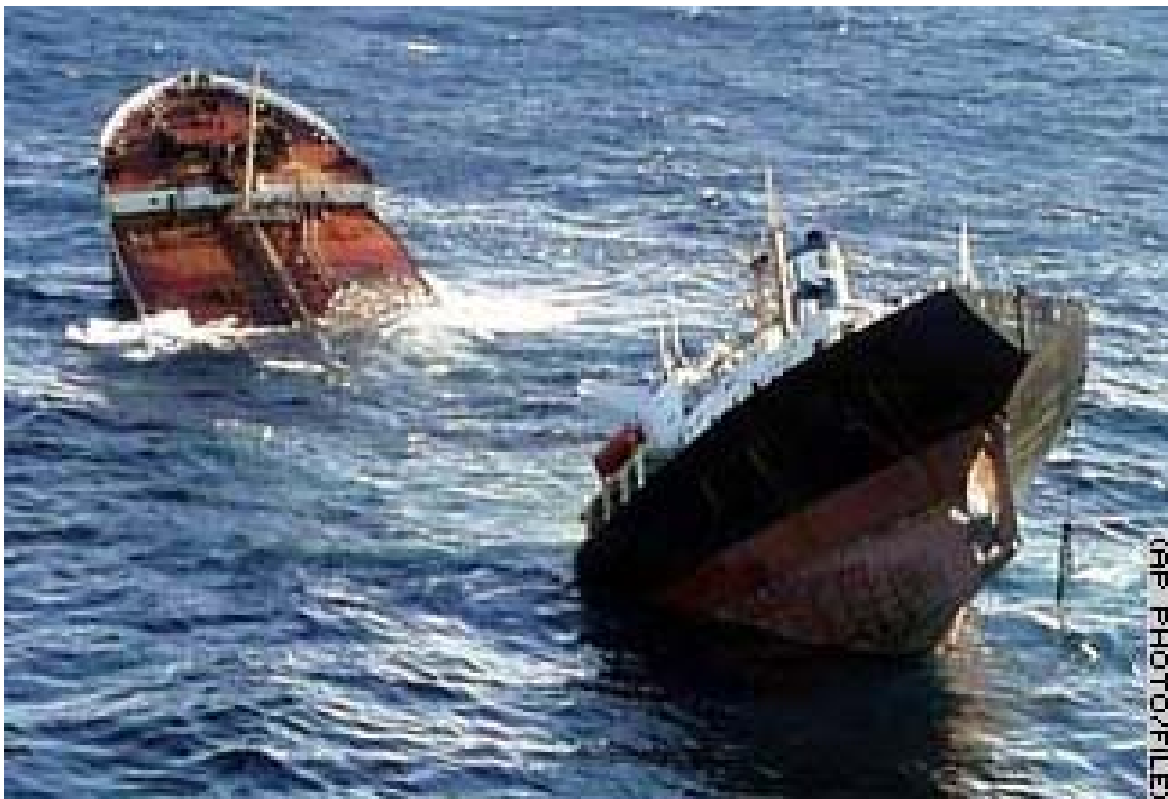
Figure 2

November 13 2002 – Initial list

November 19 2002 – The final breaking up

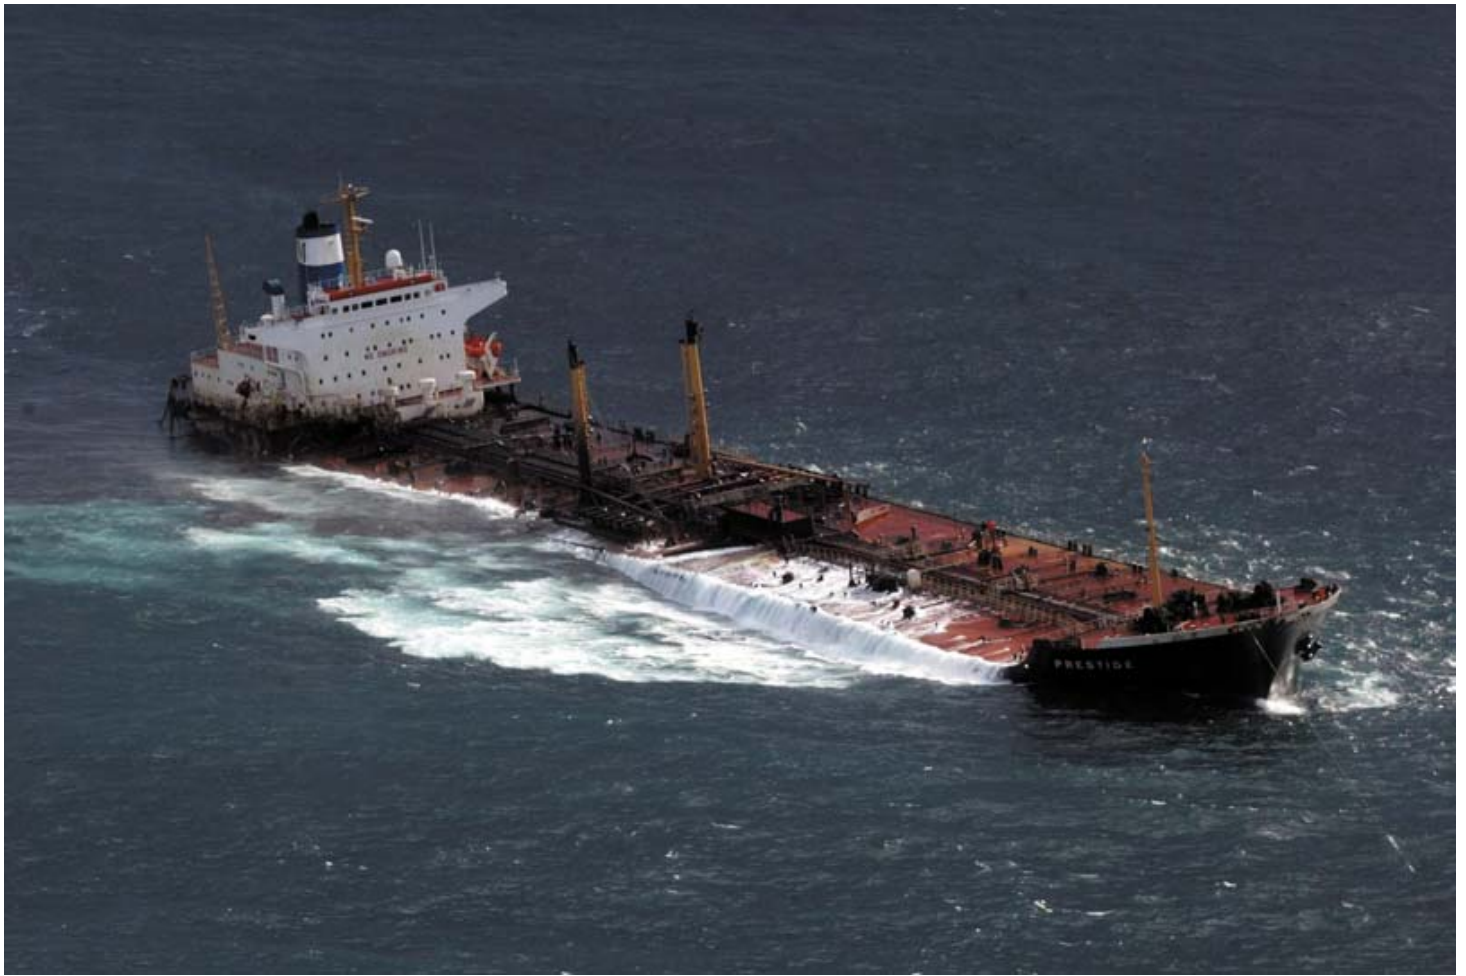
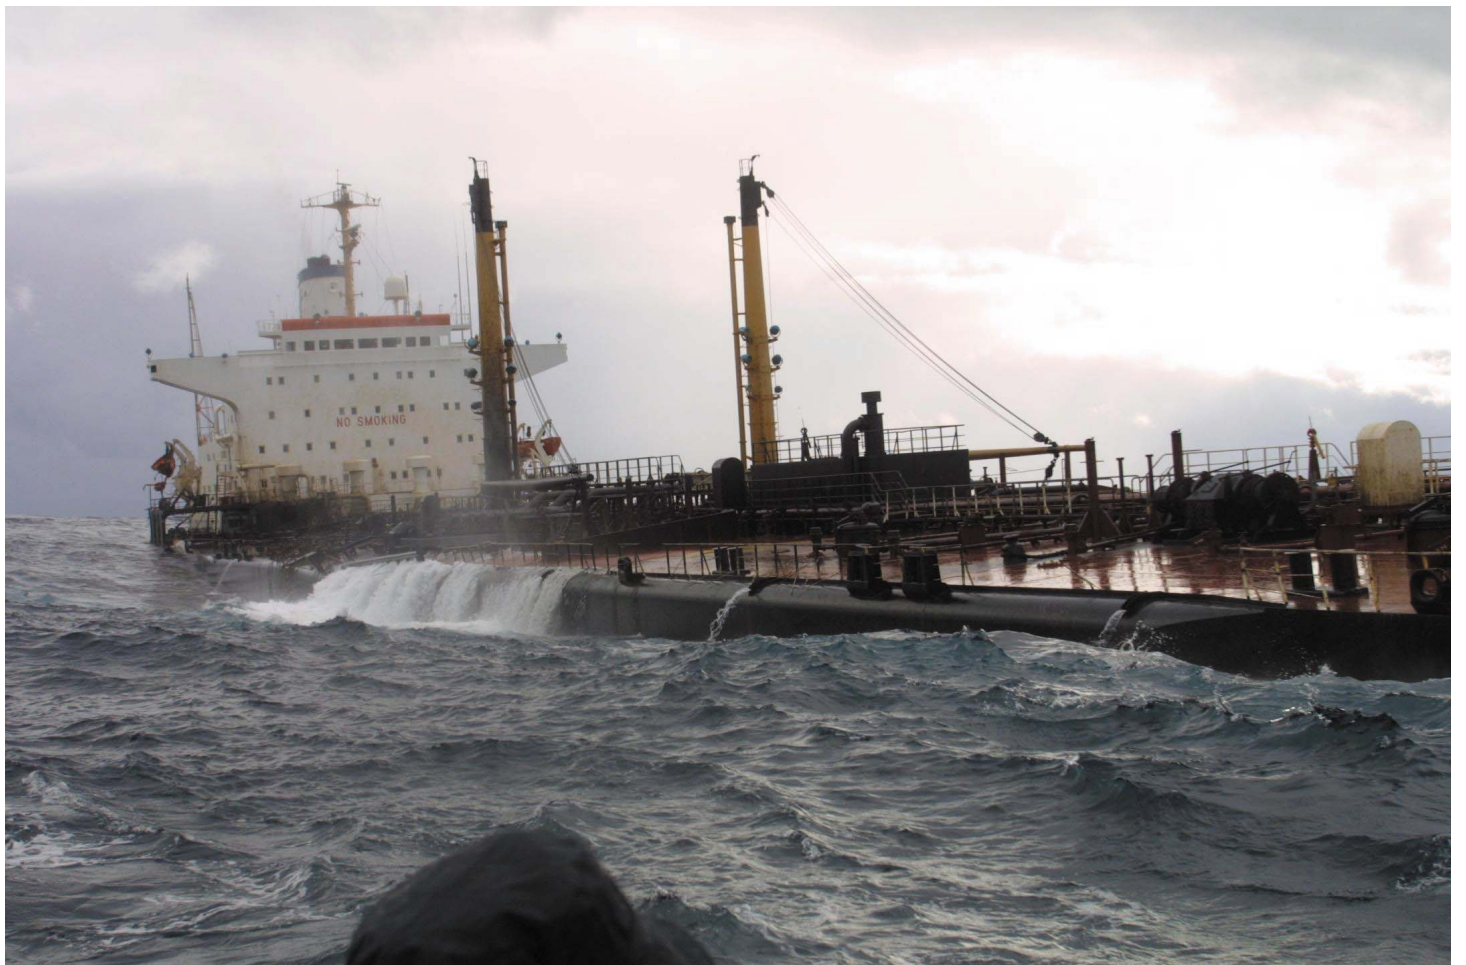
Figure 7

November 14 2002 - General views of the starboard side

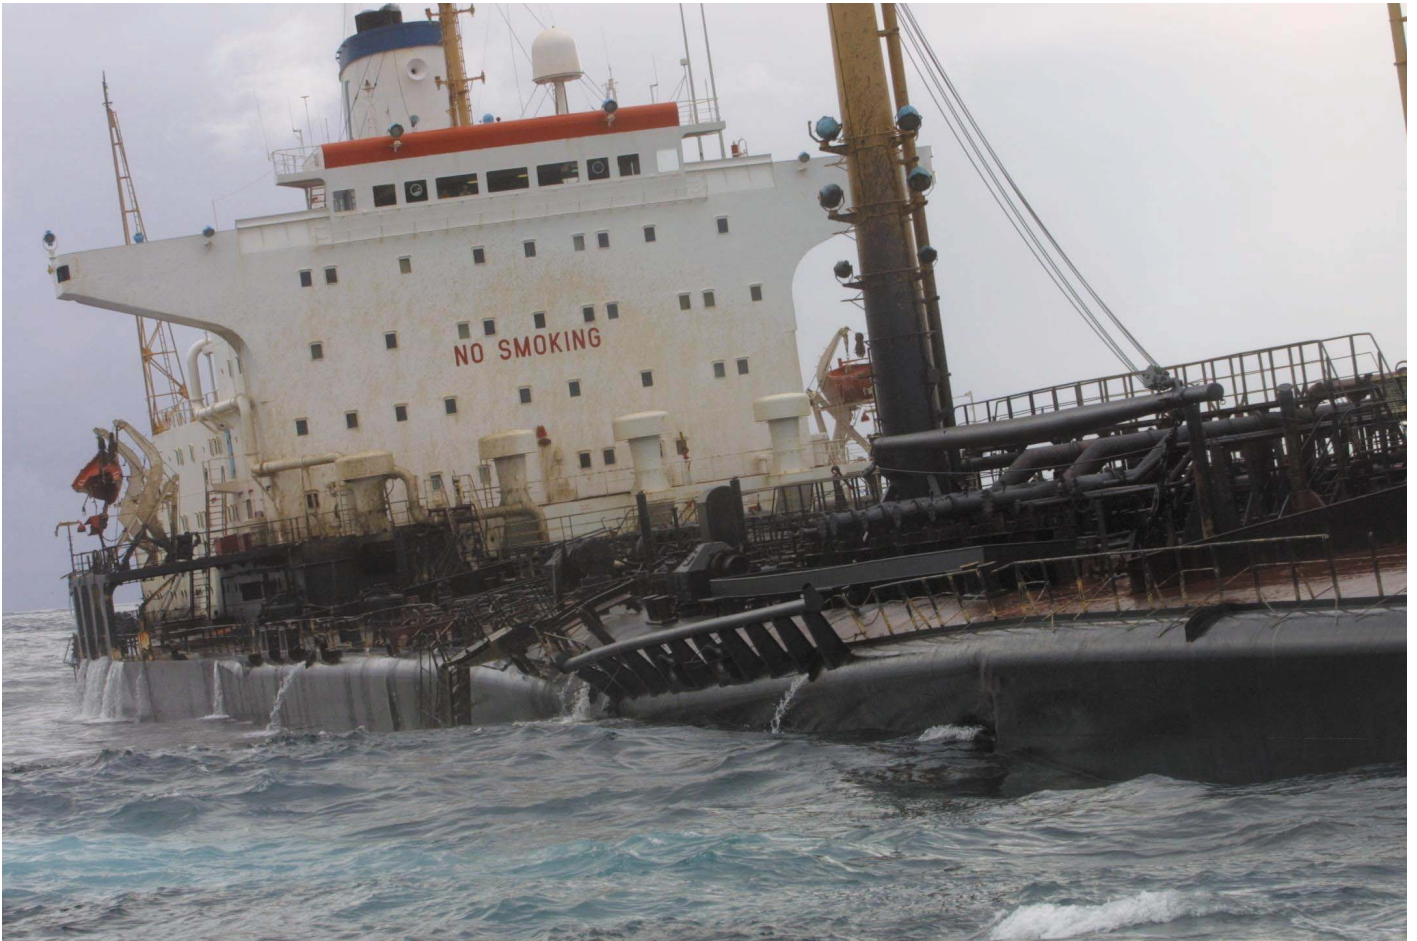
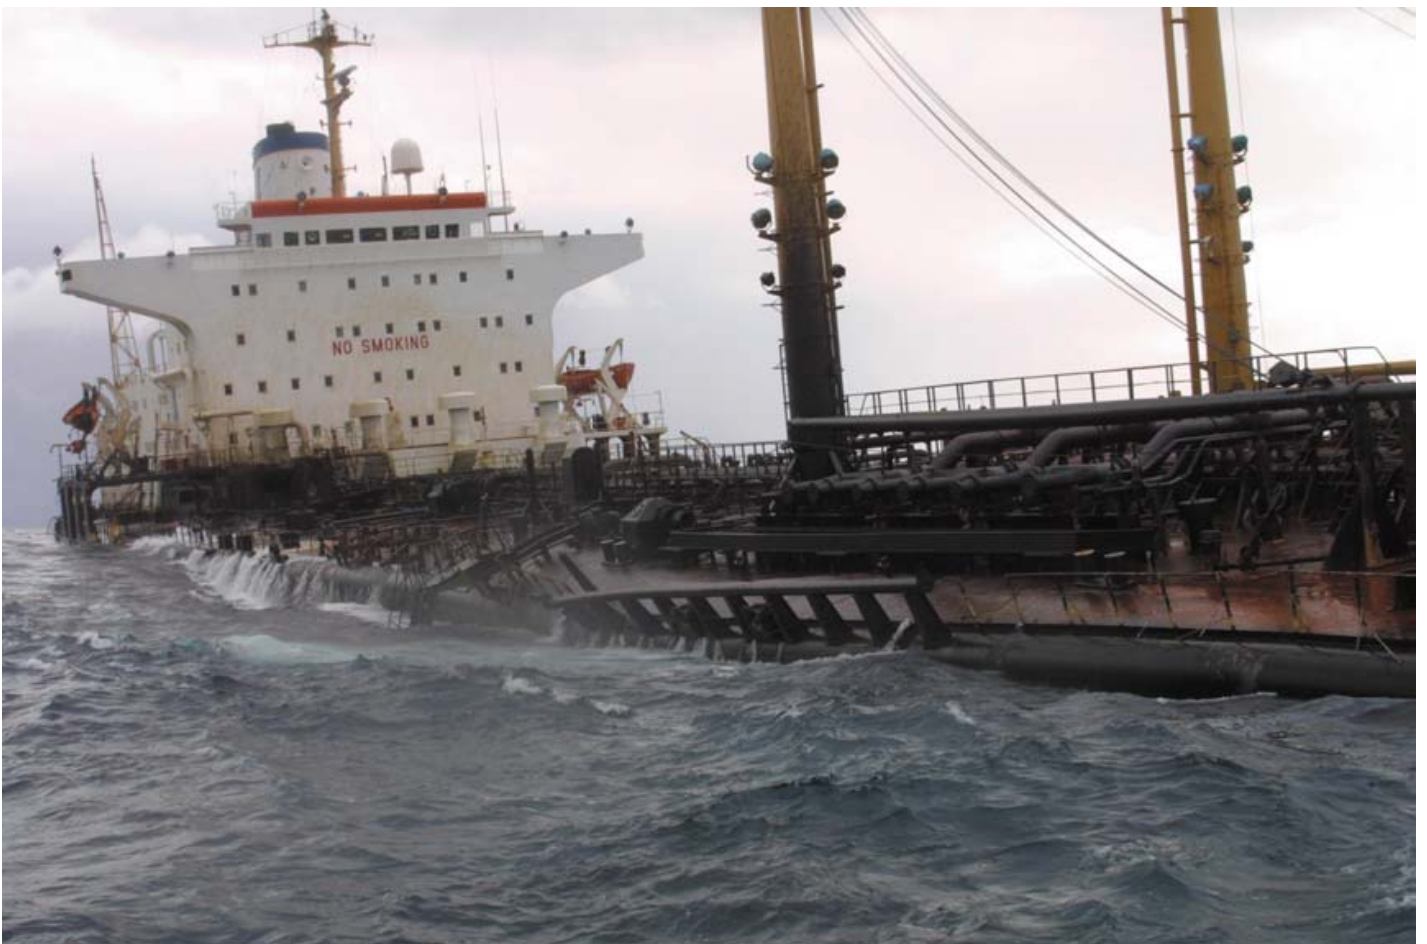
Figure 8

November 14 2002 - Damage to the starboard side (See enlarged views in Figure 9)

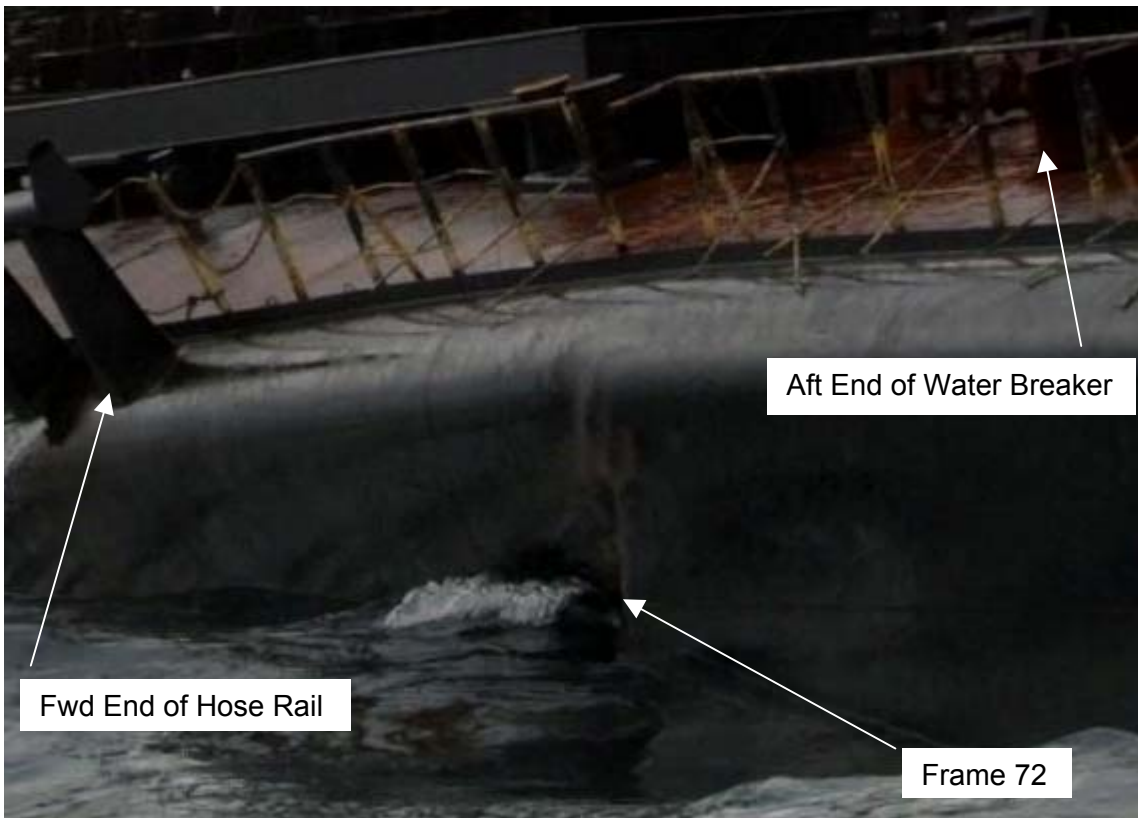
Forward most deformation of main deck edge and side in way of 3 Starboard Ballast Tank and 2 Starboard after wing tank

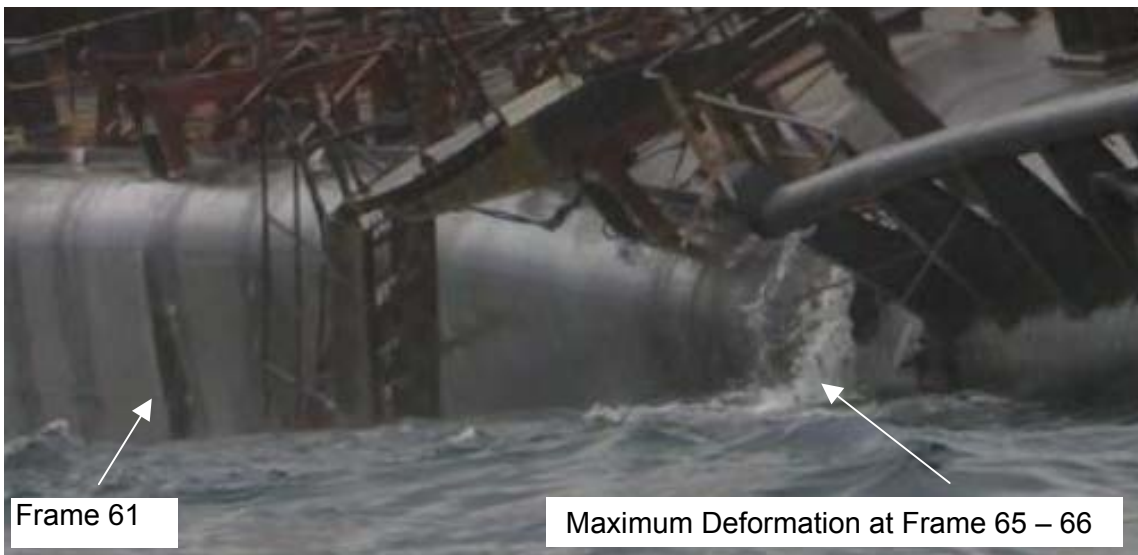
Main deck edge from aft end of 3 Starboard wing tank (Frame 61) to mid length of tank (Frame 65)

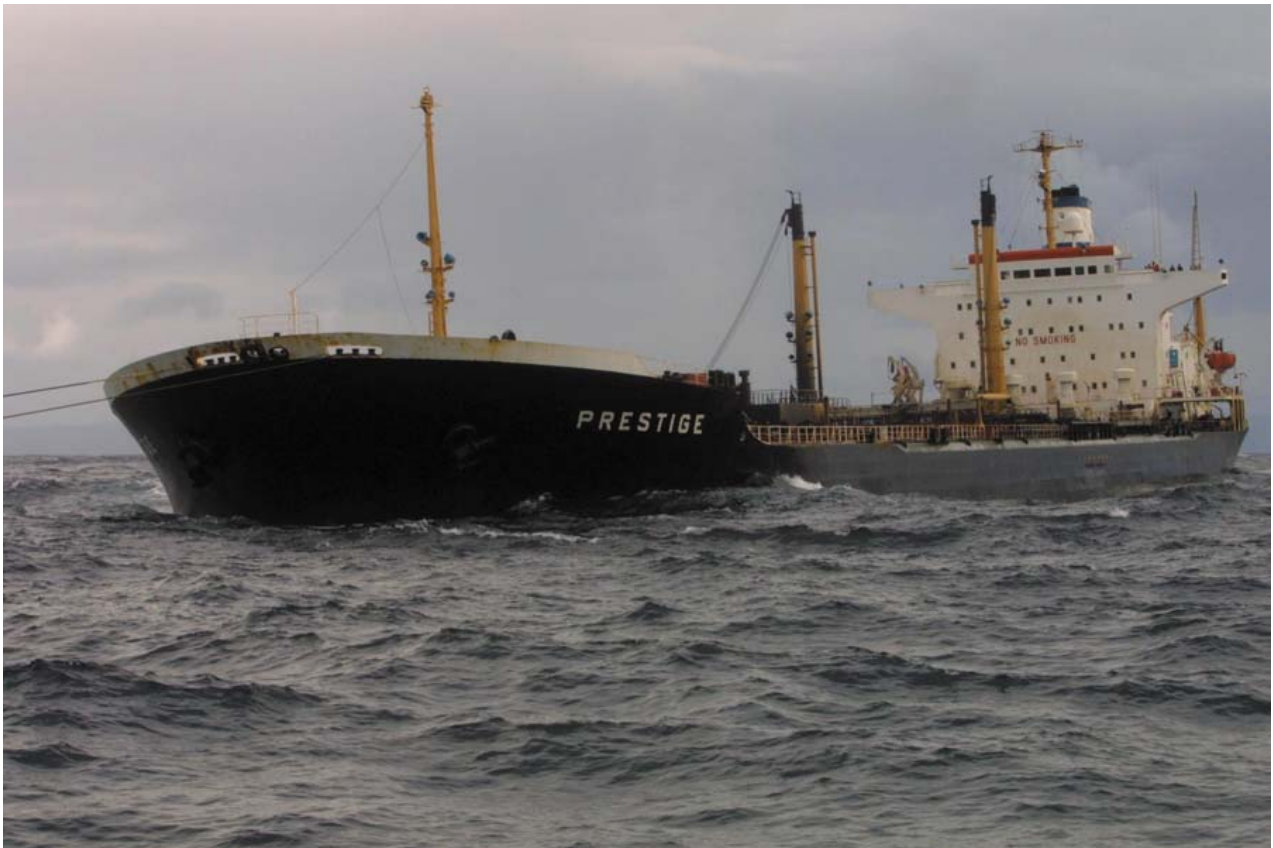
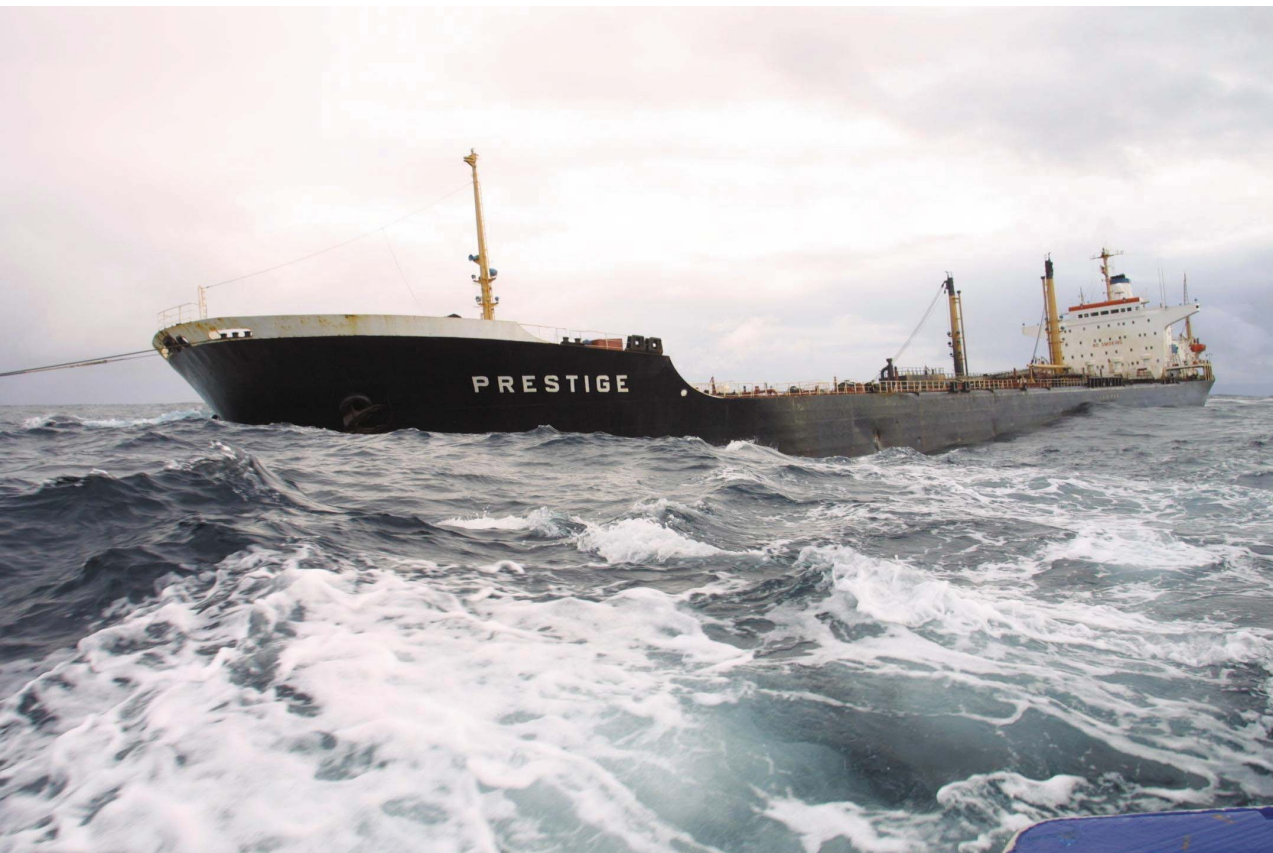
Figure 10

General views of the port side showing setting in of shell plating
(See enlarged views in Figure 11)

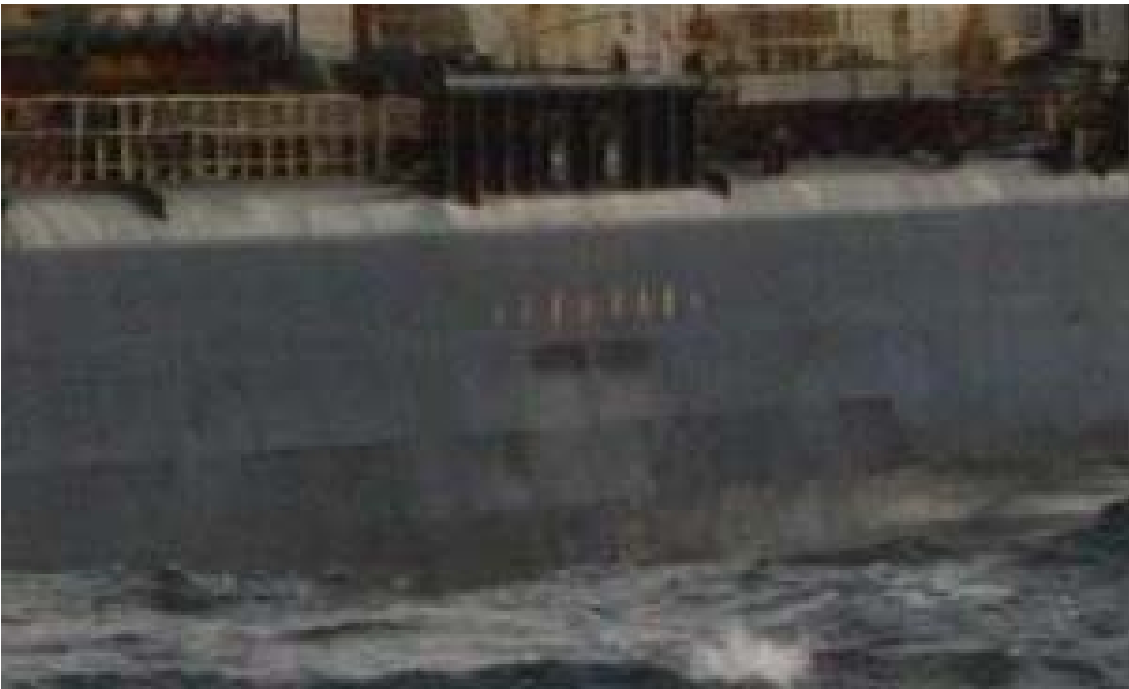
Setting in of shell plating beneath hose rack on port side of the vessel (Between frames 67 and 69)

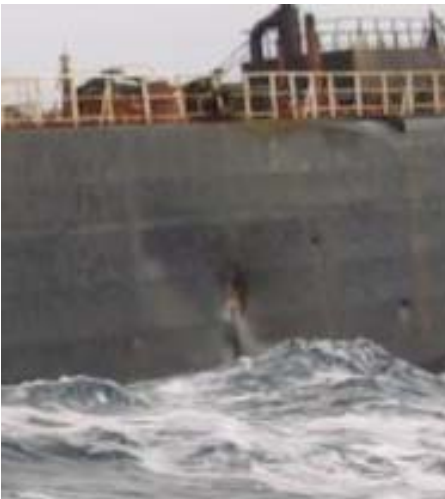
Setting in of shell plating at Frame 85 on port side of the vessel
