# National Transportation Safety Board

## Marine Accident Brief

### Collision of Bulk Carrier *Flag Gangos* with Oil Tanker *Pamisos* and Floating Pier

<b>Accident no.</b>	DCA14FM015
<b>Vessel names</b>	<i>Flag Gangos</i> , <i>Pamisos</i> , <i>WEB235</i>
<b>Accident type</b>	Collision and allision
<b>Location</b>	Mississippi River, Gretna, Louisiana, 29°55.2' N 90°04.1' W (immediately across the river from New Orleans, Louisiana)
<b>Date</b>	August 12, 2014
<b>Time</b>	2215 central daylight time (coordinated universal time – 5 hours)
<b>Injuries</b>	None
<b>Property damage</b>	About \$17.5 million
<b>Environmental damage</b>	About 1,200 gallons of oil spilled onto vessel decks and into the river
<b>Weather</b>	Clear; 10-mile visibility; calm winds; air temperature about 79°F
<b>Waterway information</b>	Mississippi River near New Orleans, Louisiana. The current was moving at 1.5 knots.

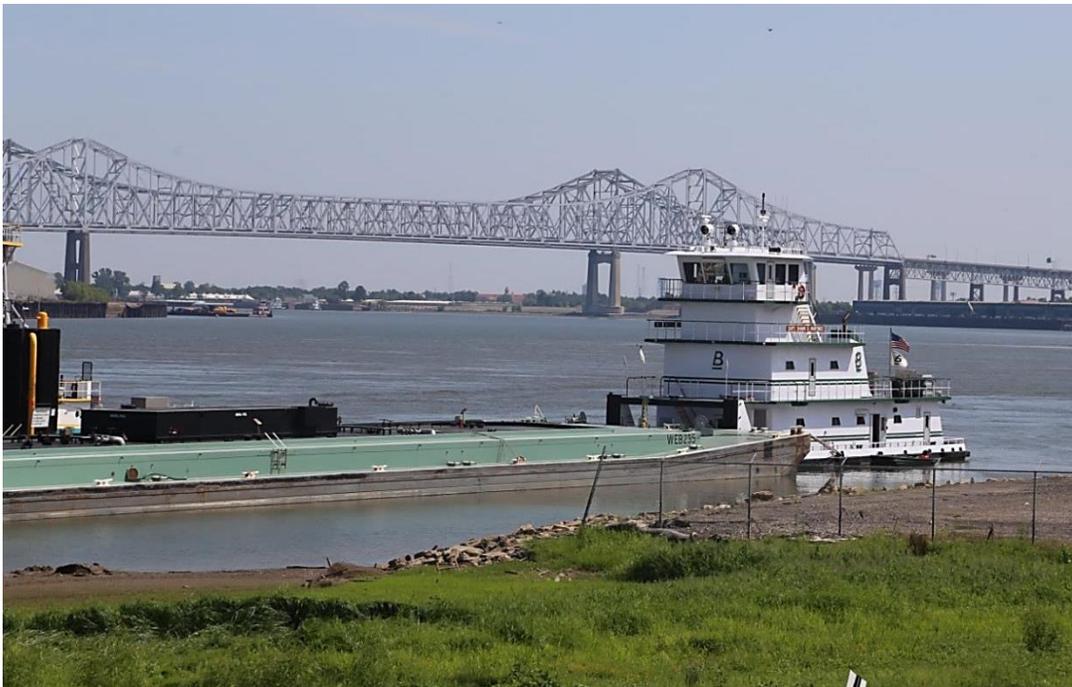
Postaccident photo of towing vessel *Captain Shawn D. Martinez*, made up to fuel barge *WEB235*.

Damage to the *Flag Gangos* totaled more than \$500,000 to the starboard bow section at the main deck and the steering system. The *Pamisos* sustained more than \$500,000 dollars in damage to its starboard quarter. The IMTT terminal sustained about \$16 million in damage to the floating pier, loading arms, piping systems, and dolphins (clusters of closely driven piles for mooring). Barge WEB235 sustained about \$418,000 in damage to the no. 4 portside wing tank deck, side shell, and knuckle (a point where two surfaces meet at an angle), as well as to the no. 3 portside longitudinal bulkhead. The *Captain Shawn D. Martinez*, to which the WEB235 was made up, was not damaged.

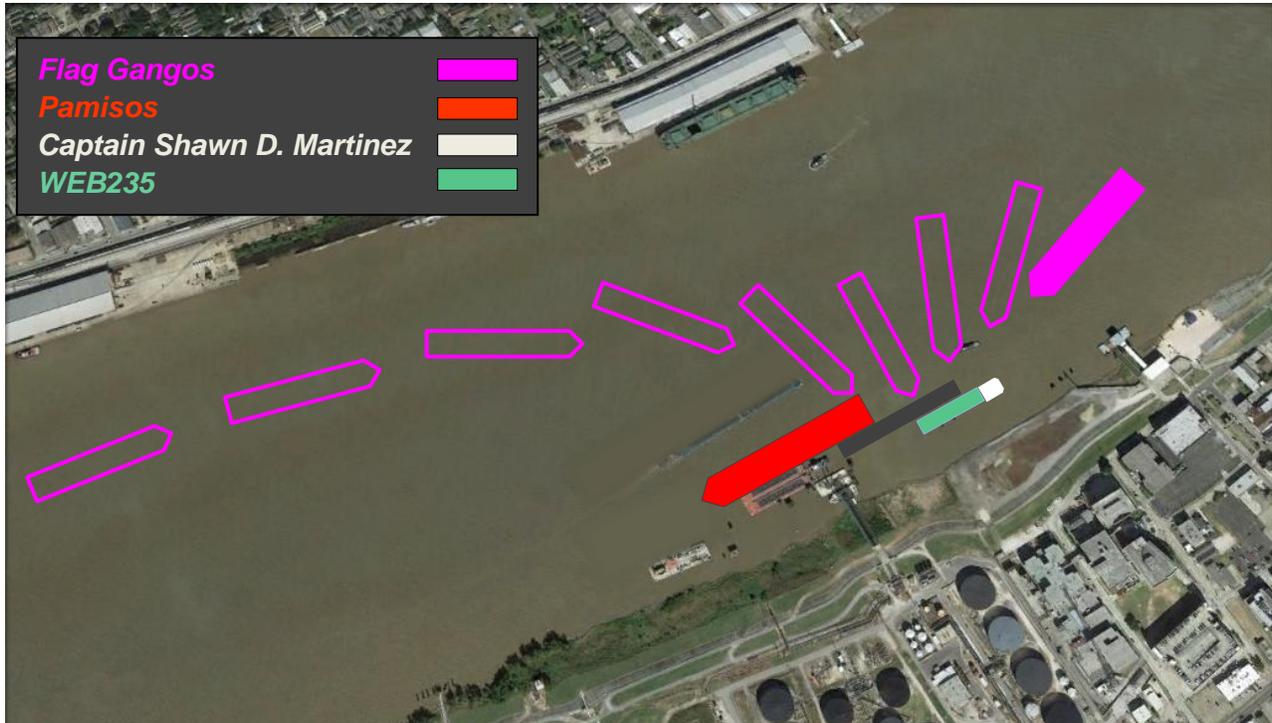
Aerial view depicting the approximate trajectory of the *Flag Gangos* as it approached the IMTT facility, struck the starboard quarter of the *Pamisos* and the floating pier, which then struck barge WEB235. Ultimately, the *Flag Gangos* turned around in the river due to the effect of the current. Overlaid symbols depicting the vessels and their positions are approximate. (Background by Bing Maps)

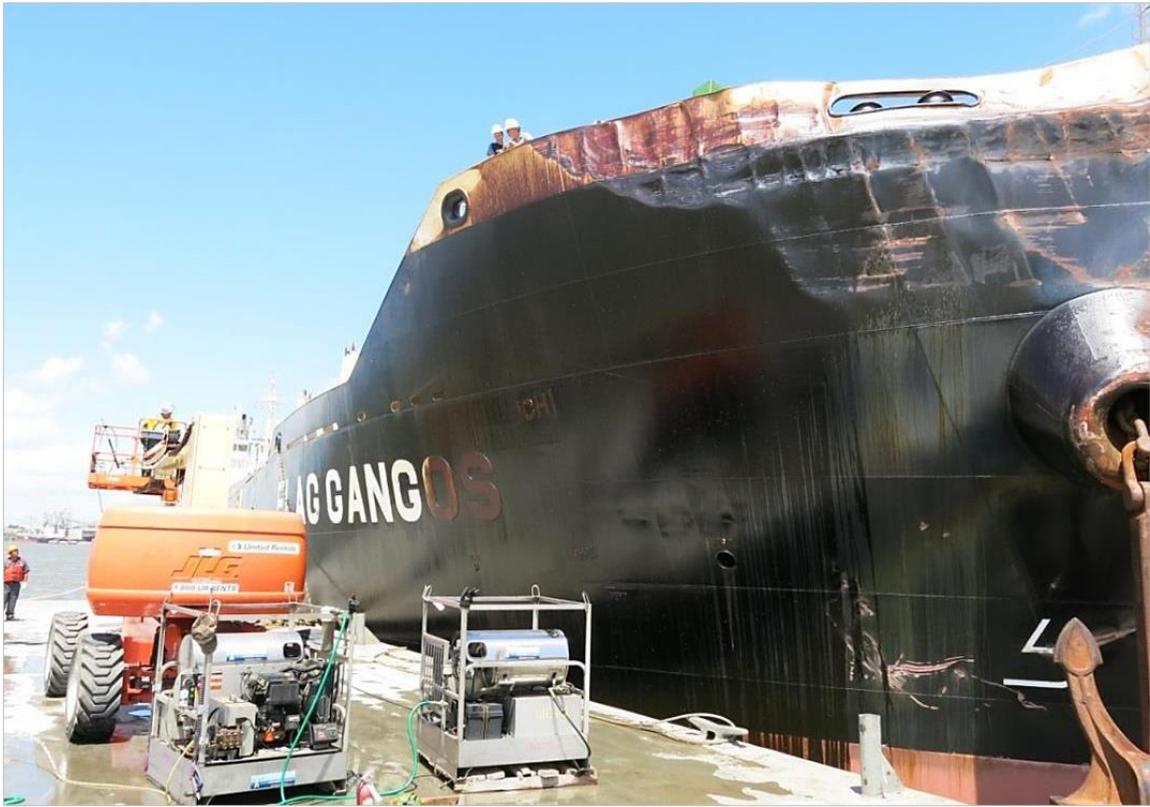
**Damage to the upper starboard side and bulwark of the *Flag Gangos* near the bow.**

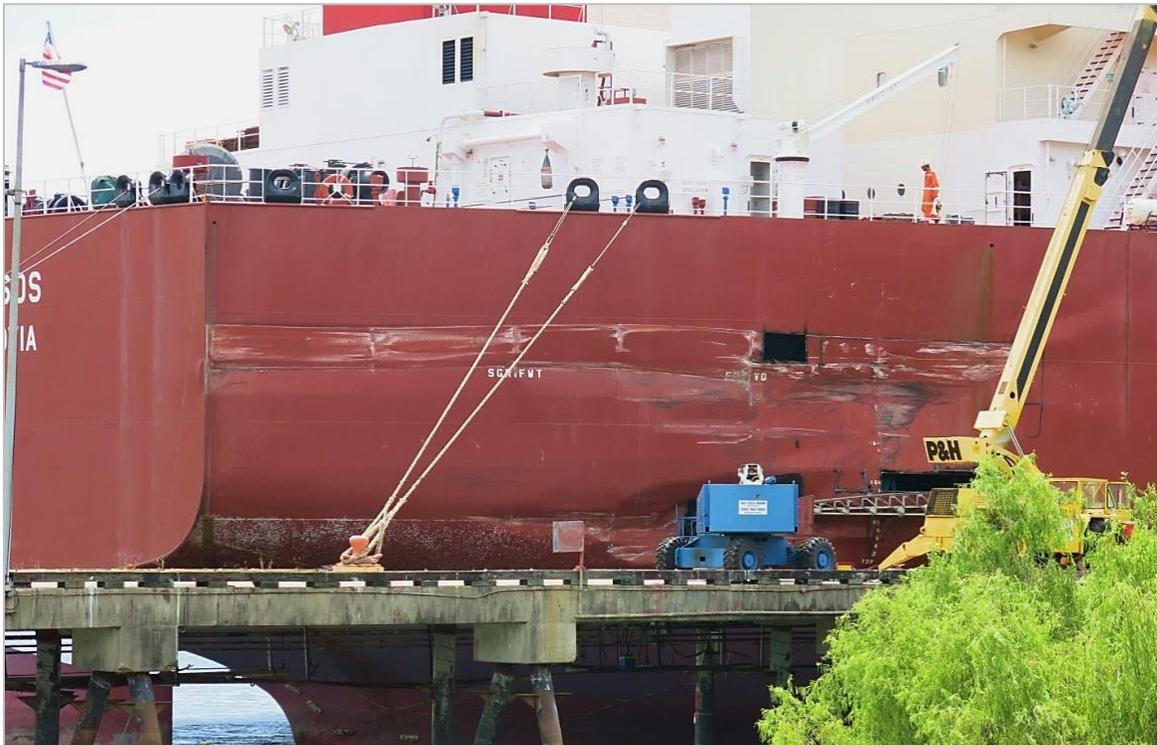
**Damage to the starboard quarter of the *Pamisos*.**

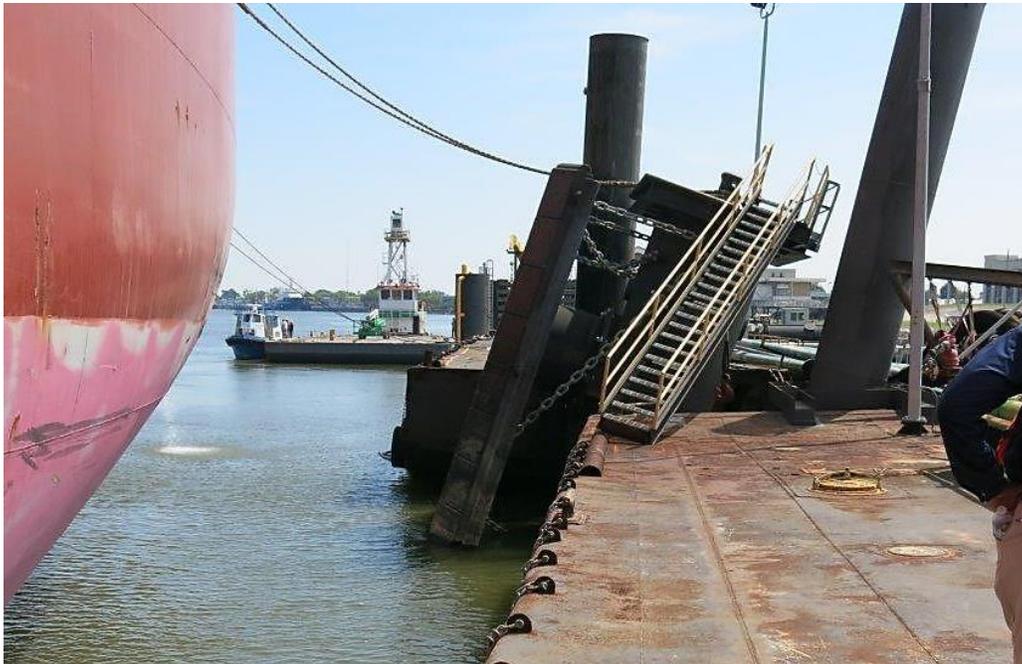
**Damage to the pilings at the IMTT facility pier.**

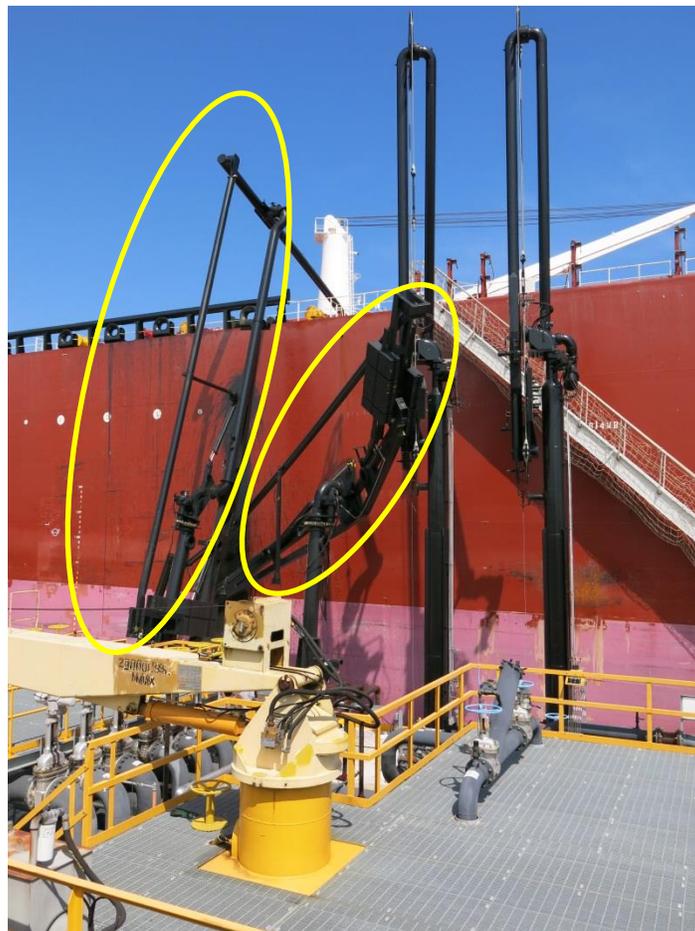
**Damage to the loading arms at the IMTT facility pier. The loading arm on the right is undamaged; the middle arm shows moderate damage, and the left arm is extensively damaged.**
