## Collision during port approach

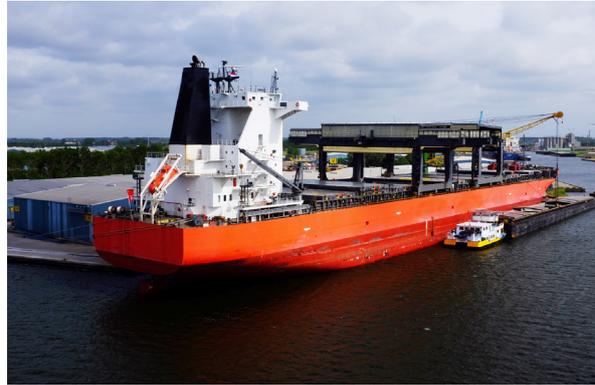
was on the port quarter 3M astern. The master acquired the cruise ship on the radar. It was inbound for the pilot station. The cruise ship was maintaining a speed of 16 knots. It became apparent that the cruise ship was overtaking the vessel and that their plan was to do this on the port side. According to the ARPA the CPA would be very close. The master reduced the speed to increase the CPA for the cruise ship.

On the vessel the Chief Officer reported to the master that the cruise ship was 3 cables off their port quarter. The master became concerned as the radar vectors indicated that the cruise ship would cross just ahead if it maintained its course. He reduced speed to half ahead to let the cruise ship cross in front.

The cruise ship crossed the vessel's bow and altered to starboard, while at the same time reducing its speed.

The bulk carrier could not avoid the cruise ship and hit it just astern of midship.

50 cabins were damaged, and the starboard side was ripped open on the cruise ship. No injuries occurred. Both vessels had to be repaired in a dry dock.

- If a situation is unclear it is very important not to let assumptions dictate, and to seek clarification.
- To prevent a situation like this, both masters should have asked for clarification from the pilot station over the VHF at an early stage before the risk of collision was apparent.

- The cruise ship was overtaking and should have stayed out of the way of the bulk carrier as per rules 13 and 16.
- The cruise ship also altered to starboard and reduced speed after it had crossed the bow of the bulk carrier. This could also be considered a breach of rule 34.

- The bulk carrier was the stand-on vessel as per rule 17 and should have maintained its course and speed until it was apparent that the cruise ship could not avoid collision.
