MARINE SAFETY INVESTIGATION REPORT

Safety investigation into the allision involving the
Maltese registered bulk carrier

CAPRI

MARINE SAFETY INVESTIGATION REPORT NO. 12/2016

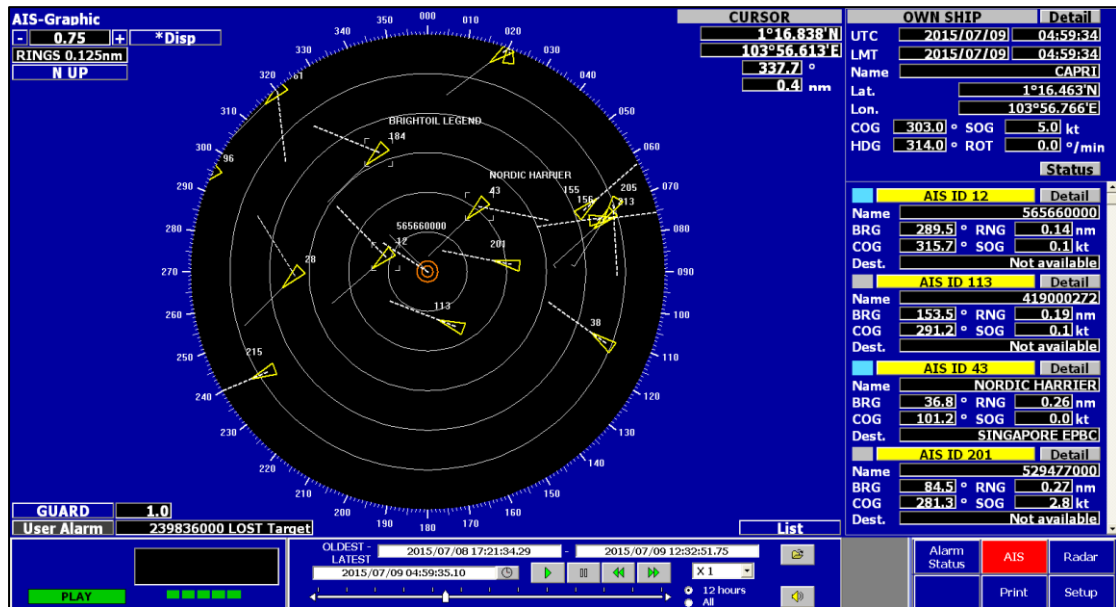
Figure 3: VDR image of *Capri* at 1259/34s

The bow of *Capri* on heading 303° cleared *Tai Health*. At 1259, the engines were stopped and the helm was set to midship. Shortly afterwards, the pilot ordered the helm hard over to port. With the engine control set to slow astern and half astern, he directed the crew to let go the port anchor (Figure 3).

Analysis of the pilot's actions recorded on the VDR indicated that the vessel was being readied for anchoring. The relative positions of *Tai Health* (AIS ID 12), *Nordic Harrier* and *Brightoil Legend* at 1259/34 s are shown in Figure 3. With the engines running on slow astern and half astern, she dropped port anchor in 25 m of water at 5 knots. *Capri* passed *Tai Health* and entered Eastern Special Purposes Anchorage where *Brightoil Legend* was anchored. The sluggish engine response caused by the shallows and a strong transverse thrust pushed the bow to starboard. Subsequent running of the engines full astern to take all way off the ship exacerbated the starboard cant towards *Brightoil Legend*.

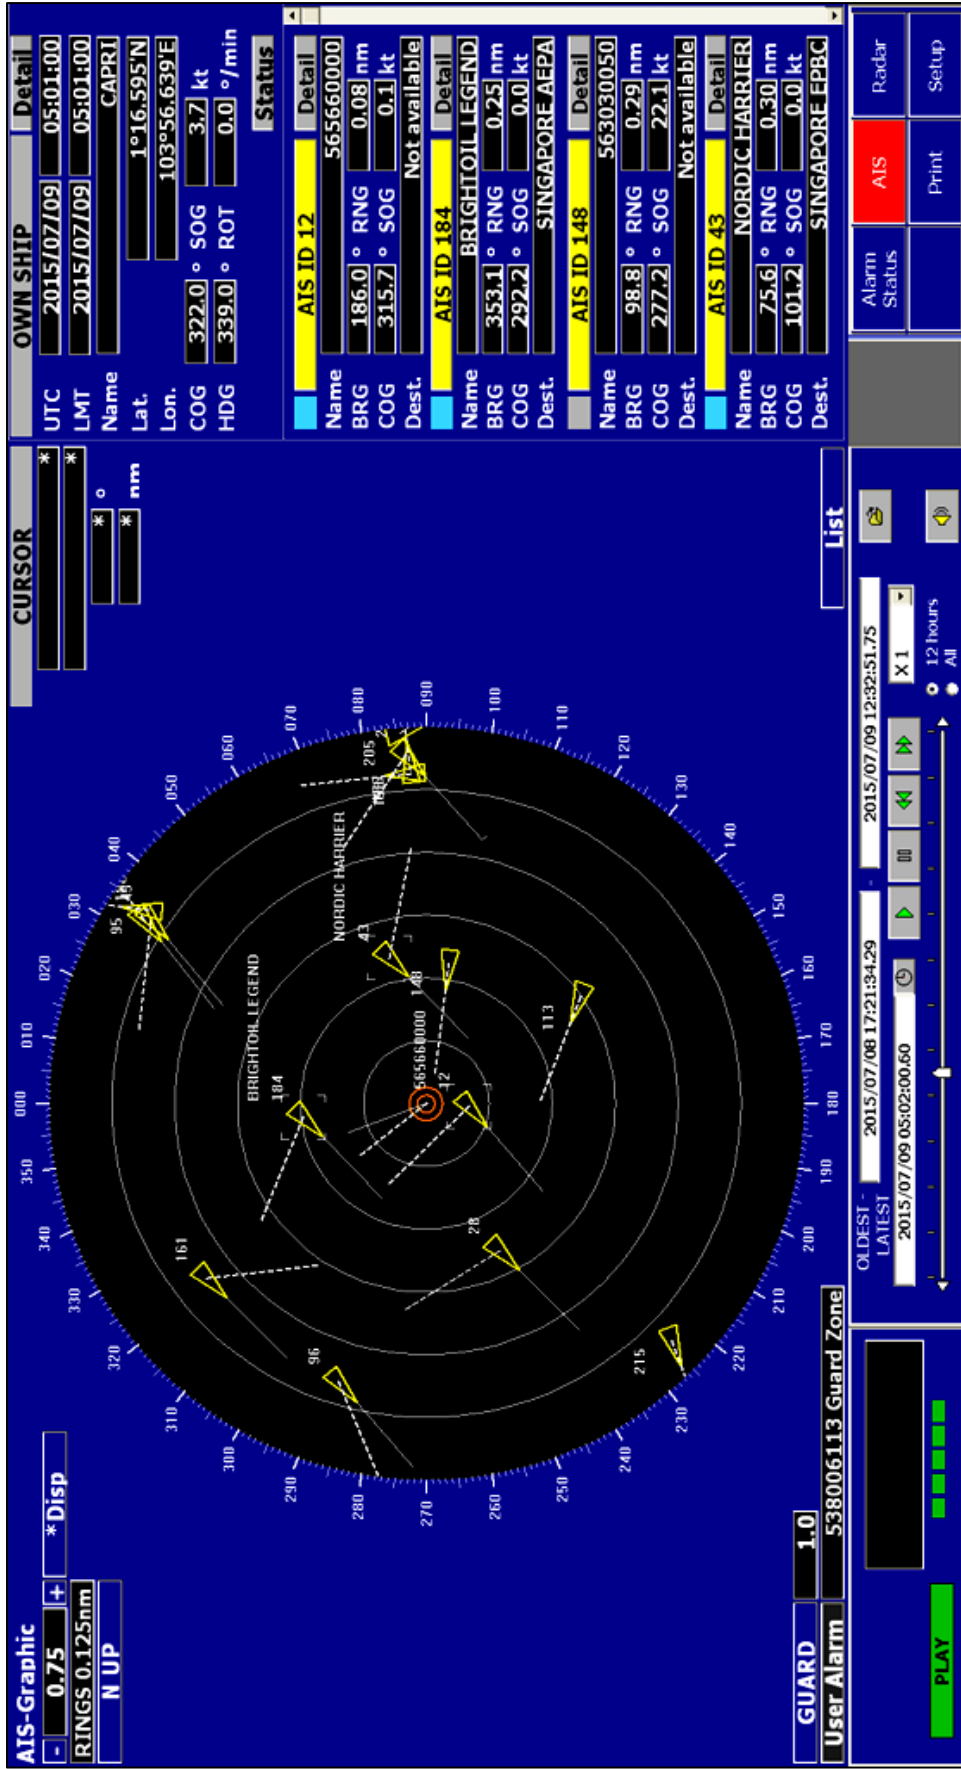
Figure 4: VDR image of *Capri* at 1301:00 s

Relative position of *Tai health*, *Nordic Harrier* and *Brightoil Legend* at 1301 is shown Figure 4. At 1303, the starboard anchor was dropped to lessen the impact of the allision, which was now inevitable. Shortly afterwards, the port bow of *Capri* made contact at an angle with *Brightoil Legend* at 2.5 knots in the Eastern Special Purposes Anchorage A, in position 01° 16.842' N 103° 56.612' E (Figures 5 and 6).

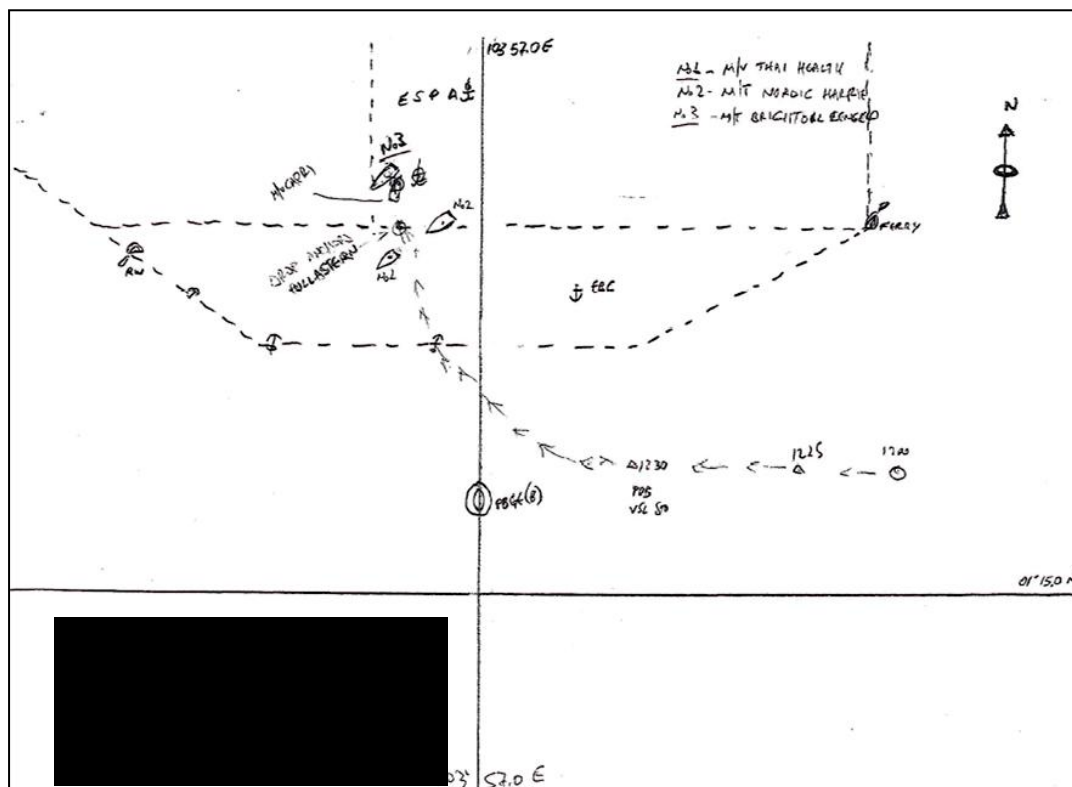
Figure 8: Allision sketch as obtained from Capri

- .4 The probability of poor engine/helm response, strong starboard cant and the risk of allision with *Brightoil Legend* were not recognised;
- .5 A copy of vessel's track submitted as documentary evidence of navigational progress was found unreliable when compared with the actual positions extracted from the VDR data;

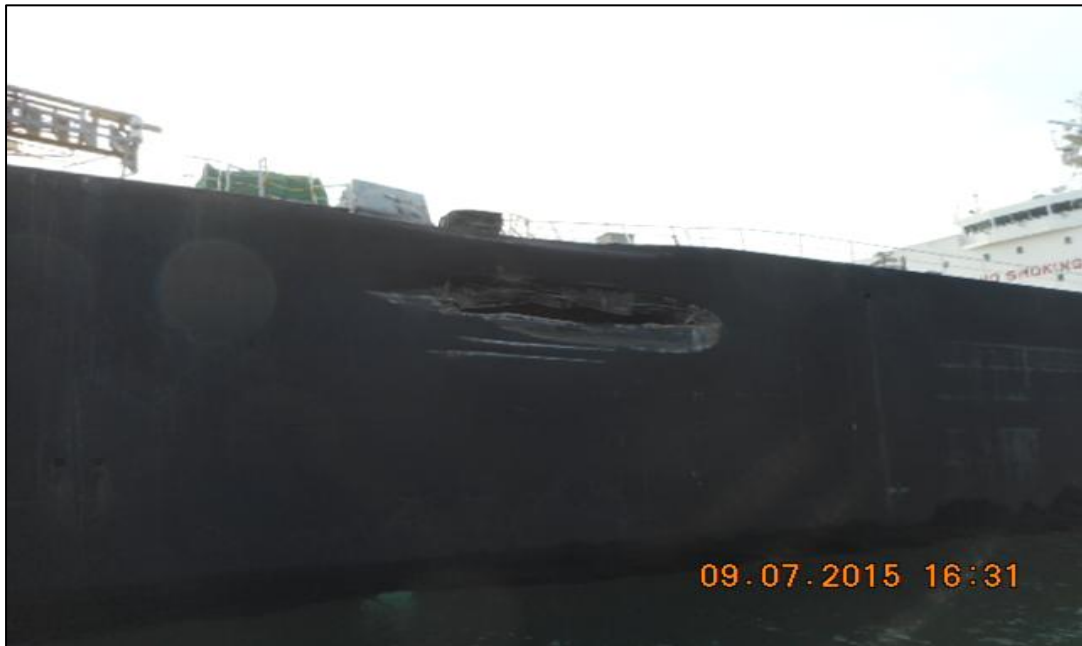
As a result of the allision, *Brightoil Legend* sustained damages above the waterline (Figures 9, 10 and 11). A hole in her side shell plating between frame 56 and 57 and shell longitudinal 40 to 42 measured 4.9 m * 0.37 m. The internal members were also found to be buckled. The main deck plating between frame 56 and 57 and deck longitudinal 21 and 22 were deformed. Damages was also visible on the port side

Figure 9: Damages to the *Brightoil Legend* side shell plating

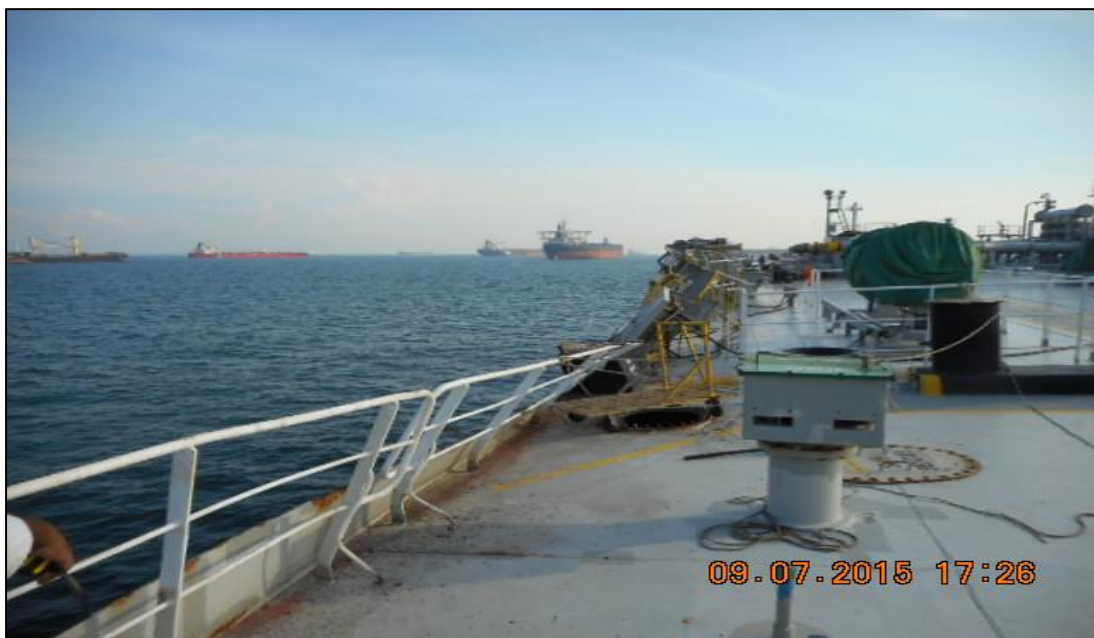
railing, fish plate, accommodation ladder and its control station/panel. One fairlead was torn off its seat.

Figure 10: Damages to *Brightoil Legend* railing and fish plate

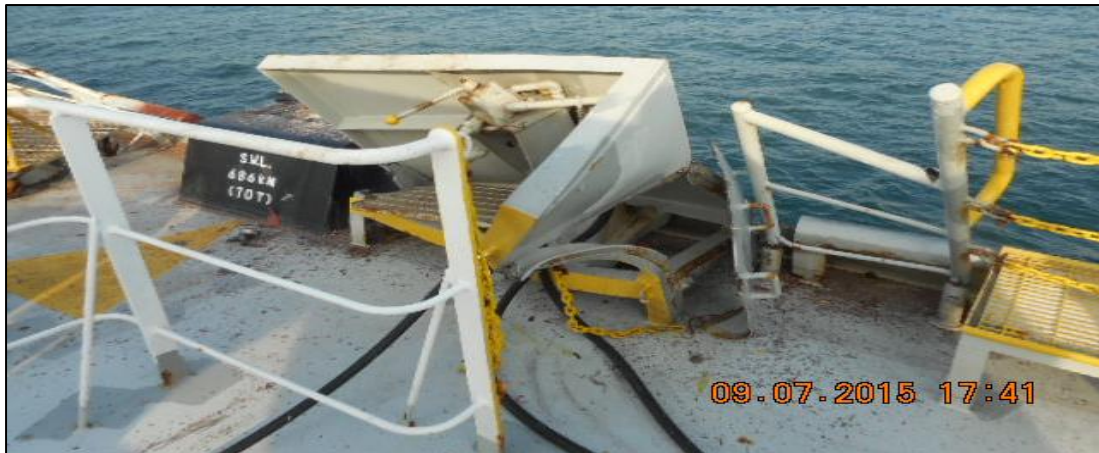
Figure 11: Damages to *Brightoil Legend* accommodation ladder, control station/panel damage and fairlead, which was torn off

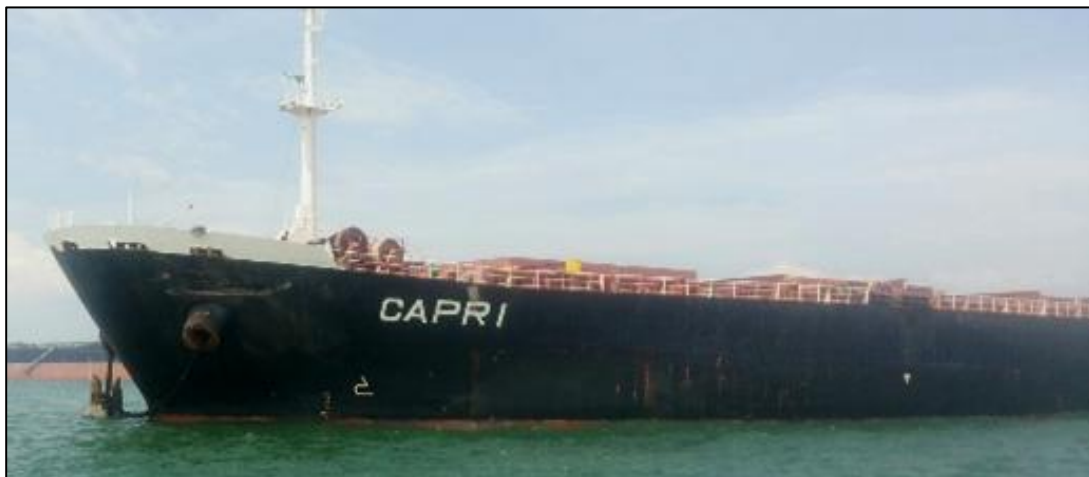
Figure 12: *Capri's* port and starboard anchors fouled

Capri had a fracture on her side shell plating at the bow, measuring 7.5 m * 0.5 m, in way of bosun store between frames 295 and 300. Adjacent stiffeners also sustained structural damages, whilst the port and starboard anchors were fouled (Figures 12 and 13).

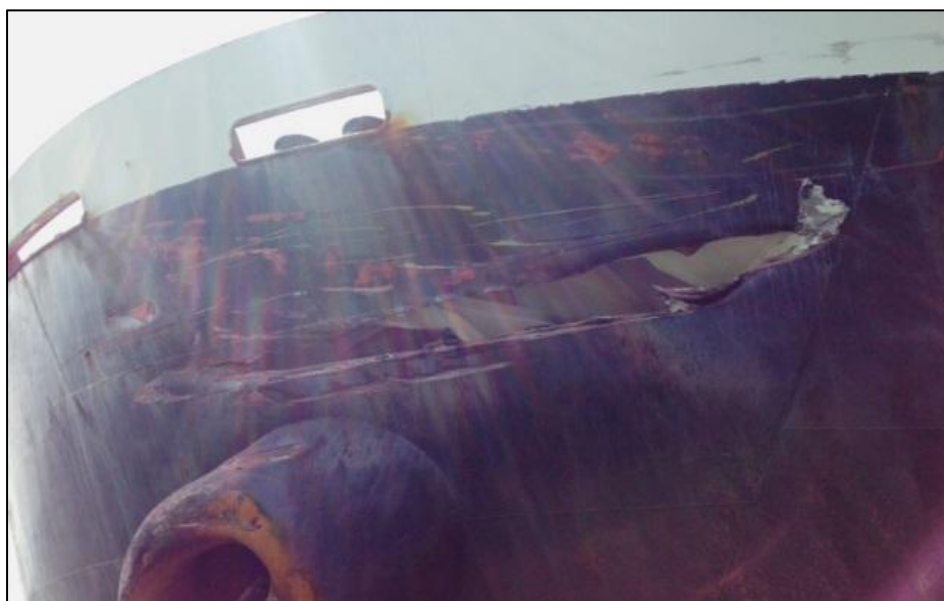
Figure 13: Damages to *Capri's* port bow shell plating
