St Apollo (BA 359) Grounding and flooding in Inninmore Bay, Sound of Mull, Scotland 24 August 2015

SUMMARY

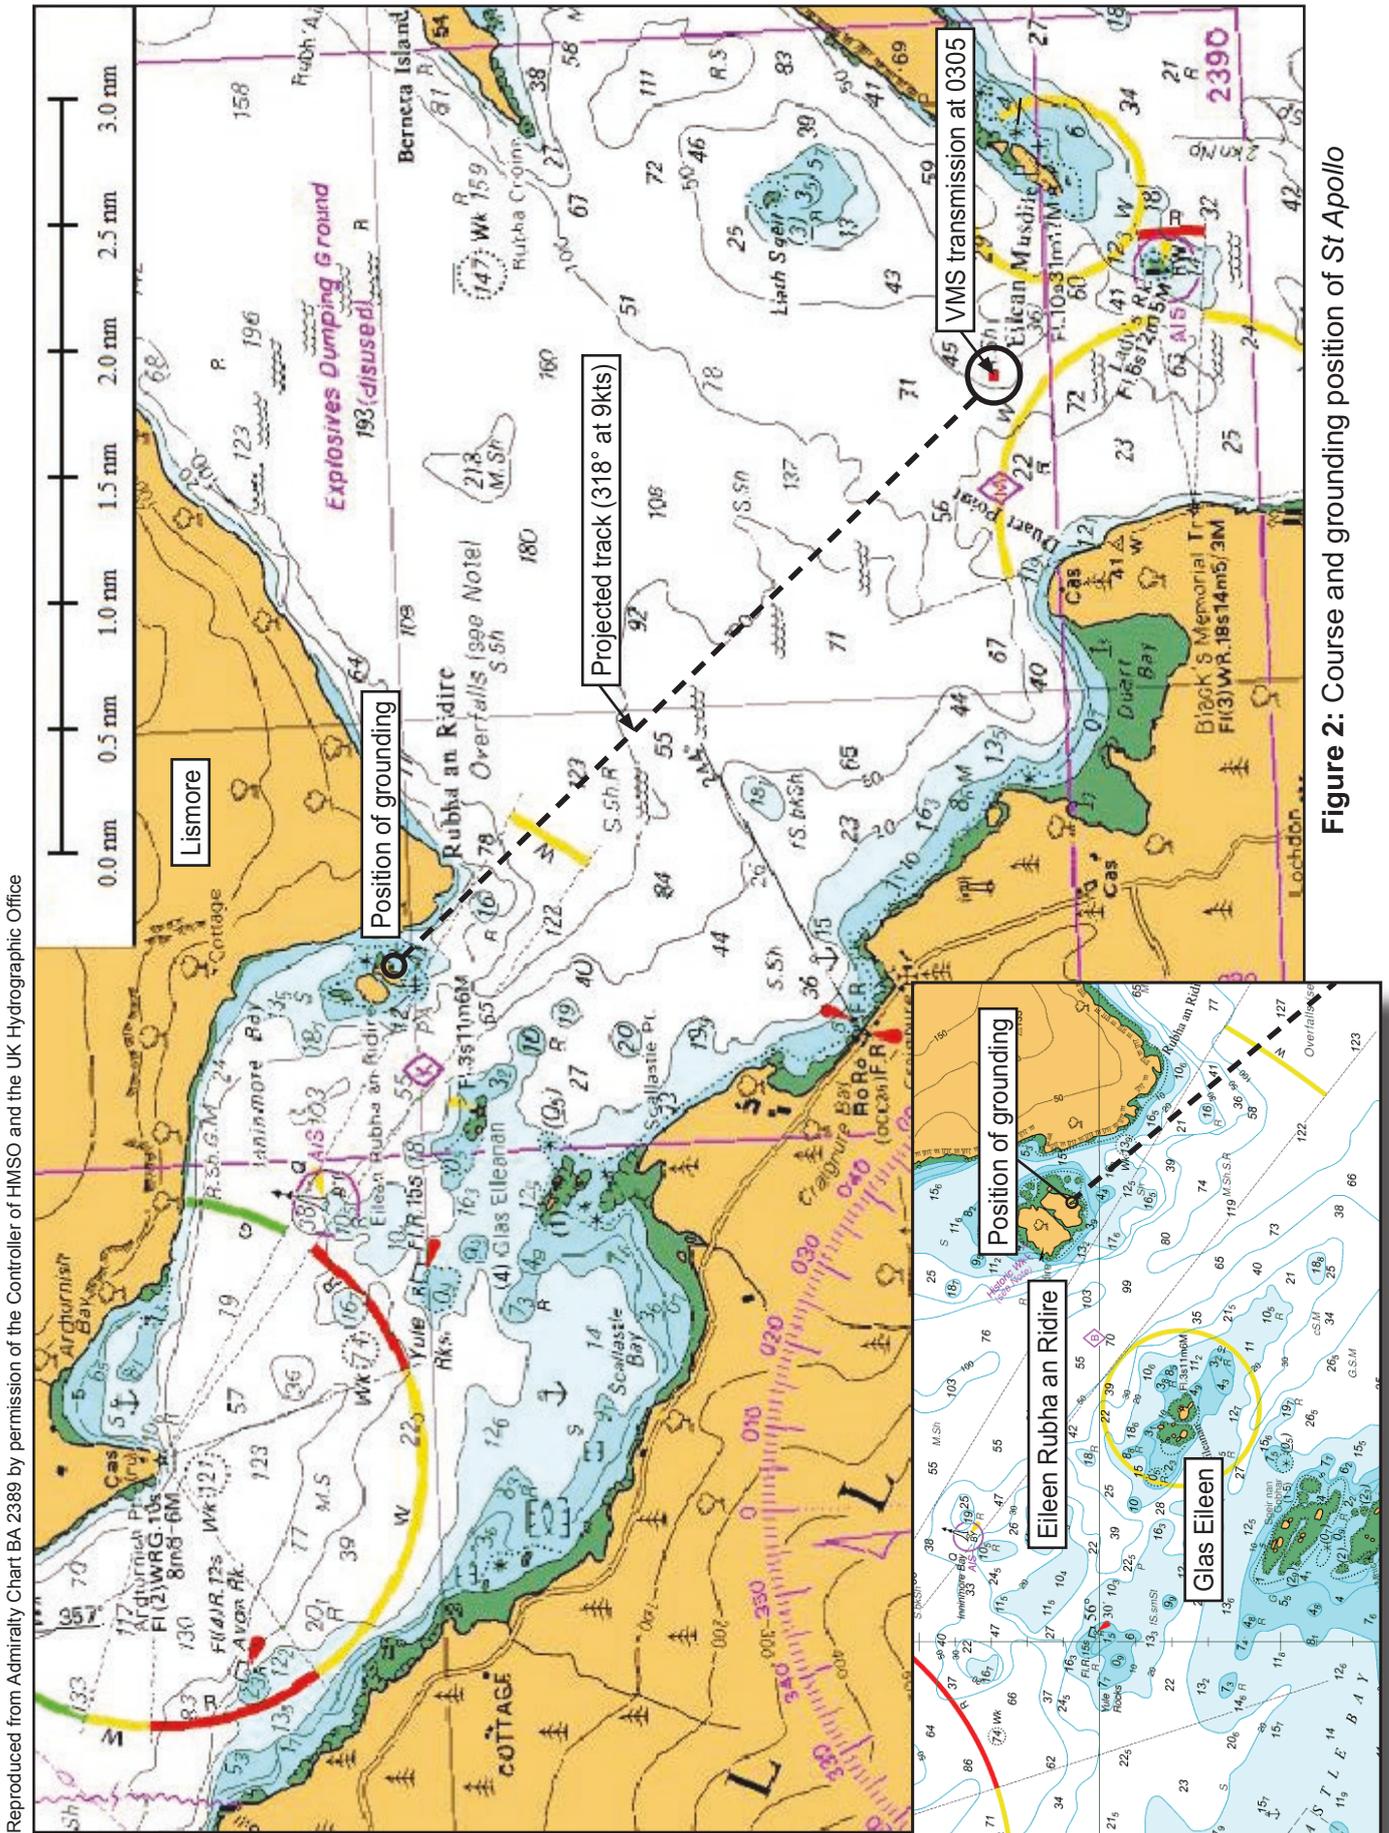
Figure 2: Course and grounding position of *St Apollo*

The skipper was woken by the watchkeeper's shouts. He got up, put on jogging bottoms and shoes and made his way to the wheelhouse. As he did so, *St Apollo* grounded on the south shore of Eilean Rubha an Ridire (**Figure 2**), a small island on the north side of the eastern end of the Sound of Mull.

If, as reported, *St Apollo*'s navigational track through the south-east end of the Sound of Mull, was equidistant from the dangers off Eilean Rubha an Ridire to the north-east and Glas Eileanan to the south-west (**Figure 2**), the vessel clearly grounded as a result of being to the north of the intended track. However, the absence of a record of the route in use, any positional data immediately before the grounding, or any material evidence of an electronic or mechanical failure, prevents a detailed and accurate analysis of the circumstances. Therefore, it is difficult to determine whether *St Apollo*'s grounding was due to navigational error, equipment malfunction, or a combination of both.

A projection of *St Apollo*'s course and speed made good (318° at 9kts) from the position transmitted by VMS at 0305 (**Figure 2**), runs directly to the grounding position at 0327 and possibly suggests that the vessel's heading was not altered during the intervening period. However, it is evident from the absence of the watch alarm sounding in the accommodation, and the watchkeeper's shout to the skipper before the grounding, that the watchkeeper had not fallen asleep.

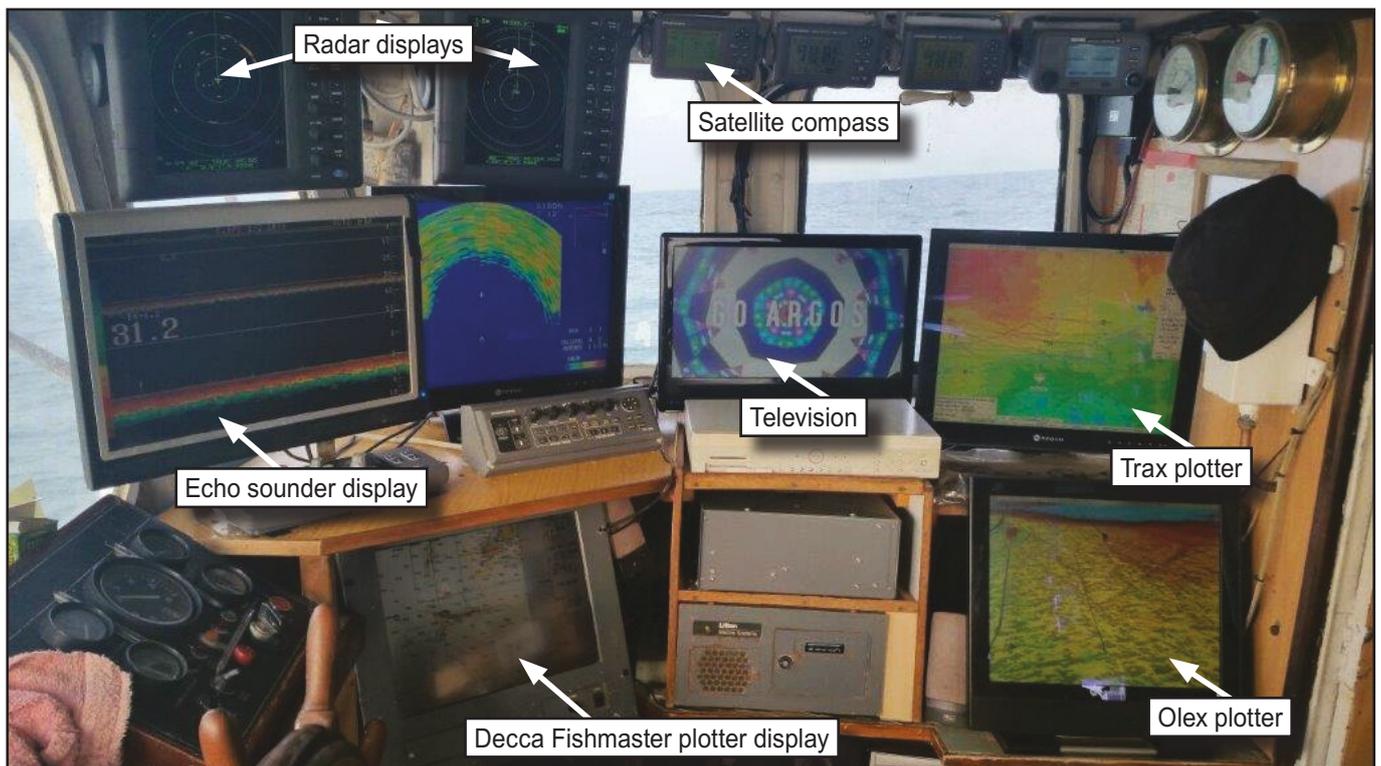
Figure 6: *St Apollo*'s wheelhouse equipment (starboard side)

Figure 6 shows the electronic equipment fitted on the starboard side of the wheelhouse.

It was reported that, with the autopilot engaged, the watch alarm alerted about every 4 minutes and it would sound in the cabin one deck below if not re-set promptly. The button to re-set the alarm could be reached from the wheelhouse chair.
