IMCA Safety Flash 23/16

September 2016

Focus: Dropped Objects

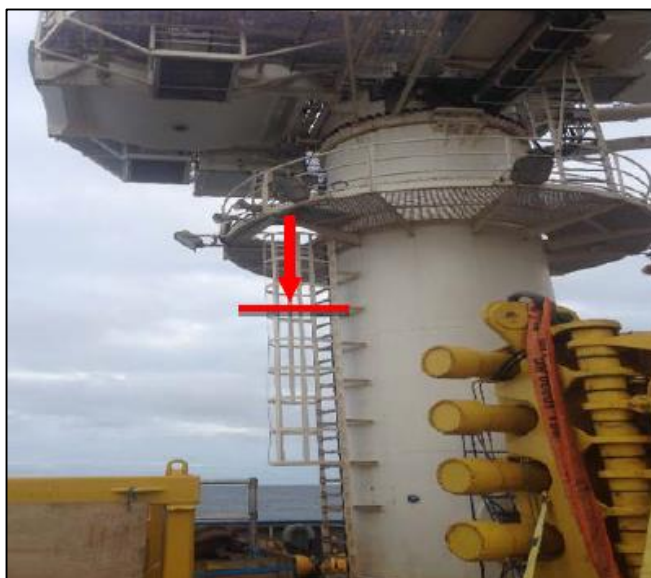
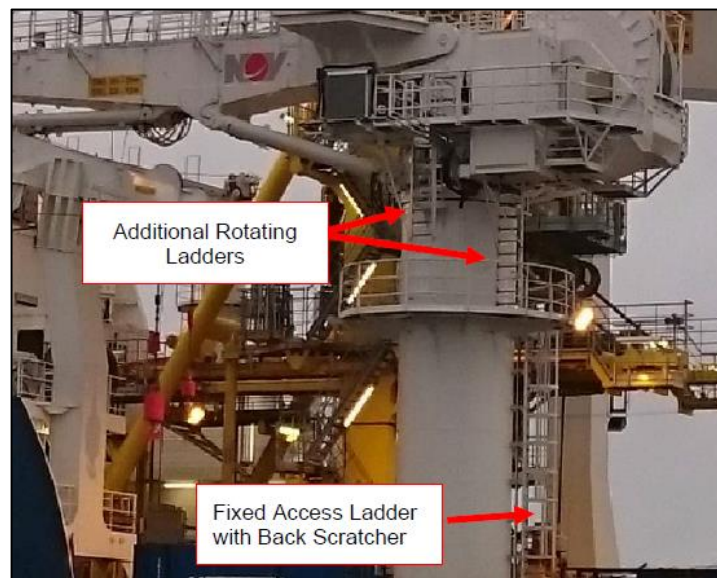
As the crane was rotated, one of these ladders caught the CCTV camera that had been secured to the walkway following maintenance during the previous shift, pulling it approximately 1 meter to the access hatch, where it fell before being arrested by the data cable.

- ◆ The faulty camera could not be repaired at the time and as such, was secured to the crane walkway using tie-wraps;
- ◆ The access hatch located on the walkway was left in an open position while crane operations were ongoing. This is common practice and is done to allow suitable access/egress to and from the crane in the event of a crane breakdown or if a rescue operation is required. The crane design prevents the hatch from being opened when one of three ladders are positioned over it, restricting access/egress;

- ◆ There was a lack of awareness and risk perception of the hazard presented by the rotating ladders;
- ◆ A more thorough pre-use inspection of the walkway would have discovered the potential dropped object;

- ◆ Improved communication – particularly at shift handover – between all parties would have raised awareness of the operation;
- ◆ Had this operation been conducted under a permit to work (PTW) or the correct process followed for routine duty activities, awareness of the operation would have been greater. It is important to highlight that control measures had been implemented by those conducting the work to ensure safe execution of the task and that these were removed when the worksite had been deemed safe;
