## IMCA Safety Flash 24/16

September 2016

### Focus: Fire

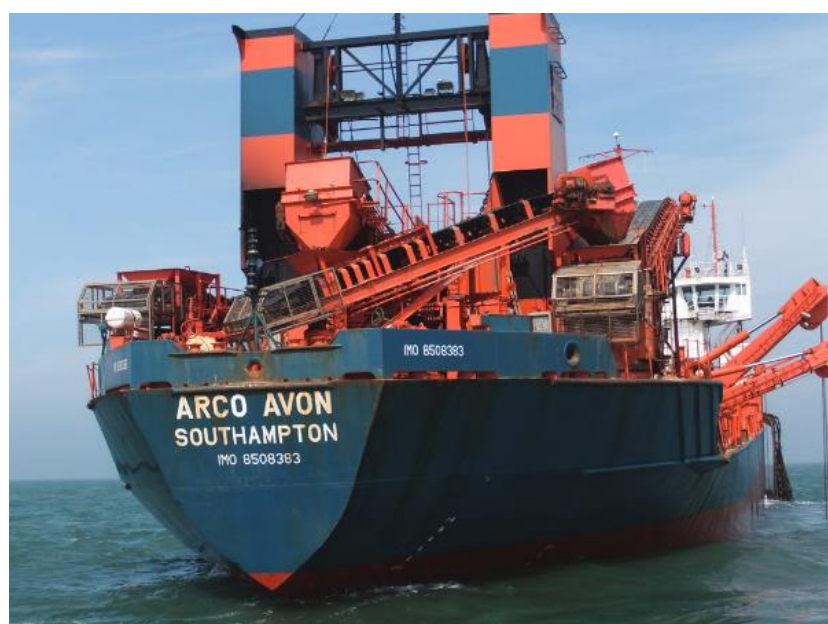
A fire broke out in the engine room while the vessel was loading a sand cargo approximately 12 miles offshore. The vessel's third engineer was badly burned in the fire and later died as a result of his injuries. As a consequence of the fire, which was extinguished following activation of the CO<sub>2</sub> smothering system, the vessel lost all power and remained at anchor with its dredging equipment partially deployed for 9 days until it could be taken under tow and delivered to a repair facility.

- ♦ The third engineer was attempting to repair a failed fuel pipe when fuel, under pressure in the pipe, ignited;
- ♦ No one else on board was aware of a failed fuel pipe or that the third engineer had apparently decided to repair it;
- ♦ The third engineer was using a portable angle grinder to access the repair site and had underestimated the risk of doing so;
- ♦ Possible contributing factors to the third engineer's underestimation of risk were that he had neither carried out a formal risk assessment nor sought a permit to work before starting the repair.

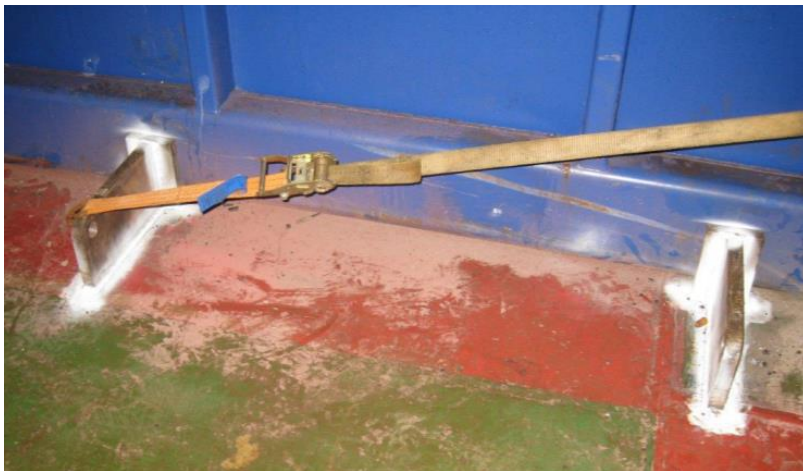
A member has reported a near miss incident in which welding was discovered which had clearly taken place in a 'no hot work' zone. The welding was discovered during pre-sail departure checks of the main deck. The Chief Officer noticed dogging plate welds securing a half-height container had been welded on to a 'no hot work' zone on the deck.

*The above figure shows Welds on 'no hot-work' zones*

Our members' initial finding was that the task was not properly planned or supervised, allowing sea-fastenings to be welded on to a 'no hot-work' zone.

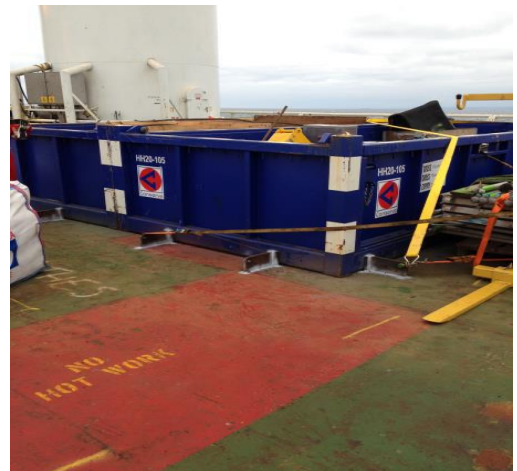
*Clearly identified RED 'no hot-work' zones*

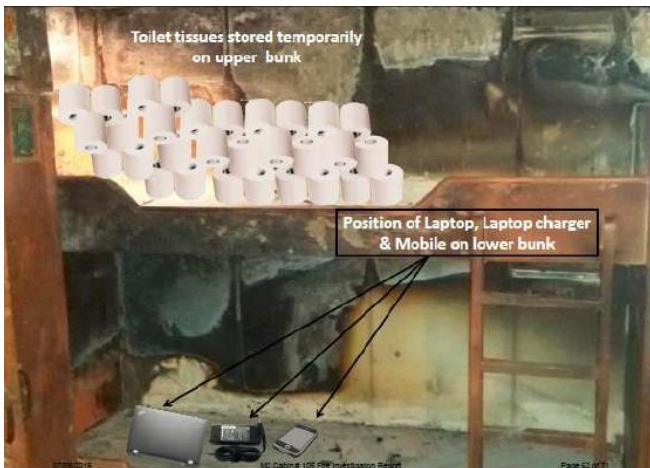
*Location of fire*

- ♦ The occupant of the cabin had borrowed the notebook computer and was not an experienced computer user;
- ♦ The notebook computer had been fully charged when he turned it on so he didn't plug it in to charge it;
- ♦ It appears that the notebook computer was inadvertently turned on whilst laying on a bunk bed, and this reduced the efficiency of the cooling fan which caused the computer to overheat;
- ♦ The integrity of the scene, with regard to investigation, was necessarily compromised after the incident;
- ♦ The remains of the notebook computer were at the heart of the fire, but had been rendered almost totally unrecognisable after being subjected to the fire and the water spray – distinctly heavy burning to the mattress and the wood underneath was evident at the notebook computer location;

- ◆ The remains of the computer along with other debris were scraped up, removed and subject to further water cooling to prevent the possibility of re-ignition;
- ◆ The bunk curtain also caught fire and this allowed the flames to track up onto the top bunk which was unoccupied. There were flammable items kept on the unoccupied bunk including toilet paper which also caught fire. The two bunks and mattresses were damaged, as were bunk curtains and adjacent wall and ceiling panels.

- ◆ Leaving the notebook computer lying on the bedding would have decreased the efficiency of the cooling fan and caused the notebook to overheat;
- ◆ The cabin was left unoccupied with electronic equipment inadvertently left powered on;
- ◆ Toilet rolls were left on the top bunk, this easily combustible material will have ignited and burnt very quickly.

- ◆ Checked of all cabins to ensure that there were no electrical/electronic items which might cause a similar incident;
- ◆ Safety flash was issued and Toolbox Talk was held to emphasise the dangers of leaving electrical items charging unattended. Also, stating that care should be taken to ensure that fans and cooling vents are not compromised on electrical equipment;

- ◆ Signs (stickers) to be posted next to all cabin sockets stating that *“No electrical items are to be left charging while unattended. Fans and cooling systems of Electrical Equipment not to be obstructed while in use or charging”*;

- ◆ Vessel inductions to be revised to include electrical safety – a do’s and don’ts list will be developed;
- ◆ Personal electrical equipment used in cabins will need to be inspected and approved by the electrical technical officer (ETO);

- ◆ ETO to conduct regular unannounced inspections to ensure that there are no electrical hazards present in the cabins;
- ◆ Extension cables and sockets to have surge protection and some form of overload or ground fault protection such as an RCD.
