Collision between Bulk Carrier *Summer Wind*
and the *Miss Susan* Tow
Houston Ship Channel, Lower Galveston Bay, Texas
March 22, 2014

Marine Accident Report
NTSB/MAR-15/01
PB2015-104888

**National
Transportation
Safety Board**

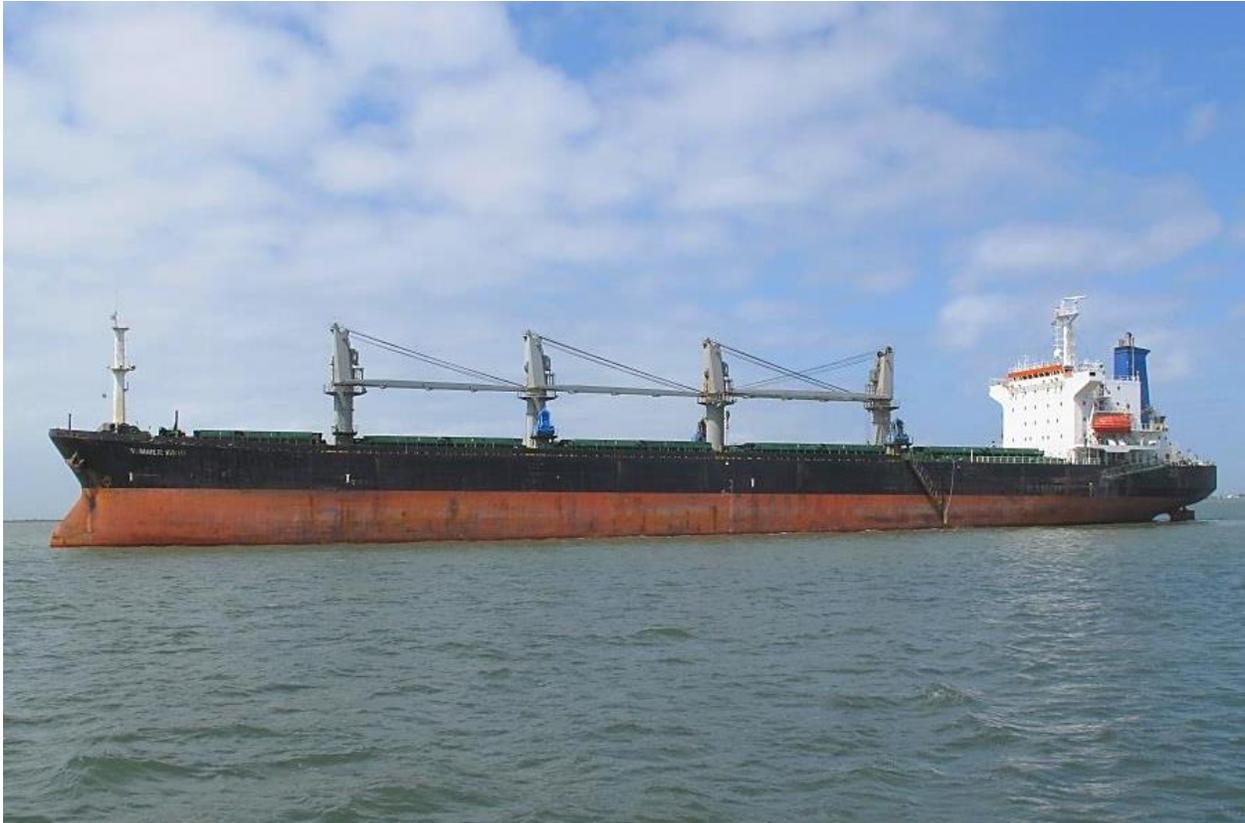
Figure 1. Bulk carrier *Summer Wind* after the collision. The vessel's cargo tanks were empty at the time of the accident and in this photo as well.

The *Summer Wind* sustained an estimated \$350,000 in damage to its bow. *Kirby 27706* sustained \$923,748 in damage, and the *Kirby 27705* sustained \$103,373 in damage.

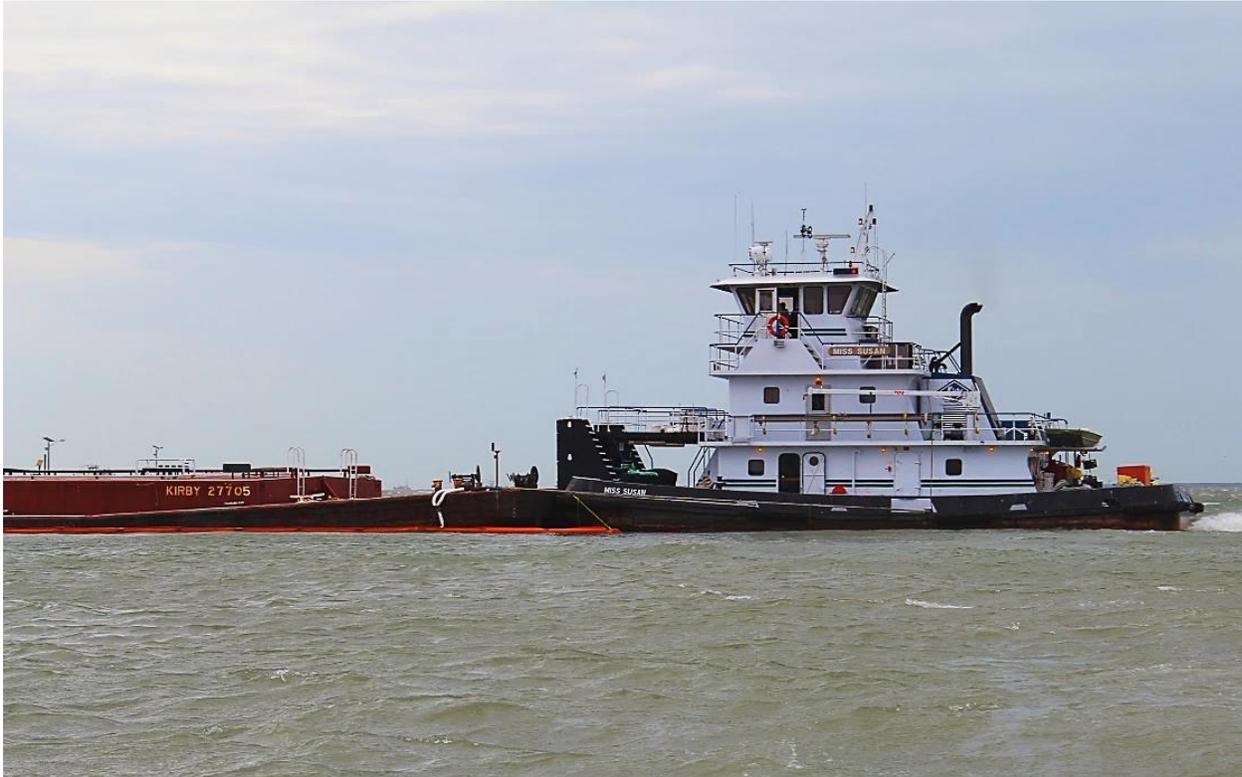
Figure 5. Postaccident photo of towing vessel *Miss Susan*, pushing barge *Kirby 27705*.

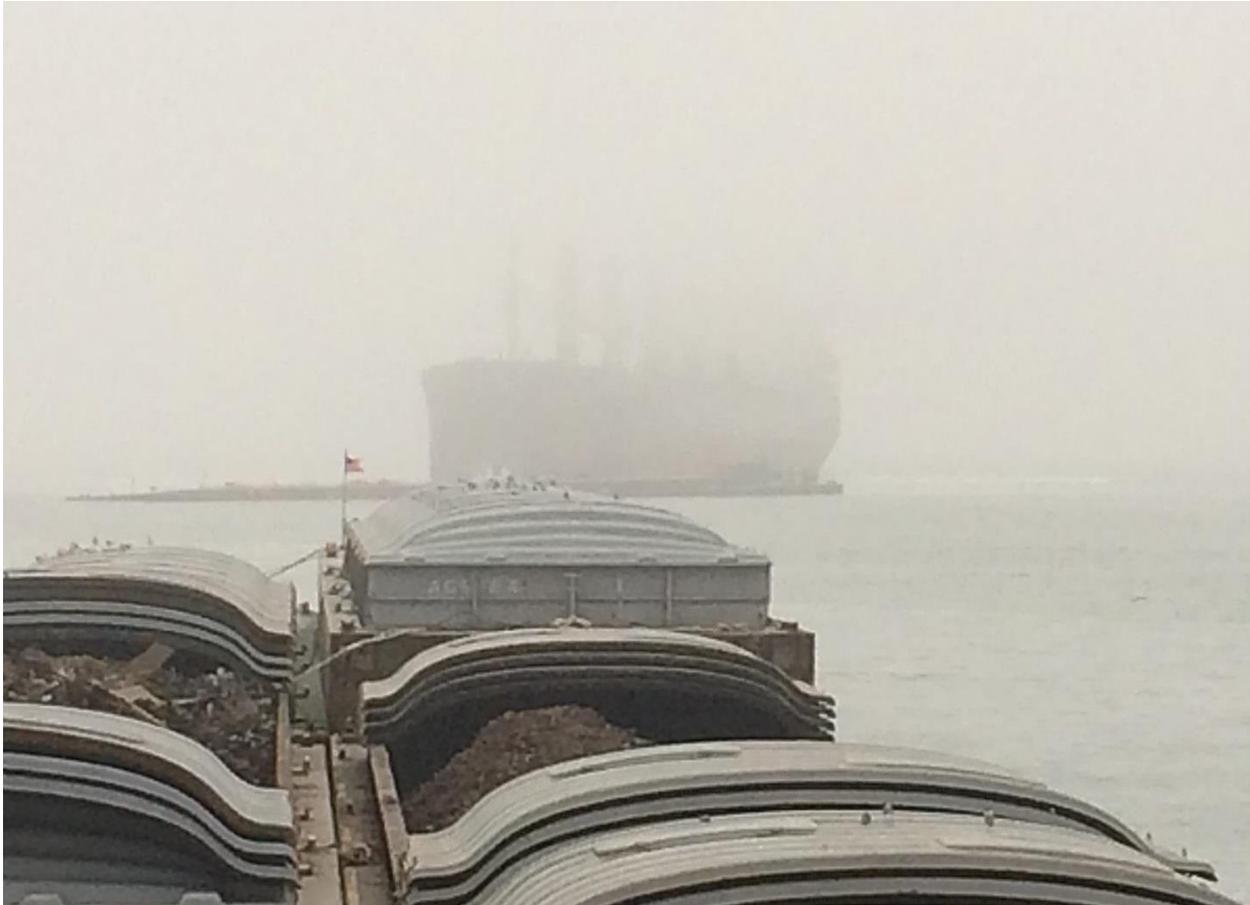
Figure 8. Photo of the collision scene, taken by the *Natures Way Commander* crew roughly 1,000 feet away, shortly after the accident.

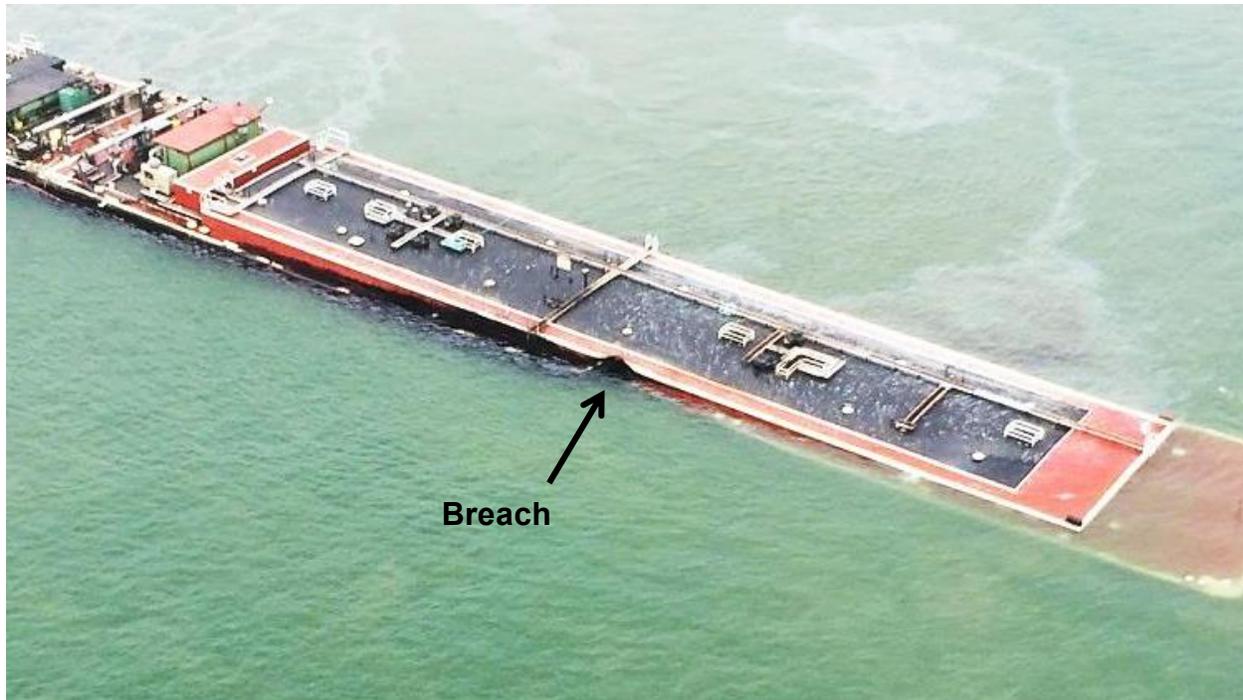
The force of the collision caused the lead barge *Kirby 27706* to separate from the tow and begin to sink. The *Miss Susan* captain instructed the crewmembers to re-attach *Kirby 27706* to the tow, and they proceeded toward the bow of *Kirby 27705*. They did not don respiratory protection before going out on the barges (see section "2.7 Policies Regarding Hazardous Materials").

Figure 9. Aerial view of the *Kirby 27706* shortly after the collision, with the point of impact damage marked. Oil sheen from leaking RMG 380 can be seen on the barge's port side. The bow of the barge is submerged in the water. (Photo by the Coast Guard)

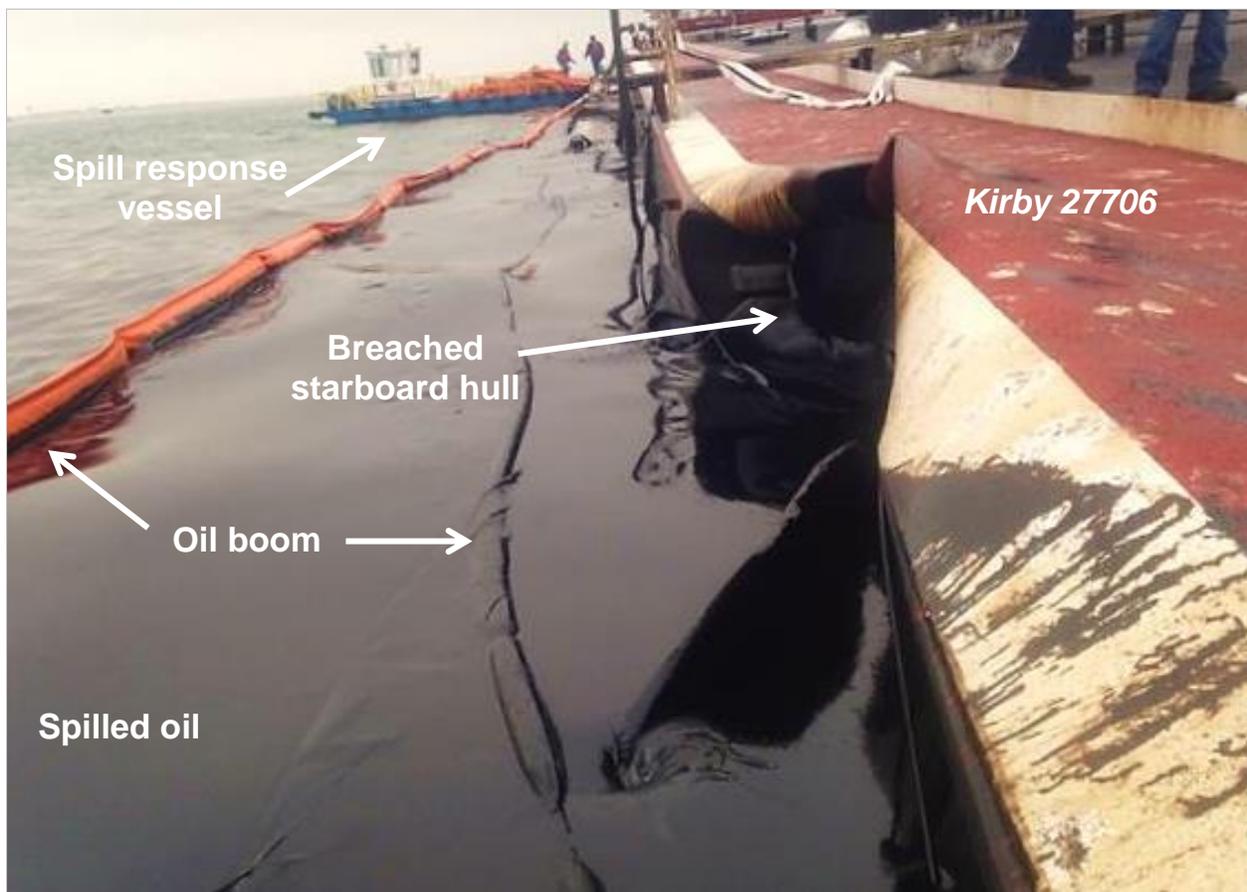
Figure 10. Close-up photo of the point of impact on the *Kirby 27706*'s starboard side. The crew of a nearby oil spill response vessel can be seen deploying boom to contain the oil closer to the barge. (Photo by the Coast Guard)

Given the size of the barge hull breach, the waterway conditions, and the time required to stabilize the damaged barge, the released oil could not be effectively contained near the accident scene. Sound strategies employed in this response were deflection of the oil away from critical resources and the use of mechanical and manual removal methods to recover the majority of the oil where stranded. The cleanup of this oil spill was accomplished in roughly the same time (about 5 weeks) as envisioned in a similar Houston Ship Channel scenario contained in the Central Texas Coastal Area Contingency Plan. Contracted resources that were brought to the accident scene significantly exceeded the response capability planning criteria of 33 CFR Part 155 Subpart D and Kirby's vessel response plan. The unified command's incident event log indicates that 8.5 hours after the accident, three of the four oil spill response organizations listed in Kirby's vessel response plan, along with two other contractors, were on scene in advance of the 12-hour Coast Guard Tier 1 response planning criteria. All of these five organizations were Coast Guard-rated oil spill removal organizations capable of responding to worst-case discharges. The incident status summaries also reflect that substantial surplus response resources (including personnel, oil booms, oil skimmers, vessels, and barges) were staged on scene throughout the response. The NTSB therefore concludes that the actions taken to recover spilled oil to minimize further environmental damage were timely and appropriate.

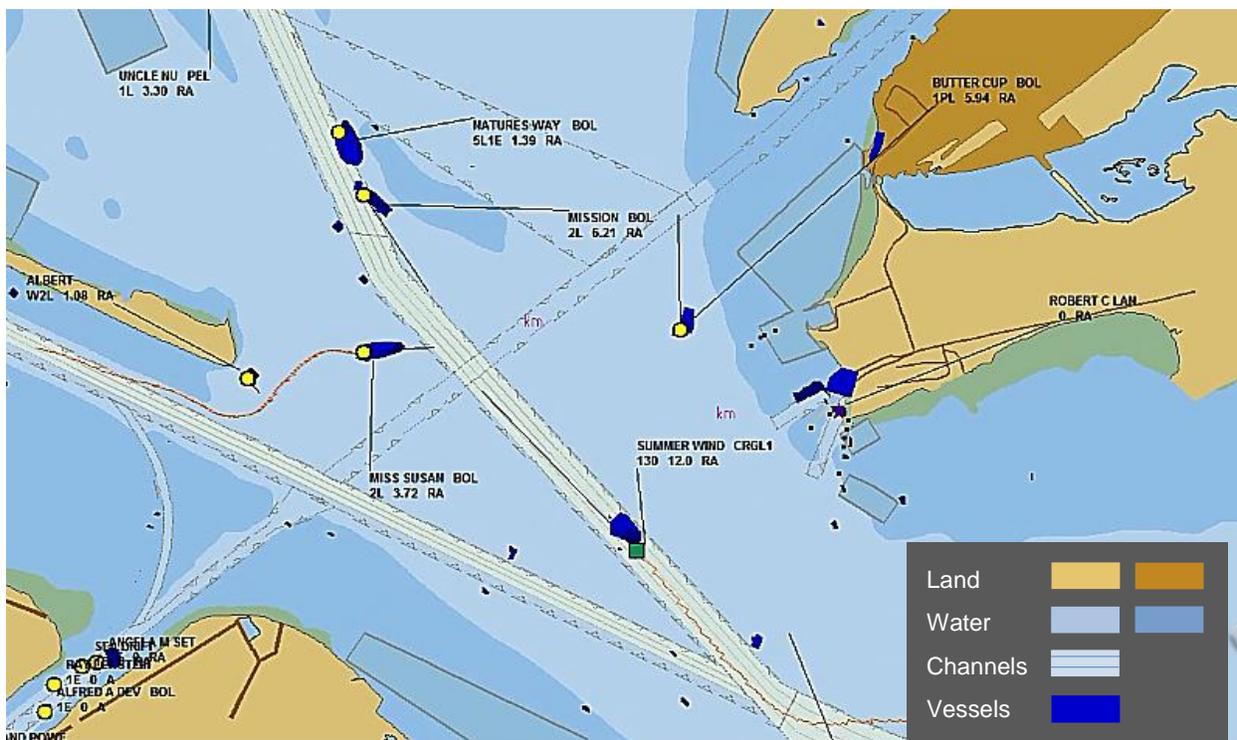
In addition, during an 8-minute time span leading up to the collision, VTS Sector I & II (in which the accident occurred) changed watchstanders three times. About 1227, the watchstander who had been monitoring that sector for the past 2 hours ended his shift. He told investigators that he had a brief exchange with his replacement watchstander (“watchstander 2”) before leaving the building. Watchstander 2 began monitoring the sector and did so for about the next 3 minutes. It was during this time that the *Mission* captain radioed the *Miss Susan* captain on channel 13 asking whether she would make it across the Houston Ship Channel before the *Summer Wind*'s passage. Watchstander 2 told investigators that he did not like monitoring Sector I & II because it had eight computer screens that needed monitoring while Sector III (the northern sector) had only four (figure 13).³³ The watchstander who was monitoring Sector III at the time (“watchstander 3”) explained to investigators that, in addition to the challenge of monitoring vessel traffic on eight screens, vessel traffic in the southern sector was expected to increase as the fog was gradually dissipating. Watchstander 3, who was more experienced, therefore offered to switch stations with watchstander 2, and they did so about 1230. The exchange between the two watchstanders during this turnover lasted only 2 seconds according to watchstander 2. He also told investigators that the VTS supervisor was occupied on the telephone at the time, so watchstanders 2 and 3 did not inform him of the station switch, nor were they required to do so.

Figure 13. Screen capture of a Sector I & II computer display at VTS Houston/Galveston 3 minutes before the collision. The vessels' completed paths are shown as red lines; their vectors, or projected course over ground at that moment, are shown as straight black lines. The vector time period is 2 minutes. About the time of this screen capture, 1232, the *Miss Susan* captain and the pilot on the *Summer Wind* began communicating directly with one another about their close-quarters situation, but none of the VTS watchstanders recognized the developing emergency at the time.
