Editorial

Flash fire – welding and painting

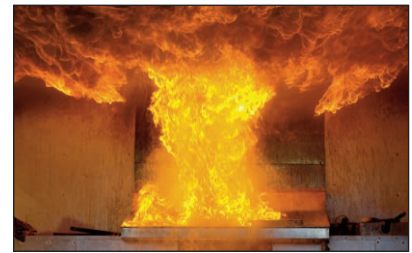
A casserole containing oil was left unattended in the oven or on the range; oil leaked through small holes at the side.

In this case an unattended leaking casserole represented a long term hazard, indicating a poor sense of hygiene and awareness of risk.

Galleys are high risk areas. Power should be switched off at the end of each use, whenever the galley is left unattended, and at the end of each working day. The fitting of external galley power breakers which do not require entry to galley spaces is a wise additional precaution.

Maintain **particular vigilance in galleys**, and invariably include them in rounds routines by day and night.

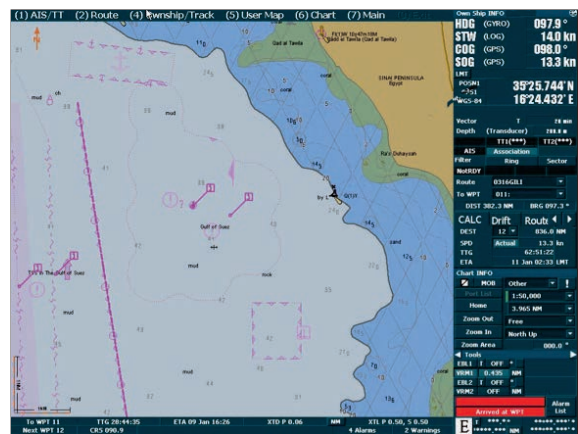
One supplier’s chart

During preparation of a passage plan for a forthcoming voyage, it was observed that one chart did not show all the information that had been seen when passing through the Suez Canal previously. There emerged considerable confusion on the source, date and identity of the right chart within the ship’s system. Space prevents detailed coverage. Eventually the correct electronic chart was identified by the ship’s provider, and supplied.

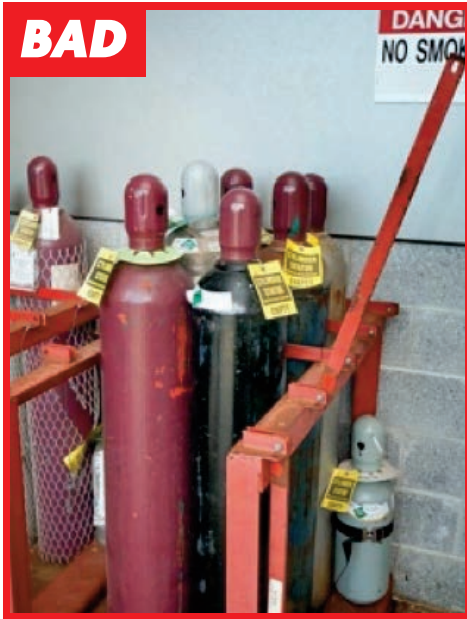
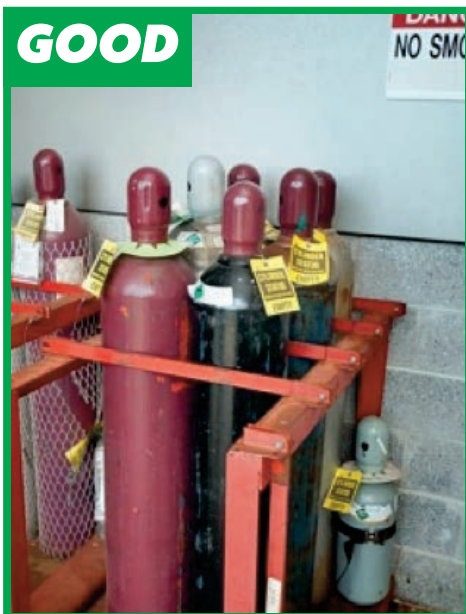
In **CASE 1**, a bulldog grip U bolt had slipped out of position on a lifeboat lashing. It was found that the grips were fitted incorrectly, and had also been subjected to wear and tear over a period of time.

In **CASE 3**, the boom of a main deck crane was heaved up, without taking out the securing turnbuckle, from the rest stand. This caused deformation to the plate to which the lug had been welded.

In **CASE 4**, oxygen and acetylene cylinders were not properly stowed and secured, and were about to fall onto the deck.

- With respect to the bulldog grips, vibration can be another cause of wear and tear. The UK MCA specifically discourages their use in Annex 18.2 of the UKCOSWP 2015, and prohibits fitting to lifeboat falls and lashings; similarly for rescue boats and liferaft lifting gear. Would you trust your life to incorrectly fitted wires?

- Working with any chemical requires proper planning including the use of the Material Hazard Data Sheets that are supplied with chemicals.
- For the crane boom incident, this is down to planning and supervision. The crane operator should respond only to the supervisor who should be using correct signalling techniques. UKCOSWP 2015 19.9 and 19.11.1 refers.

In **CASE 3**, **improper preparation, haste, and inadequate supervision** were the probable causes. Every lifting operation using the ship's crane should **apply good seamanship practices, be properly planned within the prevailing conditions, and be appropriately supervised** by a competent officer. The lifting appliance should be operated by a competent, well trained crew member.
