UNITED STATES COAST GUARD

**REPORT OF INVESTIGATION INTO THE
CIRCUMSTANCES SURROUNDING THE MULTIPLE
RELATED MARINE CASUALTIES AND
GROUNDING OF THE**

MODU KULLUK

ON DECEMBER 31, 2012

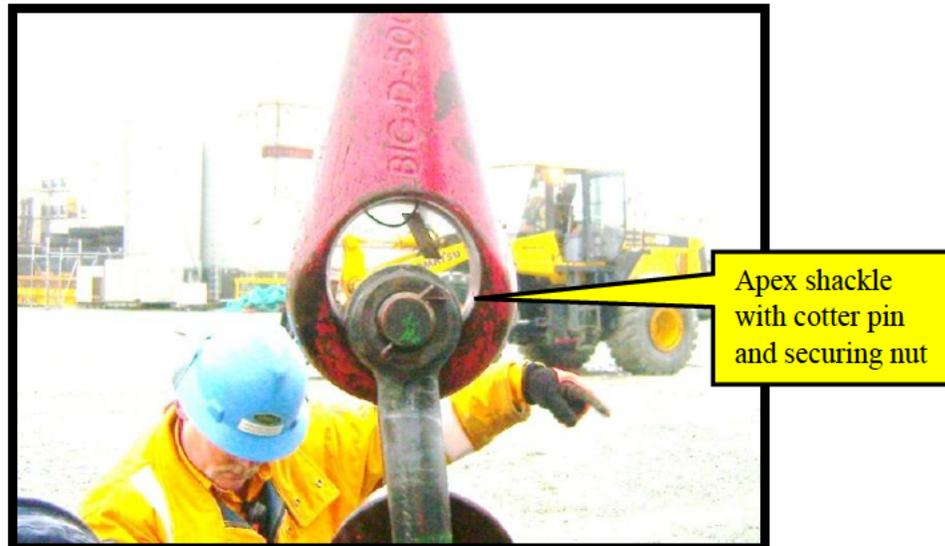
Figure 13: OSI Terminal workers hoist the tow plate and pennant wire. The photo shows the 120 ton shackle (original photo brightness adjusted) with the cotter key. The shackle (described as apex shackle) connects the tow plate to the 100' tow pennant socket. (Photo courtesy of GL Noble Denton, Mr. █████)

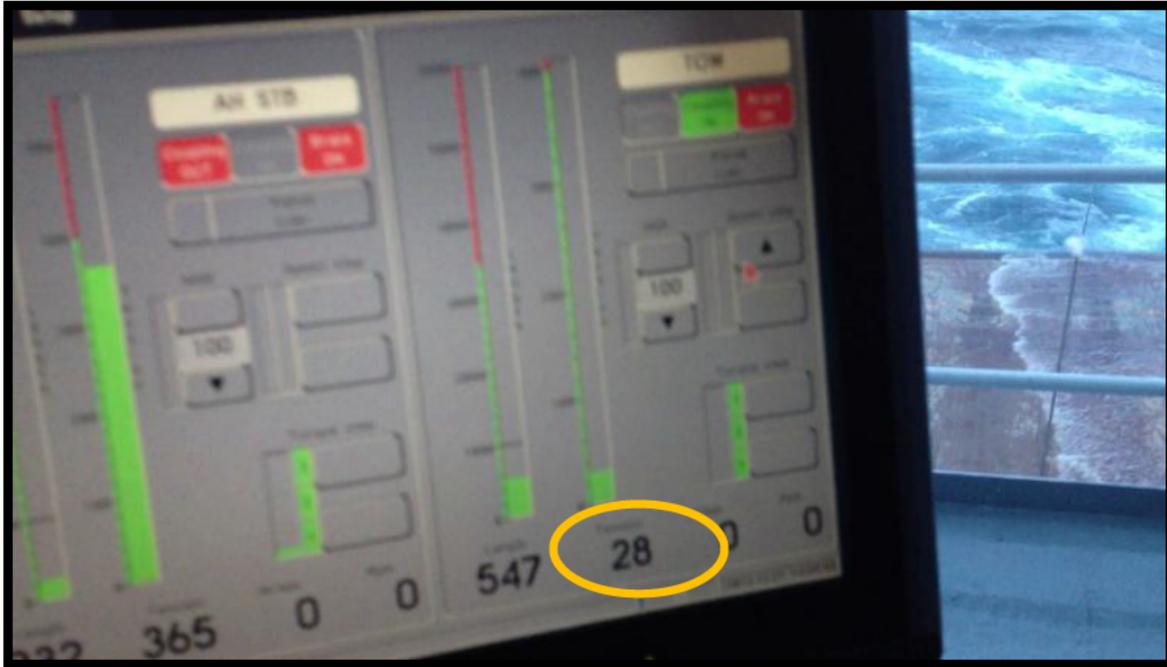
Figure 18: Screen capture from video showing tension reading of 28 tons on main tow drum. (Cell phone video screen capture provided by Mr. ██████ AIVIQ Mate)

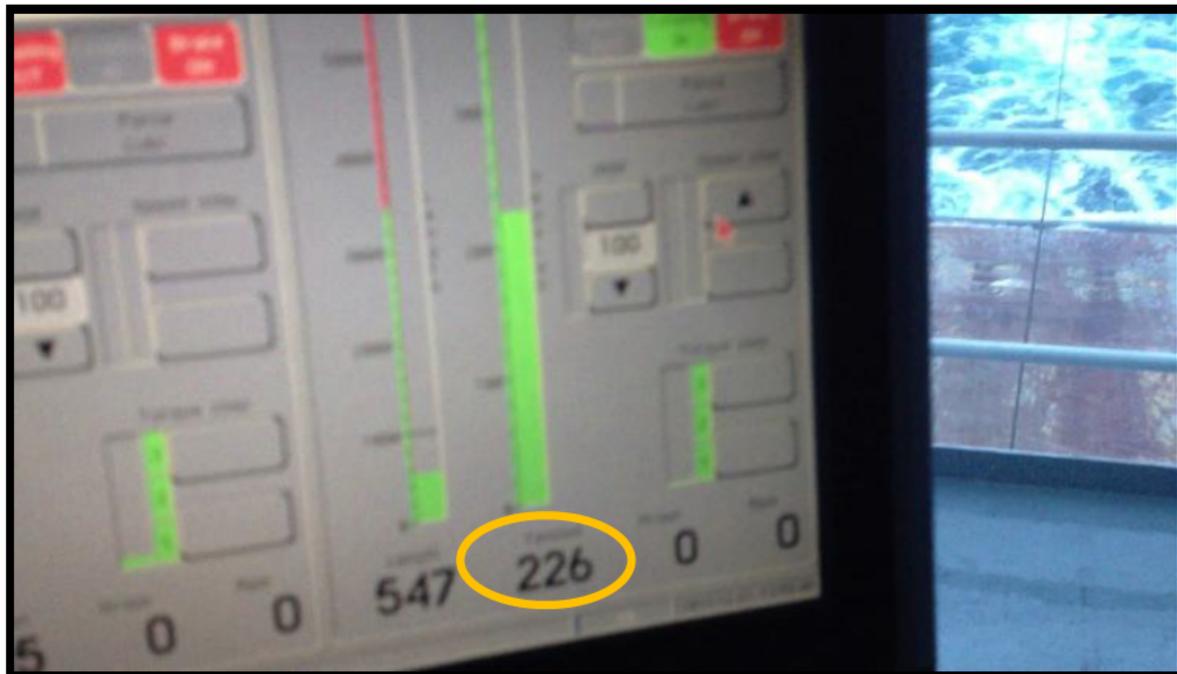
Figure 19: Screen capture from video showing tension reading of 226 tons on main tow drum. (Cell phone video screen capture provided by Mr. ██████ AIVIQ Mate)

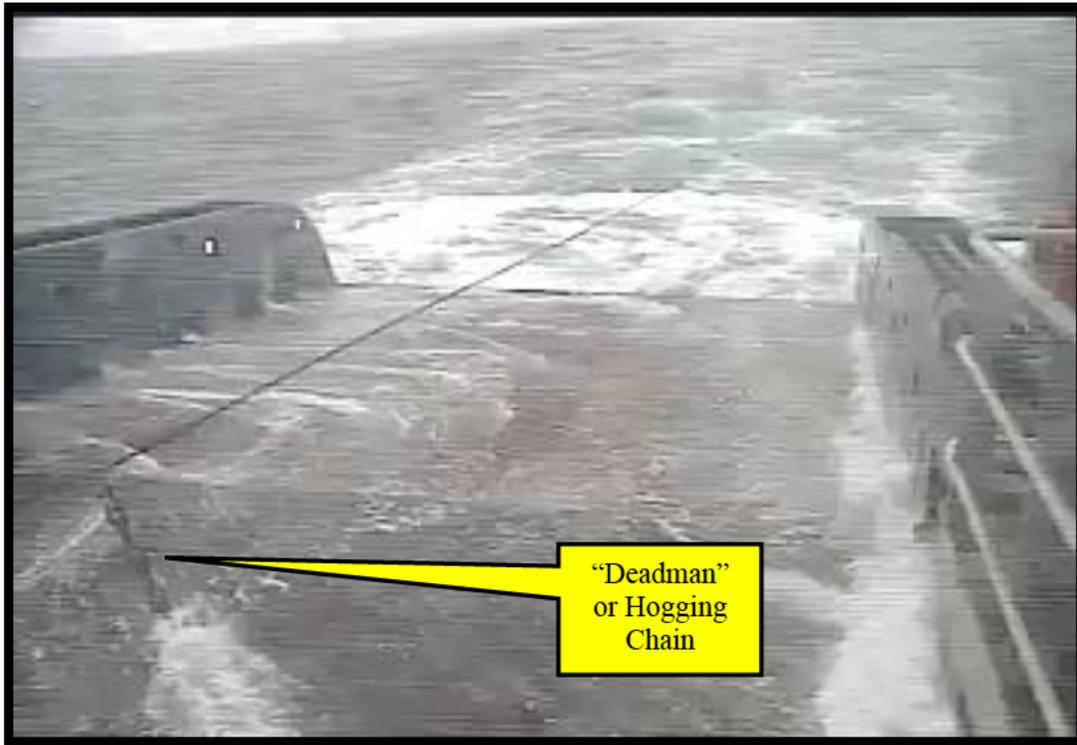
Figure 20: Screen capture of towline moments before failure of the shackle on the morning of December 27, 2012 *(From AIVIQ CCTV recording and provided by ECO)*

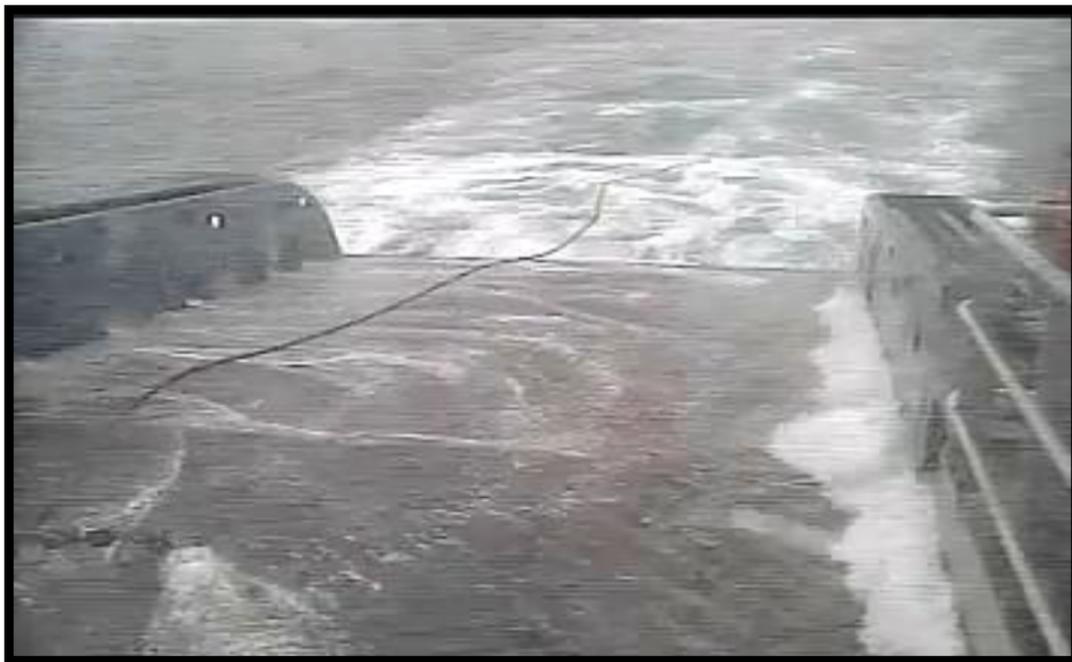
Figure 21: Screen capture of towline at moment of shackle failure on the morning of December 27, 2012 *(From AIVIQ CCTV recording and provided by ECO)*

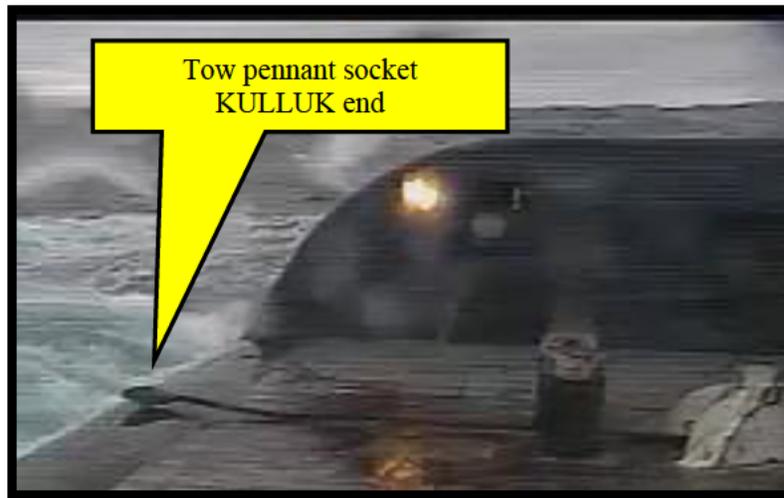
Figure 22: Screen capture showing retrieved pennant wire and socket, missing shackle later in the morning of December 27, 2012. (From AIVIQ CCTV recording and provided by ECO)

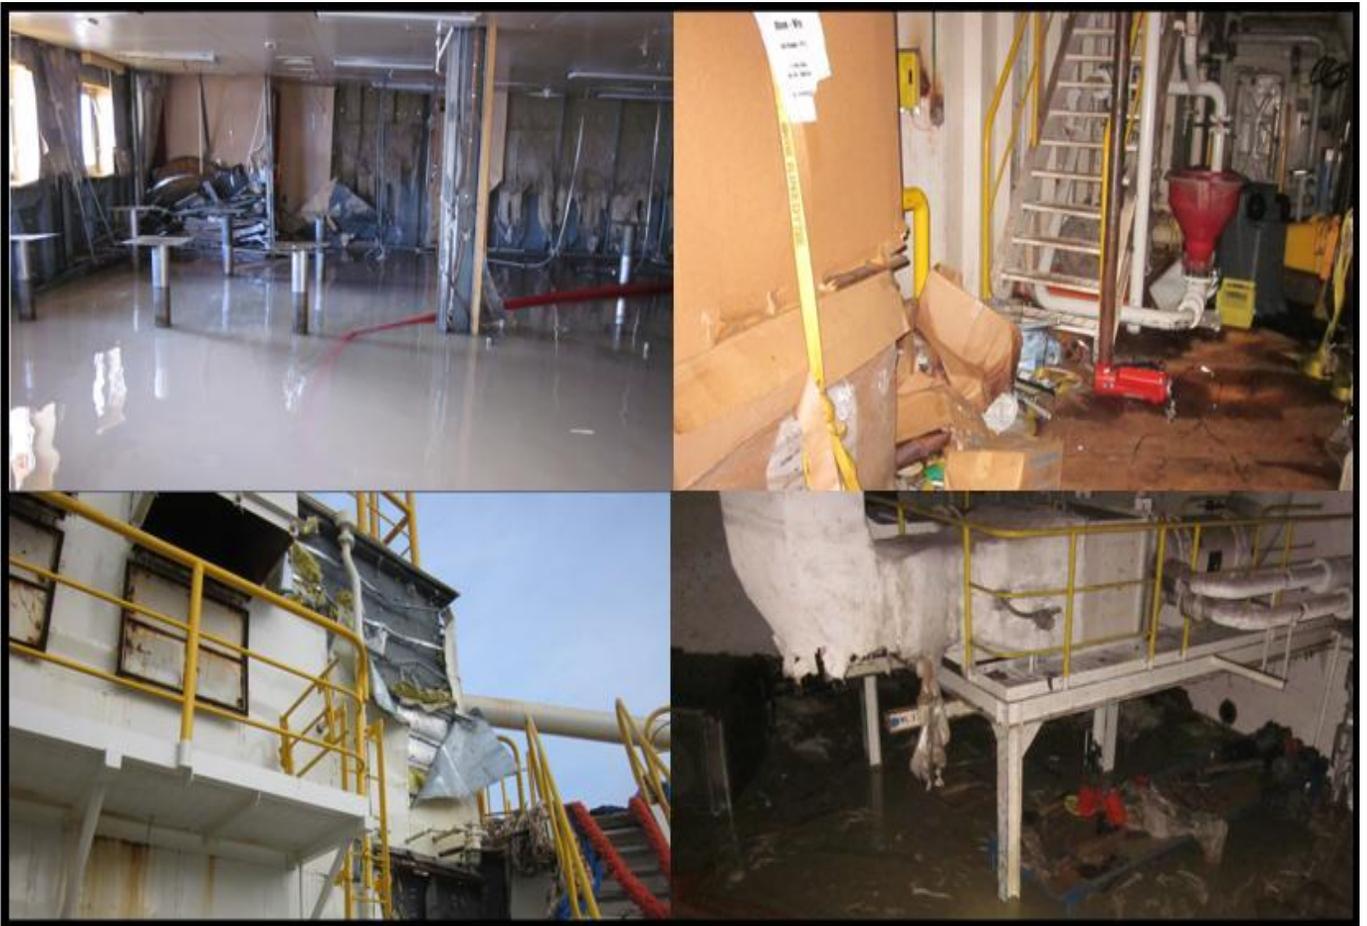
Figure 45: Composite photographs showing damage to topside areas of the KULLUK taken by USCG Inspectors after the grounding and prior to refloating. *(USCG Photos)*

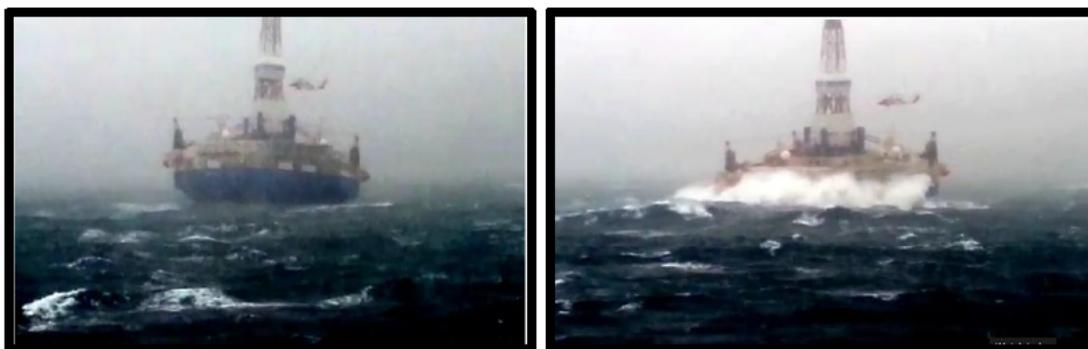
Figure 48: Screen captures showing extreme pitching resulting in the KULLUK burying hull into seaway and causing increased towing resistance. (*Taken from YouTube video taken by unknown AIVIQ crewmember during afternoon hours of 31 December with AIVIQ and ALERT towing, video titled “KULLUK rescue 2012 Gulf of Alaska”*)

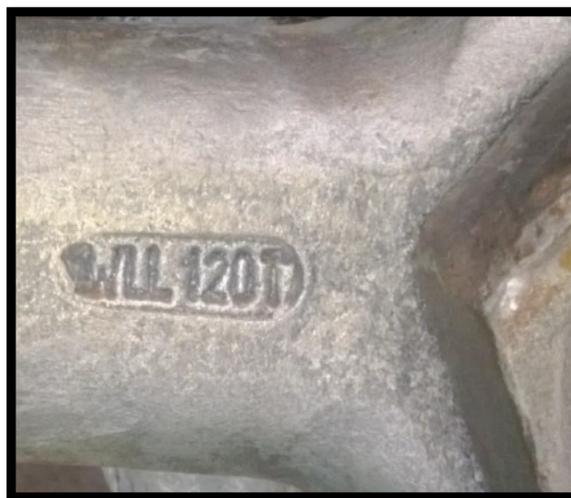
Figure 55: Photo of Working Load Limit Stamped on Bow of 120 Van Beest Green Pin® Super Shackle. (USCG Photo)

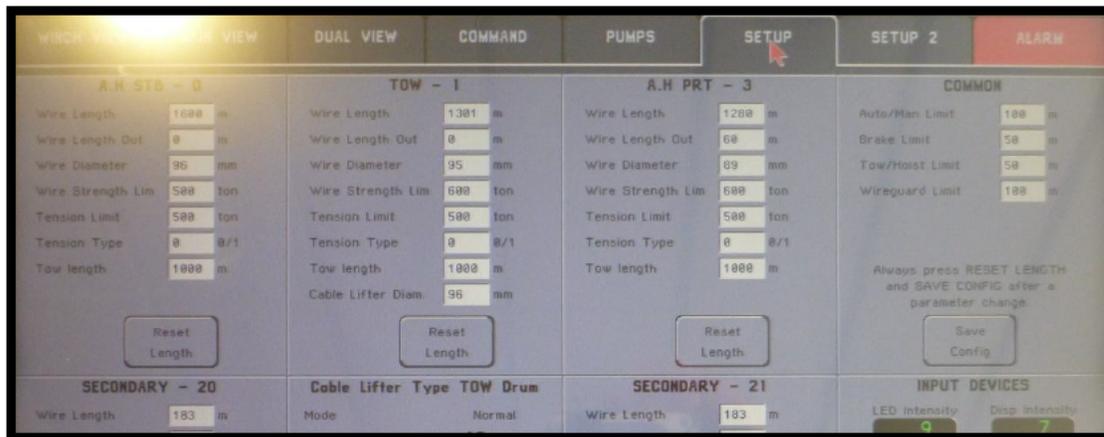
Figure 58: Photo of Towcon Setup screen showing “wire strength limit” for main towing drum is set at 600 tons. (USCG Photo)

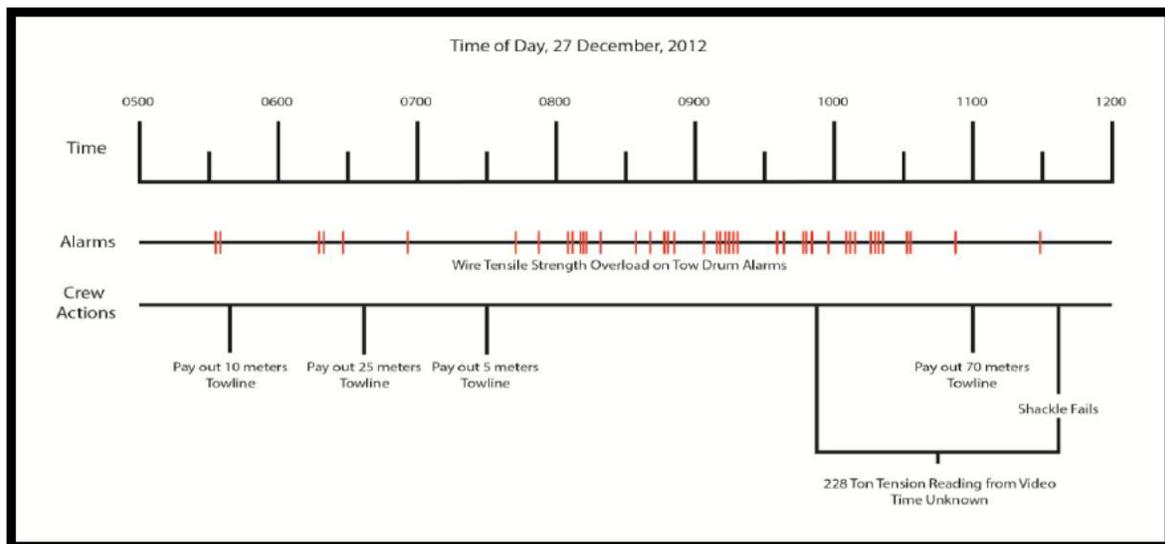
Figure 60: Summary of main towing drum data for the morning December 27, 2012 indicating time, alarms received towline length and shackle failure.¹⁰⁷ (USCG analysis)

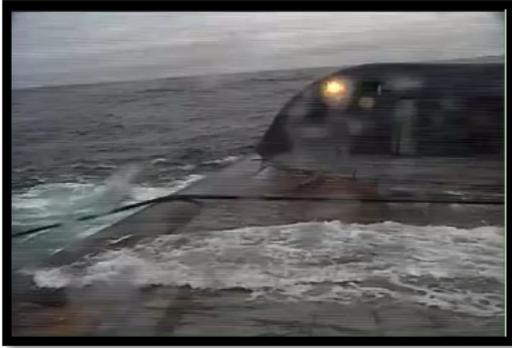
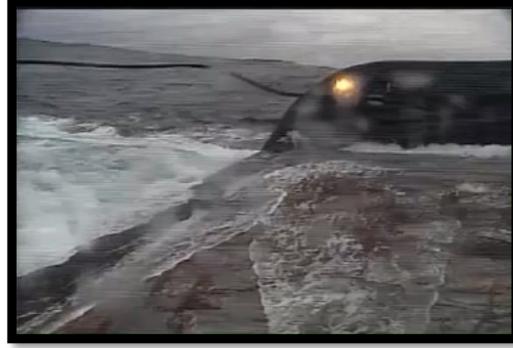
Figure 64: Starboard aft CCTV stills showing fluctuations in towline tension. Still on left shows lower tension at 11:32:06. Still on right shows high tension at 11:32:10 at the time of the shackle failure. *AIVIQ CCTV Provided by ECO*

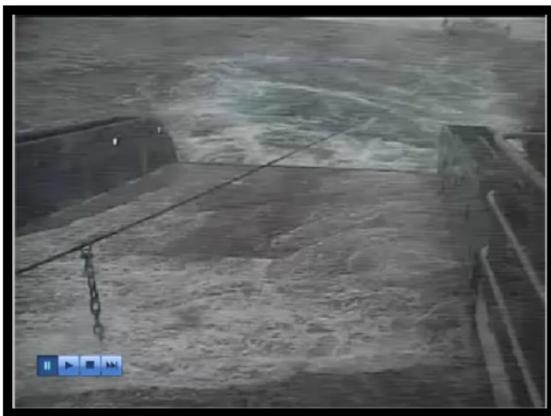
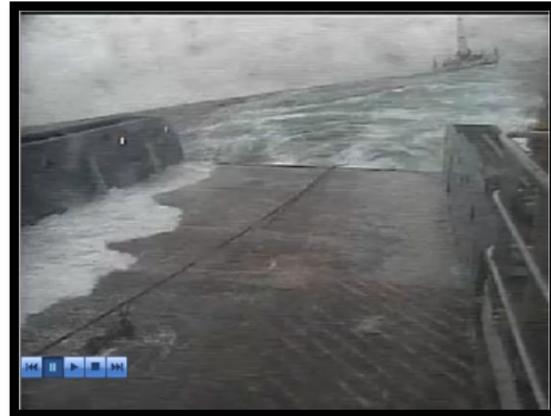
Figure 65: Port Forward CCTV stills showing fluctuations in towline tension. Still on left shows high tension at 10:54:48, demonstrated by the stiffness of the hogging chain (bottom right of still) and towline appearing to lead nearly horizontally toward KULLUK. Still on right shows low tension at 10:54:52, a mere 4 seconds later, with a slack Deadman chain and towline on the deck. *(AIVIQ CCTV Provided by ECO)*

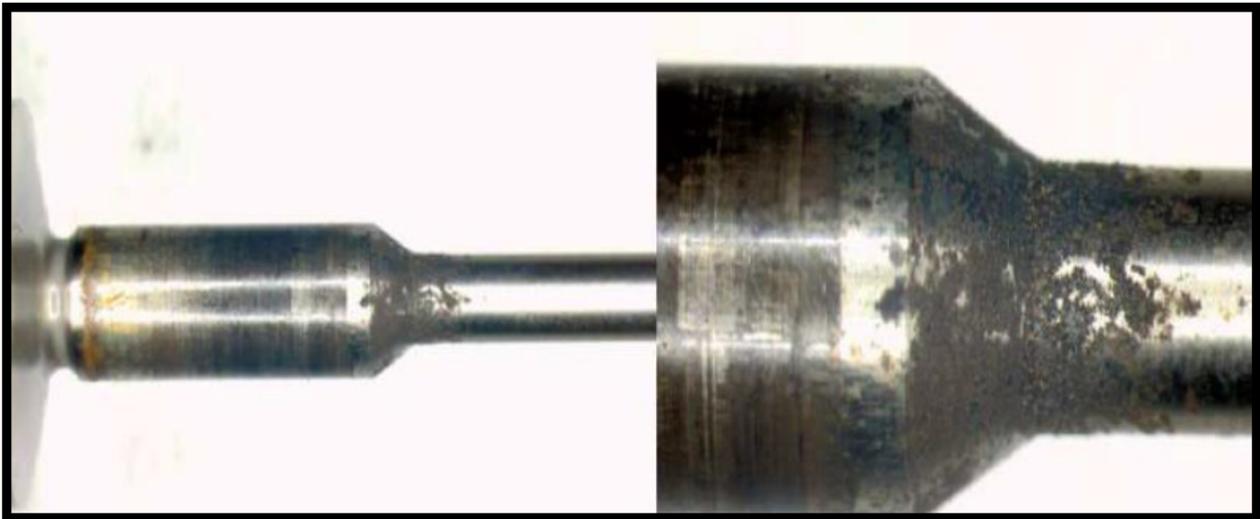
Figure 68: Two photos showing significant corrosion of injector check valve. (Provided by Caterpillar)

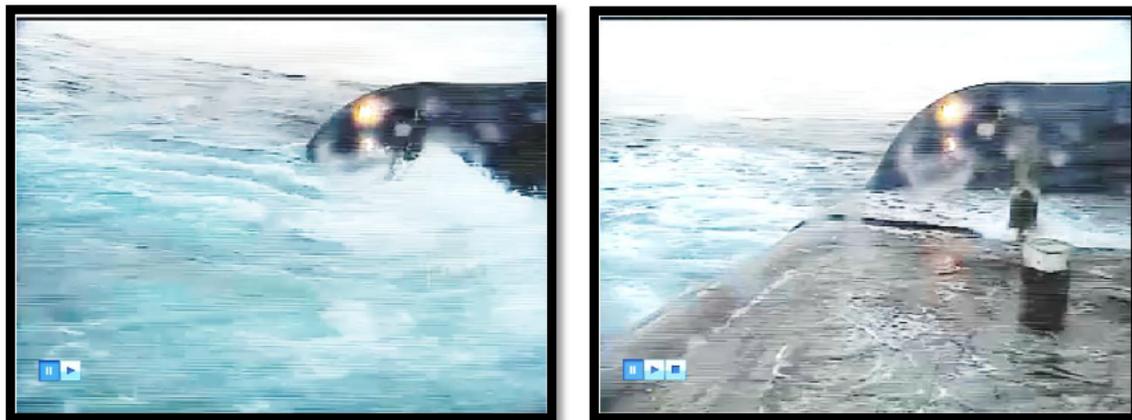
Figure 70: (left) Still from Starboard Stern CCTV showing seawater flowing over aft working deck and entering safety deck area at 15:16:47 on December 27. (right) Safety deck area at 15:16:55 after water clears from deck. Port side aft safety deck hatchway is visible. *(AIVIQ CCTV Provided by ECO)*

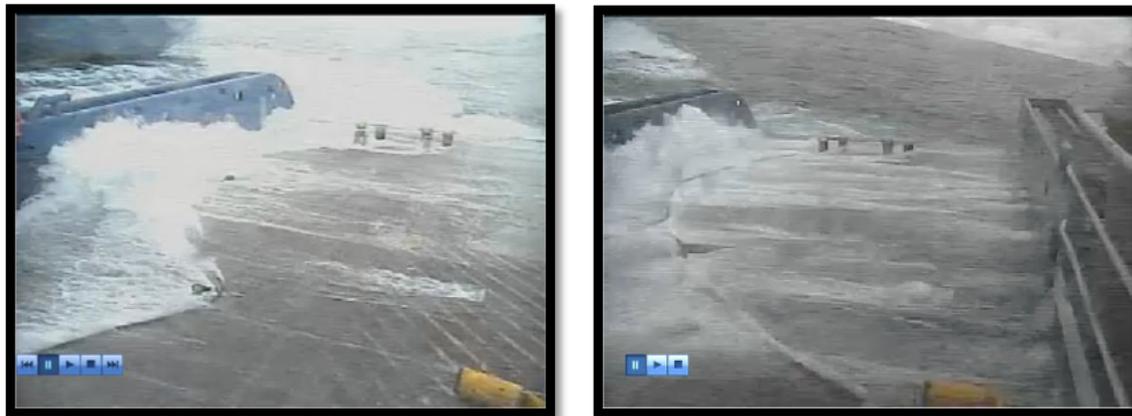
Figure 71: (left) Still from Port Forward CCTV showing seawater flowing over aft working deck and entering safety deck area at 14:39:09 on December 27. (right) Similar occurrence at 14:49:19 on December 27. (AIVIQ CCTV Provided by ECO)

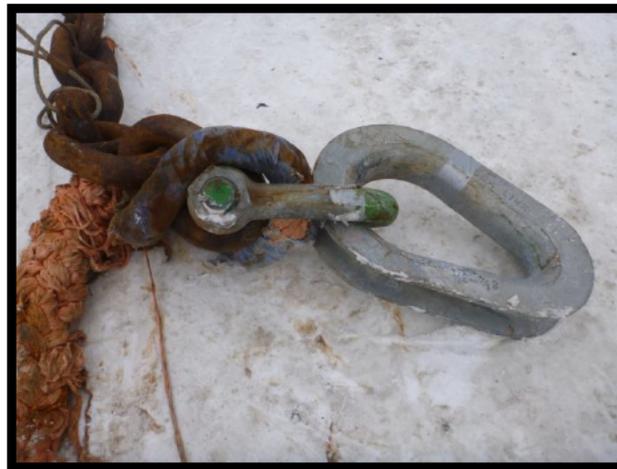
Figure 75: Photo of recovered emergency towline (eye on the KULLUK end of the emergency towline) showing missing thimble lashings allowing towline to separate from hard thimble. Blue Cordura® protection is also damaged. (*USCG Photo*)
