Isle of Man Ship Registry

Casualty Investigation Report No. CA102

Collision between the Tanker British Cygnet and  
Container ship Vera

2nd December 2006

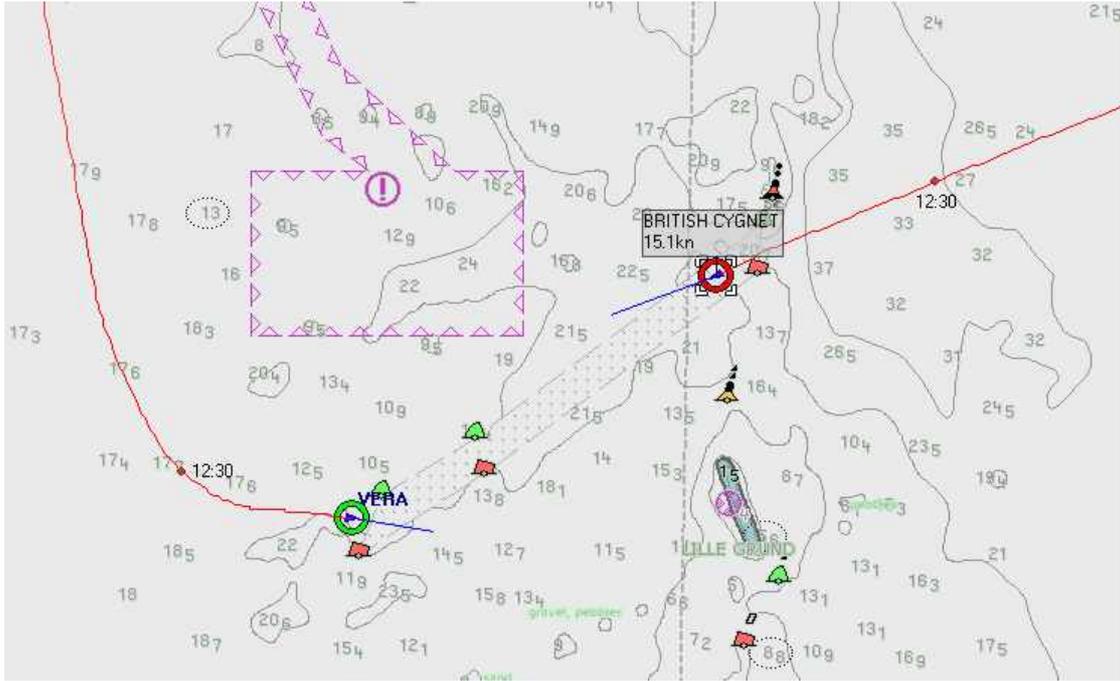
11.34 UTC Image from AIS record. (The Royal Danish Administration of Navigation and Hydrography)

- 11.33.26 The British Cygnet entered the northeast end of the deep water channel north of Fynshoved on a course over the ground of 250.8 degrees and a speed over the ground of 15.1 knots.

- 11.34.45 The Vera entered the south western end of the deepwater channel north of Fynshoved on a course over the ground of 101 degrees and a speed over the ground of 11.5 knots. The Second Officer was alone on the bridge. The ship was in manual steering. The Second Officer intended to enter the channel and remain on the starboard side. However the rate of turn was not sufficient to keep the Vera within the channel and she entered the channel between the two buoys at the south western end, then passed out of the channel across its southern boundary.

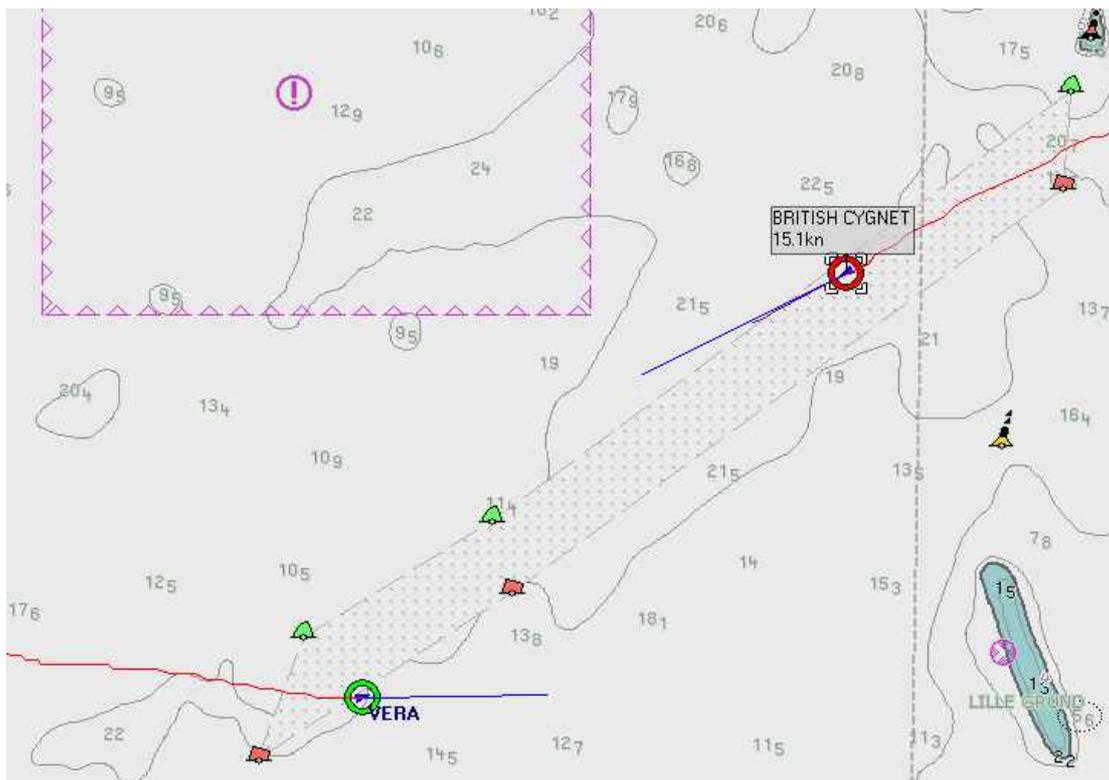
11.35 UTC Image from AIS record. (The Royal Danish Administration of Navigation and Hydrography)

- 11.35.35 The Vera passed out of the deep water channel over the southern boundary. Her course was easterly at 083 degrees and her speed was 12.3 knots.
- 11.36.14 Onboard the British Cygnet there was a brief conversation between the Master and Pilot about the vessel approaching the south western end of the deep water channel. This concluded with the assumption the vessel would remain outside of the deepwater channel. The Vera's easterly course was clearly indicated visually, by radar plots and on ECDIS and AIS.

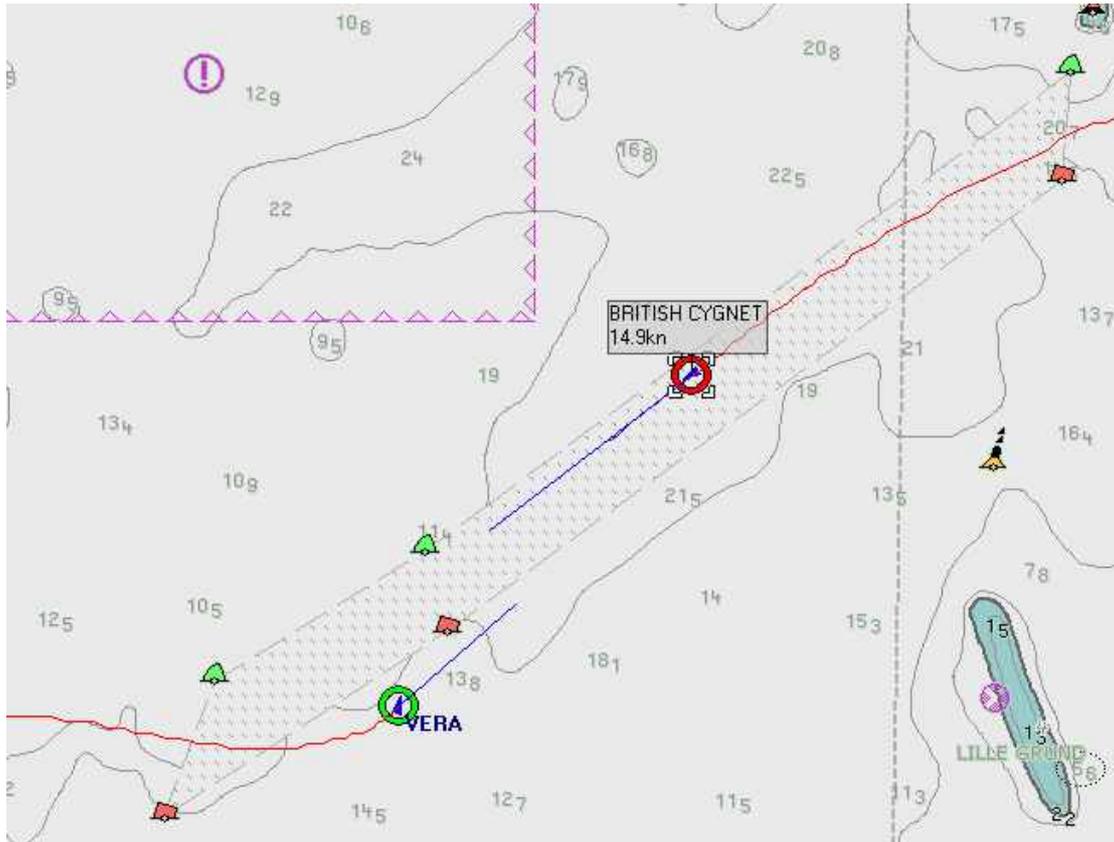
11.37 UTC Image from AIS record. (The Royal Danish Administration of Navigation and Hydrography)

11.37 The Vera altered course to port, heading back into the deepwater channel.

11.37.35 The Vera re-entered the deepwater channel across its southern boundary on a course of 038 degrees and a speed of 8.2 knots. The Vera then passed about 20 metres north of the port hand buoy. She then continued to cross the channel with a course over the ground of 032 degrees and speed of 9.5 knots.

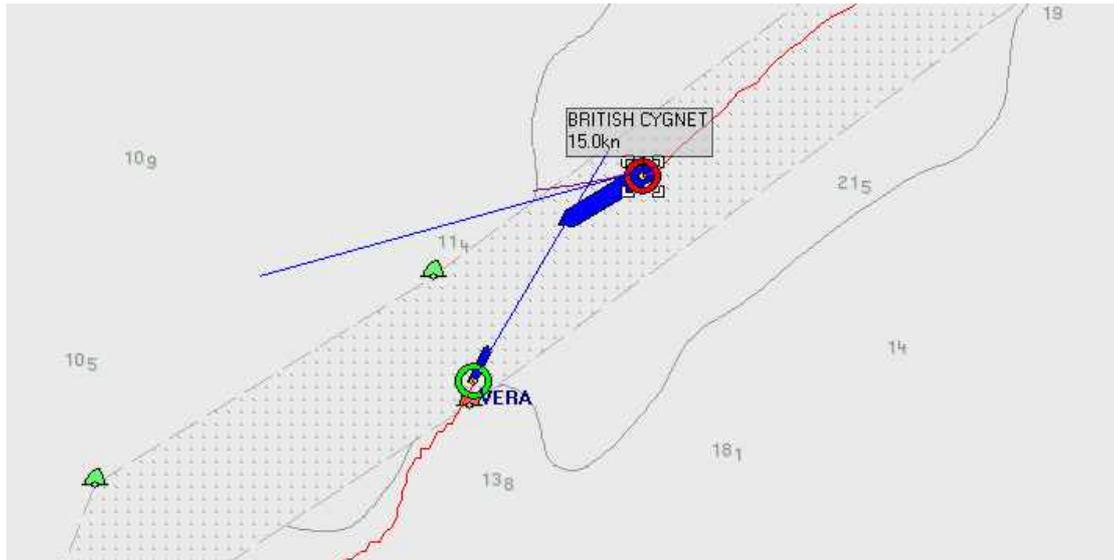
11.38 UTC Image from AIS record. (The Royal Danish Administration of Navigation and Hydrography)

- 11.37.48 The pilot on the British Cygnet makes a call on the VHF “you have to come to port, come to port please” This is not heard by the Second Officer on the Vera.
- 11.37.54 The pilot on the British Cygnet gives 5 helm orders in quick succession finishing with Hard a Port.
- 11.38.19 On board the British Cygnet the Master orders Hard a Starboard. The Pilot also orders Hard a Starboard and then requests a signal and orders Stop Engines.
- 11.38.39 On board the British Cygnet the Master orders the General Alarm to be sounded.
- 11.38.49 The Point of Collision between the British Cygnet and Vera. The Vera’s bow struck the British Cygnet amidships on her port side at an angle of approximately 60 degrees leading aft. The collision stopped Vera instantly and she passed along the British Cygnet’s port side as the tanker continued to make way.

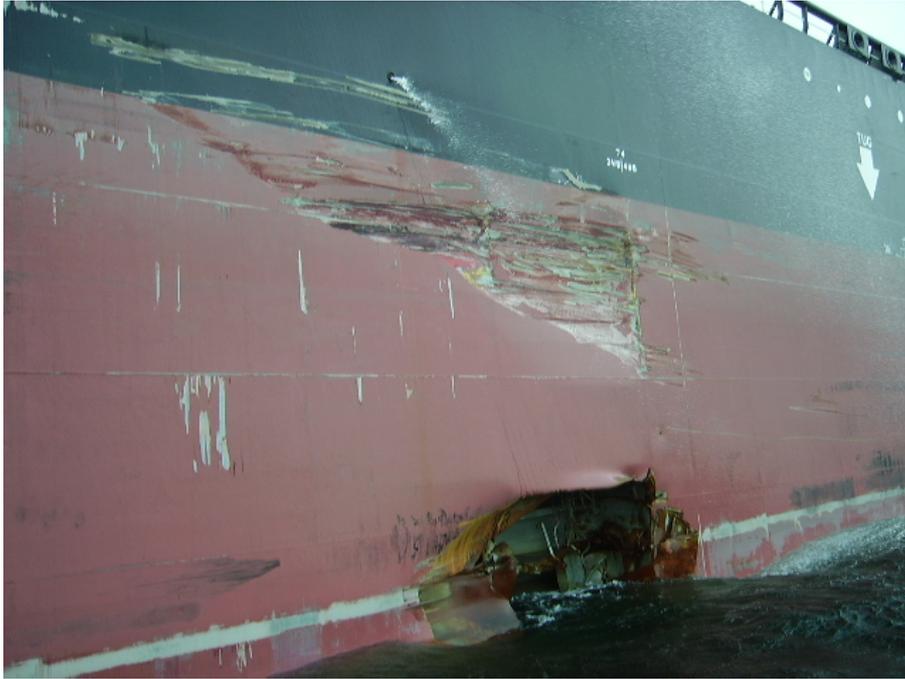
Two water ballast tanks on the port side were breached and open to the sea. The cargo tanks were empty and inerted and were not breached.

Damage to MV British Cygnet (Isle of Man Ship Registry)

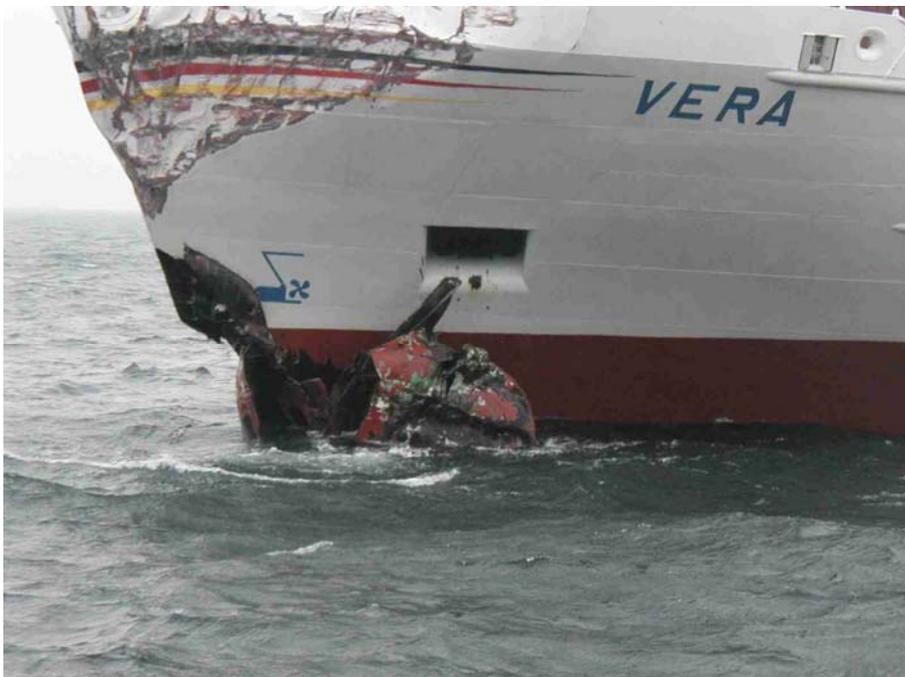
The stem, bulbous bow and upper part of the side shell were damaged.

Damage to MV Vera
