National Transportation Safety Board

Marine Accident Brief

Fire Aboard Freighter *Alpena*

Accident no.	DCA16FM012
Vessel name	<i>Alpena</i>
Accident type	Fire
Location	Fincantieri Bay Shipbuilding, Sturgeon Bay, Wisconsin Approx. 44°50'28"N, 87°22'55"W
Date	December 11, 2015
Time	1730 central standard time (coordinated universal time – 6 hours)
Injuries	None
Property damage	Estimated at \$4 million
Environmental damage	None
Weather	Clear visibility, calm winds, air temperature 45°F
Waterway information	Graving dock in Sturgeon Bay, Wisconsin

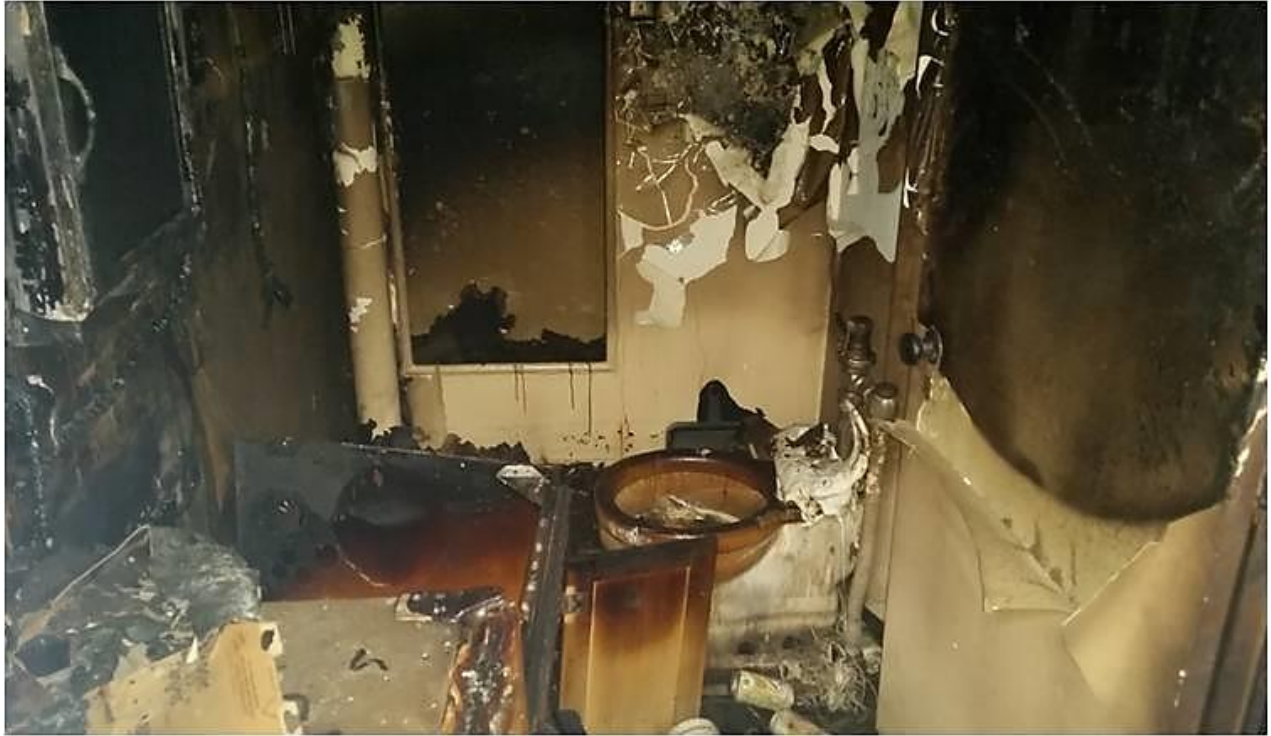
Fire damage to one of the *Alpena* bathrooms. (Photo by Coast Guard)
