## IMCA Safety Flash 33/16

December 2016

### Summary

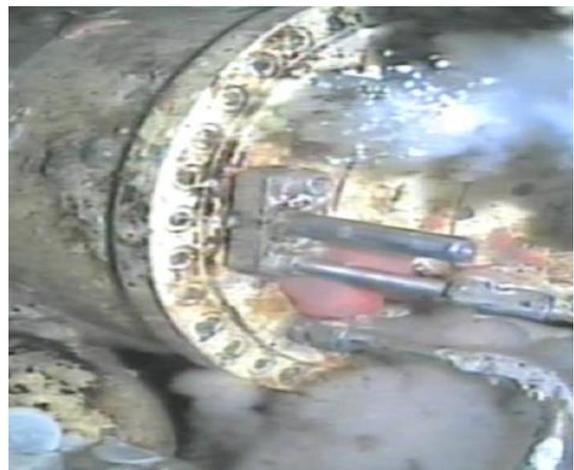
The incident occurred during subsea operations which involved divers monitoring a manifold valve. A hydraulic release occurred when a valve was operated by the client FPSO. This leak was not detailed on the Dive Log or as an anomaly within the Management of Change (MoC) step of the operation. It was not reported to the Offshore Management Team nor to the client representative on board at the time. The client became aware of the leak some four months later following a review of as-built video footage, and onshore project management were notified of the incident. In the regulatory framework within which the vessel was operating, it is a requirement that any such releases to sea are reported by the client within 6 hours of such an event occurring.

No personnel were harmed or equipment damage sustained; however, an unknown volume of fluid was discharged to the environment which was not reported at the time of the incident.

- ◆ The requirement to report all subsea leaks was not followed. Personnel were not familiar with company procedures in place to ensure compliance with local regulations;
- ◆ Project process to manage implementation of client site instructions for additional works were not clearly defined.

- ◆ Ensure that pollution reporting process requirements are understood by all key personnel both onshore and offshore;
- ◆ Dive Plans should clearly reflect requirement to notify both client, master and project engineer of any discharge observed from subsea infrastructure.

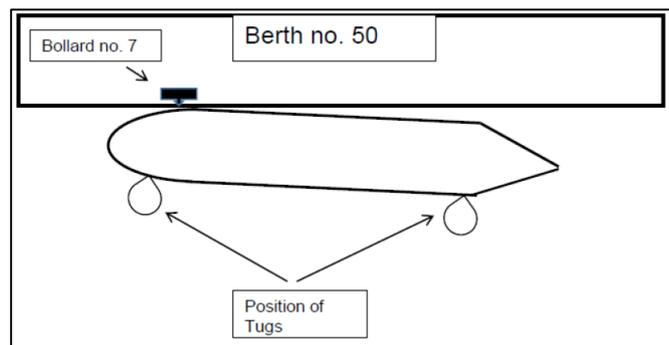
The after tug pushed more and instead of landing parallel to the berth, the vessel's port quarter landed heavily on the quay near Bollard 7. The vessel's port side shell plating was damaged near a fuel oil tank, and there was damage to the concrete of the quay itself.

- ◆ Although the shifting plan was discussed verbally, there was no evidence of a risk assessment being carried out for this operation;
- ◆ The Master and the Pilot had not agreed on a working language during their discussion and information exchange;
- ◆ The Pilot was using French rather than English to instruct the crew of the tugs;
- ◆ The Master and bridge team did not intervene with the Pilot to verify commands given to the tugs in French.

- ◆ The Pilot misjudged the tugs pushing power;
- ◆ The pilot was giving instruction in a language which was not understood by the bridge team.

A **causal factor** was **inadequate communication** – the Master failed to intervene with the Pilot when instructions to the tugs were given in a language he did not understand.

- ◆ Risk considered tolerable – this was considered by the Pilot to be a routine recurring task;
- ◆ Inadequate Standards – there were no company procedures to cover the situation, particularly with regard to the working language on the bridge during navigational operations where Pilot/tug assistance is required.

- ◆ Remind Masters that they should override the Pilot's instructions if they are considered to be incorrect or unsafe;
- ◆ Establish formal working language for ship's movement at all times including berthing/un-berthing operations;
- ◆ Ensure compliance with guidelines on relationship between Master, Officer of the watch (OOV) and Pilot.

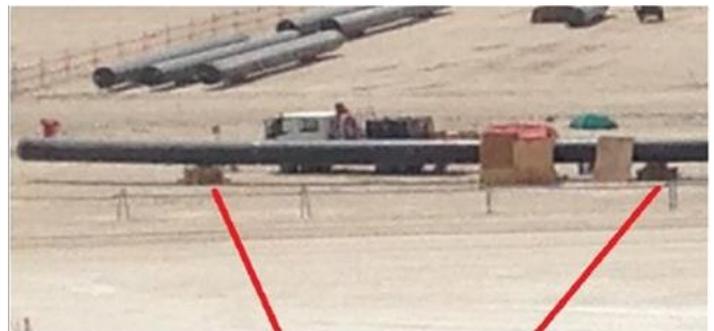
A section of 36-inch gas export line they were working under or near fell off the approximately 60cm high temporary wooden supports (skid stacks) and crushed them. The two employees, a grinder and a welder, were completing a construction weld repair at the north-eastern-most weld joint of an approximately 120m curved section of the export pipeline.

Position of pipe before falling from the two supports pictured (of eight total)

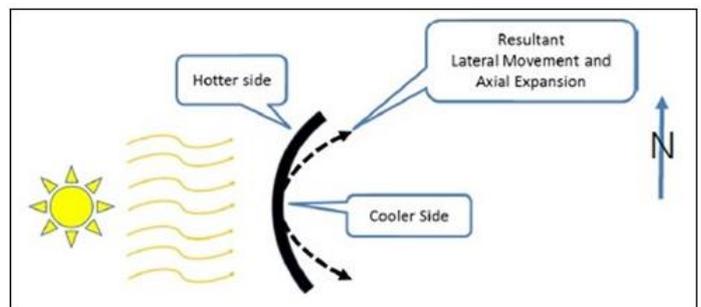
- ♦ The work permit system in place was rigorously applied to the known risks, but there was a lack of awareness of:
  - The hazard presented by temporarily suspended pipes, which constituted a dynamic load / dropped object hazard
  - The hazard of thermal expansion, differential heating, and residual pre-stress forces contributing to the lateral movement of curved pipe segments.

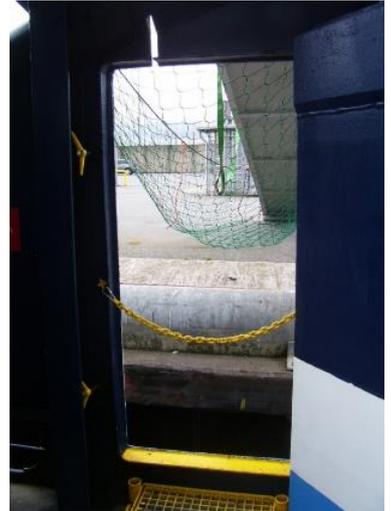
During the most recent incident, a surveyor from a classification society boarded the vessel whilst it was still being made fast, having just come alongside. The side door had been open to facilitate monitoring of the launch and recovery of the rescue boat for survey purposes – however, the safety chain was across the space. The surveyor removed the chain and jumped from the quayside onto the ship. The aft mooring station had only just confirmed to the bridge the vessel was all fast, and the engines and thrusters were still running when the incident occurred.

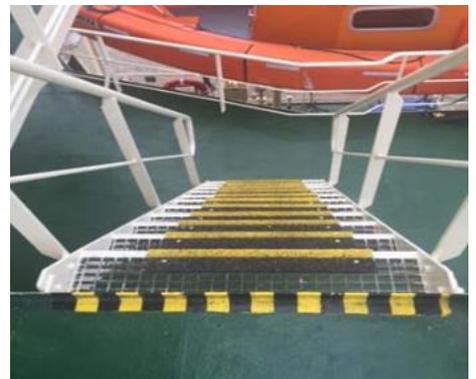
The MSF has published the following safety alert regarding an incident in which a crewman fell down the stairs and was injured. The incident occurred following recovery of the vessel's daughter craft (DC) when the crewman had informed the Officers in the bridge that the small boat had been recovered and safely stowed. He left the bridge and was making his way down the external stairway to the boat deck when he slipped and fell down the stairs to the deck below. He broke his arm and was transferred from the vessel via helicopter to hospital.

- ◆ The stairs were in good condition and were fitted with grips which were in good condition;
- ◆ The injured person was wearing all appropriate PPE, including his safety footwear, which was in good condition;
- ◆ Weather: cloudy, wind force 3 knots, sea height 1-2m, although the IP stated the vessel rolled just prior to his fall;
- ◆ The injured person stated he was using the trailing hand technique whilst going down the stairs, although he had a radio in his other hand;
- ◆ There were no radio sling/holsters on board;
- ◆ The incident occurred after the original work task had been completed. This was identified as a trend in this particular vessel owners fleet.
