Safety Alert

Number: 16-23

Subject: Crewman Fell on External Stairway

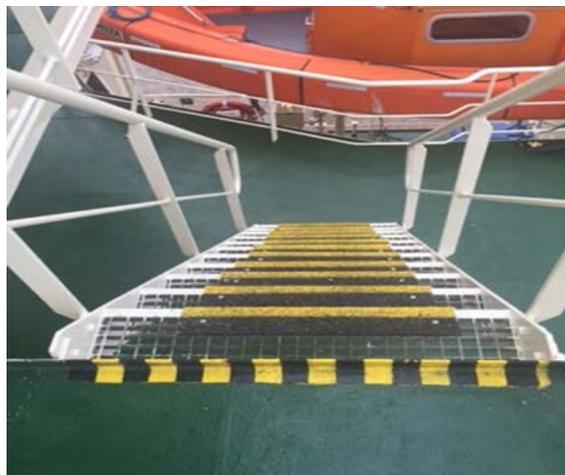
On investigation, it was determined that the stairs were in good condition they had been fitted with grips, these were in good condition. The IP was wearing all appropriate PPE, including his safety footwear, this was checked and the boots were found to be in good condition. The weather at the time was cloudy, wind force 3 knots, sea height 1-2mtrs, although the IP stated the vessel rolled just prior to his fall.

The IP stated he was using the trailing hand technique whilst transiting the stairs, although he had a radio in his other hand. No radio sling/holster onboard. Given the circumstances of the event as described, whilst it is not always possible to avoid carrying items when transiting stairways, in this circumstance it should have been possible and may have avoided the incident.

Review the provision of radio holsters on each vessel in the fleet
