**REPUBLIC OF CYPRUS**  
**MARINE ACCIDENT AND INCIDENT**  
**INVESTIGATION COMMITTEE**

**[Investigation Report No: 55E /2014]**

**Very Serious Marine Casualty**

**Death of Seaman due to entry into enclosed space, on  
the Multi-Purpose Dry Cargo Ship “UBC TOKYO”, at  
the port of Vitoria - Brazil, on the 28<sup>th</sup> of June, 2014**

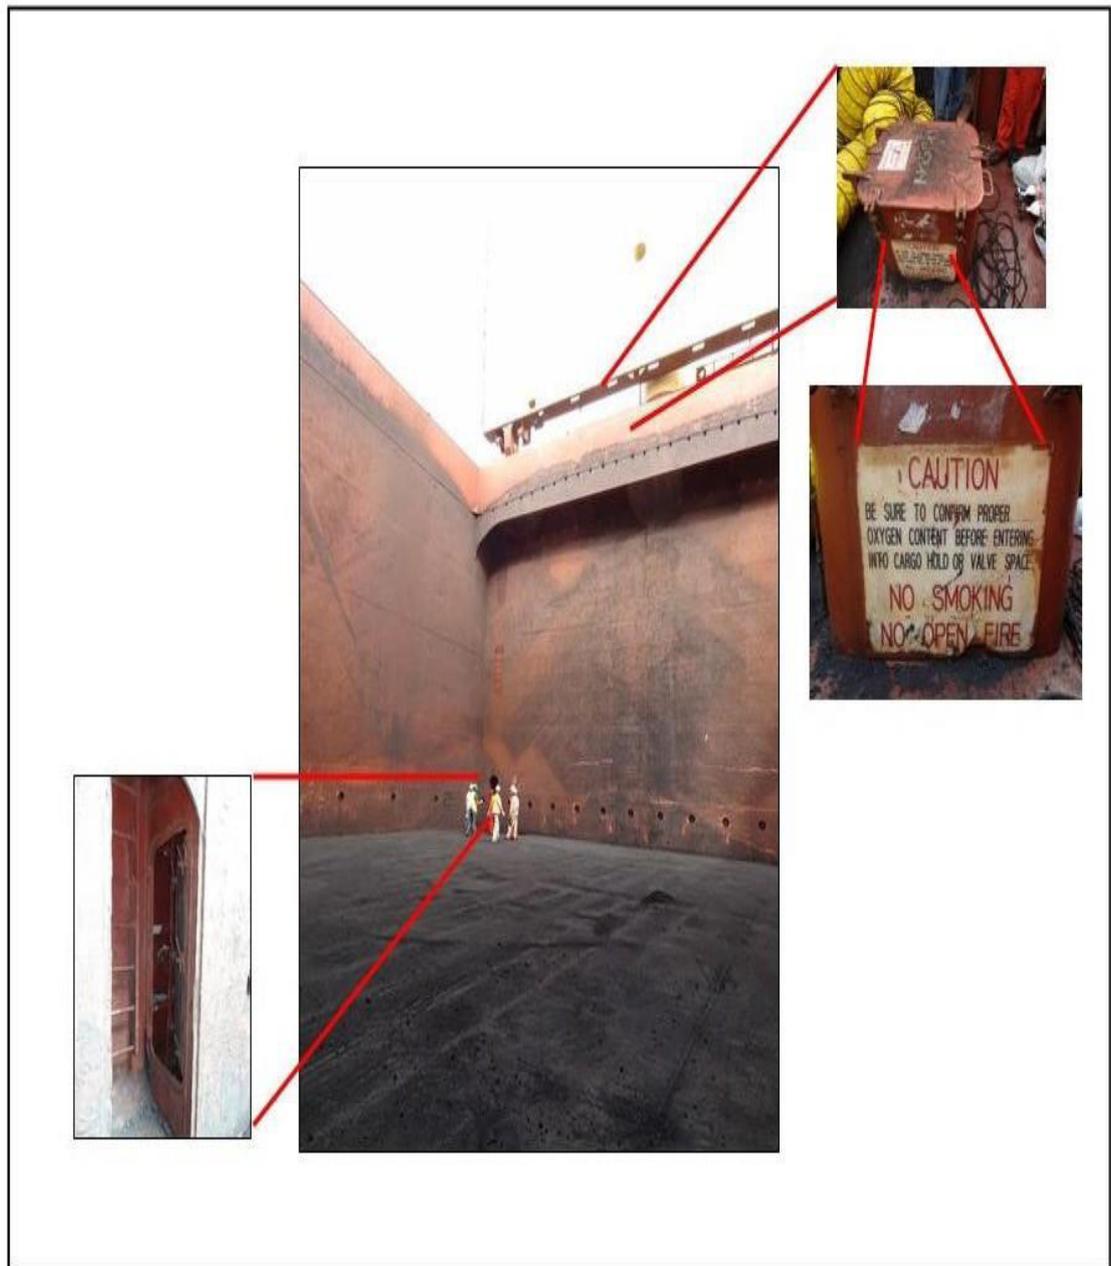
***Fig.7 Entrance hatch on deck and Lower door in the Cargo Hold***

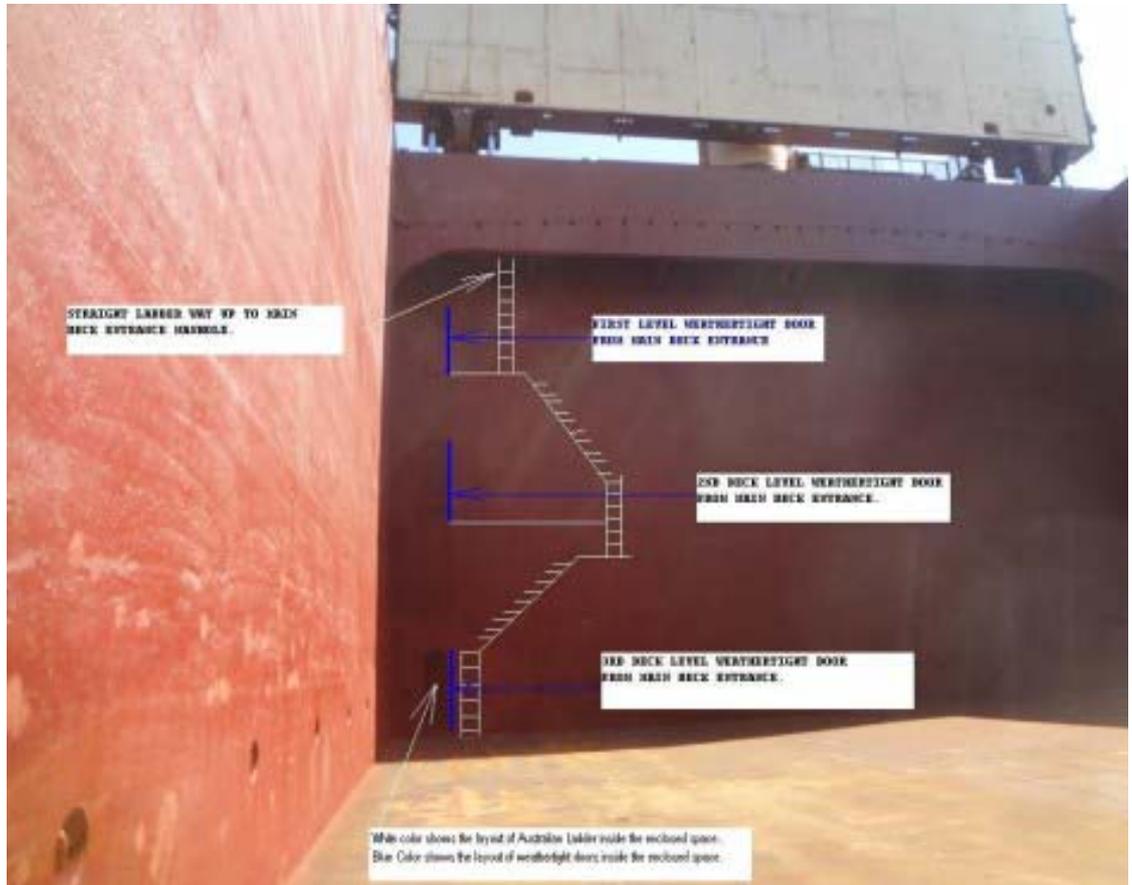
**Fig.10 Aus Ladder installed within Cofferdam**

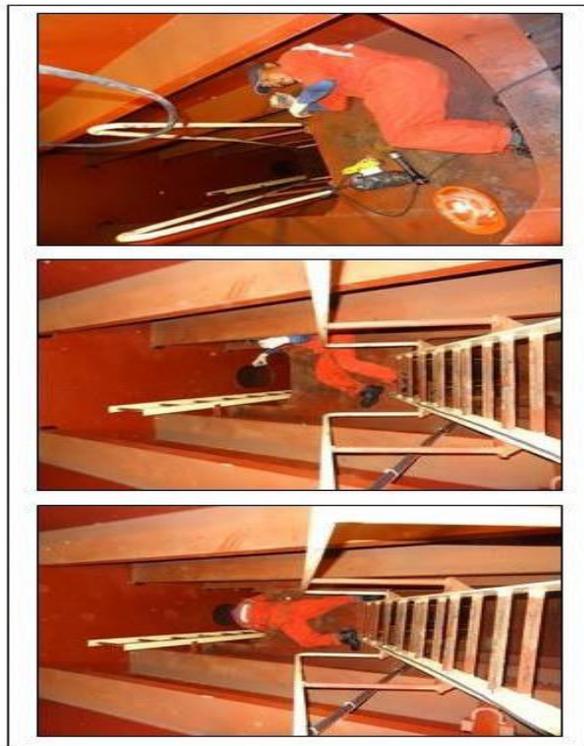
**Fig.11 The OS up, close to the entrance hatch- The 2/O and AB at the same level**

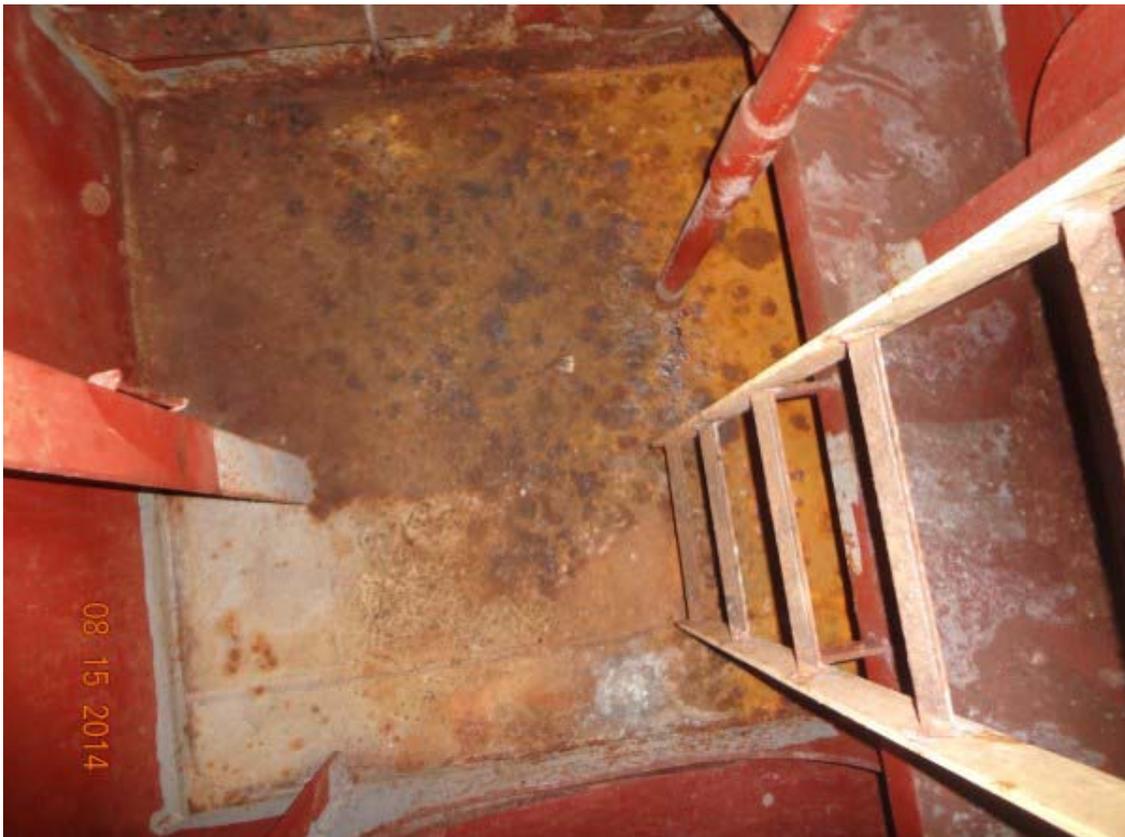
During the last voyage, i.e. from the 1<sup>st</sup> until the 27<sup>th</sup> of June, all Cofferdams' entrance hatchway covers were closed and padlocked. Also all lower doors leading into the holds were closed before commencement of loading at Jose Venezuela, (to not leak cargo from the holds into the Cofferdams). Any one of the ship's Cofferdams was for about a month, an hermetically enclosed space. Photographs of the lower part of the Cofferdam show that rust was formed. It is assumed that the reason was consumption of oxygen which existed in the hermetically closed Cofferdam. Ongoing corrosion of the Cofferdam's steel structure caused oxygen depletion. The deterioration in O<sub>2</sub> levels would have been slow and progressive. Normal air contains 21% oxygen. Subsequent measurements made by the Management Company's Superintendent indicated that the oxygen content in ship's Cofferdams at the level of the 2<sup>nd</sup> platform was 14% which causes respiration increase and poor judgment. Oxygen content 8-10% causes fainting (weakness) unconsciousness, nausea, vomiting.

*It is assumed that ongoing corrosion of the Cofferdam's steel structure that caused oxygen depletion was a contributing factor to the accident.*

***Fig. 12 Lower part of Cofferdam – Rusty surface***
