**Report of Investigation  
into the injury of a crew  
on board Hong Kong  
Registered Ship  
“BREVIK BRIDGE” in  
Singapore on 30 August  
2015.**

The Hong Kong Special Administrative Region  
Marine Department  
Marine Accident Investigation Section

29 August 2016

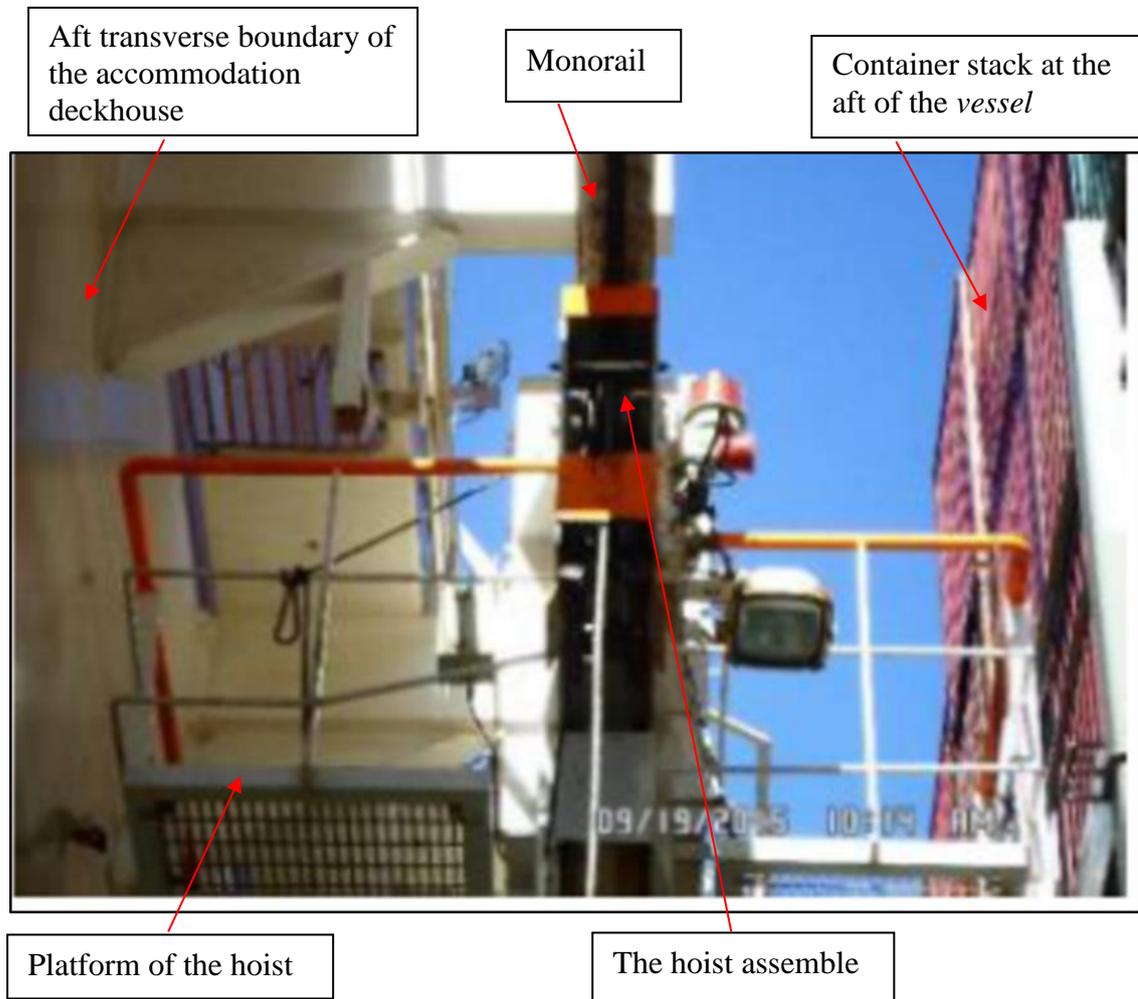
- 4.3 At about 1715, the newly joined fitter was called to help shifting the provision stores which were received on board by means of the ship’s monorail transverse hoist (the hoist) located just at the aft of the accommodation deckhouse (Fig.2). The hoist was provided with a lifting hook block on each side (i.e. portside and starboard side).

- 4.7 Electrician A was testing the function of the local controller (Fig.6) while Electrician B was removing the canvas cover of the control panel box. Electrician A could lower down the portside hook block by about half a meter by operating the local controller. He then asked the bosun to rise up the portside hook block using the remote controller to see whether the hoist could be reset. However, the hook block still could not be operated by the remote controller. Electrician A then repeatedly and quickly pressed the “Up” button on the local controller and the hook block hoisted up quickly. At about 1820, when the hook block was about to reach its parking socket fitted within the frames on the monorail of the hoist, the steel wire of the hook block parted. The hook block dropped down from a height of about 7 meters and hit the fitter who was staying on the main deck underneath of the hook block (Fig.2, Fig.3 & Fig.4).

Fig.2- View beneath the monorail hoist (portside hook assemble but without hook)

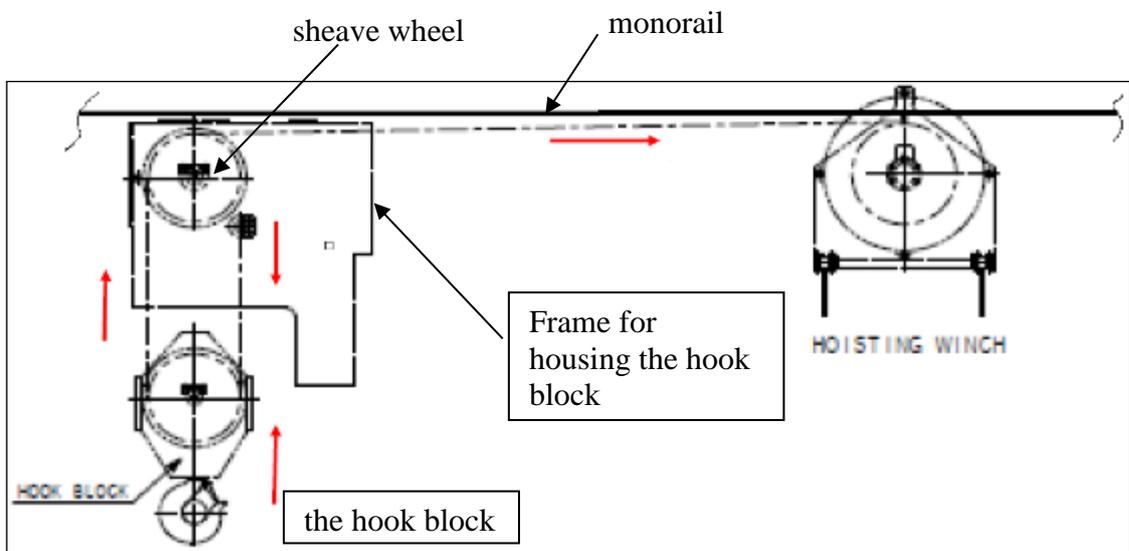
Fig.3- Arrangement of the monorail transverse hoist (portside hook)

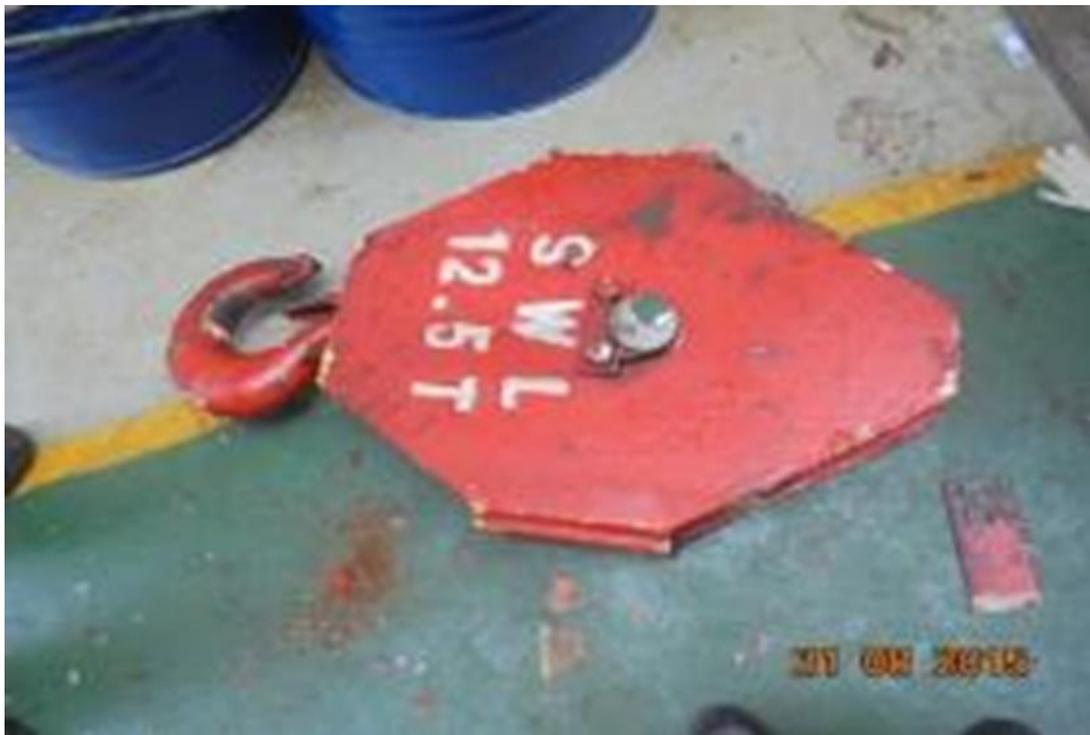
Fig.4- The hook block fell down on the deck

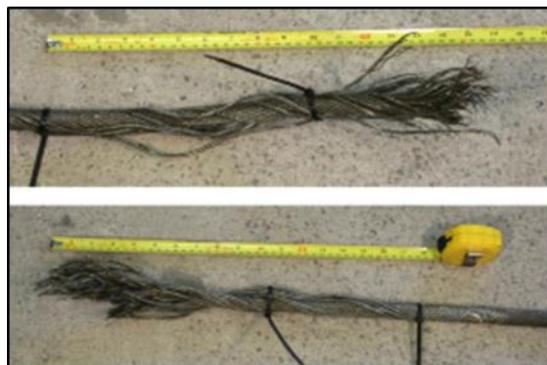
Fig.5- the parted hoist wire

5.12 Samples of the parted wire (Fig.5) were collected for micro analysis in laboratory and the results were as follows:

- a) the parted steel wire whose nominal diameter of 20mm with a breaking strength of 33.83 tons did satisfy the maker’s specification requirement. As the maximum pulling force provided by the winch motor and transmitted to the wire was about 9.9 tons, the steel wire matched the requirement of the manufacturer of the hoist. Under normal operating condition, the steel wire should not part;

- b) there was no sign of damage to the steel wire due to, for example, corrosion, pre-existing crack; and
- c) inspection of the fracture ends of the parted steel wire revealed that the majority of the wire strands was yielded under excessive shearing force applied to the materials while the remaining wire stands yielded under excessive tensile force. This was supported by the bend in small radius on the steel wire in adjacent to the parted section. Steel wire failed prematurely due to excessive shearing force (typically at about 50-60% of the maximum tensile force).

- 5.16 According to the micro analysis report, the parted steel wire was jammed during the upward movement of the hook block that in turn induced excessive shear force to part the wire. Therefore, it was probable that when Electrician A kept pressing the “UP” bottom on the local controller to bring up the portside hook block, the hook block snagged on the frame without the awareness of Electrician A. It caused the majority of the steel wire strands yielded under excessive shear force and finally it parted.

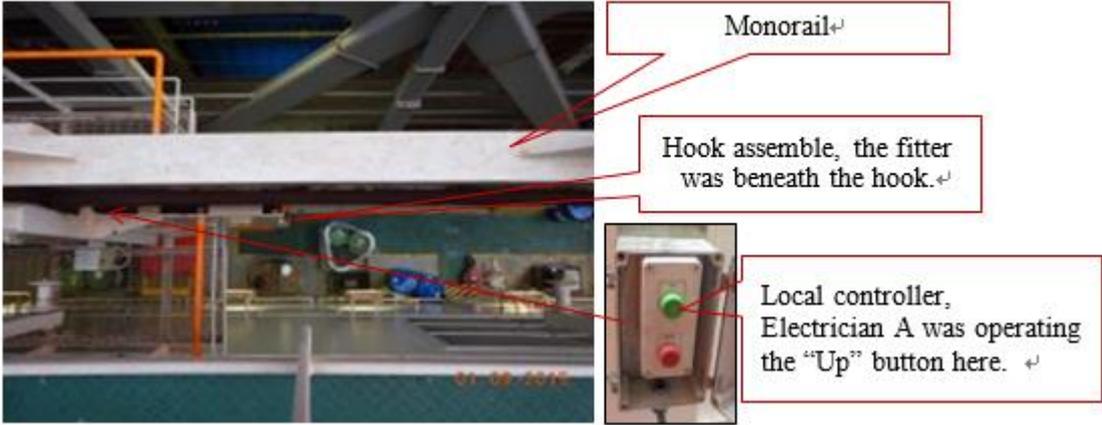
Fig.6- A view from top of the hoist

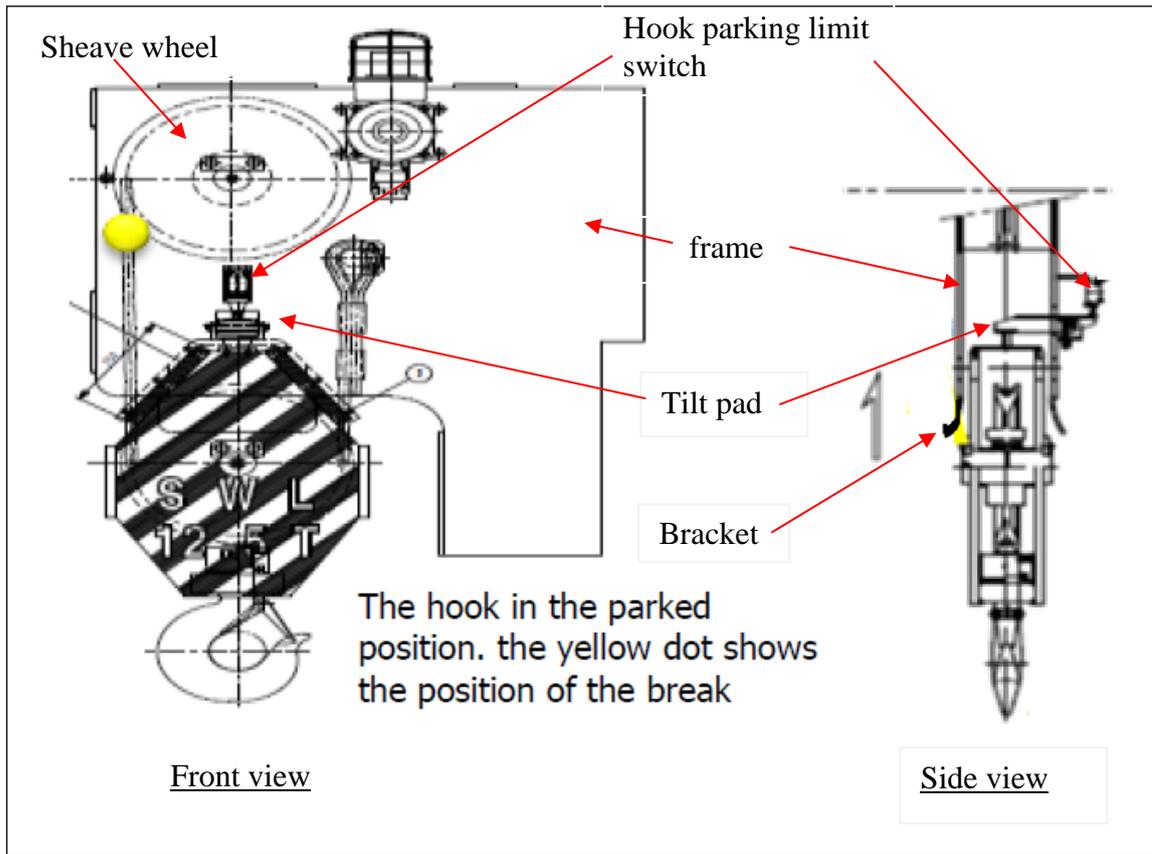
- 5.15 It was found out that the wire parted at a position close to the sheave wheel (the yellow spot in Fig.7) when the hook block was about to reach its parking socket. The hook block could probably snagged on the frames on the monorail at either of the two points marked “A” or “B” (Fig.9), especially when it was swinging during parking. The crew reported that they kept on encountering difficulties in parking the hook block before the accident happened.

Fig.7- The hook in parking socket

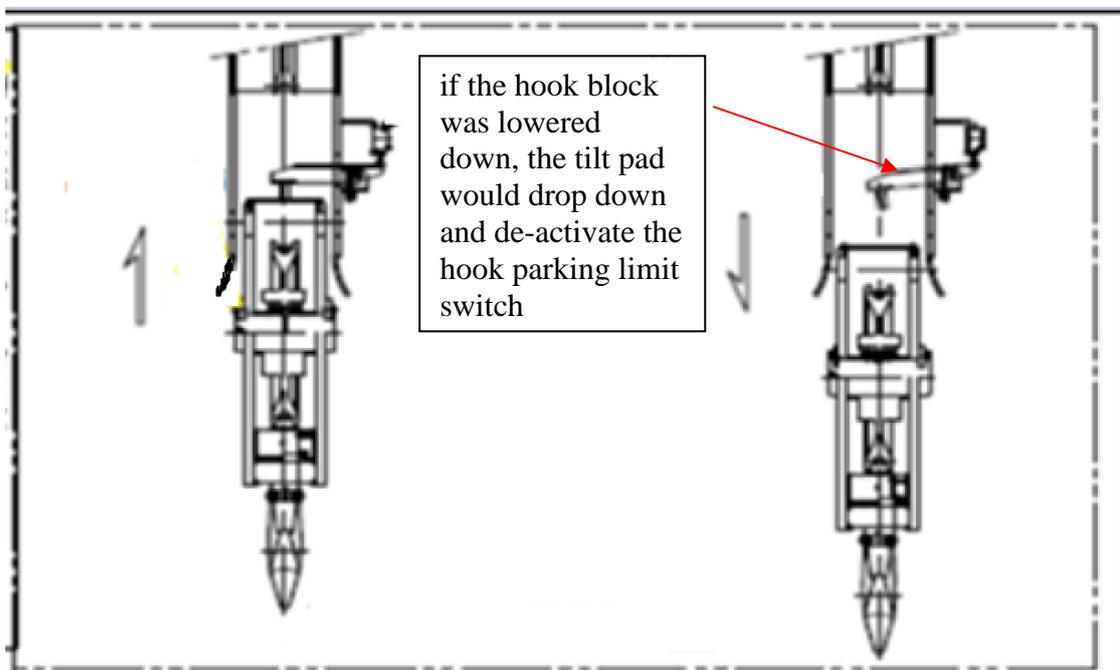
- 5.17 Under normal operation, the hook block would be seated in the parking socket and stopped when it pressed against a tilt pad, which in turn triggered a limit switch in the control circuit and stopped the movement of the hoist.
- 5.18 After the accident, it was found that the tilt pad was not free to move due to excessive painting work. It may render the safety control system of the hoist not reliable.

Fig.8- Side view of the hook block in the frame, showing the mechanism of the tilt pad and the hook parking limit switch.

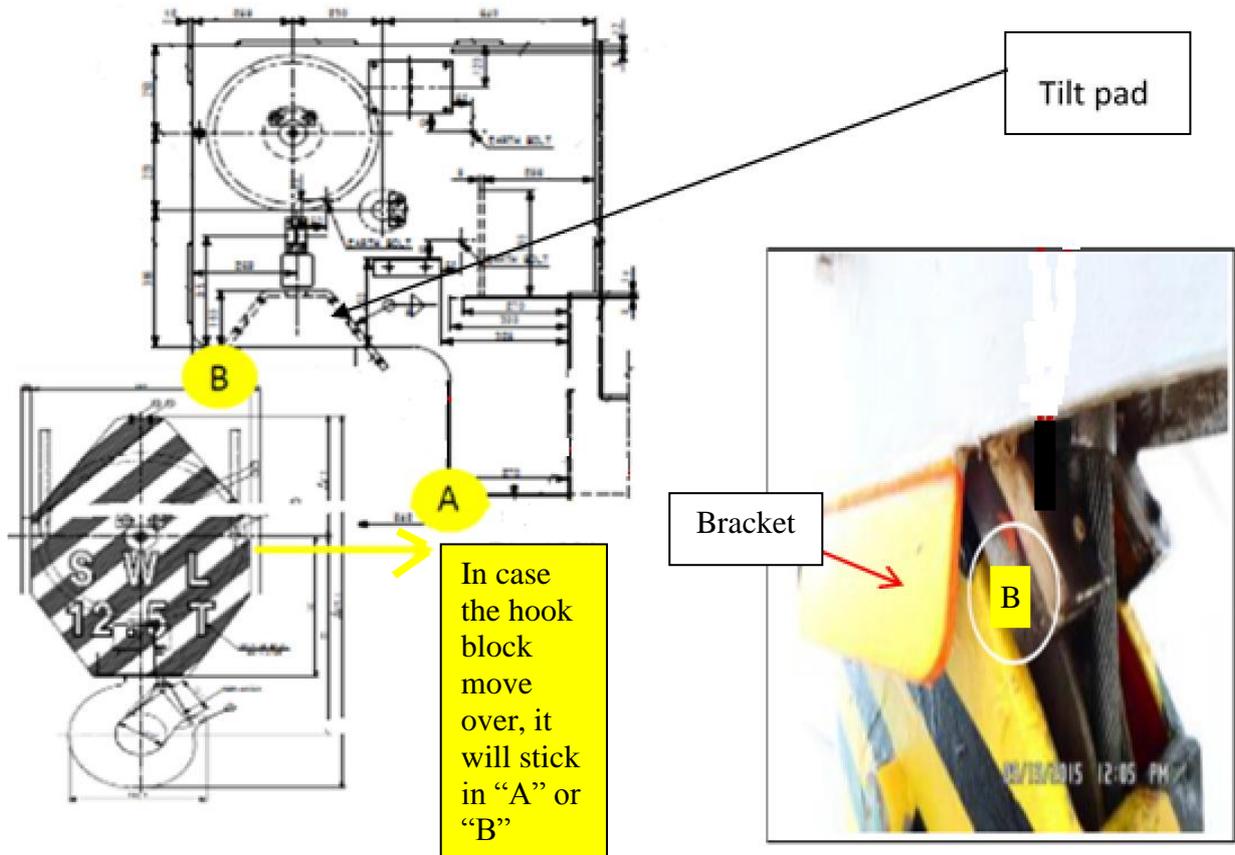
Fig.9- The frame of the hoist. (A: the edge of the assembly; B: the edge of bracket)
