ATSB TRANSPORT SAFETY INVESTIGATION REPORT
Marine Occurrence Investigation No. 243
Final

Independent investigation into the grounding of the
Panamanian registered bulk carrier

Pasha Bulker

on Nobbys Beach, Newcastle, New South Wales
8 June 2007

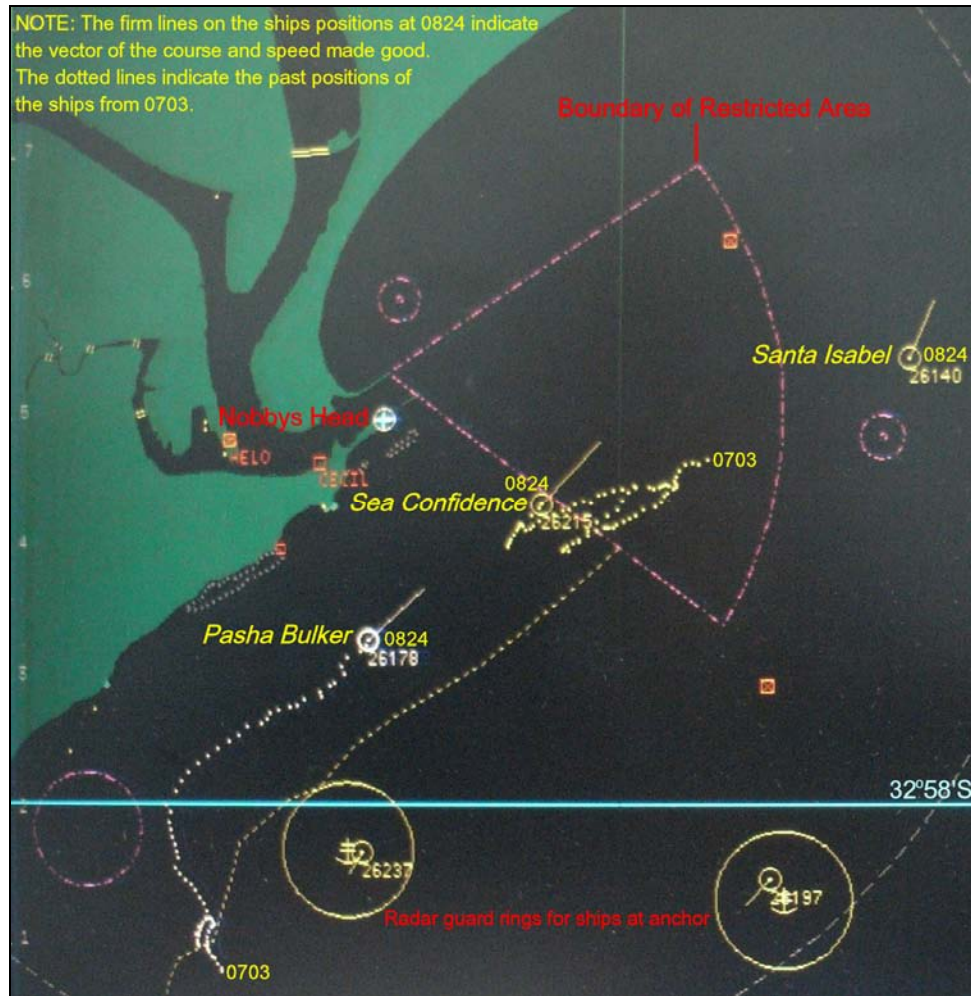
Figure 6: Section of VTIC radar screen at 0824 with relevant notations

Pasha Bulker's master listened to the conversation and remarked to the chief mate that his 'own ship's GM¹⁶ was good with no slack¹⁷ tanks'. The ship's ballast condition had remained unchanged since its arrival. The aft peak tank was empty, the fore peak tank one-quarter full and the other water ballast tanks were full.

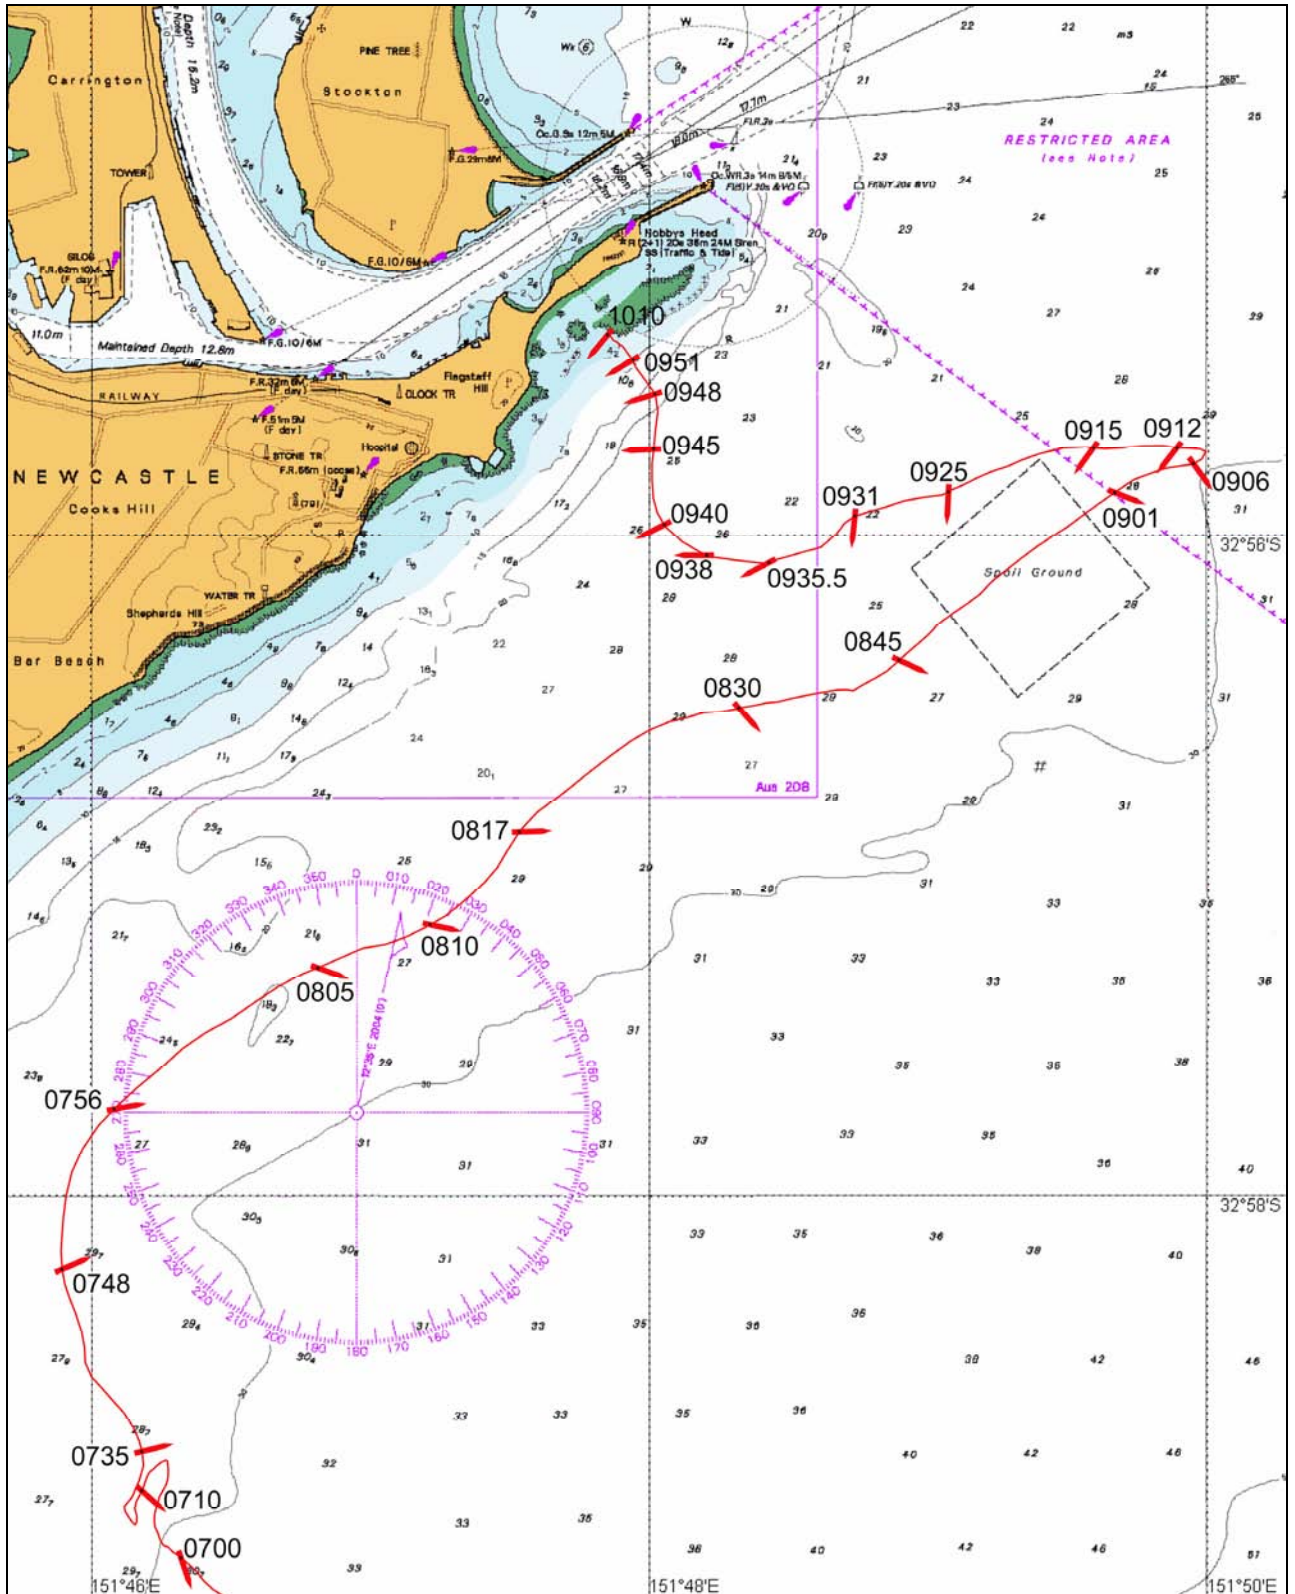
Figure 8: Section of navigational chart Aus 207 indicating *Pasha Bulker's* track on 8 June 2007. Images (to scale) of the ship, aligned to its heading at various positions, have been superimposed on its track

At 0906, just as the ship's heading returned to 140°, the master ordered it to 160°. In response, the helmsman applied nearly full starboard rudder and the ship's head started to swing rapidly to starboard. The wind which had been ahead was now on the port bow. At the time, the master remarked to the chief engineer that a ship's heading of 140° was 'face to face' with the wind and 'not good'.

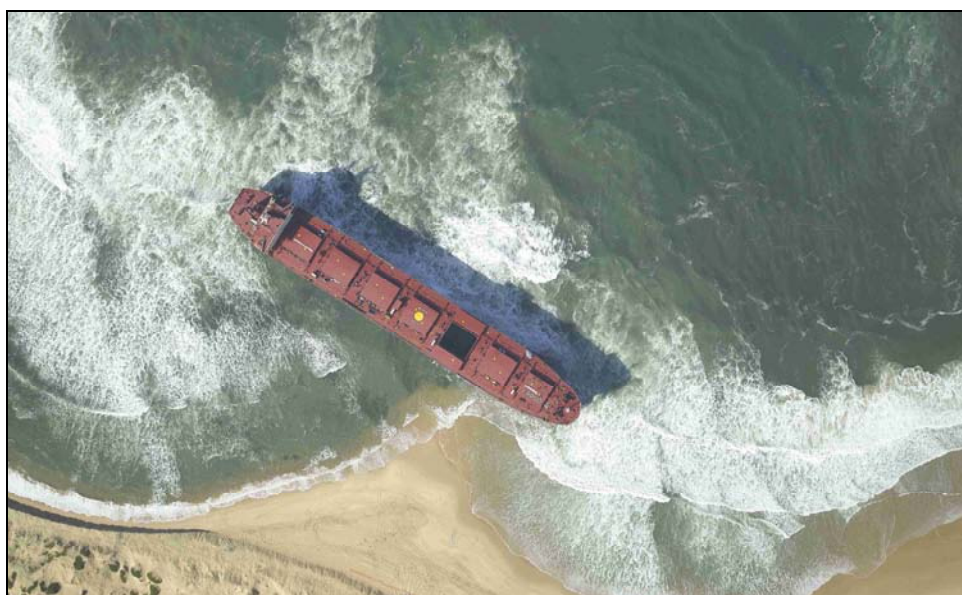
Figure 10: An aerial view of *Pasha Bulker* aground on Nobbys Beach

Pasha Bulker's fuel oil tanks had not been breached. A small quantity of oil had escaped from a fuel tank air vent pipe onto the deck but no pollution in the water was observed. Newcastle VTIC called on the VHF radio and obtained a variety of information including the quantity and disposition of fuel and other oils on board the ship. The centre had also been communicating with other authorities, including the local police who had enquired about the number of ship's crew to arrange a rescue helicopter for an evacuation.

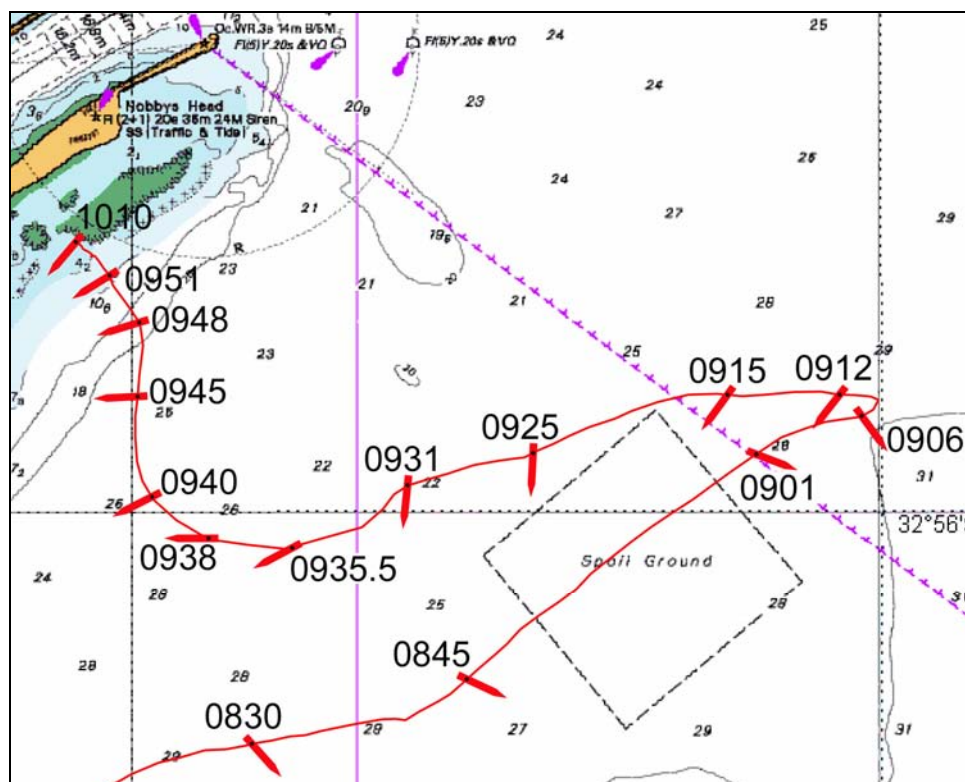
Figure 14: Pasha Bulker's progress towards Nobbys Beach

The master told the chief engineer that he did not want the ship facing directly into the wind. A course change to a gyro heading of 160° at that time might have been a feasible alternative. However, it did involve bringing the ship's head 20° through the wind to put it on the port bow. The change should have been a carefully controlled manoeuvre, particularly in view of the earlier difficulties keeping the ship's head up to the wind. However, the master, probably encouraged by the improved control at the increased engine speed, once again gave the helmsman a course to steer rather than controlling the turn himself with rudder orders.

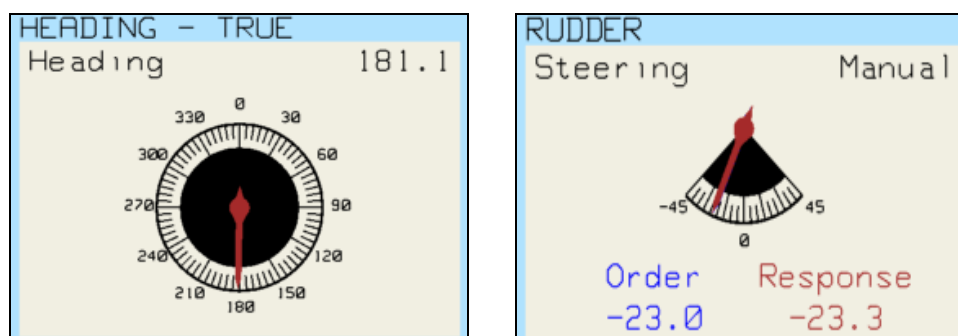
Figure 15: Ship's heading and rudder angle at 0923 (VDR display)

At 0927, the master declined an offer of assistance by VTIC advising that the situation would improve after '10 minutes'. He was worried and completely focussed on turning the ship to port. It is likely that fatigue, anxiety and uncertainty were overloading him. This was probably aggravated by the fact that he had little effective support from the bridge team as indicated by the communications on the bridge. While the chief engineer had been on the bridge, the master had conversed with him at length. In comparison, his communication with bridge team members was minimal with no discussion about the situation at hand.

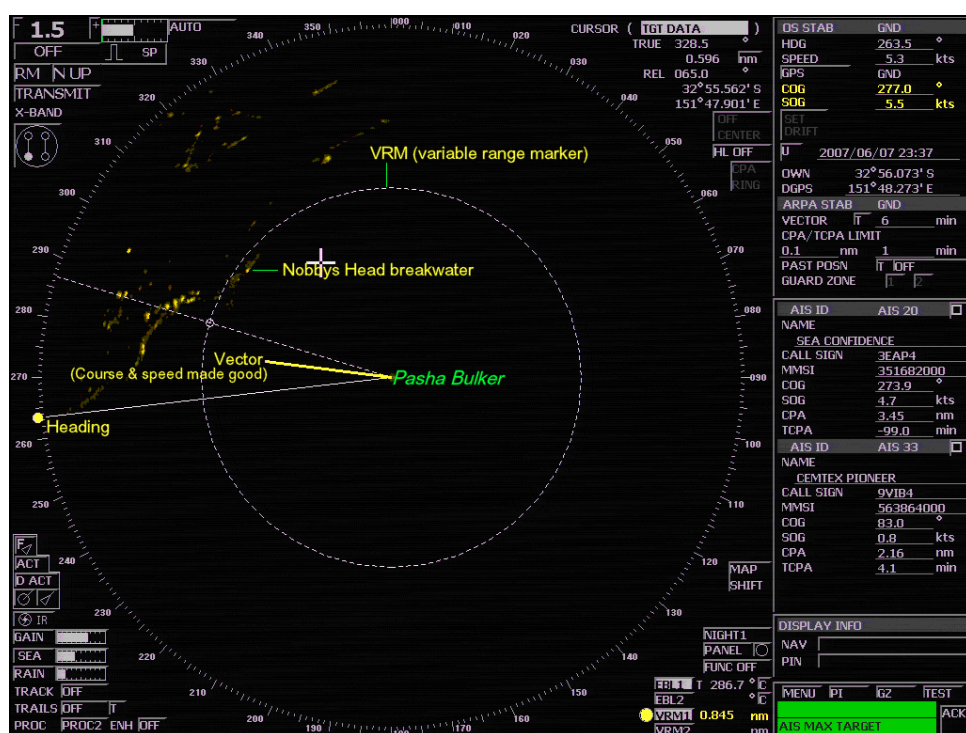
Figure 16: Pasha Bulker's radar display at 0937

At 0939, the master declined another offer of assistance from VTIC. He advised that the ship was turning to starboard with the engine operating full astern. It is possible that he thought going astern would assist the starboard turn. However, neither the transverse thrust from the right-hand turning propeller nor the stern seeking the wind under sternway could realistically, in the circumstances, be expected to assist the manoeuvre. The ship's headway and the extreme weather made success very unlikely.

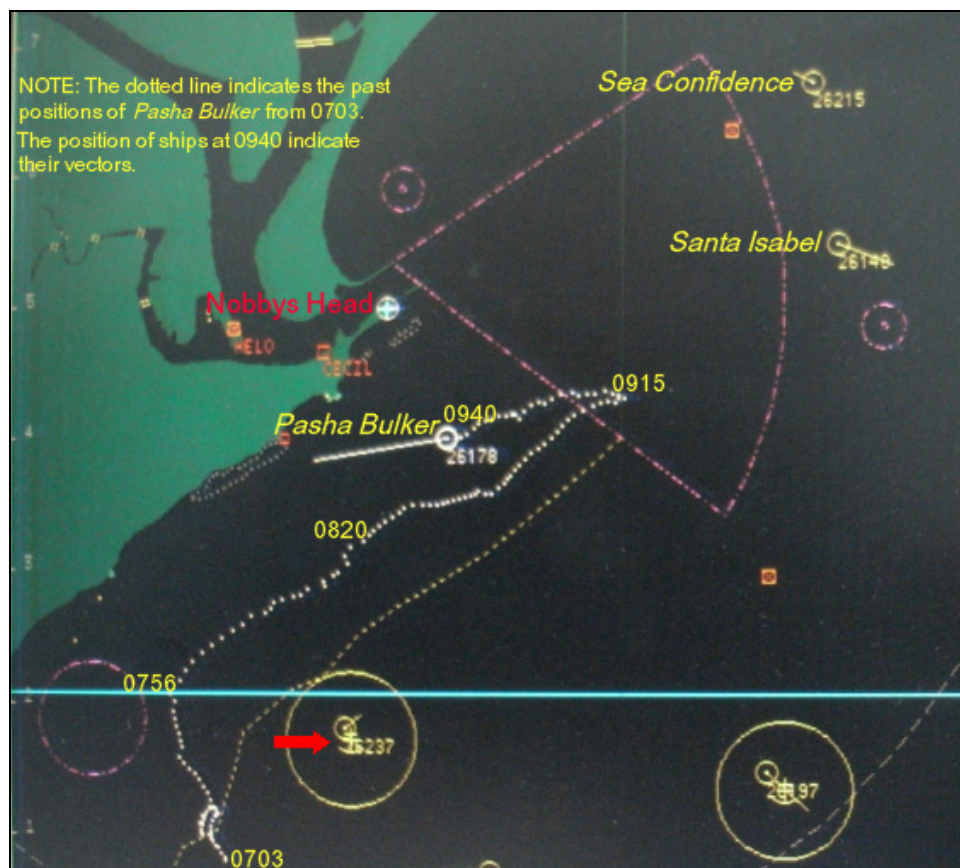
Figure 22: Section of VTIC radar screen at 0940

Even with the resources available to NPC, including the collective local knowledge of the harbour master and pilots and the weather monitoring equipment at VTIC, the port corporation was not sufficiently responsive to the increasing seriousness of the situation that developed from the evening of 7 June. By the early hours of 8 June, a dangerous situation had already developed but it appears not to have been recognised until the corporation's 'incident control system' was activated at about 0830. After this time, the situation was more closely monitored and weather advisories were provided. Consequently, the masters of those ships that were relying on guidance from VTIC probably did not assess the risks appropriately and eventually were surprised by the severity of the weather.
