MA2017-3

**MARINE ACCIDENT
INVESTIGATION REPORT**

Vessel type and name: Container Ship “SINOKOR INCHEON”

Accident type: Collision

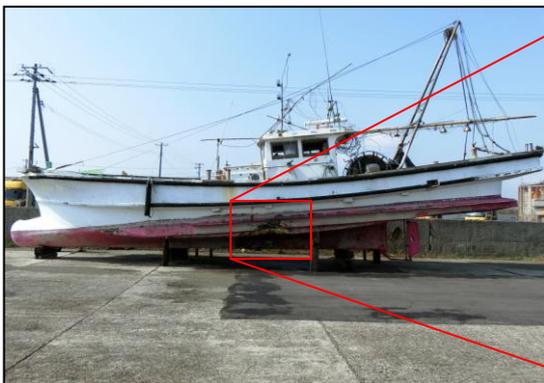
Photo 2.3-1 Damage to Ship B

Ship B had a hole and cracks in her port-side center shell plating and capsized, becoming a total loss. (See Photo 2.3-1 and Photo 2.3-2)

It is highly probable that a hole and cracks were caused in her port-side center shell plating and that she capsized, becoming a total loss.

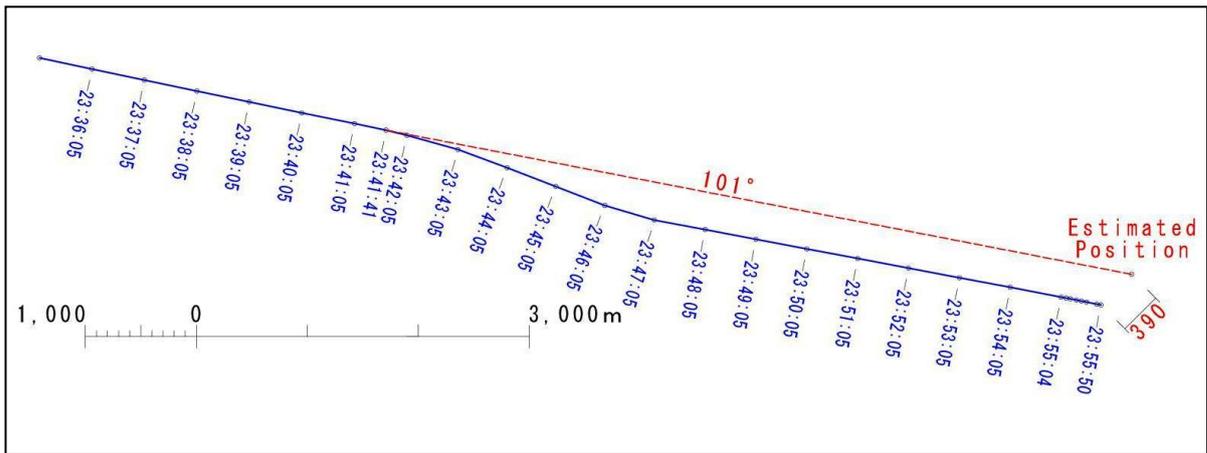
Figure 3.1 Ship A's Navigation Path and Estimated Position

As described in 2.1, it is probable that Ship A began a turn to starboard at around 23:41:45, and that, when the ship's position was estimated based on the assumption of a direct course without a starboard turn from her heading and speed over the ground at 23:41:41, just prior to the turn, Ship A's estimated position would have been approximately 390 m (approximately 0.21 M) southwest from her actual position at around 23:55:50. (See Figure 3.1)
