National Transportation Safety Board

Marine Accident Brief

Engine Room Fire on Board Towing Vessel *Dennis Hendrix*

Accident no.	DCA15LM002
Vessel name	<i>Dennis Hendrix</i>
Accident type	Engine room fire
Location	Lower Mississippi River, about 10 miles* northwest of Baton Rouge, Louisiana; 30°34.1' N, 91°16.3' W
Date	October 31, 2014
Time	0742 central daylight time (coordinated universal time – 5 hours)
Injuries	None
Property damage	\$3,800,000
Environmental damage	None
Weather	Daylight with clear visibility, light and variable winds, air temperature 47°F
Waterway information	Lower Mississippi River

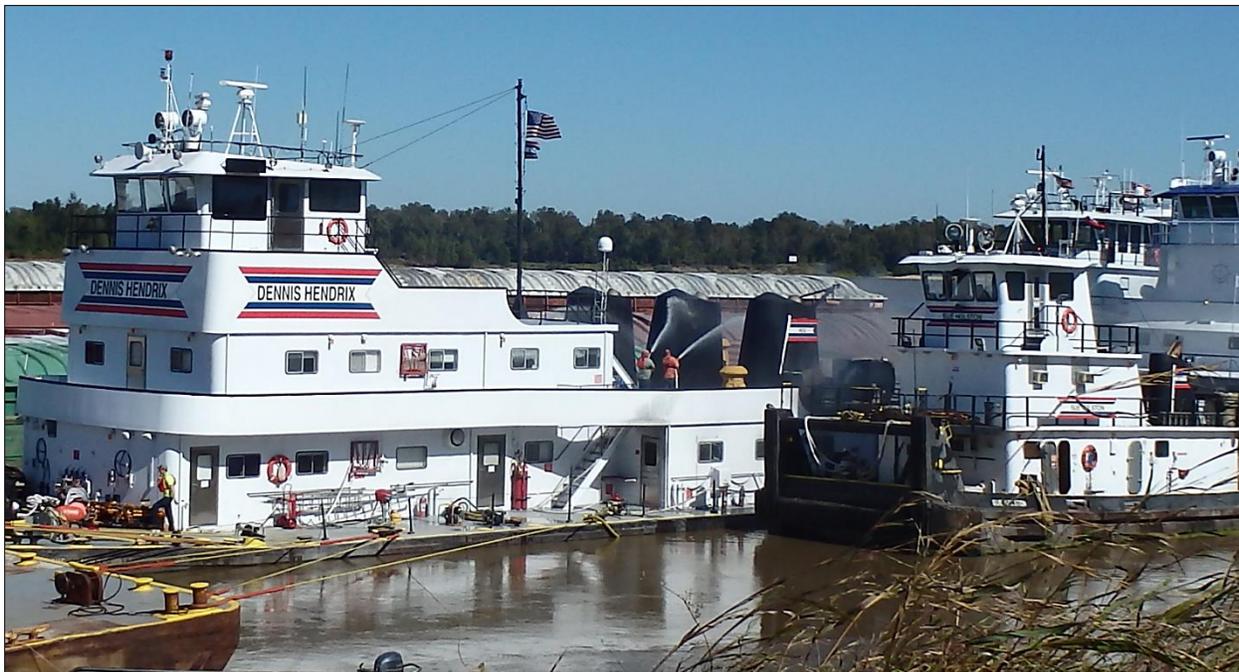
Firefighting efforts on the *Dennis Hendrix*. (Photo by the Coast Guard)

The engine room on board the *Dennis Hendrix* was significantly damaged as a result of the fire, and the remainder of the vessel's spaces suffered heat, smoke, and water damage. Postaccident surveys conducted by the Coast Guard and ACL described distorted decks and bulkheads, burned and charred wooden structural members, and soot and smoke damage throughout the main accommodation deck.

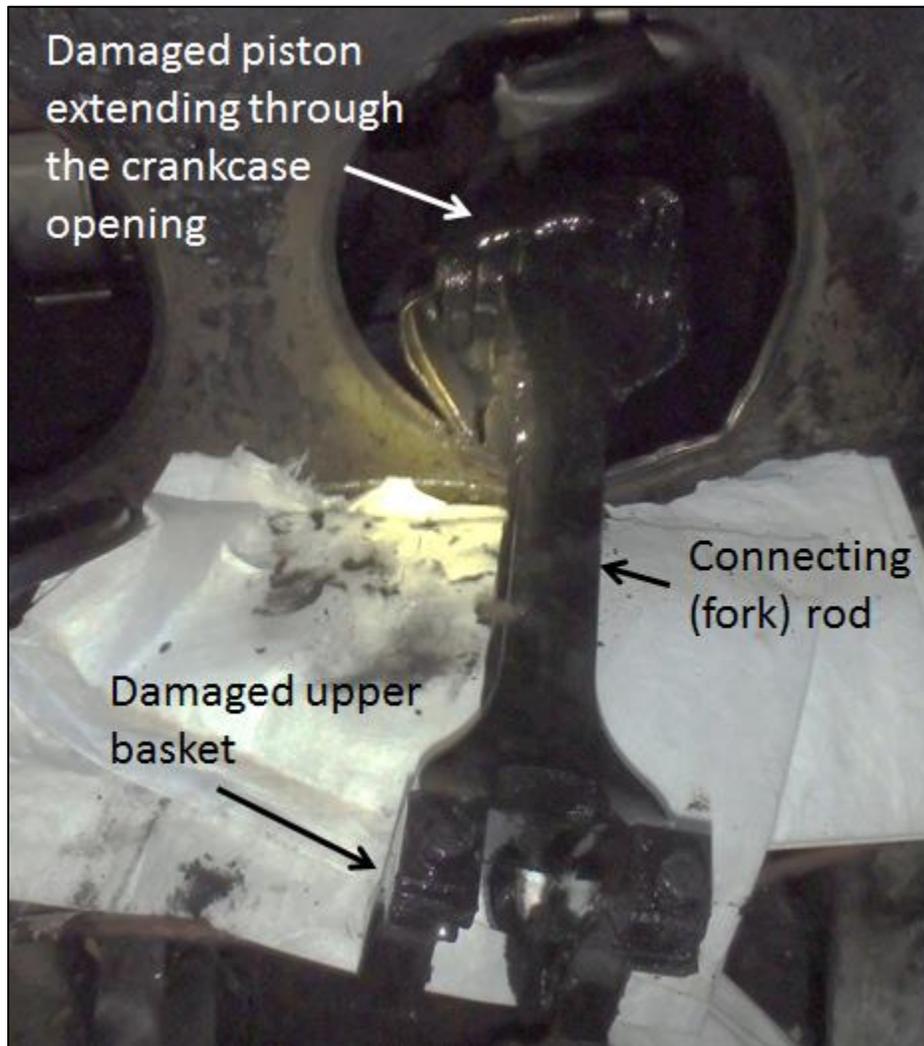
The most significant fire damage was in the vicinity of the starboard engine. It was found to have one of the crankcase doors blown out on its starboard side. Inside the crankcase door opening, parts of the bottom basket (or rod cap) for the connecting (fork) rod of piston no. 5 were found; this bottom basket had separated from the rod. In addition, the piston and piston skirt were fragmented and deformed. On top of the engine, the rocker gear covers were melted.

The damaged lower connecting rod attached to the no. 5 piston, partially removed from the starboard main engine. (Photo by the Coast Guard)

The damaged no. 5 piston and the connecting rod assembly were removed from the starboard engine and sent to a mechanical and metallurgical consultant for examination. The specific items examined were from starboard engine cylinder no. 5 and adjacent cylinder no. 13. A report submitted by Busch and Associates Inc. to ACL concluded that the no. 5 piston and connecting rod assembly failed due to loose bolts on the lower basket, leading to fatigue failure of the blade and rod and upper connecting rod bearing.

The National Transportation Safety Board determines that the probable cause of the engine room fire on board the *Dennis Hendrix* was a catastrophic failure of the starboard main engine resulting from loose bolts on the no. 5 cylinder rod cap while the engine was operating at a high load condition.

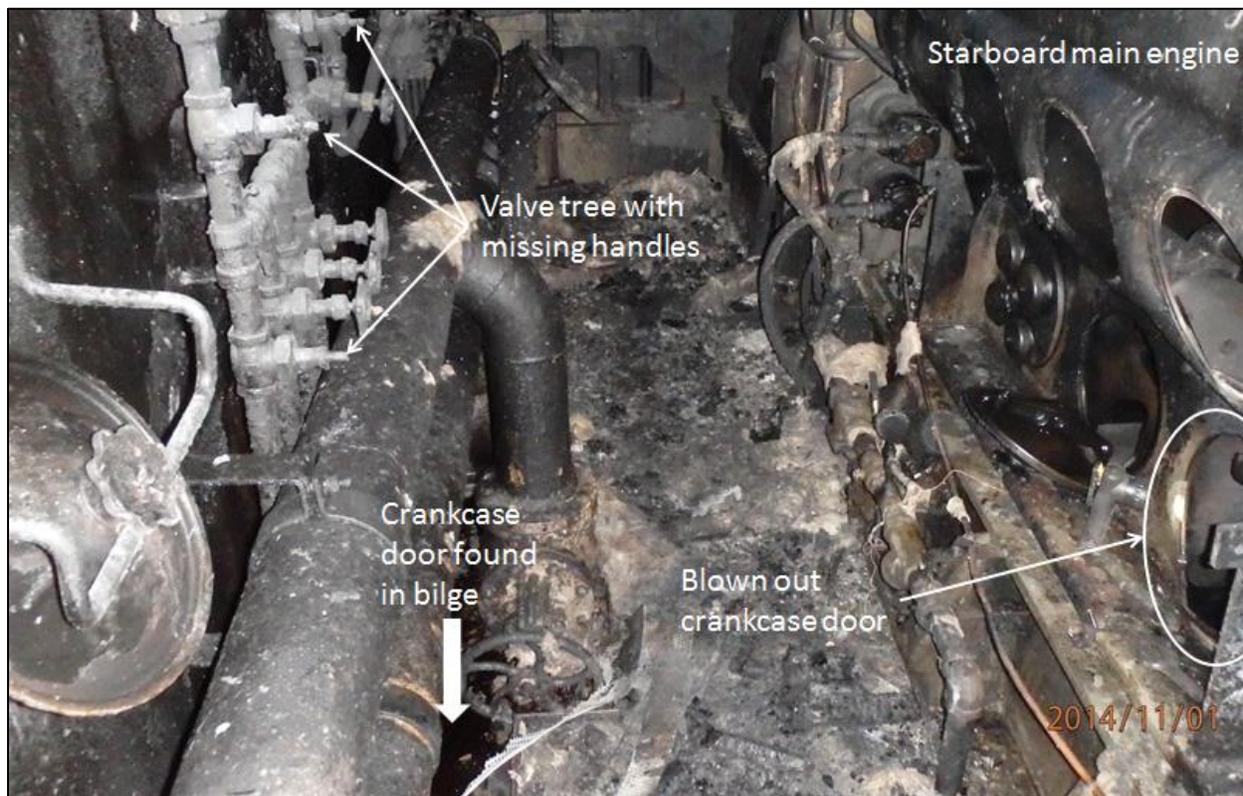
The crankcase door that blew out was found in the bilge between the engine and the starboard lube oil tank. Investigators determined that the door made contact with a nearby bank of valves for the lube oil tanks. Some of the valves had missing handles that showed evidence of being sheared off due to direct force in the area immediately adjacent to the crankcase door opening.

Starboard main engine with the crankcase door blown out. (Photo by the Coast Guard)
