National Transportation Safety Board

Marine Accident Brief

Grounding of Freighter *Roger Blough*

Accident no.	DCA16FM040
Vessel name	<i>Roger Blough</i>
Accident type	Grounding
Location	Gros Cap Reefs, Sault Sainte Marie, Ontario, Canada 46° 30.8' N, 084° 37.2' W
Date	May 27, 2016
Time	1312 eastern daylight time (coordinated universal time – 4)
Injuries	none
Damage	\$4.5 million
Environmental damage	None
Weather	Partly sunny, visibility 10 miles, winds south-southeast at 10 mph, air temperature 52°F
Waterway information	From Whitefish Bay at the southeast corner of Lake Superior, the St. Marys River flows in a general southeast direction to empty into Lake Huron. Birch Point Course is the entry channel to the St. Marys River. On the accident date, the water level in eastern Lake Superior was 1.01 feet higher than the charted depth at low water datum. ¹

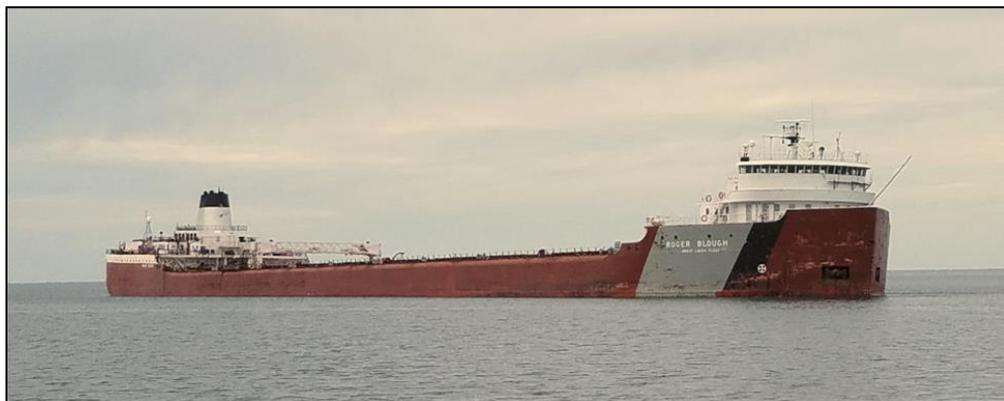
***Roger Blough* aground on Gros Cap Reefs. (Photo by US Coast Guard)**

The grounding caused multiple punctures and large fractures to the hull: the forepeak, no. 1 port ballast, and no. 2 port ballast tanks were breached and flooded to the waterline; no. 1 port void space located in the double bottom was breach and fully flooded; other ballast tanks, void spaces, and the port side cargo belt tunnel were flooded; there was significant deflection of

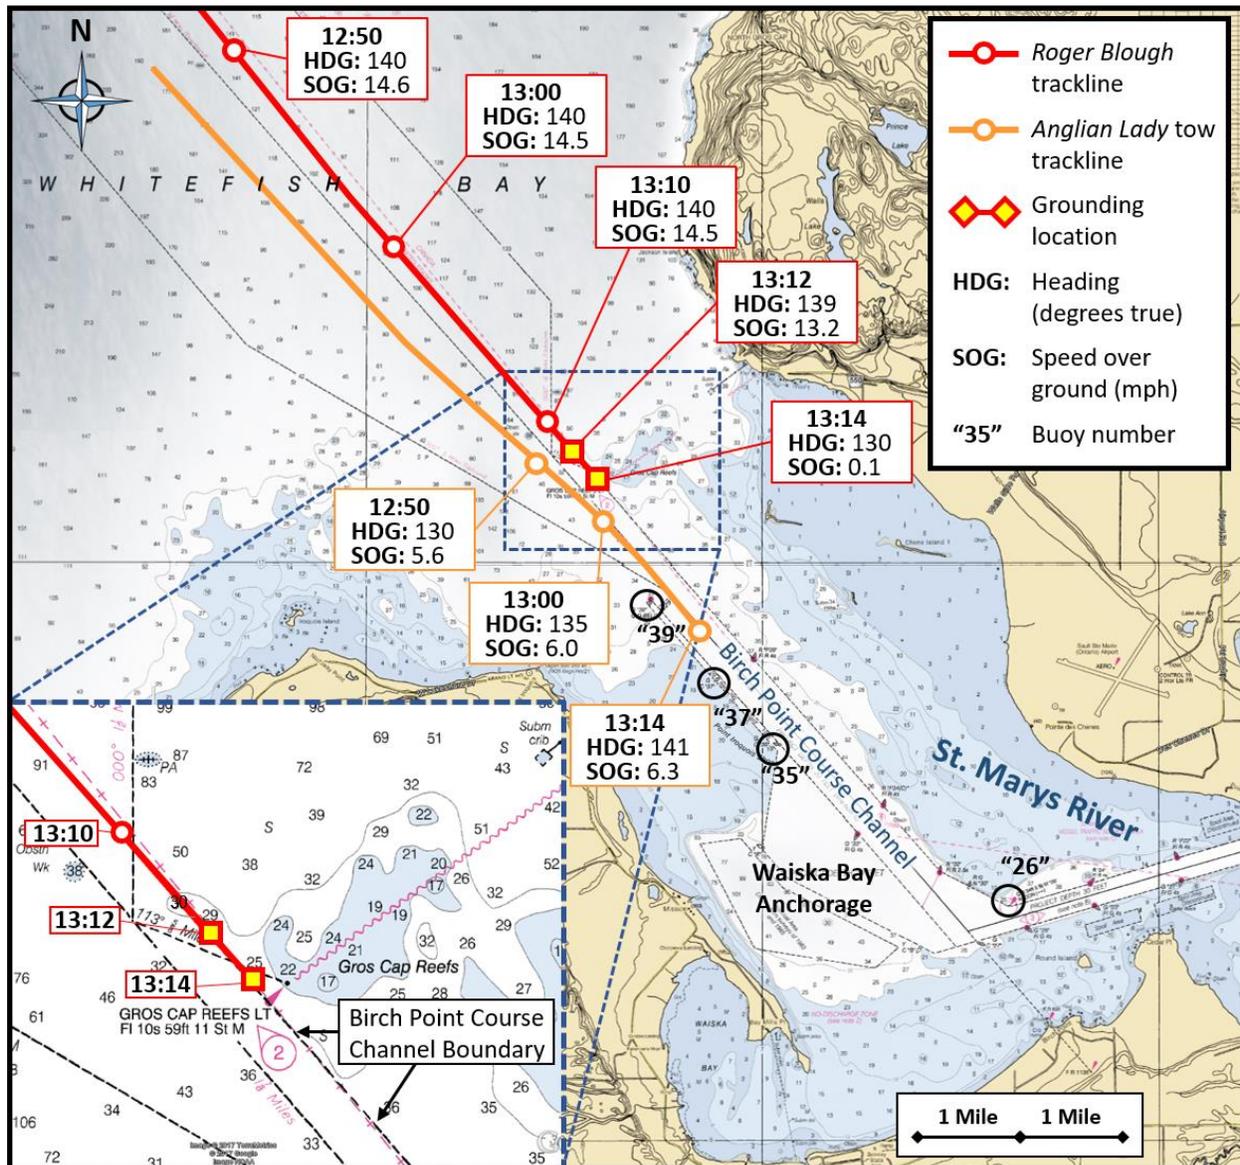
At the same time, according to ECPINS and automatic identification system (AIS) data, the *Roger Blough*’s centerline was on the outer edge of the left side of the channel, with its port side outside the channel. The vessel was on a course of 140 degrees true at a speed through the water of 14.4 mph when the its speed began to slow. At 1312, the *Roger Blough* passed over a charted 30-foot depth curve near the Gros Cap Reefs. About this time, the vessel hit the bottom.

The *Roger Blough's* heading shifted about 8 degrees to port as the vessel continued to move forward for two minutes, dragging the hull an additional ship-length over the reef's bedrock until the vessel came to rest.

Portion of NOAA chart 14884 showing AIS data for the *Roger Blough* and *Anglian Lady* tow in the approaches to the Birch Point Course navigation channel of the St. Marys River. Inset is a close-up of the accident location near Gros Cap Reefs Light.

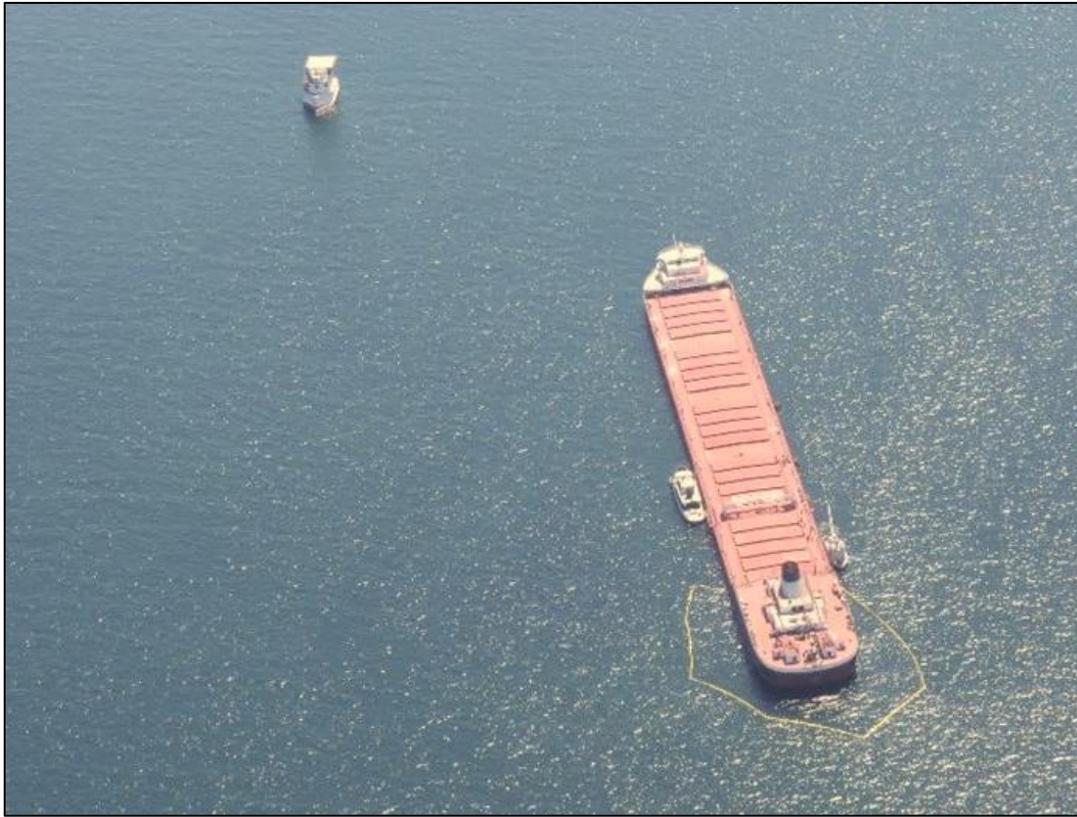
Roger Blough aground near the Gros Cap Reefs Light. The distance to the light was 240 yards. (Photo by US Coast Guard.)
