PB94-916301
NTSB/RAR-94/01

RAILROAD-MARINE ACCIDENT REPORT

DERAILMENT OF AMTRAK TRAIN NO. 2
ON THE CSXT BIG BAYOU CANOT BRIDGE
NEAR MOBILE, ALABAMA
SEPTEMBER 22, 1993

Adopted: September 19, 1994
Notation 6167B

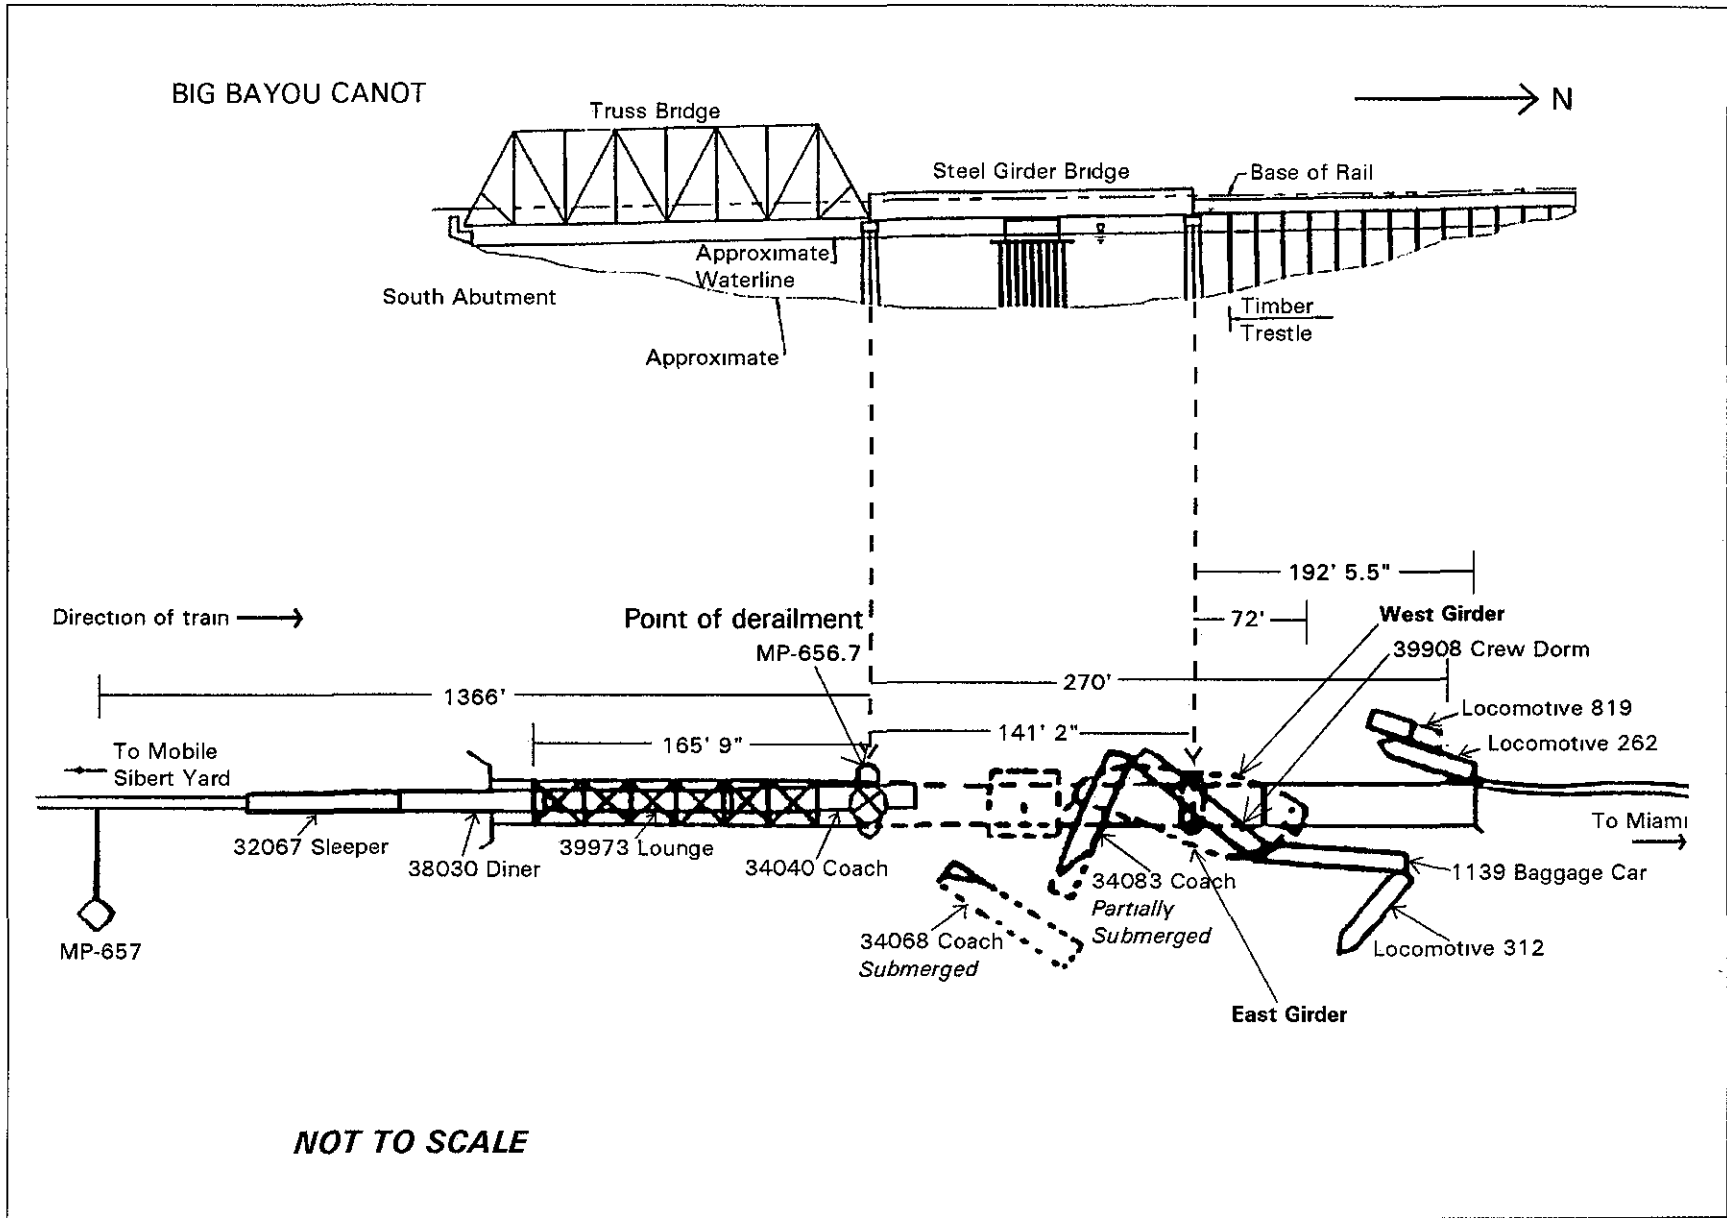
Baggage car 1139 and dorm-coach 39908, also on the east side of the bayou, were gutted by fire, and parts of both cars sustained major structural damage. About half of coach 34083, which rested against the bridge after the accident, was submerged, and coach 34068 was almost totally submerged. The next four cars, coach 34040, lounge 39973, diner 38030, and sleeper 32067, remained on the bridge. All passenger cars were double-decker cars. (See figure 6.)

Figure 6.--Diagram of accident scene.

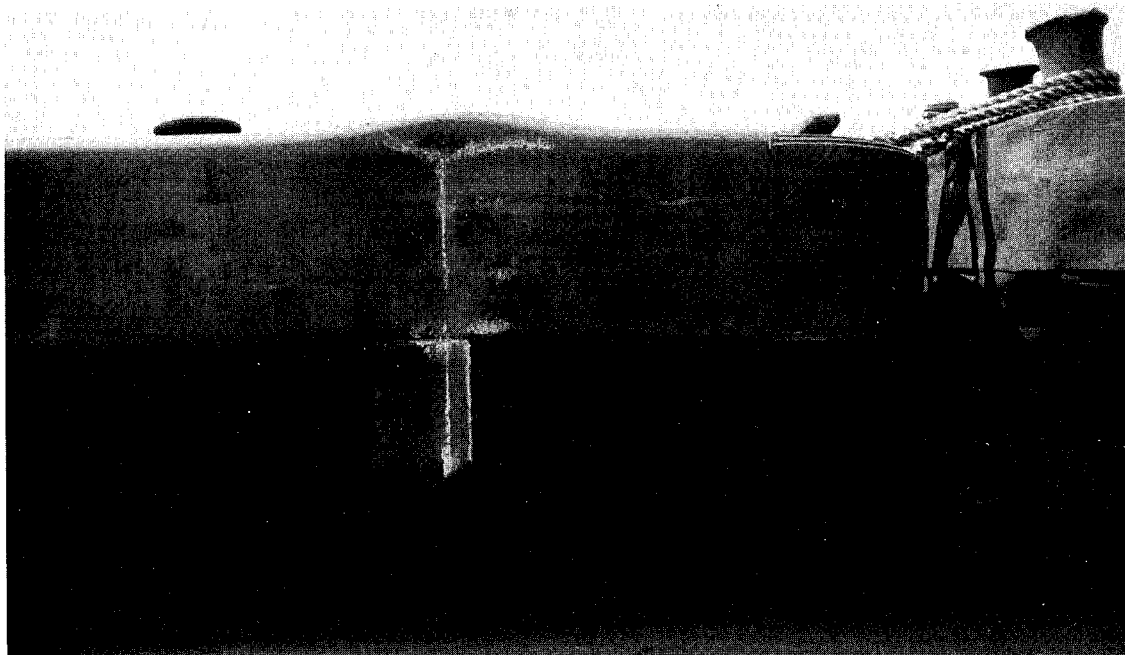
was drydocked at W&GN's yard on September 27, 1993, for a hull survey. The marine investigative group noted no apparent damage to the hull, rudders, or propellers. Inspection revealed no evidence of a wire or other item having been wrapped around the propellers or rudders. The lead port (WGN 285) and starboard (WGN 208) barges (see figure 8) were slightly dented where they struck the bridge's concrete piers, and the center lead barge (WGN 258) had six marks on its headlog where it struck the vertical stiffeners on the bridge span (see figure 4). The other three barges were undamaged.

Figure 8.--Collision marks on barge.
