SAFETY INVESTIGATION REPORT

REPORT NO.: 12/2012

MV Purki **Serious injury of ordinary seaman and subsequent death of the second mate In the port of Alger, Algeria 29-30 September 2011**

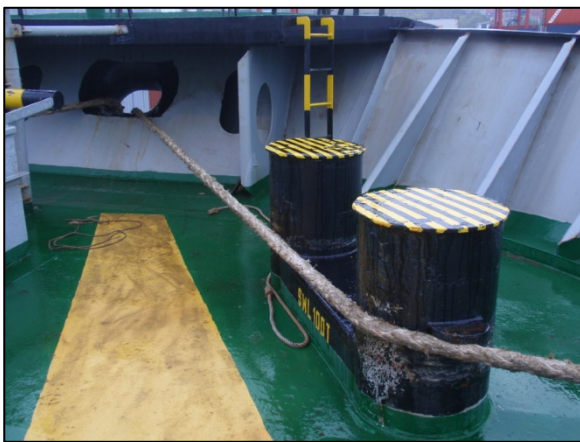
Figure 2: *Purki*'s forecastle showing the centre lead forward and starboard mooring bitts

The tug line was now slack on the main deck but still fast to the tug boat. Suddenly, with three turns still on the bitts, the tug line came under tension once again, removing any slack and as a consequence, striking the OS in his legs.

The dynamics of the accident seemed to indicate that the OS may have been standing in a bight of the tow line so that when it came under tension it hit the OS in the legs.

It is unclear whether the OS was injured as a result of being in the "snap-back" zone or because he was standing in the bight of the line that hit his legs. Whatever the cause, the result was an injury sustained by the OS who was standing in close proximity to the line.

12/2012_R2 discuss with crew members and introduce measures to improve safety during mooring/unmooring operations, taking into consideration the potential of a tug line coming unexpectedly under tension;

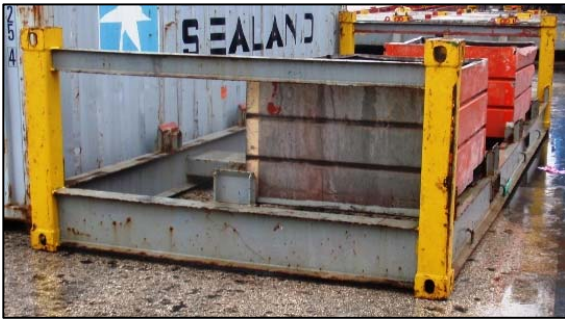
Figure 3: The frame used to hold the container lashing gear storage box used to lower the injured OS on the pilot boat

The plan was to transfer the injured crew member to a boat, which was standing by. On 30 September at about 0010 hours, the boat made heavy contact with the container lashing gear storage box whilst manoeuvring alongside the ship. The impact of the boat against the lashing gear storage box forced the release of the storage box's lifting strops from the crane hook. Consequently, all fell into the sea.

Furthermore, the use of shackles instead of hooks could have avoided the container lashing gear storage box coming free from the points of suspension.

12/2012_R4 prepare and circulate a fleet memorandum on the accident and highlight that cargo gear is not to be used as a means for crew evacuation.

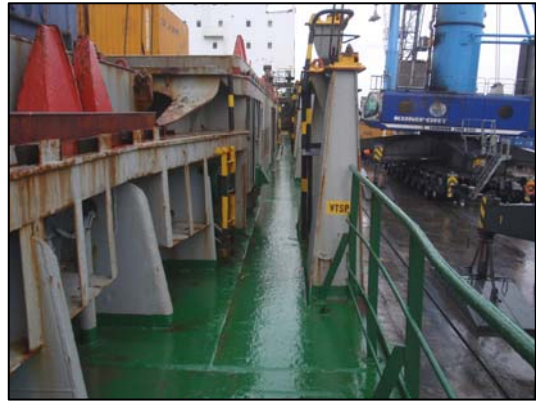
Figure 5: *Purki*'s passage way on port side main deck.

According to the master, the main deck was not wide enough to carry someone to the rescue boat (located aft) by a stretcher (Figure 5).

been held or that such drills and training were required by the Company's SMS. This is being highlighted because the problem of narrow deck passages was only identified during a real case scenario, when ideally, it should have been identified during one of the drills held on board.

12/2012_R3 emphasis through their SMS manuals that on board crew training includes casualty evacuation from different areas of the vessel which are not classified as enclosed spaces;

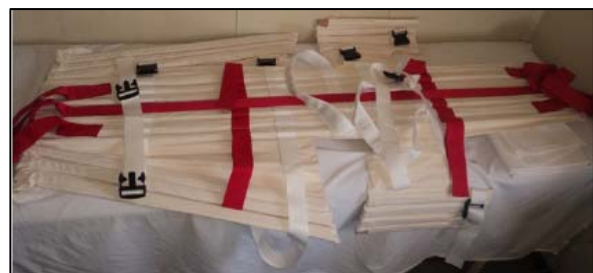
Figure 6: The Neil Robertson stretcher on board *Purki*

However, it was reasonable to assume that an appropriate stretcher such as the Neil Robertson type would have been able to do the job especially considering the fact that it is a rescue stretcher specifically designed for the recovery of victims in difficult and cramped / confined situations, especially where the patient has to be raised and carried to safety.

This element alone casted doubt as to whether or not the vessel was actually equipped with this type of stretcher at the time of the accident, even though the vessel's managers provided a photograph of a Neil Robertson stretcher during the analysis stage of the accident (Figure 6).
