# REPUBLIC OF THE MARSHALL ISLANDS

### MV FELICIA CASUALTY INVESTIGATION REPORT

Third Officer's Loss of Life Due to A Shipboard Injury When Underway,  
Approaching the Port of Tianjin, China

4 May 2012

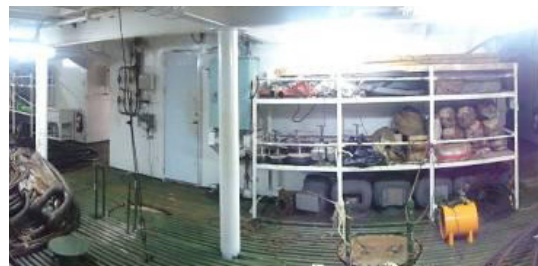
- the manhole of the forepeak void space, located inside the forepeak stores, was left uncovered, unattended, and not illuminated; and
- the Third Officer entered the forepeak stores without turning on the lights.

1. Vessel particulars: see chart to right.
2. On 3 May 2012, at approximately 0830, the manhole located on the ship’s centerline providing access from the forepeak stores, i.e., forecastle stores, to the forepeak void space was opened. *See Figure 1.* The forepeak void space, which extends from the ship’s stem to the collision bulkhead, is located above the forepeak tank and below the forepeak stores and has a depth of approximately

Figure 1: Forepeak stores looking aft. The manhole that was opened is on the centerline; the manhole on the starboard side was left closed.

1. The Third Officer died as the result of injuries sustained when he fell into the forepeak void.<sup>13</sup> Contributing factors included that although the open manhole was cordoned off with a small line, it was not covered with a grate or similar cover. Additionally, because the Third Officer did not turn on the forepeak stores' lights, he did not have adequate situational awareness of the safety hazards associated with the open manhole. These contributing factors are the result of human error.
2. The Chief Officer did not initiate either a permit to work, and/or formal or informal hazards assessment prior to having the forepeak stores' and forepeak void space manhole covers removed. This contributed to not identifying the need to put a temporary cover over the manhole access when work was not being performed, which resulted in a hazard to crew safety.

2. The use of manhole safety covers was made compulsory on all of the company's vessels.
3. The company commenced a fleet-wide campaign on the daily performance of "toolbox talks".
