REPORT

Marine 2017/04

REPORT ON OCCUPATIONAL ACCIDENT, FALL ON BOARD MARINOR (LAGQ7) ON 21 DECEMBER 2015 OFF THE COAST OF CALIFORNIA

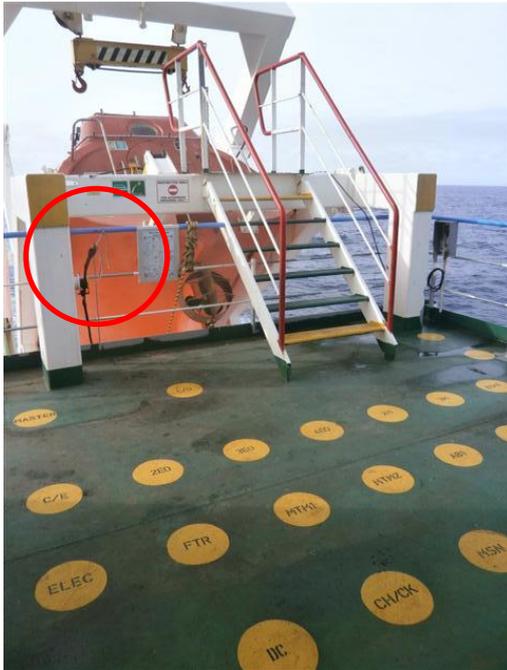
No work permit was issued for this job, since the work would take place at a height of only just over one metre and in an area secured by railings, see Figure 2 and 3. The chief mate carried out a verbal risk assessment of the maintenance job together with the two bosuns. It was mandatory practice on board to use relevant personal protective equipment (PPE) (helmet, gloves, coveralls, protective footwear etc.) for this type of work.

Figure 2: The lifeboat muster area, where the agreed maintenance job was to be carried out (working area marked with a red ring). Photo: Thome Ship Management Pte. Ltd.

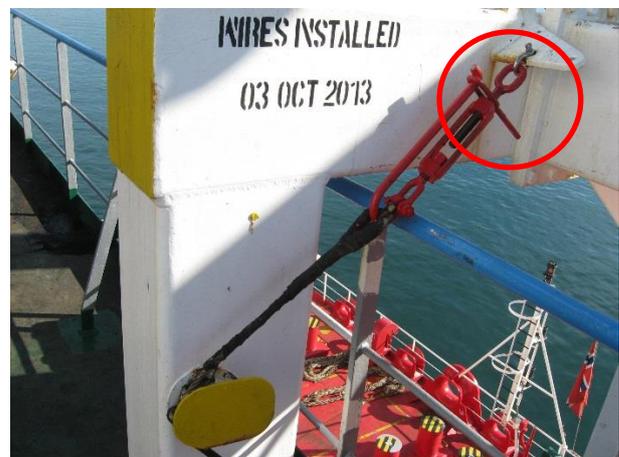
On Sunday 20 December, at sea while preparing for a USCG inspection that was to take place while the tanker was berthed in Los Angeles, the crew found that one lashing turnbuckle for the free-fall lifeboat had corroded. It was not possible to move the securing pin. The job of removing the rust was carried out there and then, but it was decided to do a more thorough job the next day. The chief mate explained to the able bodied seaman (AB) who was to carry out the work that the job only involved rust removal and painting of the turnbuckle.

Figure 3: The photo on the right shows the turnbuckle and the securing pin (marked with a red ring) after the maintenance job had been carried out. Photo: USCG

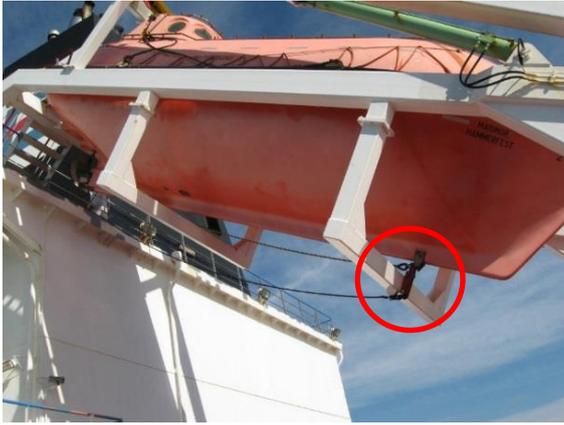
The AB said that, while performing the job, he had observed that the forward hook for the free-fall lifeboat needed to be lubricated with WD40 penetrating oil. He asked bosun 1 to assist him by steadying a ladder he had positioned on deck below the lifeboat to reach the forward hook in the davit, see Figure 4 and 5.

Figure 4: The free-fall lifeboat and the forward hook (marked with a red ring). Photo: USCG

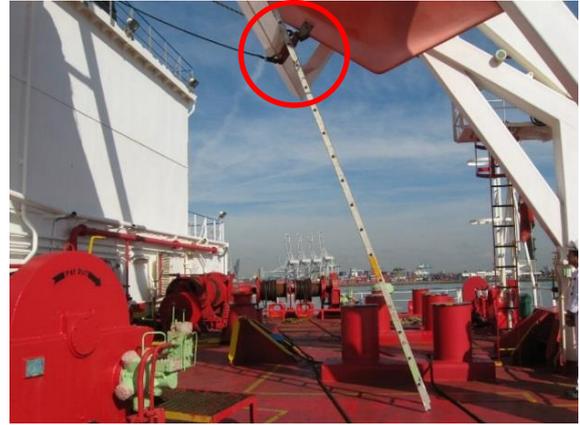
Figure 5: The ladder as positioned by the able seaman to reach the forward hook. Photo: USCG

Bosun 1, who was asked by the AB to steady the ladder while the AB climbed up to carry out the lubrication job, could have stopped the job. The ladder was not suitable for the job since it was not secured in any way. It was unsteady and the rubber feet on the ladder legs were significantly worn.

- As a corrective measure, the ladder that was used in the accident was removed.
- Preventive measures included a review of applicable procedures (work at height, safe work practice, use of STOP CARDS etc.).

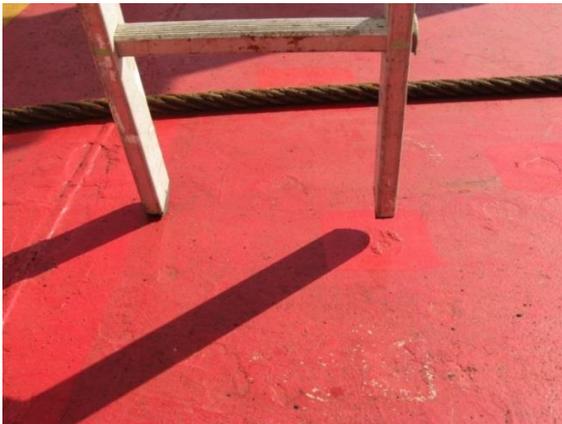
Figure 6: The ladder was unstable, among other things because both feet were not in firm contact with the deck. Photo: USCG

The height from the deck to the forward hook was 4.8 metres. The ladder was five metres long and was equipped with rubber feet at the bottom of each leg. The rubber feet were significantly worn. The ladder was not secured with ropes or in any other way, and it was unstable because both feet were not in firm contact with the deck, see Figure 6.

c) The rubber feet that were used on the ladder were significantly worn, and the ladder was therefore not suitable for use on board a vessel in operation.
