Final report MO-2018-203: Grounding of container ship *Leda Maersk*,
Otago Lower Harbour, 10 June 2018

Marine inquiry MO-2018-203
Grounding of container ship *Leda Maersk*
Otago Lower Harbour, 10 June 2018

Approved for publication: September 2019

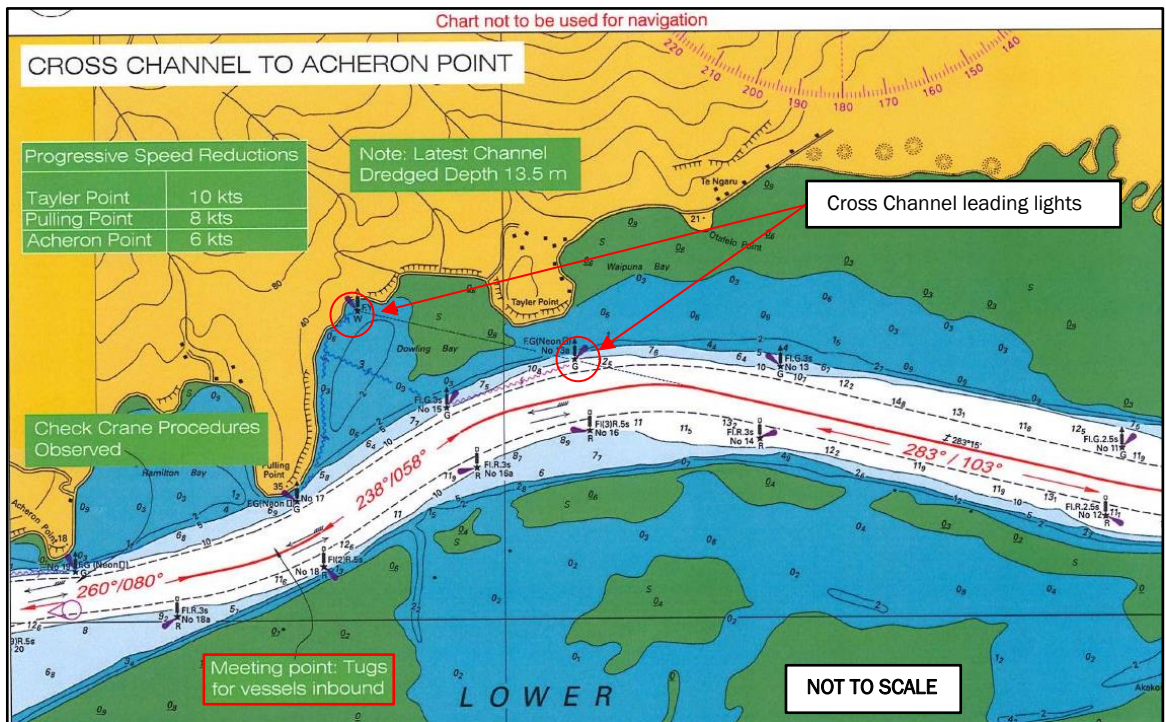
Figure 1
Page from the Otago Lower Harbour Pilotage Guide showing the Cross Channel leading lights

- 3.2.5. Between 1806 and 1810, when the ship was lined up with the Cross Channel leading lights⁹ (see Figure 1), the pilot's PPU indicated that the ship was slightly off track. The pilot checked the settings on the PPU and found that there was an 18-metre offset to starboard¹⁰ to allow for the position of the PPU aerial in relation to the ship's centreline. The offset was causing the PPU to indicate that the ship's position was 18 metres, approximately half the ship's breadth, further to port¹¹ than it really was. The pilot was unable to remove the offset so decided to discontinue using the PPU for monitoring the ship's progress. Instead the pilot

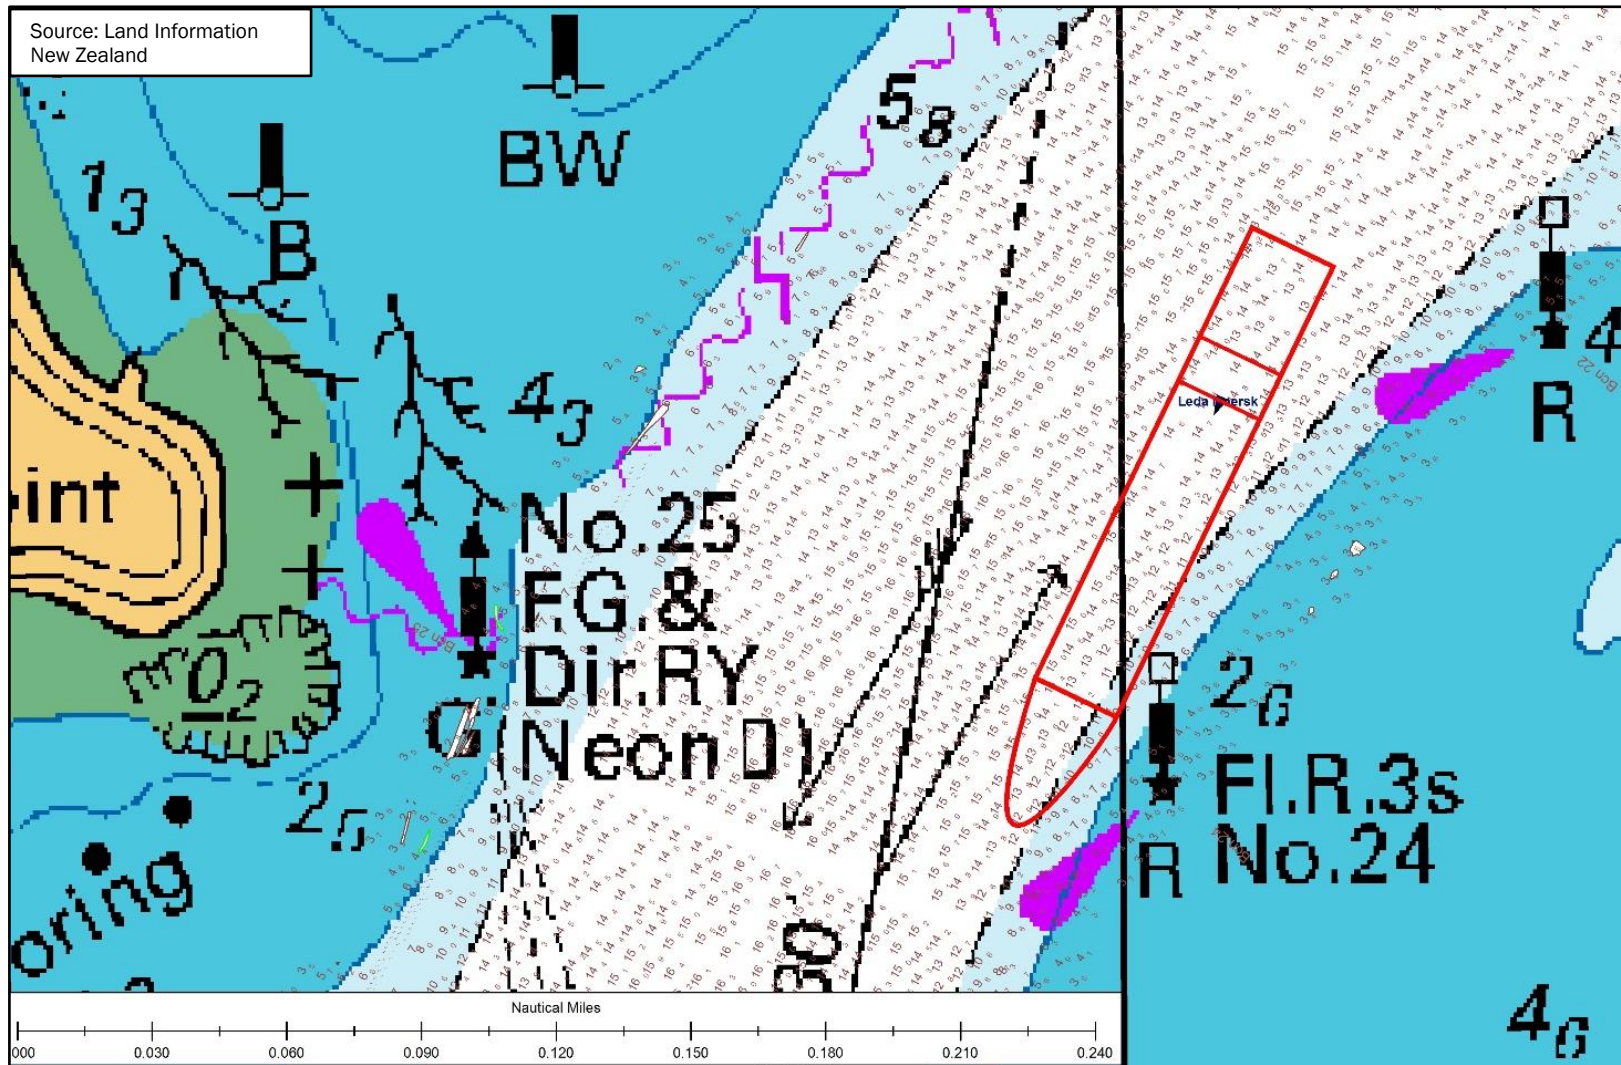
Figure 3
Position where the *Leda Maersk* grounded with depths (in metres) added

- 1.2. The ship was rounding the final bend in the channel before reaching its berth, when a combination of factors caused it to deviate from the planned track in the centre of the channel, and ground on the left channel bank. Nobody was injured and damage to the ship was confined to scraping of the paintwork on the hull.

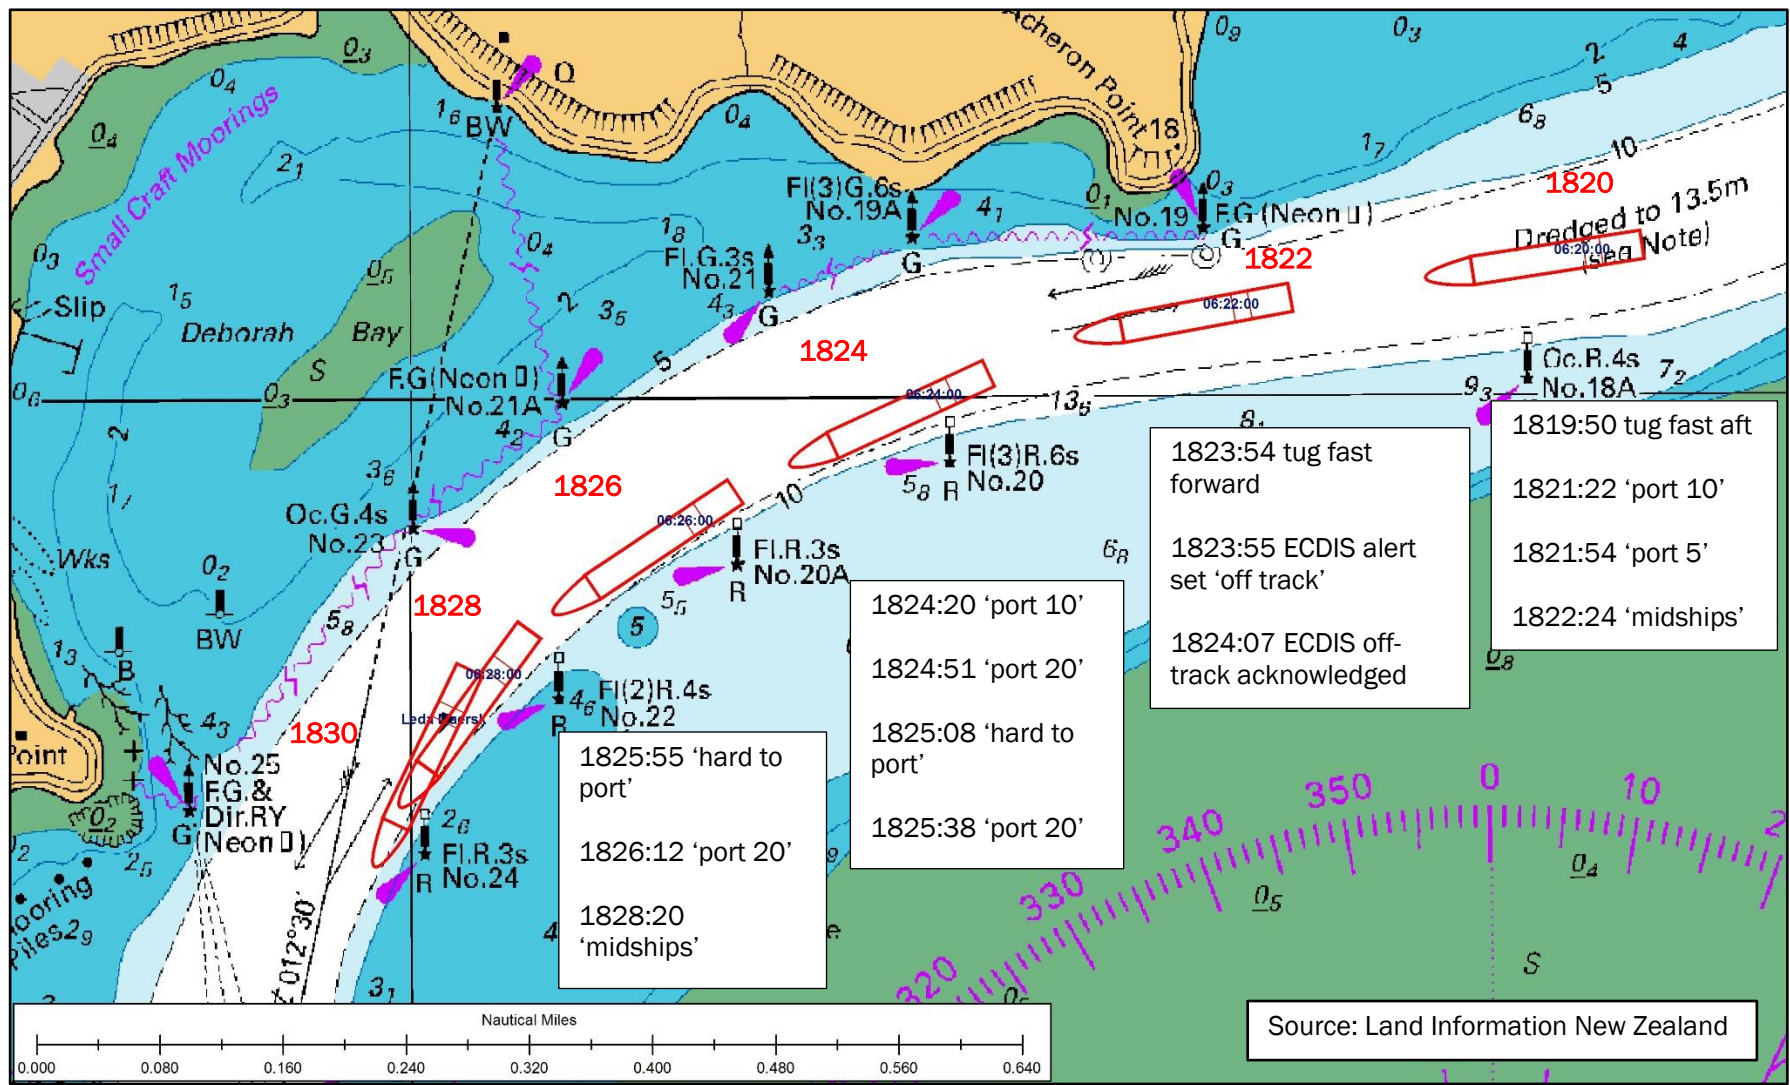
Figure 4
 Events and helm orders immediately before the Leda Maersk grounded (ship outlines drawn to scale)

- 4.2.7. As the left turn continued, a large amount of port helm was being applied (Figure 4). The heading of the ship changed marginally to port and the ship continued moving further left of the planned track. When it had deviated approximately 55 metres left of the planned track, the ECDIS off-track alert activated. The alert was informing the bridge team that the ship had reached the pre-set cross-track limit.²⁴ However, this important information was not brought to the attention of the master or the pilot.

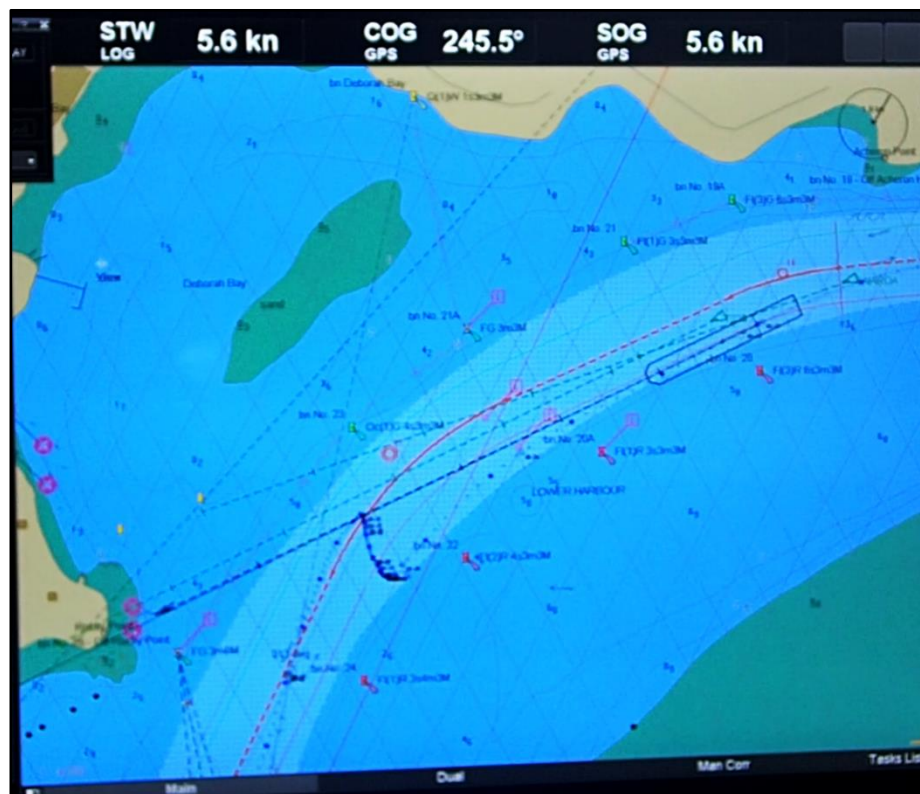
Figure 5
The *Leda Maersk*'s position at 1824 from the ECDIS replay

4.2.6. The ECDIS display (Figure 5), the radar display (Figure 6) and the pilot's PPU (Figure 7) clearly showed this drift towards the left bank of the channel.

representation of the surrounding channel. The diamond hatching in Figure 5, which is known as the shallow pattern, indicates “non-navigable” water that is shallower than the safety contour programmed into the ECDIS. However, the settings were such that there were no navigable areas of water shown on the ECDIS, despite the presence of the navigable dredged channel. Figures 10 and 11 show how the ECDIS display can be optimised to give the bridge team a better understanding of the surrounding navigable and non-navigable waters.

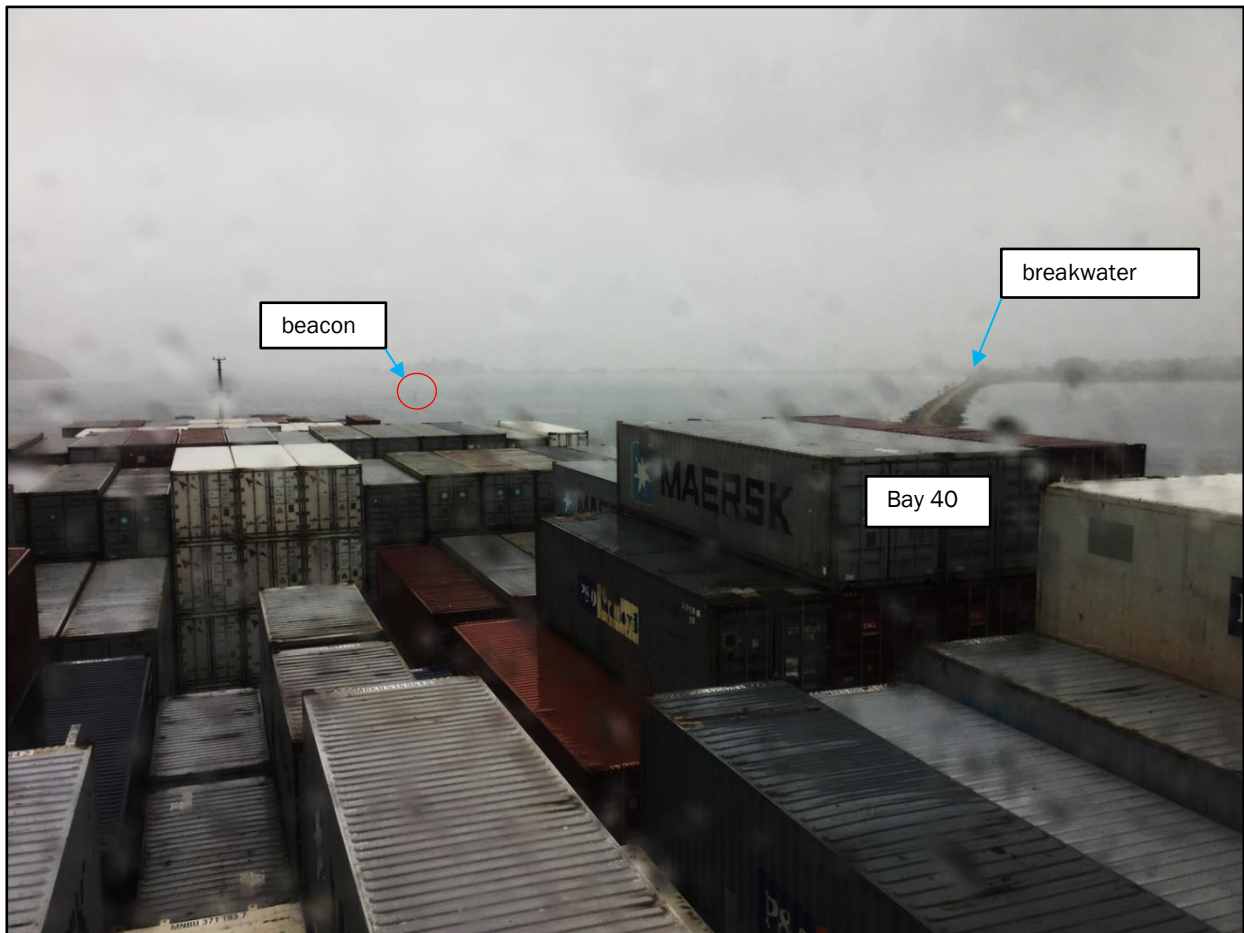
Figure 8
 Example of an L-class ship where the beacon is about to be lost from view and the breakwater is obscured by the containers stowed six high
 (Photo courtesy of Port Otago)

- 4.2.10. Additionally, containers had been stacked six tiers high near the extremities of the ship. On the L-class container ships this was known to cause bridge teams to lose sight of channel beacons passing close by the ships. As the ship drew closer to the left bank, from where the pilot was standing the pilot would have lost sight of the left bank channel markers below the container stacks. Figure 8 shows an example of how containers stacked in this manner can affect visibility.

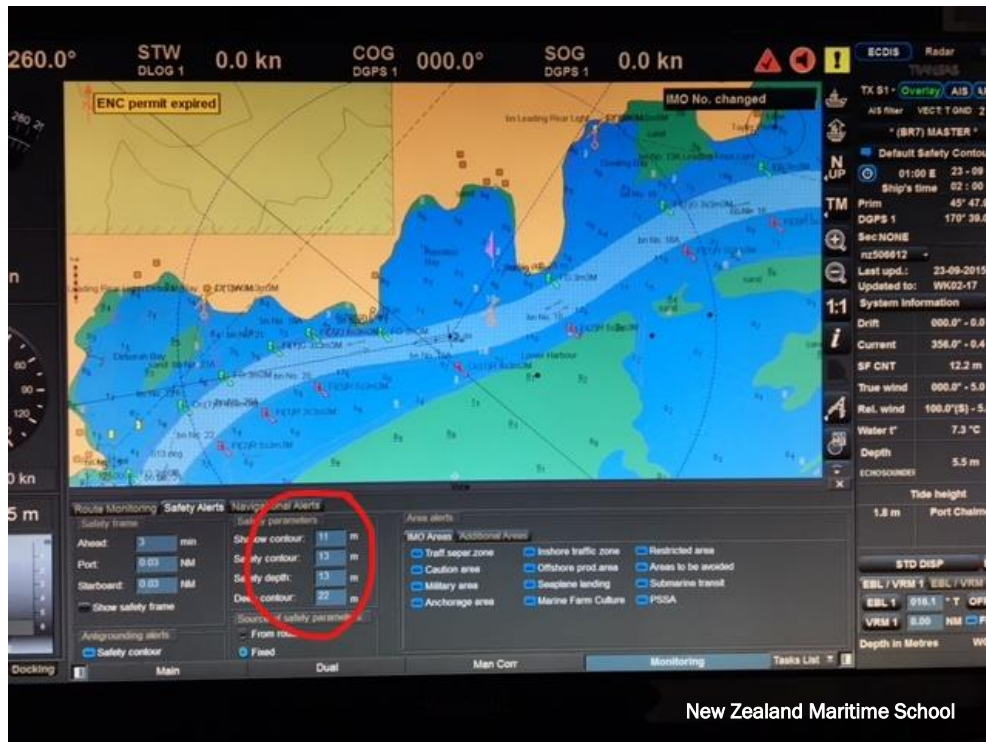
Figure 10
ECDIS safety settings closely aligned with the operator’s guidelines²⁹

- 4.11.10. The ECDIS safety settings were not consistent with the settings recommended in Maersk's policy and guidance documents, nor were they optimised to give the bridge team the best
