Bundesstelle für Seeunfalluntersuchung
Federal Bureau of Maritime Casualty Investigation
Federal Higher Authority subordinated to the Ministry
of Transport and Digital Infrastructure

Investigation Report 15/19

Serious Marine Casualty

**Fire in the area of the deck cargo
on board the container ship
YANTIAN EXPRESS
in the Atlantic Ocean
on 3 January 2019**

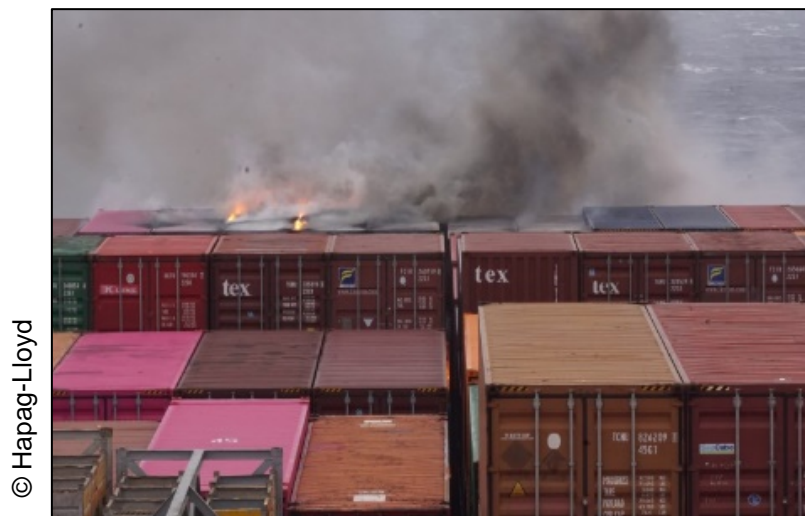
Figure 11: Bay 12 on fire

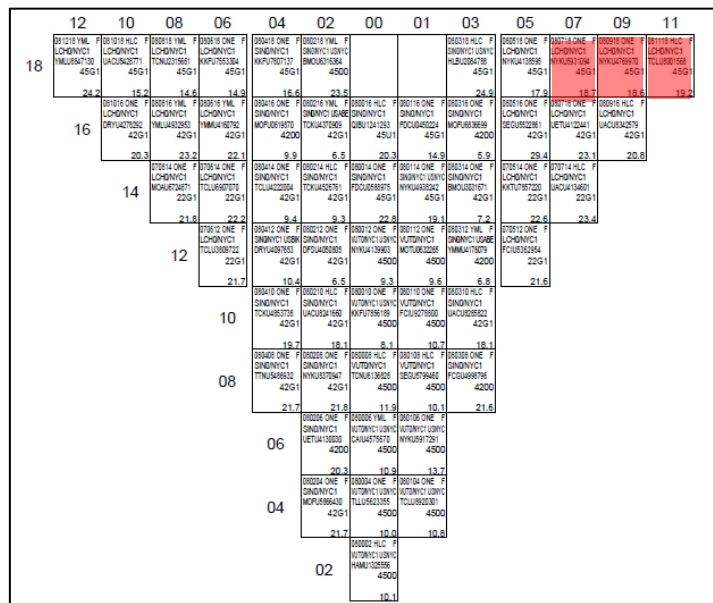
The container at slot 080718 now also exhibited an increase in temperature. 190 °C was measured at slot 080918. All three containers were further cooled from the outside. To fight the smouldering fires, the containers in positions 080918 and 080718 were opened and nozzles positioned.

Figure 17: Containers on fire in cargo hold 1, bay 7

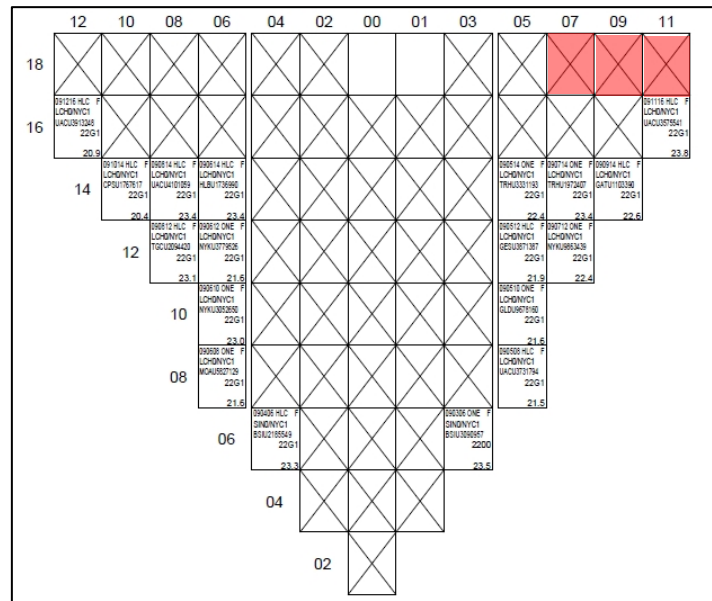
Figure 18: Containers on fire in cargo hold 1, bay 9

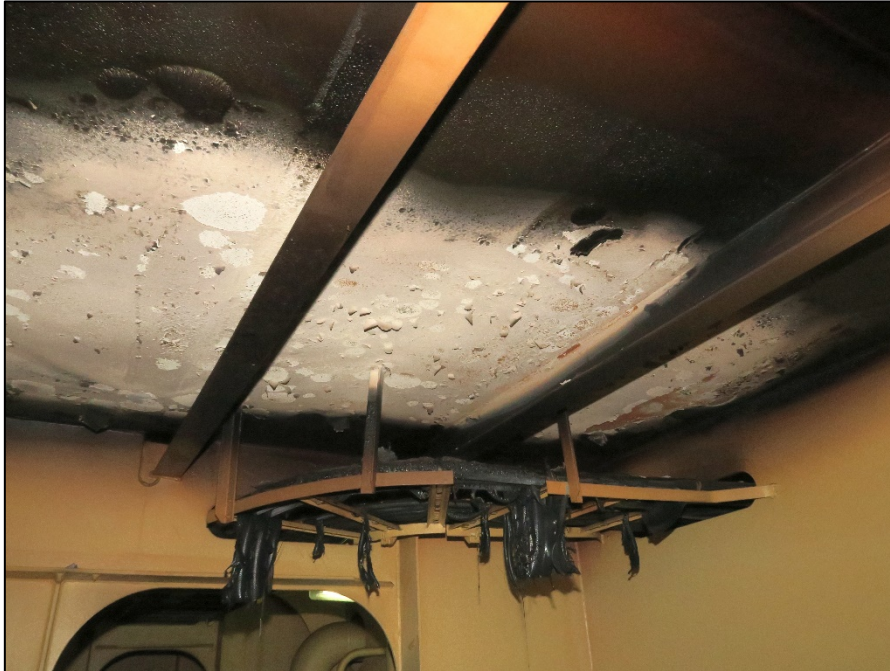
During the inspection of the passageways, major damage to the ceiling of the corridor and to the equipment and cable looms located there could only be identified on the starboard side in the area of cargo hold 1.

Figure 25: Thermal damage in the starboard passageway adjacent to bay 3

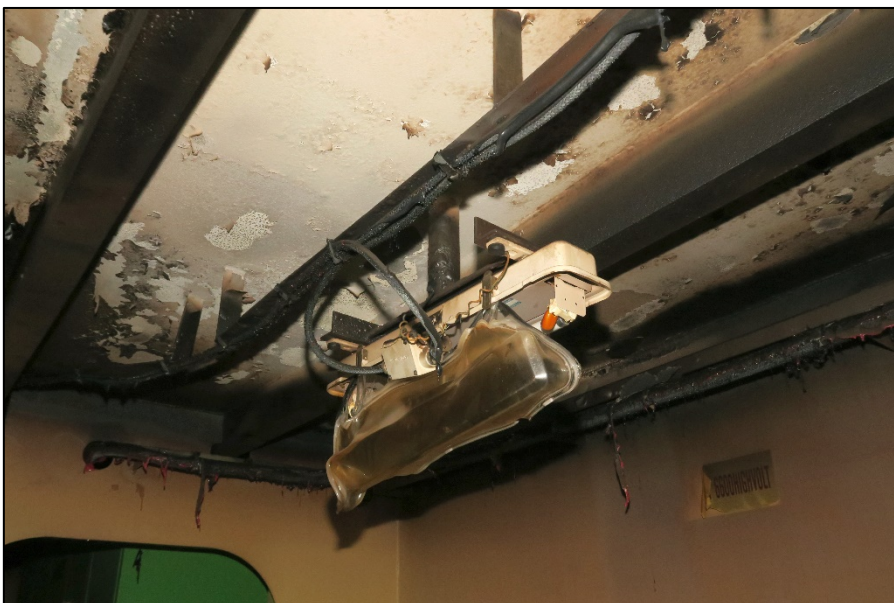
Figure 26: Thermal damage in the starboard passageway adjacent to bay 5

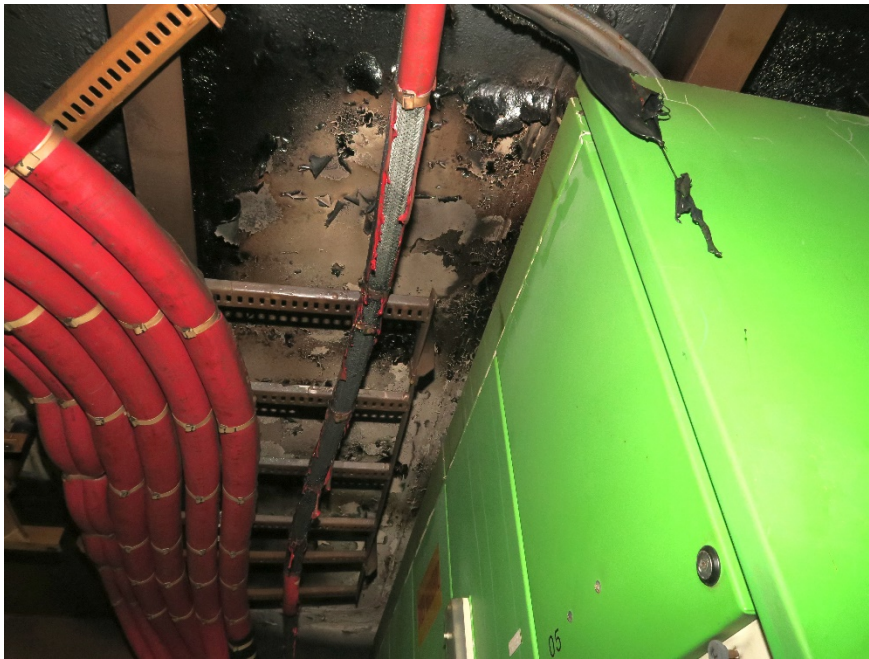
Figure 27: Thermal damage in the starboard passageway adjacent to bay 7

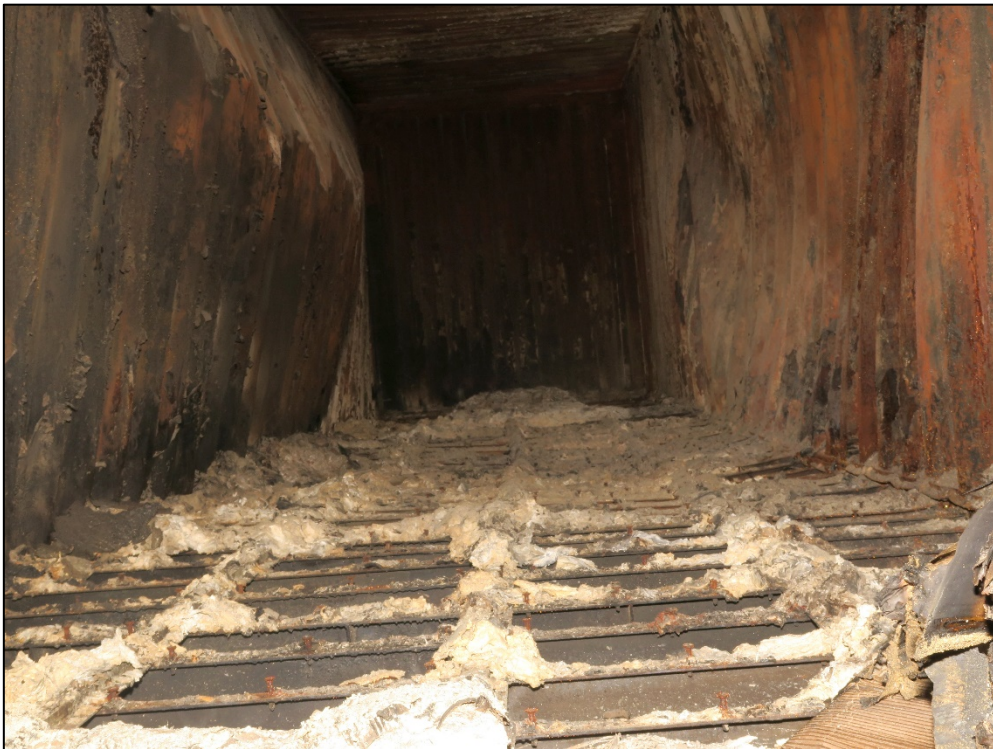
Figure 29: View into the container at slot 120382

- the container at slot 120382, which according to the cargo documents originally contained knitted or crocheted baby garments, was completely burnt out:

Only a small amount of fire debris; floor completely burnt.

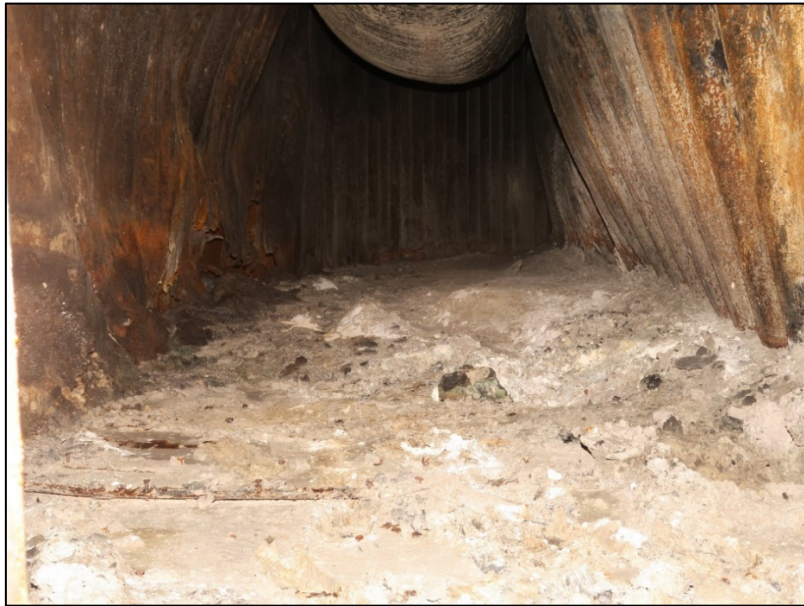
- the container at slot 120582, loaded with polypropylene woven shopping bags, was also completely burnt out:

Figure 30: View into the container at slot 120582
Small amount of fire debris; floor completely burnt.

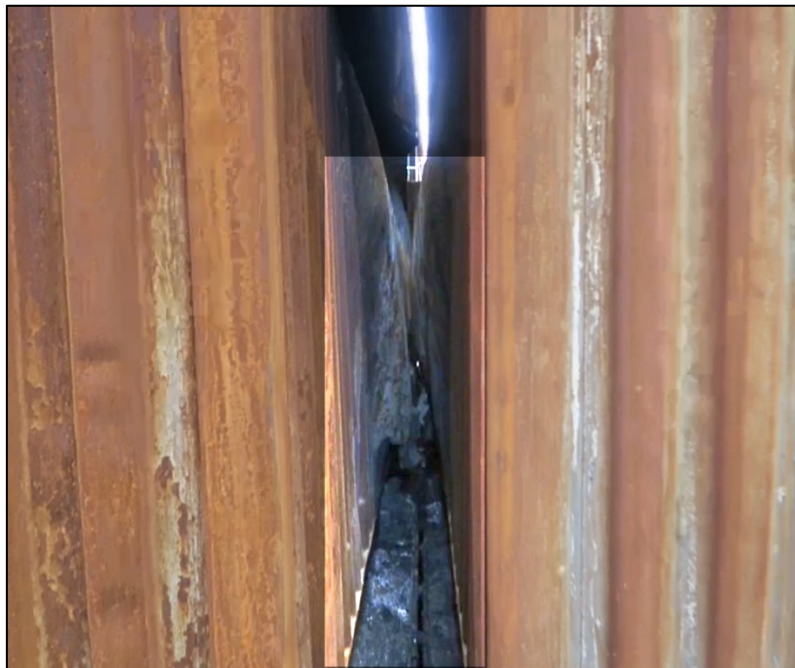
Figure 31: Gap between the containers at slots 120382 and 120582
The two containers are touching due to the effect of the heat. Middle of image brightened.

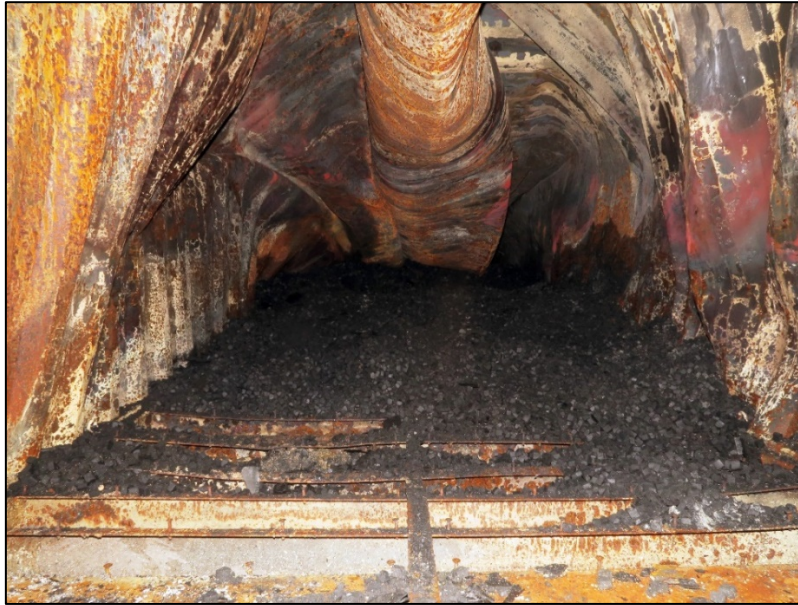
Figure 32: View into the container at slot 120782

- the container at slot 120782, which according to the cargo documents was loaded with coconut pellets, still contained the remnants of a coconut pellet load. The pellets, made of a compressed material, were cuboid with an edge length of 2.3 cm x 2.3 cm x 1.5 cm:

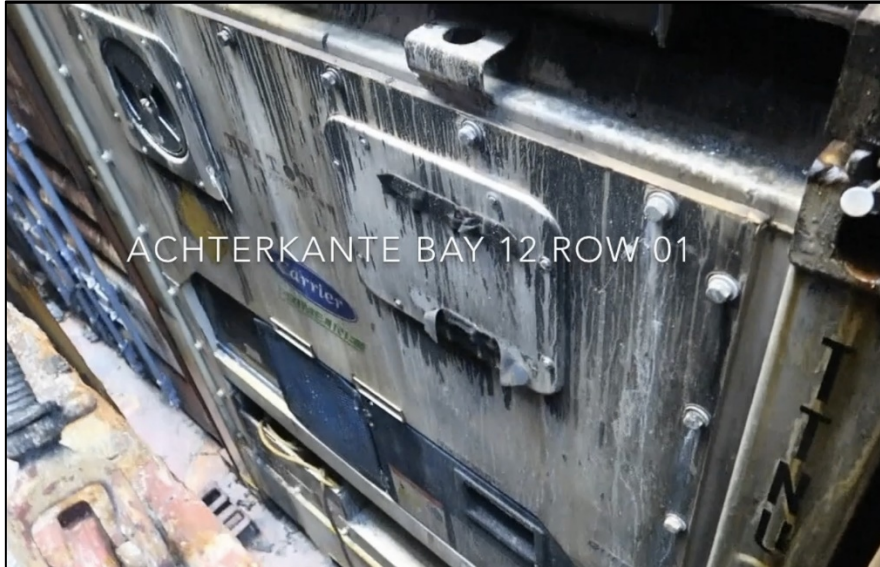
During the inspection, the refrigerated container at slot 120182 was also viewed. No effects of fire could be found on the refrigerating unit side located on the aft edge of bay 12 (see also Figure 34).

Figure 34: Undamaged refrigerated container at slot 120182

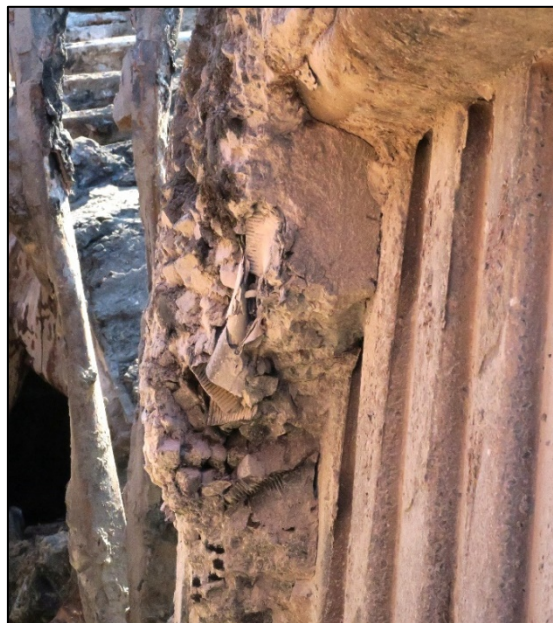
After the container had been unloaded from slot 102582, this area was examined. It was found in the process that parts of the charcoal load had also been under this container. Some of the pyrochar (in its cardboard packaging unit) was baked into the fire debris of the polypropylene shopping bags (see Figures 43 to 45).

Figure 43: Underside of container from slot 120582

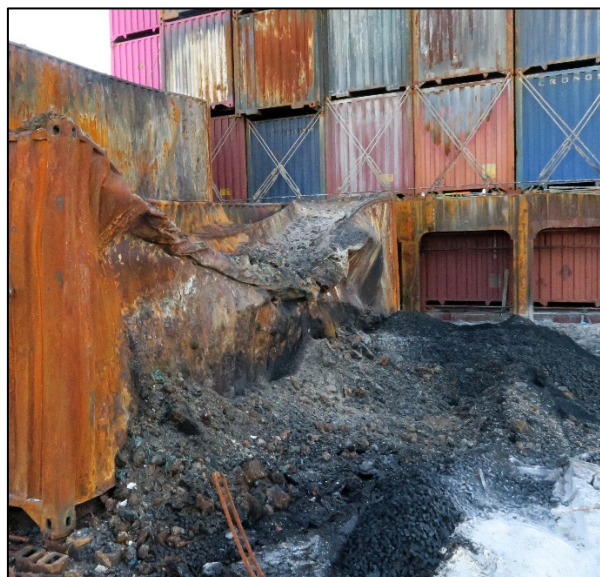
Figure 46: Slot 120782, unburnt pyrochar
The contents spilled out when lifting.

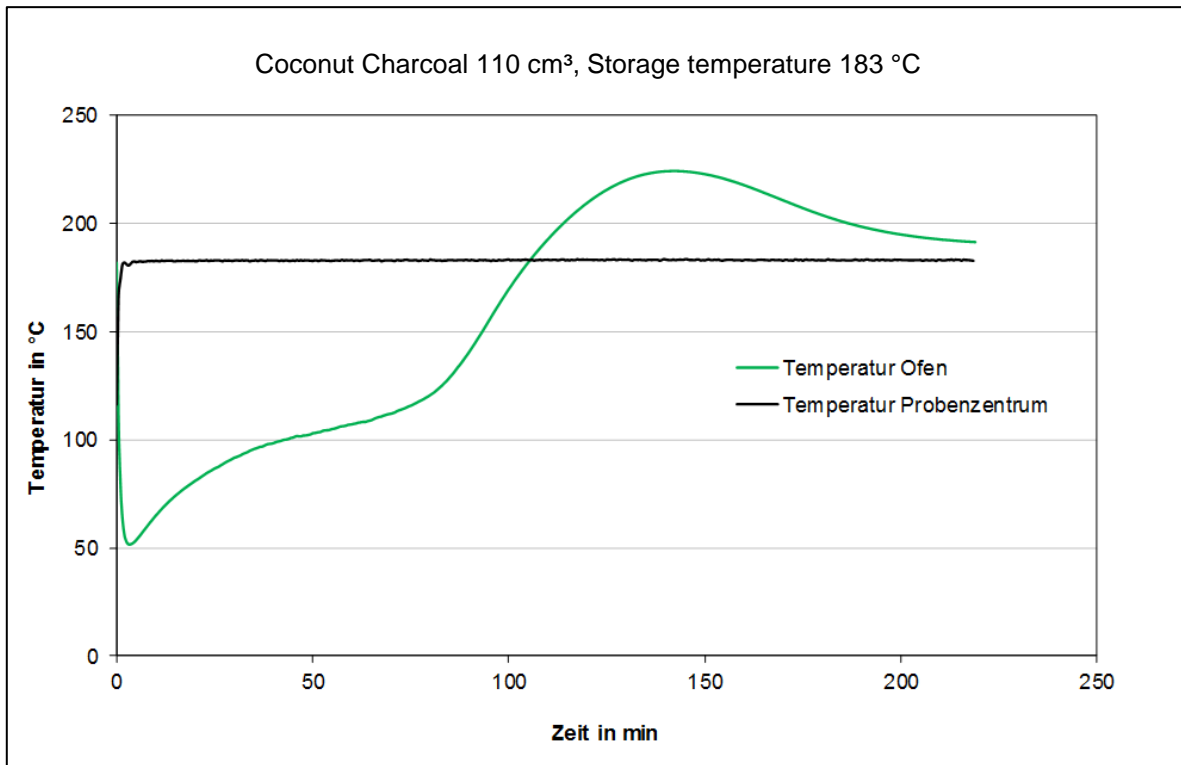
Figure 47: Iso-peribol test with cocolut charcoal (110 cm³) at 183 °C

The examinations allow for the conclusion that the fire could have been caused by self-igniting of the coconut charcoal.

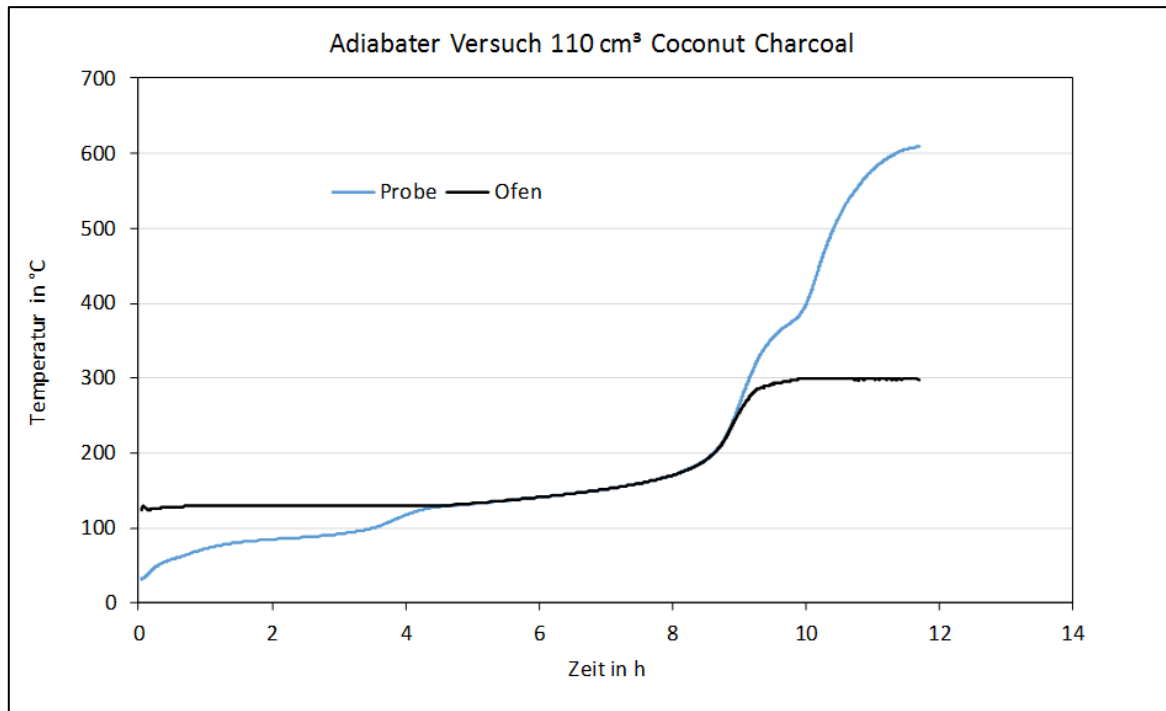
Figure 48: Adiabatic test with coconut charcoal (110 cm³)

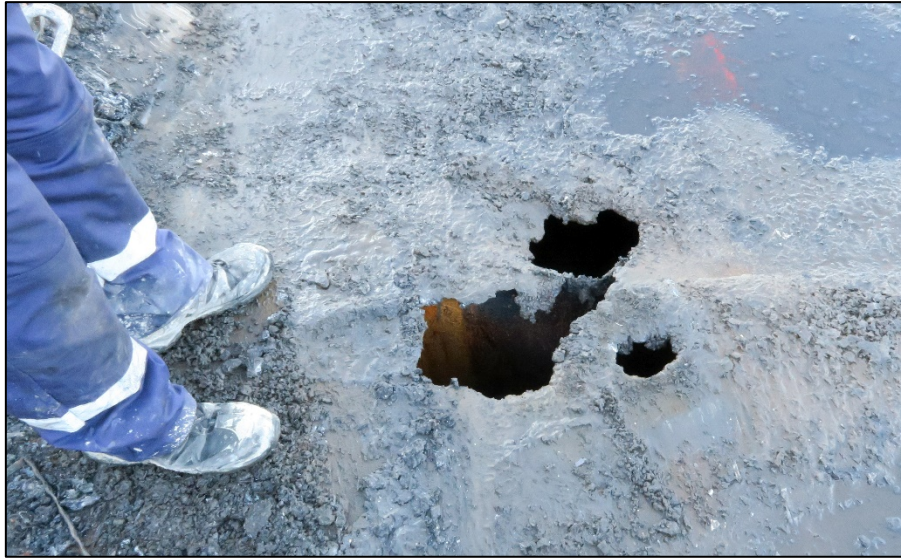
In the area of the container loaded with nitrocellulose in slot 080782, a hole was later found in the hatch cover. In the opinion of the firefighters commissioned by the salvage company, it was caused by the combustion of the nitrocellulose. The fire then developed via this hole into hold 1 and led to the ignition of the containers loaded with tires in slots 080718, 080918 and 081118.

Figure 50: Comparable hole on position 080182

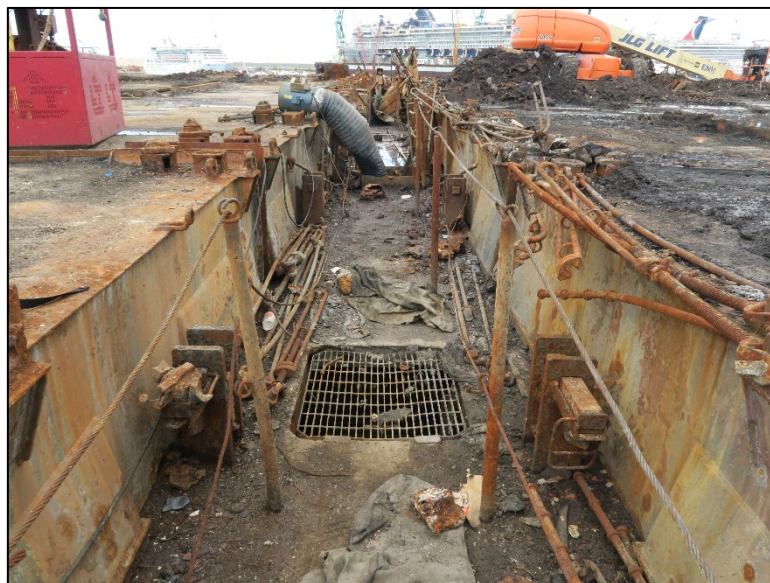
Figure 54: Grill over port ventilation opening in the transverse corridor between bays 4 and 8

It was found here that the flap of the ventilation opening under the grill was not locked. Access to the flap was not possible because the grill was secured by a chain and lock.

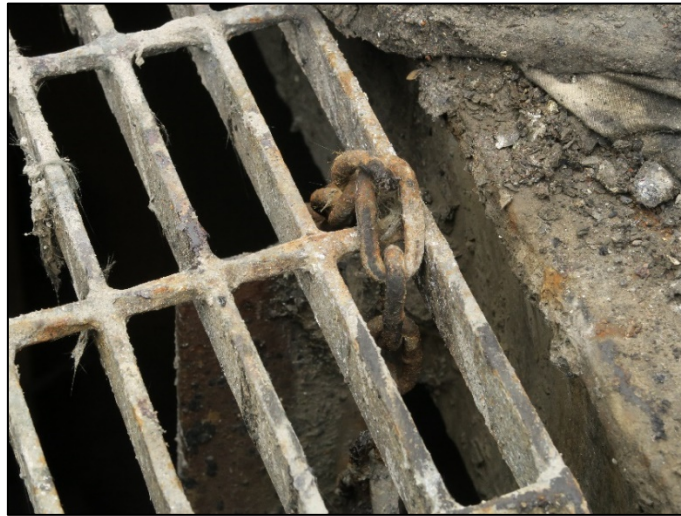
Figure 55: Grill over ventilation opening secured by chain and lock

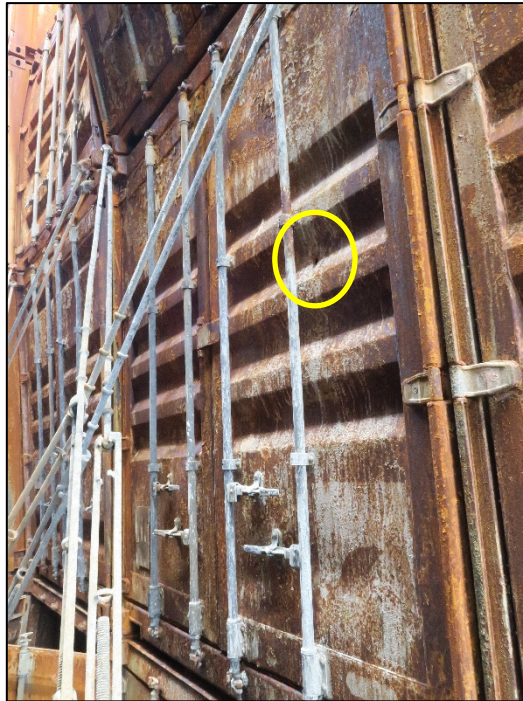
During the firefighting operation, the YANTIAN EXPRESS's crew opened the container at slot 120582, which was filled with polypropylene shopping bags, and found that the container was completely filled with this cargo. This illustrates that the use of water mist lances in containers is not without problems, as a fire in the middle of the container cannot be reached due to the stowage situation. This is all the more true when, as on the YANTIAN EXPRESS, it is only possible to reach half way up the containers in the second tier due to the structural conditions of the lashing bridge.

Figure 57: Container at slot 120984 with hole for water mist lance

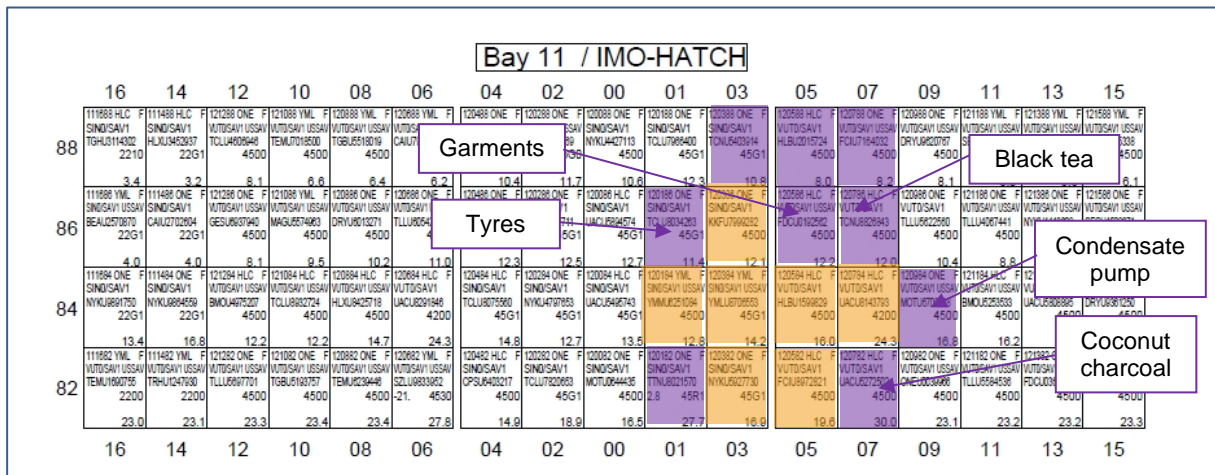
Figure 60: Containers emitting smoke at 1116 on 3 January 2019
