DUTCH  
SAFETY BOARD

# Perception of pilotage

Collision between pilot vessel and bulk carrier in the Scheldt area

*The Hague, January 2021*

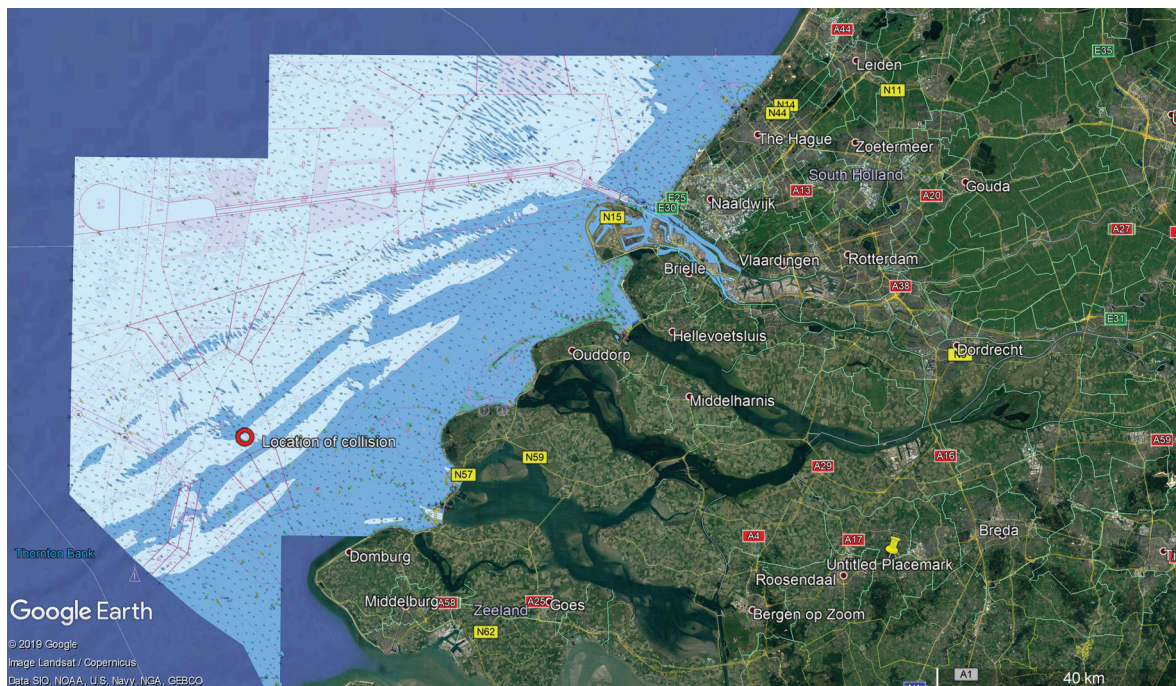
Figure 1: Position of collision northwest of the Middelbank.

In the early morning of Sunday 21 January 2018 at 04.12<sup>1</sup> hours, the Dutch pilot vessel Pollux and the Panamanian bulk carrier Nord Taurus collided with one another, off the coast of Zeeland, Netherlands. At that moment, both vessels were located 1.3 nautical miles<sup>2</sup> northwest of the Middelbank, a sandbar 12 miles northwest of Westkapelle (see Figure 1).

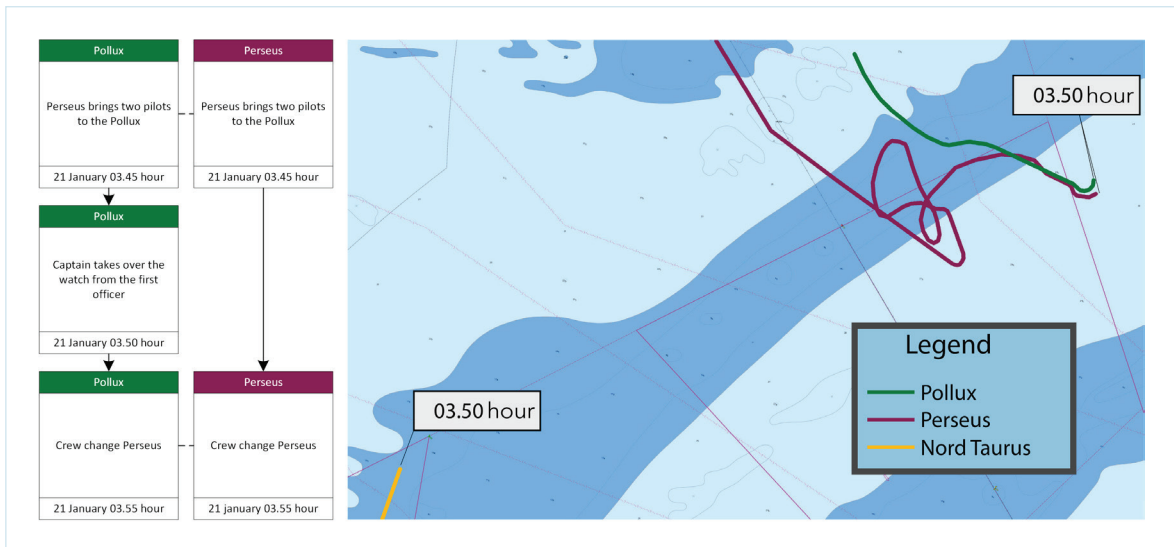
Figure 6: Situation at 03.50 hours LT.

At 01.25 hours in the morning of 21 January 2018, the Dutch pilot station vessel Pollux was positioned approximately one mile northwest of the Schouwenbank Zuid buoy (SBZ buoy). Between then and 03.45 hours, a series of movements were carried out under pilot guidance, all undertaken by the Perseus or tenders. Three pilots were disembarked, two of whom were then transferred to the Pollux, while a third pilot was transported to an incoming vessel. Throughout this period, the Pollux anticipated the movements of surrounding shipping and on several occasions made space for vessels from which the pilot was disembarked.

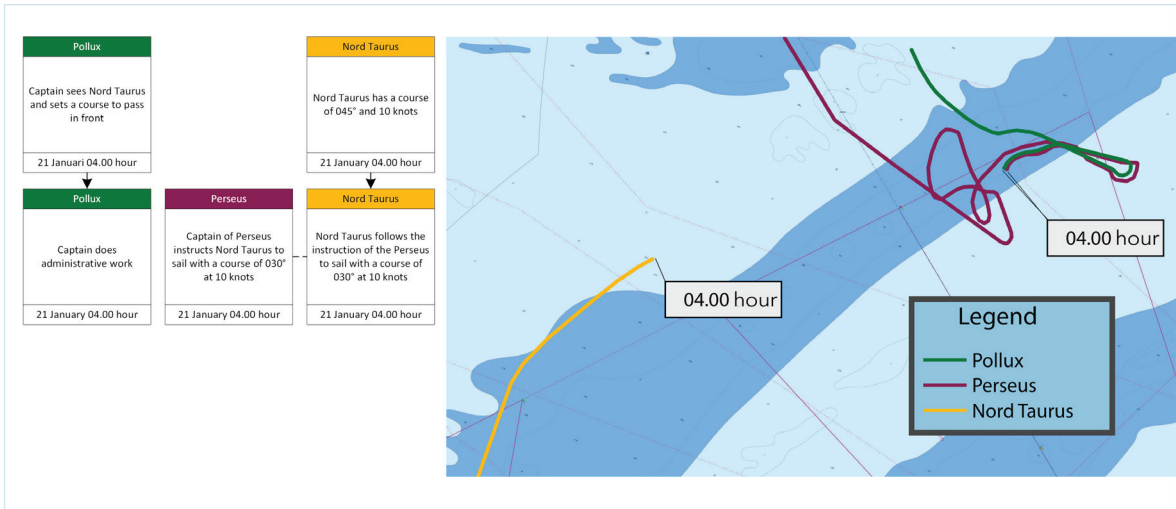
Figure 7: Situation at 04.00 hours LT.

In the meantime the captain of the Pollux wanted to return to the, for him, usual starting position. After the captain of the Pollux saw the Nord Taurus, he plotted a course to cross the Nord Taurus by its bow. At 04.00 hours, the Pollux set a course of  $300^{\circ}$  at a speed of 8 knots (Figure 7). At 04.02 hours, the automatic pilot<sup>4</sup> was activated. The Pollux was sailing with pilot lights on and therefore recognizable as pilot vessel. The captain then focused his attention on his administrative tasks. At that point, the Nord Taurus was sailing on a heading of  $045^{\circ}$  at a speed of 10 knots. To set course for the Perseus to safely disembark the pilot, via the VHF radio, the Nord Taurus was informed by the Perseus to sail on a heading of  $030^{\circ}$  and to maintain a speed of 10 knots. The Nord Taurus then shifted its heading to port, adopting a heading of  $030^{\circ}$ .

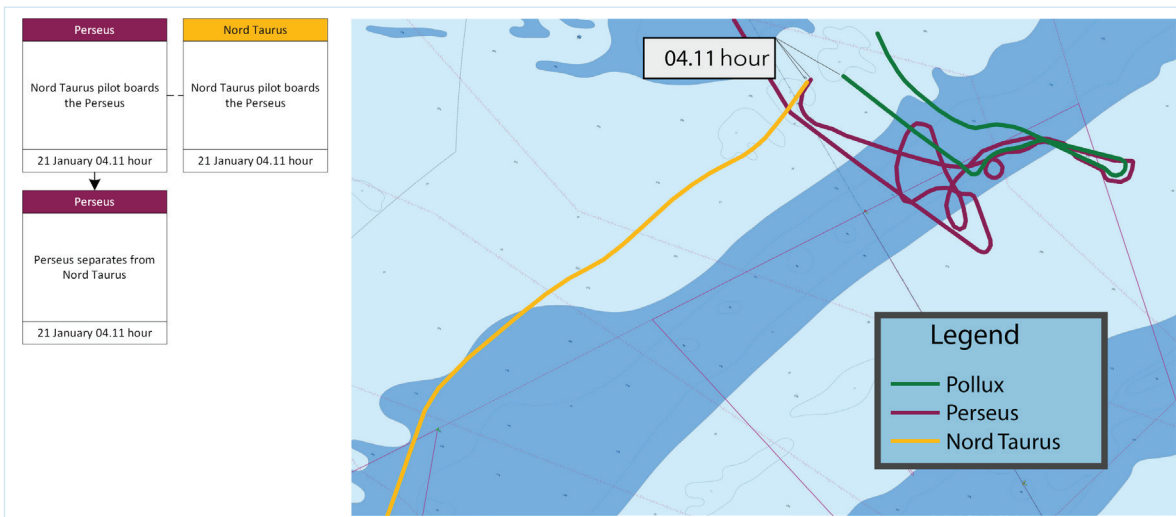
Figure 8: Situation at 4.11 hours LT.

Because the combination of gangway and pilot ladder on board the Nord Taurus was hung low, the crew of the Perseus had to be particularly careful to ensure that the pilot could be safely brought on board. The long gangway and pilot ladder increased the risk that the Perseus could damage the gangway. At 04.11 hours, the pilot had disembarked from the Nord Taurus, onto the Perseus (Figure 8). The Perseus then cast off from the Nord Taurus. After the pilot had been safely disembarked, the captain of the Nord Taurus issued the order port 20, in order to adopt a heading of 350°, as had been advised by the pilot, before he disembarked.

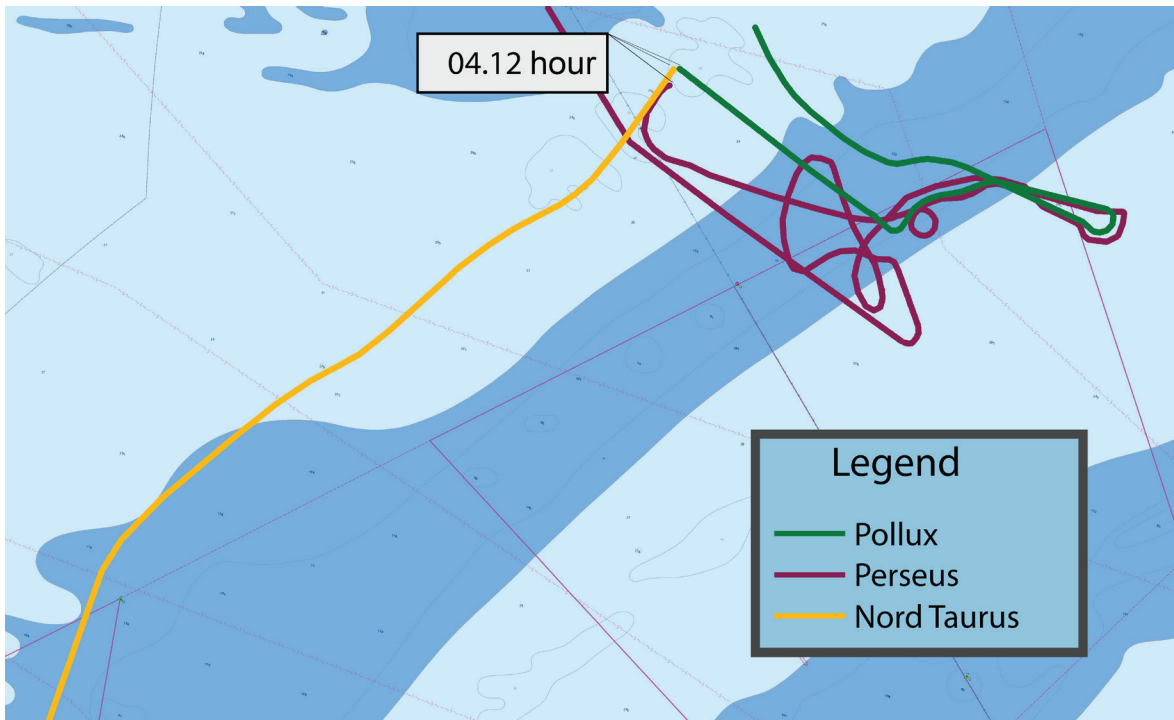
Figure 9: Situation at 04.12 hours LT, the collision.

The Pollux continued along the same heading at the same speed, on the automatic pilot. At 04.12 hours, the collision occurred between the Pollux and the Nord Taurus whereby the starboard bow of the Nord Taurus came into contact with the portside of the Pollux (Figure 9). On board the Pollux a number of crew members suffered minor injuries; there were no injuries on board the Nord Taurus. The Pollux suffered severe damage to its

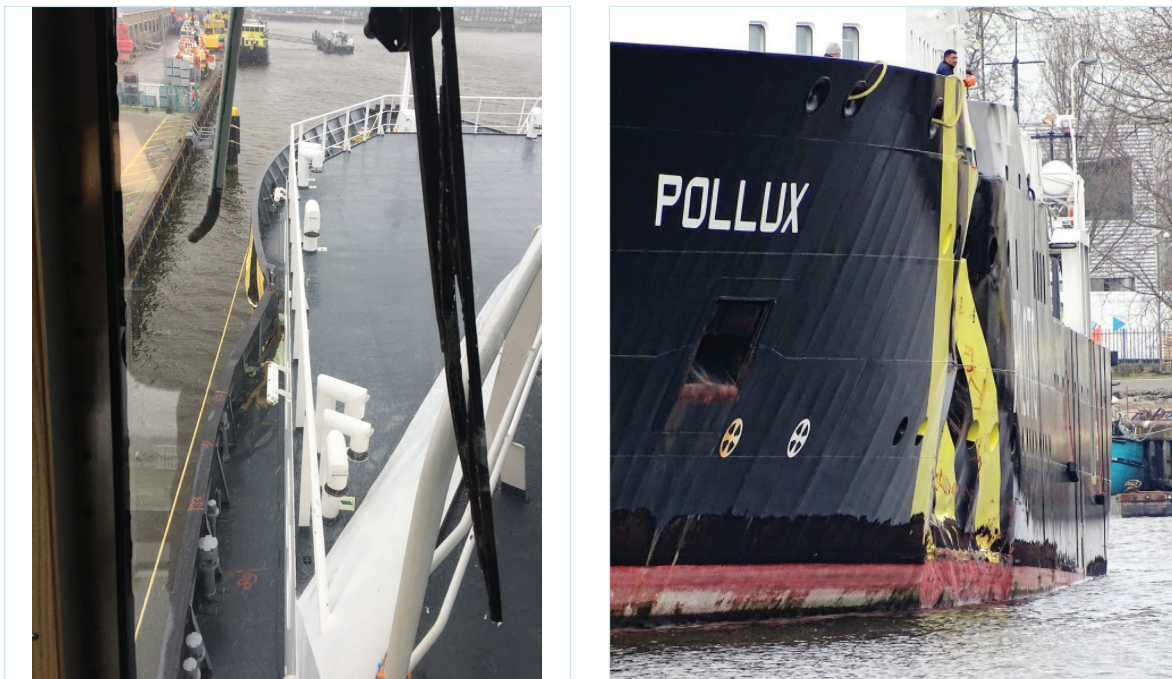
Figure 10: Damage to the Pollux. (Source righthand picture: Kees Torn)

The Pollux was hit on the port side and among others suffered damage to the bridge and hull. A number of crew members suffered minor injuries. The Pollux remained afloat and was able to sail to Vlissingen under its own power. The Nord Taurus anchored off the Steenbank, with minor damage.

portside (see Figure 10). Immediately following the collision, the crew of the Pollux completed the checklist from the emergency procedure manual, which included an inspection for leaks. Contact was also sought with the coastguard and the Traffic Centre Steenbank, to report the collision. Because the Pollux had suffered no leaks, and because propulsion and steering were still working correctly, the Pollux sailed to Flushing, under its own power. The Nord Taurus anchored off the Steenbank, with slight damage to her bow.

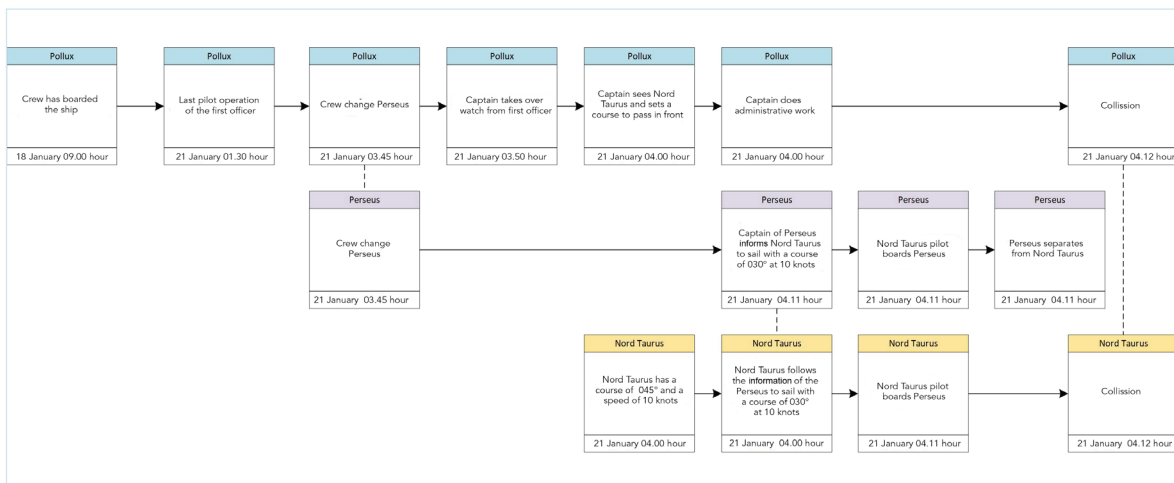
Figure 11: Timeline, leadup to the collision.

Using the TRIPOD incident analysis method, the failing safety measures, the direct causes, the circumstances and the underlying factors were investigated. To analyse the collision between the Nord Taurus and the Pollux, the accident was considered both from the perspective of the Nord Taurus and the perspective of the Pollux and Perseus.
