DUTCH
SAFETY BOARD

Collision on the Western Scheldt

River cruise ship Viking Idun and chemical
tanker Chemical Marketer, 1 April 2019

The Hague, December 2020

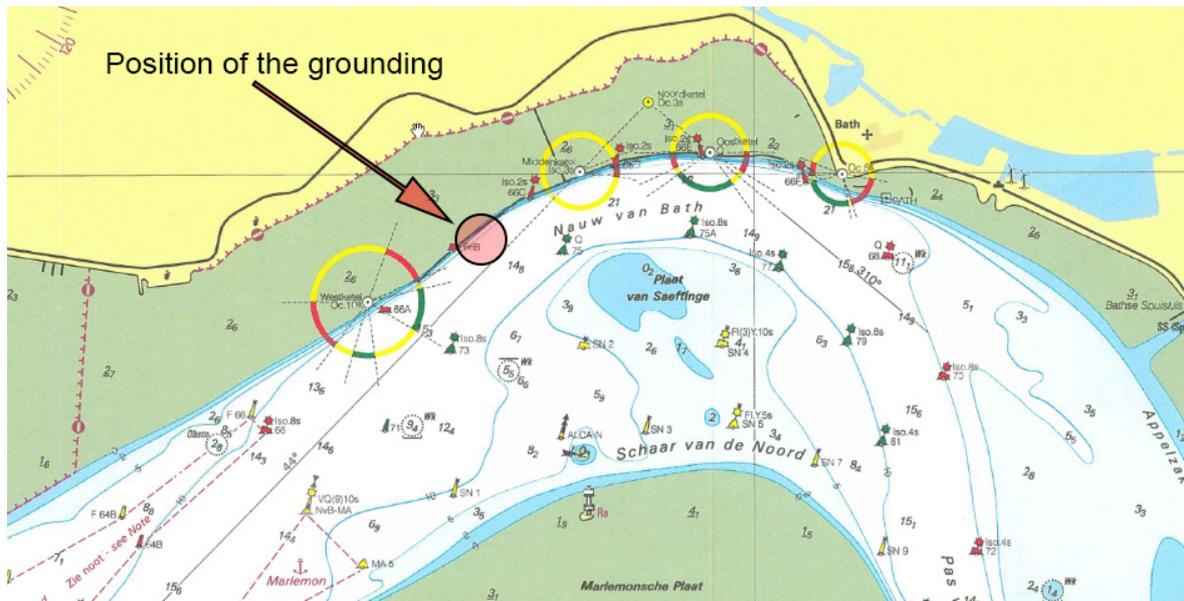
Figure 2: Extract from the sea chart marking the location of the grounding in the Nauw van Bath. (Source: Map 1803.4 "Western Scheldt. Walsoorden to Bath", Hydrographic Service)

Following departure from Antwerp, at around 21.45 hours, in the Nauw van Bath, the Viking Idun was overtaken by the Morning Calm, a Bahamian-flagged car carrier, with a length of more than two hundred metres. This manoeuvre was carried out at the request of the pilot on board the Morning Calm. In order to make sufficient room for this vessel in the narrow channel, the Viking Idun maintained its course as far as possible towards the starboard side of the channel, but close to buoy 66B left the navigation channel and subsequently ran aground (see figure 2).

Earlier that evening, the Viking Idun had run aground near the Nauw van Bath, as a result of an evasive manoeuvre to allow the passage of a car carrier. Immediately outside the navigation channel, the water becomes shallow, which is a clear example of the treacherous character of the Western Scheldt. If a vessel does run aground on the Western Scheldt, this must be immediately reported to the authorities, as outlined in the block below. A grounding can have consequences for other shipping or the technical condition of the vessel.

Following the collision with the Chemical Marketer, the Viking Idun was placed in dry dock for bow repairs. During this work, damage was discovered which could not have resulted from the collision, but could have been caused by the grounding in the Nauw van Bath.

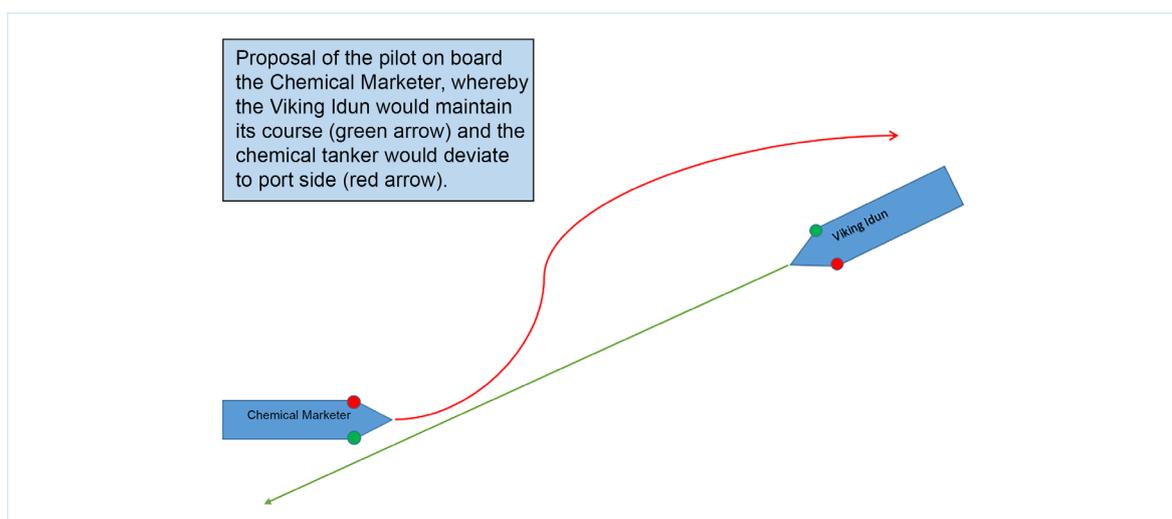
Figure 3: Schematic presentation of the green-on-green proposal from the pilot.

The Viking Idun continued its journey towards the Eastern lock in Terneuzen. In the meantime, the Chemical Marketer was sailing towards Antwerp.⁵ At that time, both vessels were within the supervision area of the Terneuzen traffic control centre. At 23.55 hours, the pilot on board the Chemical Marketer contacted Terneuzen traffic control centre to ask whether the Viking Idun was intending to enter the Eastern lock at Terneuzen. This was confirmed by the traffic control centre. In response, the pilot suggested to the traffic control centre that the Chemical Marketer should maintain its course on the red side (the port side as seen from the Chemical Marketer) of the fairway, so that the Viking Idun could pass in front of the Chemical Marketer, and in that way cross the navigation channel. This would mean the vessels would pass green-on-green (see figure 3).

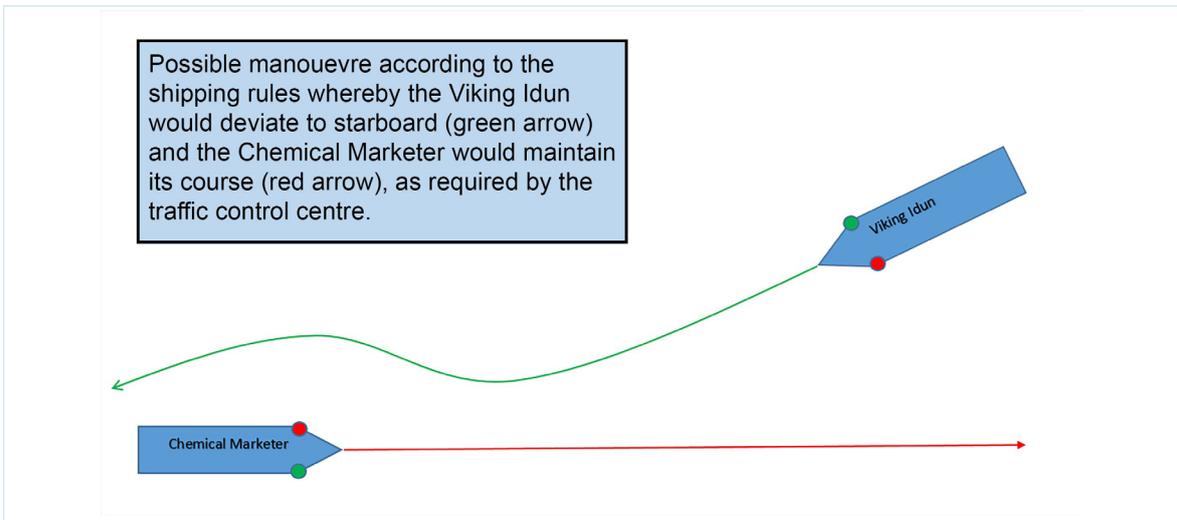
Figure 4: Schematic presentation of the standard avoidance manoeuvre.

The traffic controller rejected this proposal. He stated that the standard shipping rules had to be followed, whereby the vessels would pass each other red-to-red, and the Viking Idun would subsequently pass behind the Chemical Marketer (see figure 4).

In the case of the Chemical Marketer, taking account of the outgoing shipping exiting the lock and the local dredging activities, the traffic controller decided it would be wiser to instruct the red-to-red passage of the Viking Idun, in line with the shipping traffic rules. The plan put forward by the pilot could have led to a chain reaction, because if that plan had been followed, the Viking Idun would have come into a conflict situation with outgoing shipping. The situation whereby the Viking Idun would fail to turn to starboard, and would turn to avoid the Chemical Marketer was not foreseen.

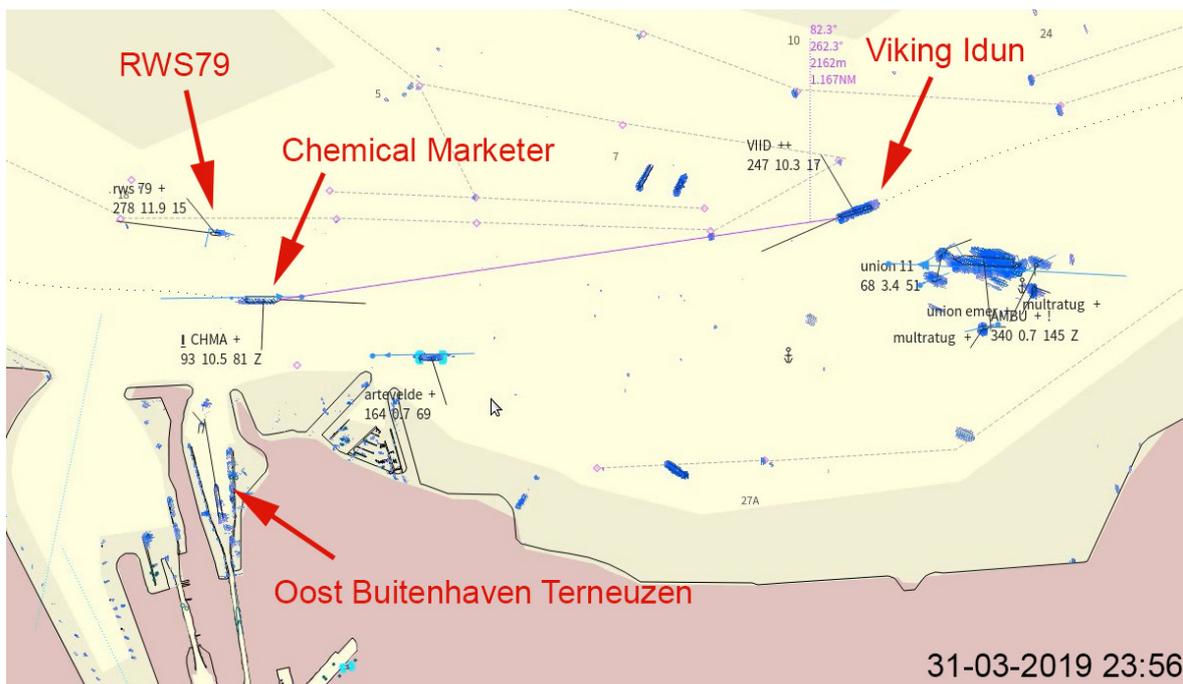
Figure 5: Screenshot of the radar image at Terneuzen VTS centre at 23.56 hours on 31 March 2019. For the purpose of visibility, the colours have been adjusted. (Source: RWS Scheldt Coordination Centre).

Upon passing red buoy 22 at 23.56 hours, the Viking Idun once again reported to the Terneuzen traffic control centre. The traffic control centre informed the Viking Idun that there were three vessels departing from the Oost Buitenhaven, destined for Flushing. These vessels are shown in figure 5, in the Oost Buitenhaven. The traffic controller did not name the Chemical Marketer because at that time the Chemical Marketer had already passed the Oost Buitenhaven, and was in its judgement no longer relevant for the Viking Idun. The Viking Idun maintained its course and sailed towards the lock (see figure 5). The VTS operator offered no further advice to the captain of the Viking Idun about the ideal course for the entry to the lock in Terneuzen.

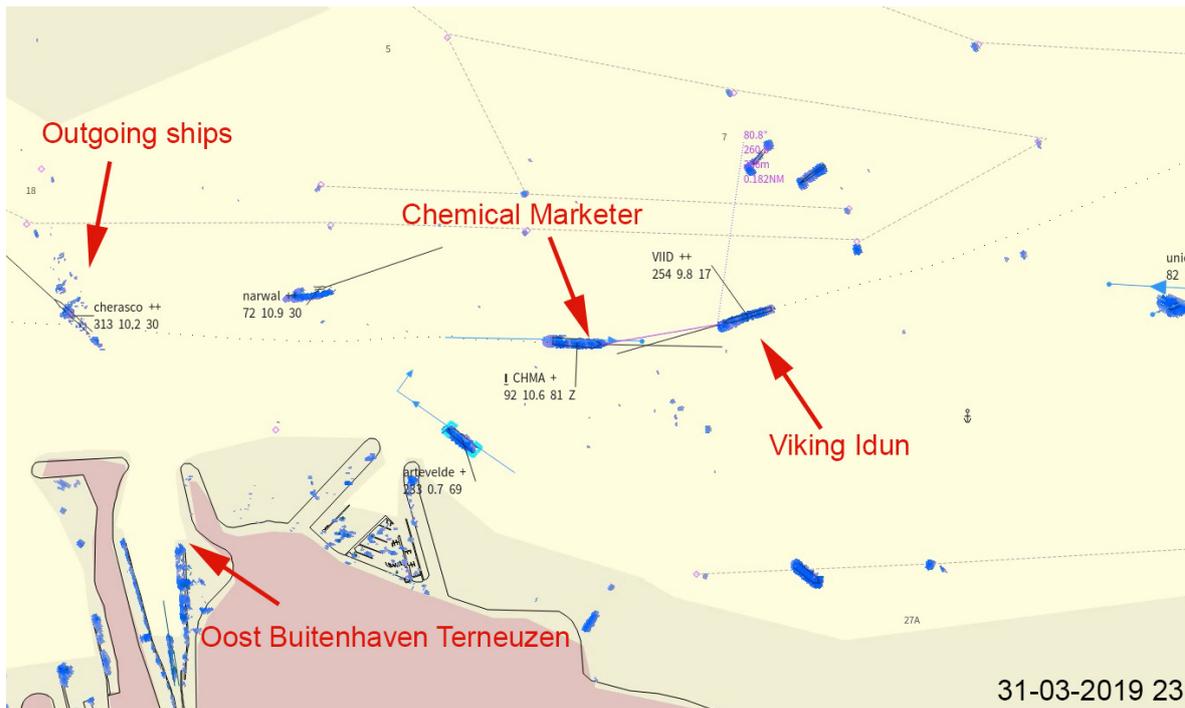
Figure 6: Situation at 23.59.30s. (Source: RWS Scheldt Coordination Centre)

At 23.58 hours, the pilot on board the *Chemical Marketer* called the *Viking Idun* via the traffic channel, to request confirmation of the red-to-red passage. The *Viking Idun* failed to respond to the pilot's call, and maintained its course towards the lock, instead of turning to starboard, to make room for the chemical tanker and sticking to the starboard side of the channel. The Terneuzen traffic control centre then called the river cruise ship; the vessel did reply to this call. The traffic controller explained that the plan was a red-to-red passage of the ship heading in the opposite direction, referring to the *Chemical Marketer*. The captain of the *Viking Idun* replied that he had not understood, and asked for the message to be repeated. The traffic control centre repeated the red-to-red passage rule, at which point the captain of the *Viking Idun* replied affirmatively. However, the *Viking Idun* failed to change course (see figure 6).

The direct cause of the collision was the failure by the Viking Idun to maintain the specified shipping route (according to the SRW), which placed the vessel in the course of the Chemical Marketer. Because the Viking Idun maintained its course and crossed the navigation channel, the river cruise ship found itself in the course of the chemical tanker. The pilot and the mate on the Chemical Marketer were unable to avoid the collision.

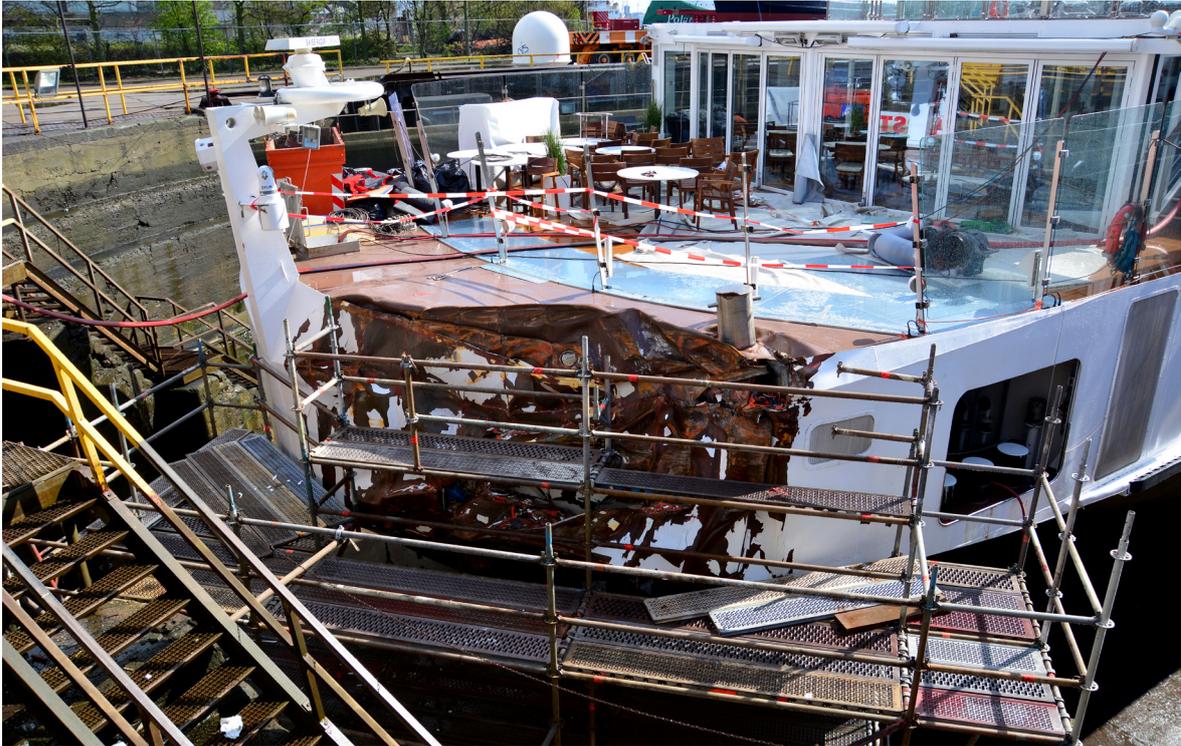
Figure 7: The damage to the bow of the Viking Idun, photographed in dry dock.

In the meantime, the *Chemical Marketer* had also continued on the same course, at the same speed, and the two vessels were approaching each other rapidly. At 23.59.35, the pilot issued a warning via the VHF marine radio that the situation was at risk of going wrong, and shortly afterwards ordered the helmsman to turn hard starboard, to ensure that the larger seagoing vessel would not hit the river cruise ship amidships thereby as far as possible avoiding damage to the river cruise ship. In the meantime, the traffic control centre called upon the *Viking Idun* on two occasions to turn to starboard, but without further reaction. At 00.00.08s on 1 April 2019, the pilot announced via the VHF marine radio that a collision had taken place. The *Viking Idun* had collided with the *Chemical Marketer* on the port side, just astern of the forec⁶ (see figure 8).

Both vessels suffered severe damage. On board the Viking Idun, a number of passengers suffered minor injuries. One crew member of the Viking Idun's hotel service was subsequently transported to a local hospital for medical examination. The Viking Idun suffered damage to the bow (see figure 7) and was towed to the West Buitenhaven of Terneuzen by tugboats. Later that night, the Viking Idun was guided through Terneuzen's Western lock, and berthed at the Goese Kade.

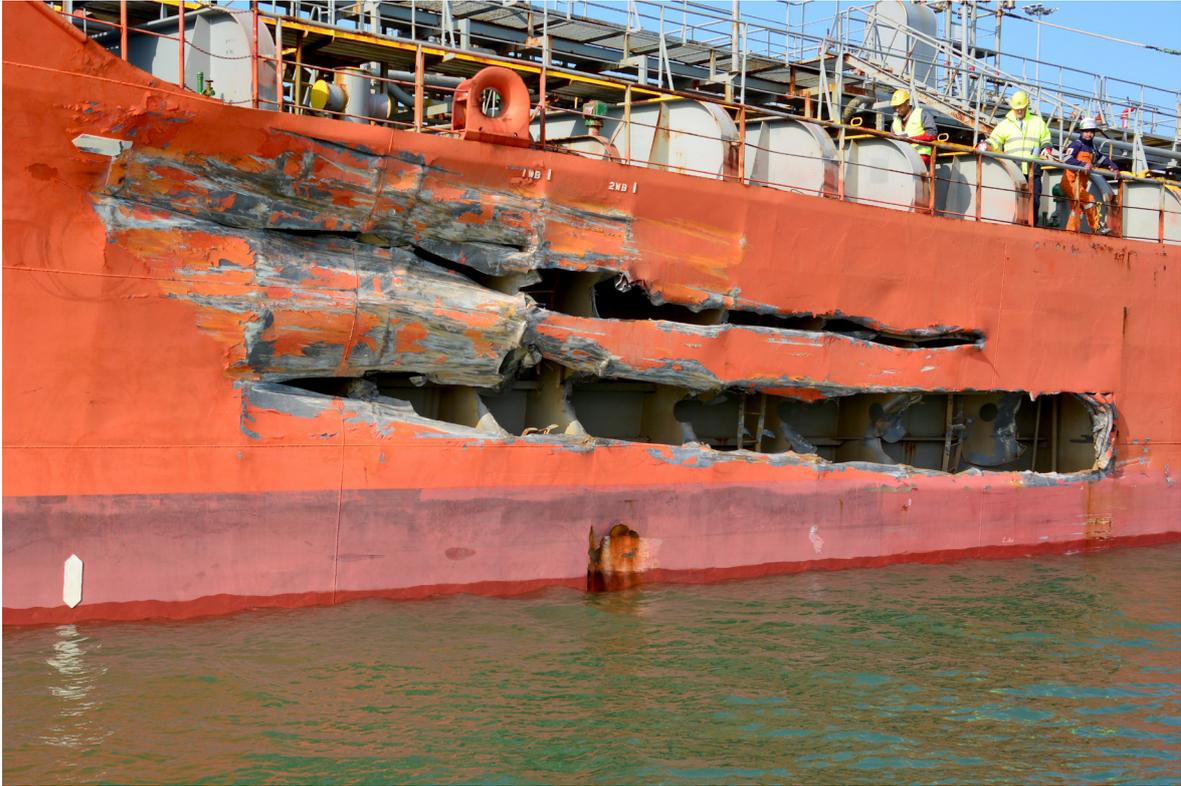
Figure 8: The damage to the Chemical Marketer following the collision with the Viking Idun.

The Chemical Marketer suffered a tear of more than eight metres in length in the ship's skin, one metre above the waterline (see figure 8), but there was no spillage of cargo or other liquids from the vessel's double-walled tanks. However, because of the tear in the ship's skin, the vessel was no longer seaworthy. The vessel was anchored at mooring A in the Put van Terneuzen, to the southeast of the accident site, and was subsequently transferred with permission from the Human Environment and Transport Inspectorate (ILT) so that the cargo could be discharged and the damage repaired.

An agreement was reached between the pilot, the traffic control centre and the Viking Idun about the red-to-red passage. In hindsight, it can be concluded that the crew of the Viking Idun failed to understand this agreement, or did not act accordingly, and as a consequence they were unable to avoid the collision. The outdated knowledge of the navigation zone and a limited understanding of the compulsory English language, in particular nautical English, on the part of the two crew members on the bridge of the Viking Idun were the underlying cause. As a consequence, the Viking Idun deviated from the prevailing traffic rules, thereby seriously threatening the safety of the passengers and crew on board the Viking Idun and the crew of the Chemical Marketer. In the event of a spillage, the cargo of the Chemical Marketer could also have caused serious environmental damage.
