SAFETY INVESTIGATION REPORT

REPORT NO.: 04/2021

MV NAVIOS AMITIE

Man overboard and loss of life of a crew member while rigging a combination pilot ladder in position 39° 59.92' N 026° 05.33' E

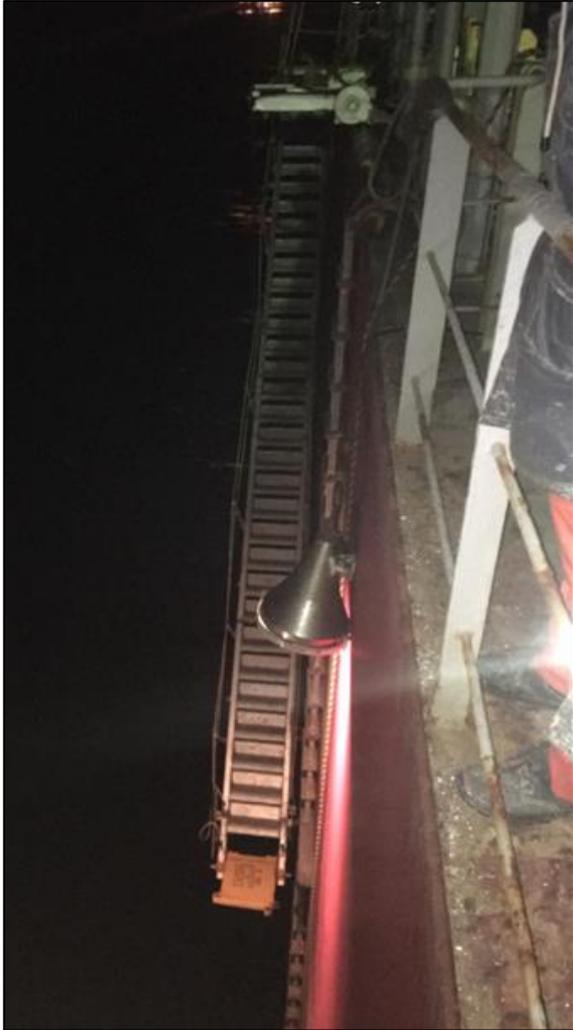
ladder on the port side (which was the leeward side of the vessel). As *Navios Amitie* exceeded the 9.0 m height criterion, the pilot ladder had to be rigged in conjunction with the accommodation ladder / gangway, located abreast of cargo hold no. 4. Since it was dark, the overside floodlight was switched on (Figure 1).

Figure 1: Photo showing port side combination pilot ladder with overside light

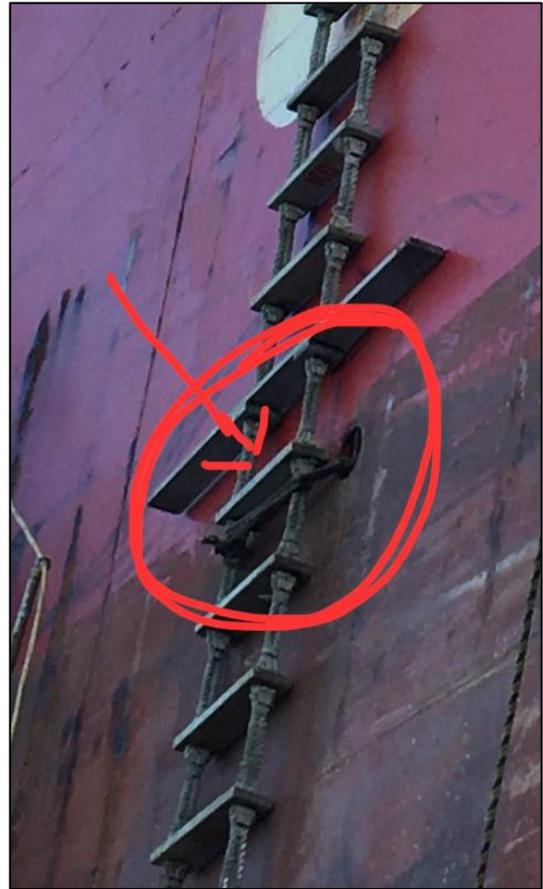
The pilot ladder was lowered over the ship's side and the accommodation ladder was swung out and rigged. The bosun went down the accommodation ladder to the lower platform. After completing the lashing of the pilot ladder to the ship's hull (Figure 2), he called the OS on deck to fetch a piece of rope to secure the gangway to the vertical pilot ladder.

Figure 2: Pilot ladder lashed to the ship's hull

As noted above, the environmental conditions were severe. The probability of the waves buffeting the underside of the lower platform or its upper surface being wet from sea spray was not excluded by the safety investigation. Therefore, it seemed most likely that the bosun may have lost his

balance and / or slipped while securing the lower platform to the pilot ladder.

04/2021_R1 Review and revise the SMS procedure for working over the side to rig combination pilot ladders. The work permit and risk assessment forms should specifically identify this task taking account of vessel's movement and weather conditions.

04/2021_R2 Ensure that a formal risk assessment and permit to rig combination pilot ladder overside is carried out and ensure that relevant PPE is worn by the crew.

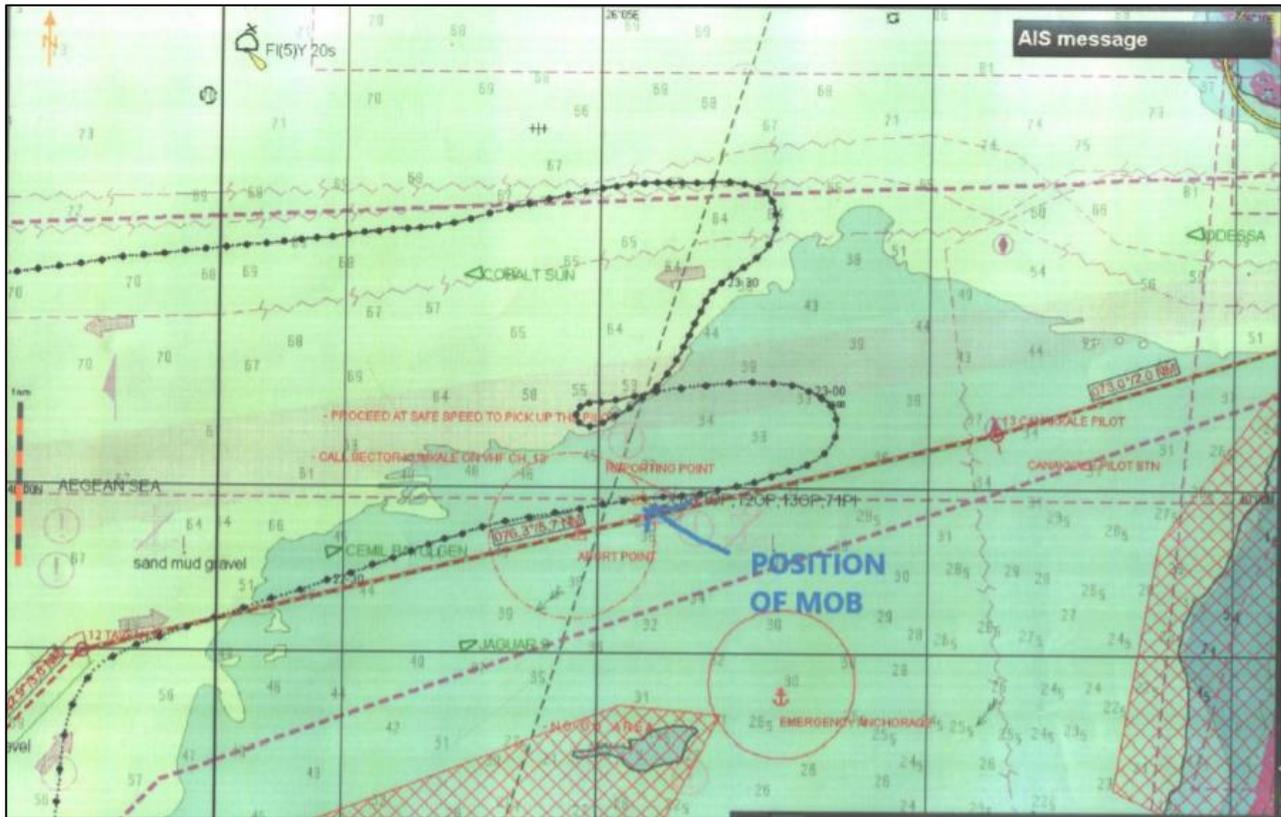
The chief officer presently involved in the rigging, instantly reacted and threw the self-igniting light lifebuoy, and reported to the bridge that the bosun had fallen into the sea. A second lifebuoy with light was released by one of the crew members. The accident occurred at 0145 in position 39° 59.92' N 026° 05.33' E, about two nautical miles West of the Çanakkale Strait's pilot boarding area (Figure 3).

Figure 3: Position of MOB and *Navios Amitie*'s search track

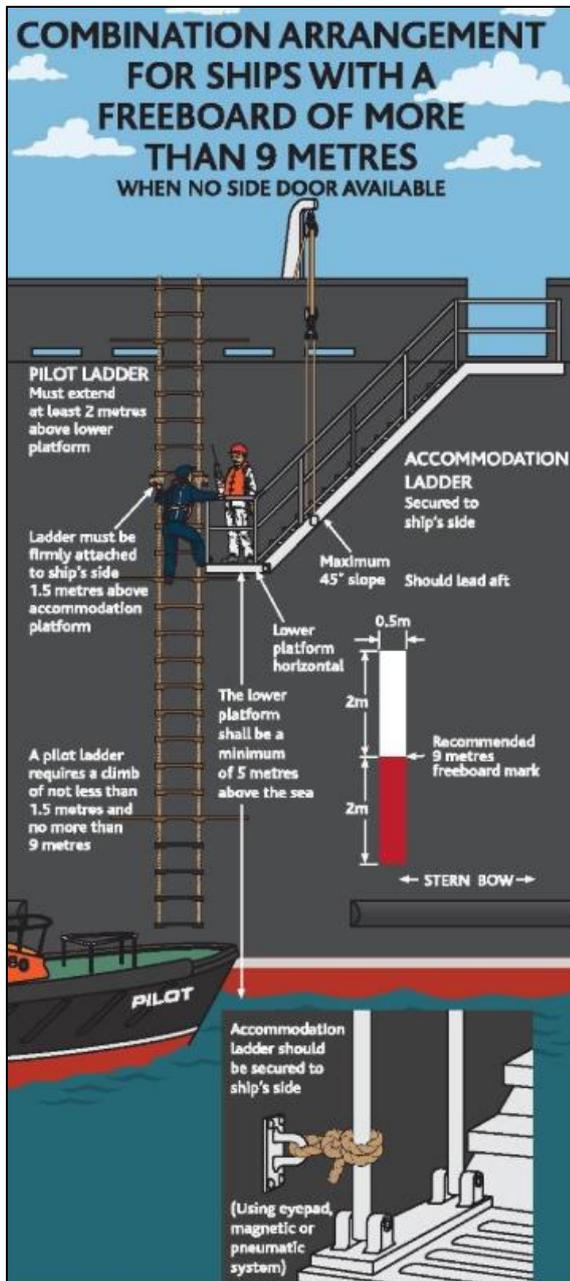
Where either the freeboard or the point of access on deck exceeds the height of 9.0 m, SOLAS Regulation V/23 requires that accommodation ladders or gangways are used in conjunction with vertical pilot

Figure 4: Extract from IMPA's poster showing pilot boarding arrangement for vessels with freeboard of more than 9.0 m

The pilot transfer arrangement on board the vessel was being rigged in accordance with the requirements of the SOLAS regulation.
