SINGAPORE SPIRIT CASUALTY INVESTIGATION REPORT

Enclosed Space Fatality

Atlantic Ocean | 15 March 2020

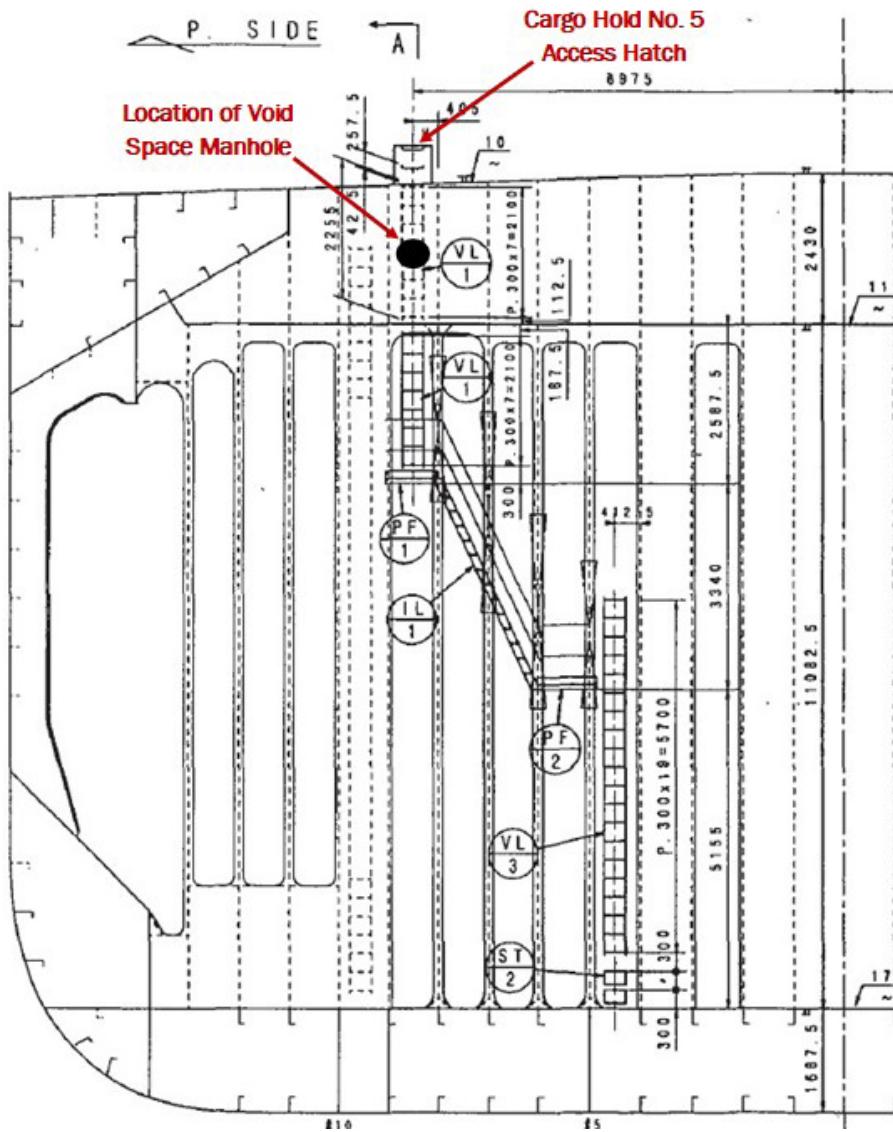
- The No. 4 port WBT control valve is located in a void space inside Cargo Hold No. 5. This void is accessible through a manhole 1.6 m below the top of the access hatch of the Cargo Hold No. 5 port side ladder.
- The Cargo Hold No. 5 port side ladder consists of two sections of vertical ladder which are connected by two intermediate platforms and an inclined ladder (*see Figure 1*).

Figure 1: Location of Cargo Hold No. 5 access hatch and void space access.

- iii. provide warning that the open Cargo Hold access hatch was not safe to enter when left unattended;
 - (c) the location of the void space manhole inside the Cargo Hold access ladder trunk, that required constructing a working platform to access it;

1. review and update, as necessary, its enclosed space rescue training procedures to ensure that the dangers of immediate rescue attempts without taking the necessary precautions are reviewed during each enclosed space entry and rescue drill;
2. review and update, as necessary, its procedures related to training of crewmembers on the specific hazards posed by cargoes carried on board prior to loading; and
3. conduct a review of other ships in their managed fleet for similar void space accesses and consider implementing safe working procedures which reduce the risk of a fall from height during construction of a working platform.

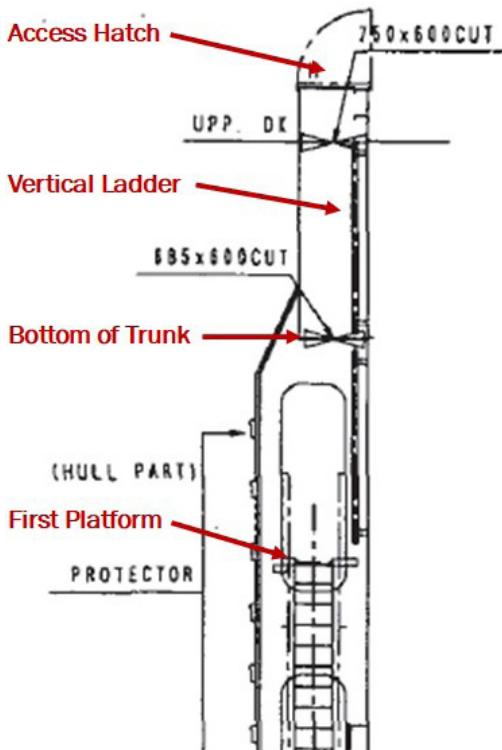
6. The top 2.25 m of the upper most vertical ladder is contained within a 750 mm x 600 mm trunk. The top of this trunk is covered by the access hatch, while the lower end has a 685 mm x 600 mm opening into the cargo hold. No cover or grating is provided for this opening. The remaining sections of ladder and both intermediate platforms are open to the cargo hold (*see Figure 2*).

Figure 2: Profile view of the Cargo Hold No. 5 port side ladder from the upper deck to the first platform.

7. No permanent platform is provided below the void space manhole. The lower opening of the ladder trunk is smaller than the trunk, creating a ledge around the opening.

To carry out the maintenance on the ballast valve, a working platform needed to be constructed below the void space opening. This necessitated positioning wood pieces over the lower opening of the ladder trunk while suspended from the vertical ladder. It is possible that the ASD1 fell while attempting to construct this platform without any assistance.

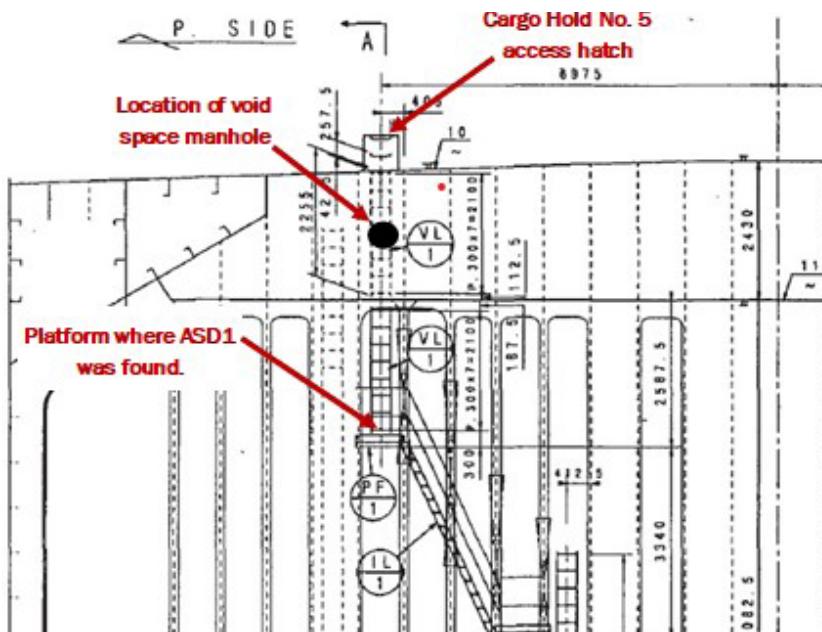
11. At about 1727, the ASD2 saw the ASD1 lying on the first platform of the cargo hold ladder, about 4.6 m below the access hatch (*see Figure 3*). He also saw that several pieces of wood were lying near the ASD1 on the first platform.

Figure 3: Location where the ASD1 was found.

It is most likely that the ASD1 was overcome by a hazardous atmosphere while inside the ladder trunk, causing him to fall to the first platform. It is also possible that the ASD1 fell while attempting to climb down the ladder while holding wood pieces or while constructing a working platform in front of the void space.
