**Marine pollution accident from the collision between
crane barge Samsung No. 1 towed by tugboats
Samsung T-5 and Samho T-3, and
oil tanker Hebei Spirit**

Prepared by
The Korean Maritime Safety Tribunal

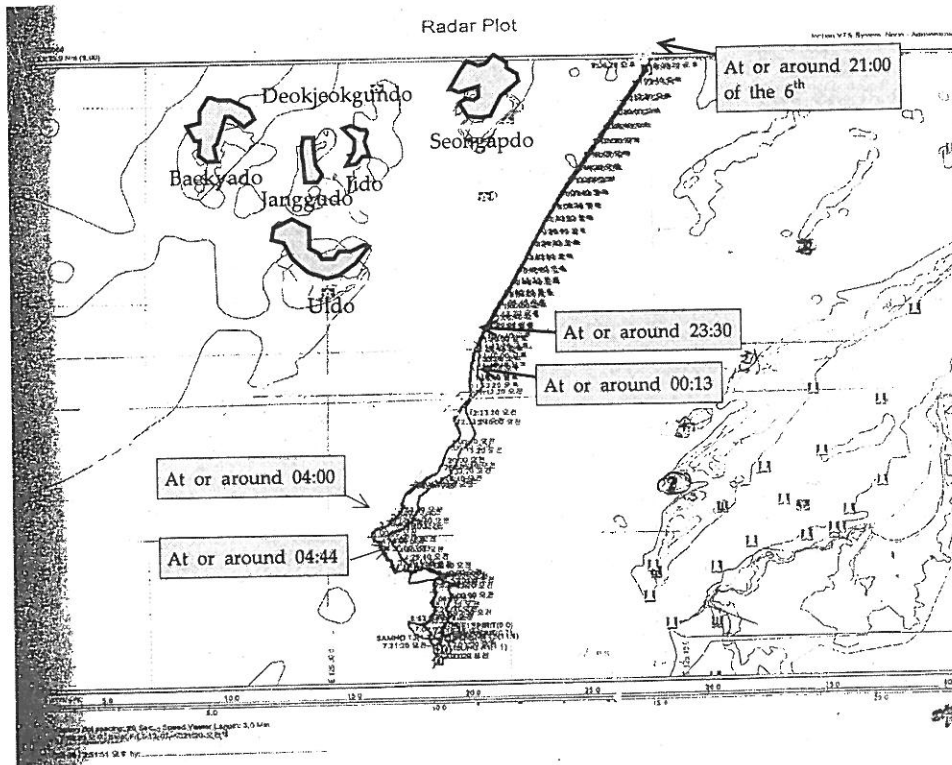
While the tugboats progressed on a gyro course of 230°, the actual track progressed at direct ship course was approximately 210°, that he thought it was sailing without much difference from the intended ship course of 206°, and he said through VHF

channel 15 to Samho T-3, "...we are sailing unto 230° because of bad weather. But actually, we are on the right course...", indicating that he did not seriously realize the towing fleet's zig zagging. ([Diagram 18], [Diagram 19])

[Diagram 18] At around 23:30, approximately 30 minutes before the hand-over of navigational watch by the Master of Samsung T-5 to its Chief Officer, the ship was about to pass Uldo Island, when the tugboats began to drift South, and thereafter, the track of the towing fleet began to be seriously unstable.

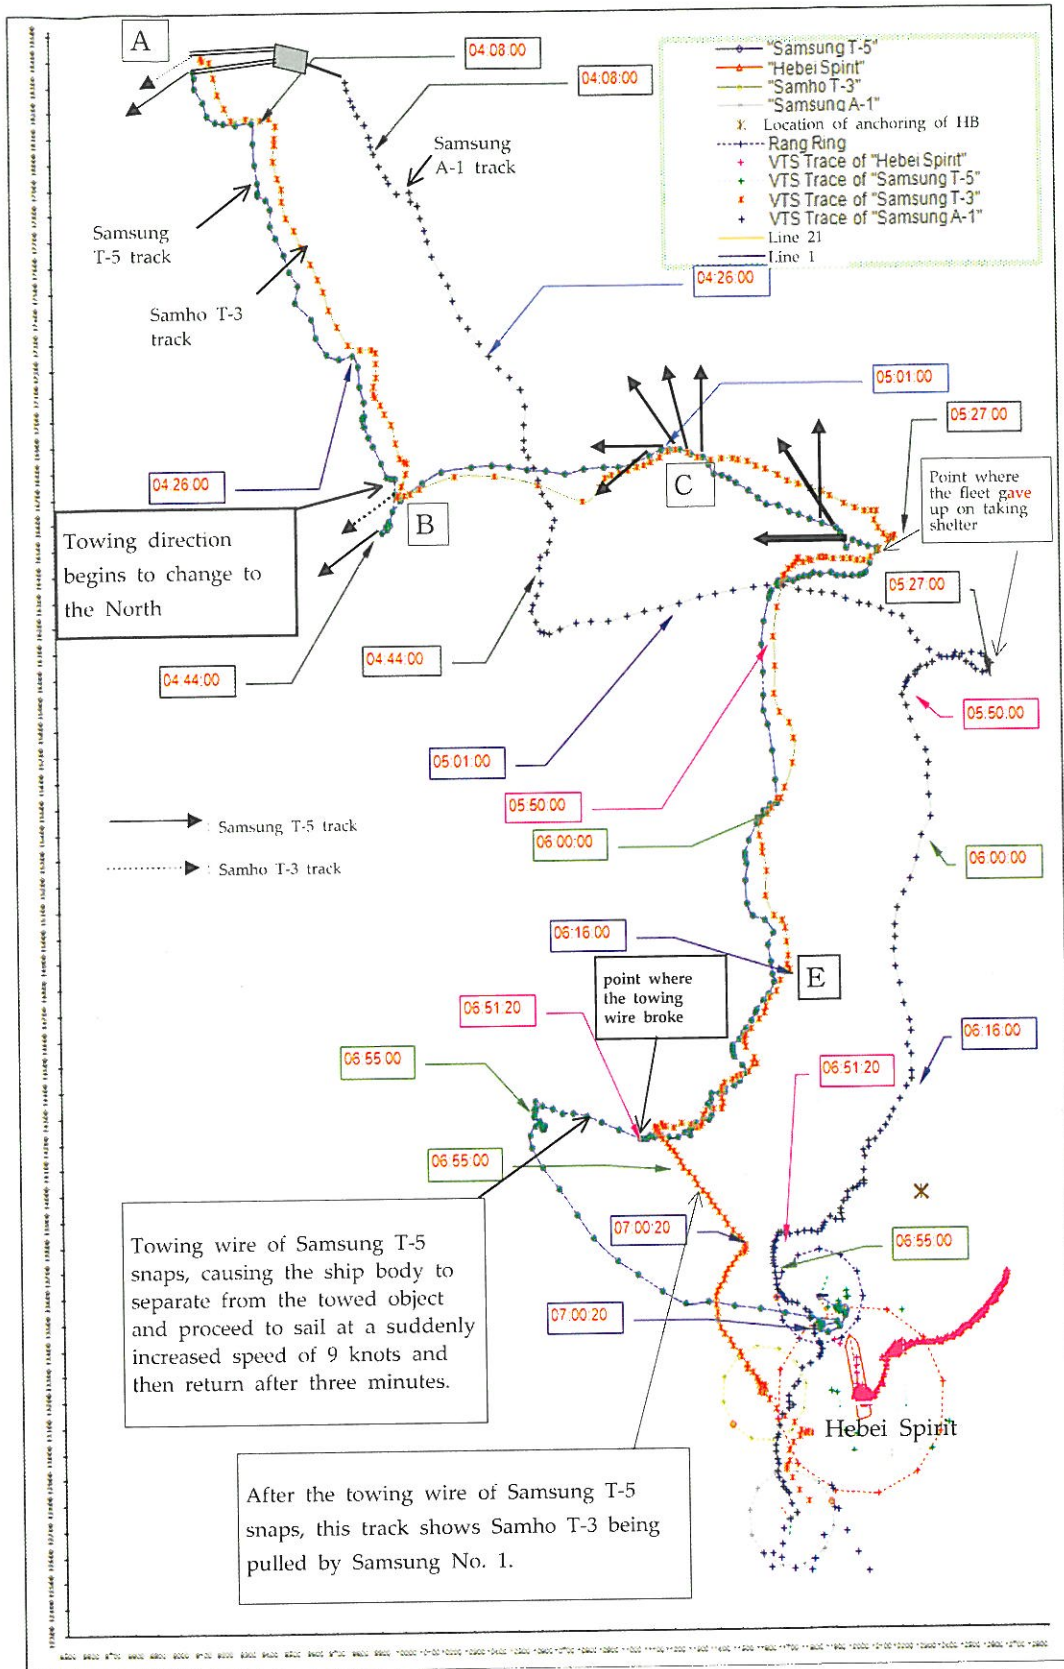
While the towing fleet was seized by heavy weather at around 00:00 the same day and sailed zig zagging, it maintained the intended course with a track of approximately 210° overall. However, from around 04:00, the weather got very worse, that the fleet prepared to take shelter toward Incheon Port by reducing the speed, when its passed track changed by almost 90° from SW to SSE. The ship rapidly drifted for approximately 1 mile without any resistance([Diagram 19], from “A” to “B”). From around 04:44, the tugboats' bow direction slowly turned right, and the towing fleet began to be pushed over to the East again. (Point "B" in [Diagram 19]).

[Diagram 19] This diagram has the towing fleet's tracks synthesized with the related ships' tracks as shown on the radar screen of the VTS Center of Daesan Port and information provided by related people's statements.

Despite the fact that several large ships and an very-large crude carrier, Hebei Spirit, loaded with crude oil, were anchored at approximately 2 miles Southeast of the towing fleet's track sailed from 04:00 to 04:44, the Master of Samsung T-5 did not inform about its dangerous situation to the nearby VTS Center or to any other ships. And right after 05:00 (Point "C" in [Diagram 19]), the towing fleet continuously got pushed over to the East, even after changing the gyro ship course to 000° over for several minutes toward Incheon Port (From point "C" to point "D" in [Diagram 19]). Even if Master of Samsung T-5 changed the tugboats' ship course to 000°, in order to take shelter toward Incheon Port, Samsung No. 1 did not get pulled, and heavy seas kept pushing it to the East.

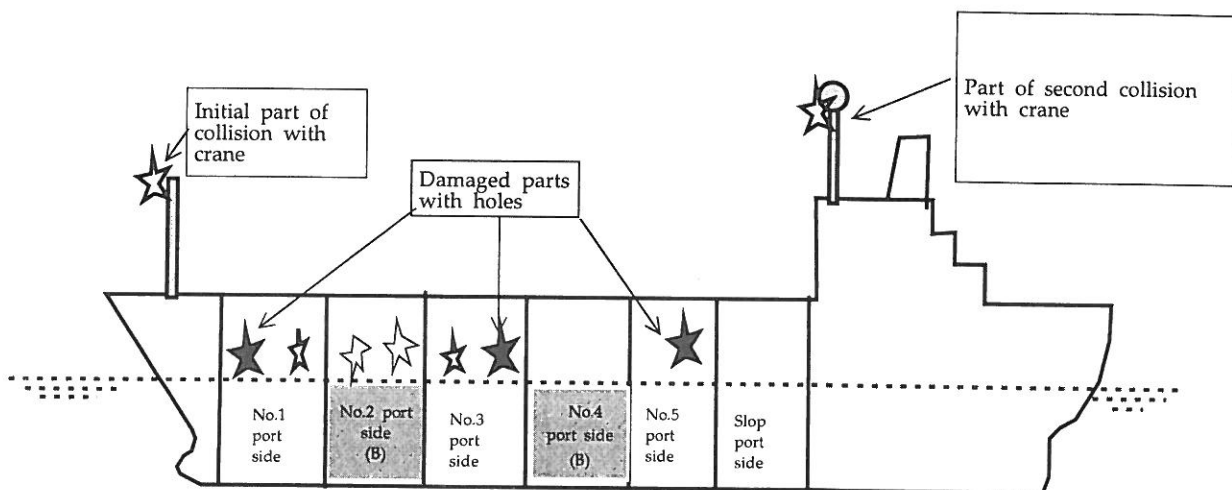
Later, at around 07:13, the port bow of Samsung No. 1 collided at approximately 30° with the upper part of the hull plate bow on the side of Hebei Spirit's cargo tank no. 1(port), making a hole that began leaking crude oil. Thereafter, Samsung No. 1 kept

drifting toward Hebei Spirit's stern side, while continuing to touch the hull plate of the port side, colliding 8 more times in total. As a consequence of the collisions, holes resulted on cargo oil tanks no. 3 and no. 5, both on the port side, adding up to three holes in total, with substantially more oil beginning to leak into the sea. ([Diagram 20]. [Table 8])

[Diagram 20] Damaged parts on Hebei Spirit from the collision. There were a total of 9 collisions that caused three holes. The areas shaded in gray are ballast water tanks.

Tank number	Distance from upper deck line to damaged holes (m)	Size of the damaged (mm) (length x width)
1 (p)	Approximately 5.3	300 x 30
3 (p)	Approximately 7.8	1,200 x 100 (maximum value)
5 (p)	Approximately 7.2	1,600 x 2,000

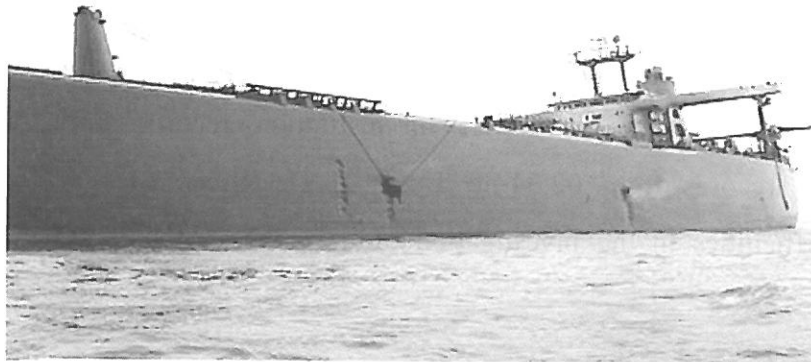
The ship's port side cargo oil tank no. 5 finally stopped leaking cargo oil at around 12:00 on December 7, the port side cargo oil tank no. 3 at 16:00, and port side cargo oil tank no. 1 at 23:40 on December 8, each. As a result, a total of 12,547 kilo-liters (approximately 10,900 tons and approximately 78,918 barrels) of crude oil leaked, causing a major oil pollution accident that seriously polluted the western coast of the Republic of Korea. ([Table 9])

[Diagram 21] Damaged holes on cargo oil tanks nos. 3 (port) and 5 (port) of Hebei Spirit (vapor leakage after the oil leakage)

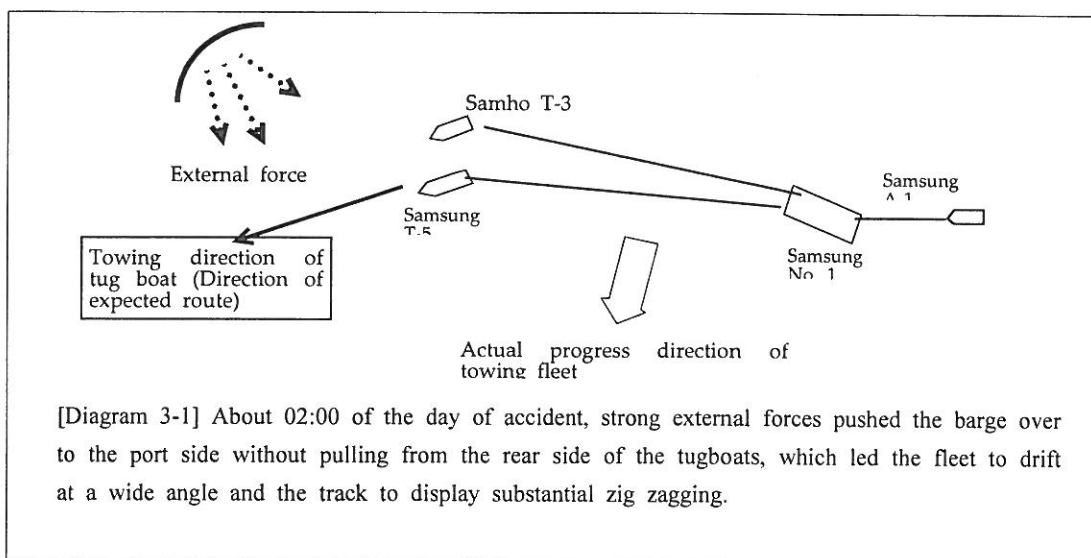
When it decided to take shelter by 04:00, the external forces imposed on the towed object Samsung No.1, exceeded the total bollard pull of the tugboats, Samsung T-5 and Samho T-3, such that Samsung No.1 drifted toward the force (the combined vector) of the bollard pull and external forces combined, instead of the direction to which the tugboats were towing Samsung No. 1. Thus, Samsung No.1 pulled the tugboats instead. Because of this, the fleet sidled as the tugboats' towing direction and the actual track of the towing fleet drew an extremely abnormal drift angle of almost 90°. ([Figure 18], [Figure 19], [Figure 3-1])

This situation means that the tugboats' towing ability had been lost, as the Master of Samsung T-5 could not keep its intended course. As a result, the Master determined to take shelter at around 04:00 on December 7, having decided that keeping the intended course was impossible. This well explains that the tugboats' towing ability was actually lost.

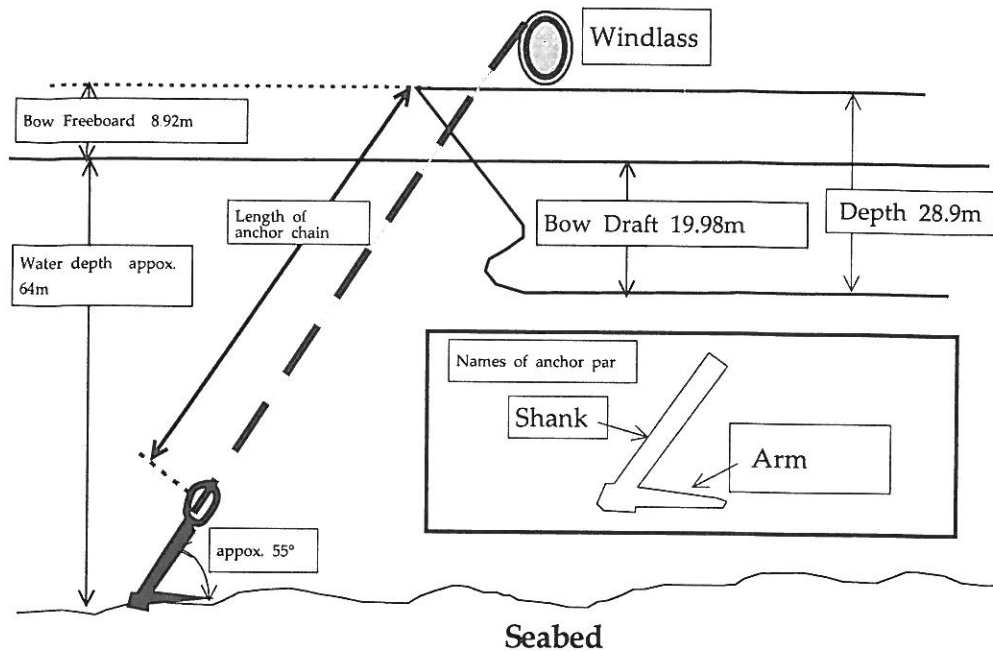
Whether the Master's counter measures were appropriate are examined here. First, was he able to heave up the anchor to avoid a collision? The calculations indicate that he could.

Although a total of 8 shackles of anchor chain was under water from heavy seas, an extended catenary could have been formed and could be calculated. Diagram 3-2 shows the method applied to obtain the shortest length of the anchor chain from the bow freeboard line of the ship to the bottom of the sea at zero holding power.

[Diagram 3-2] At 0 holding power and under a weak external force, the length of the chain could be approximately 85 meters (about 3 shackles) from the seabed to the bow freeboard line of the ship, given the depth of water and the structure of Hebei Spirit. A longer catenary distance would have been formed due to heavy seas on the day.
