Report on the investigation of  
the grounding of the general cargo vessel

***Kaami***

on Sgeir Graidach, the Little Minch, on

REPORT NO 7/2021

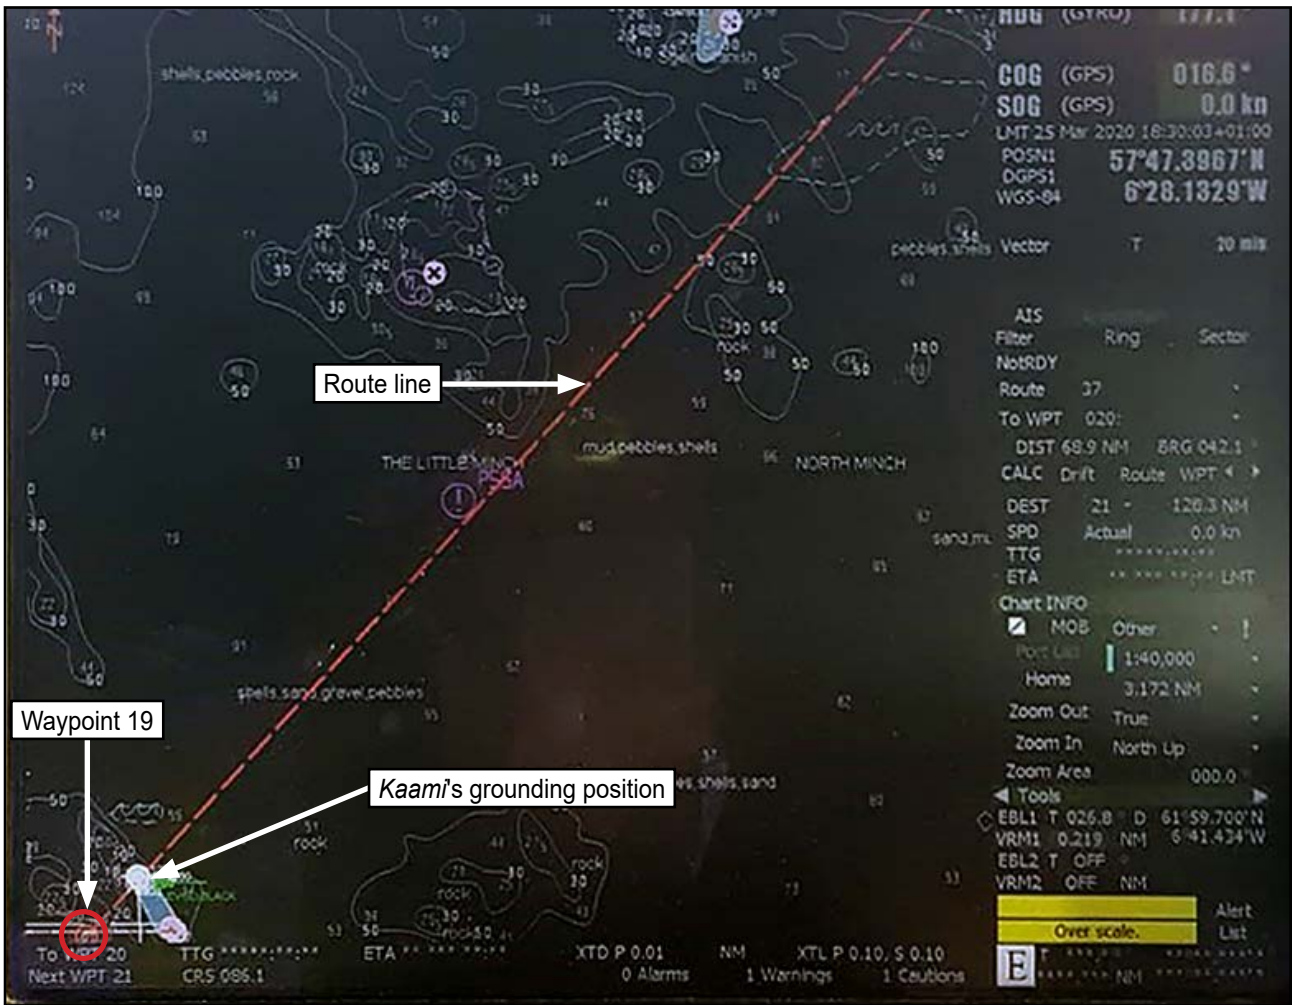
Figure 3: Kaami's starboard ECDIS showing waypoint 19

Soon after, *Kaami's* C/O used the autopilot to alter course 10° to starboard at waypoint 19 (**Figure 3**), in accordance with the voyage plan.

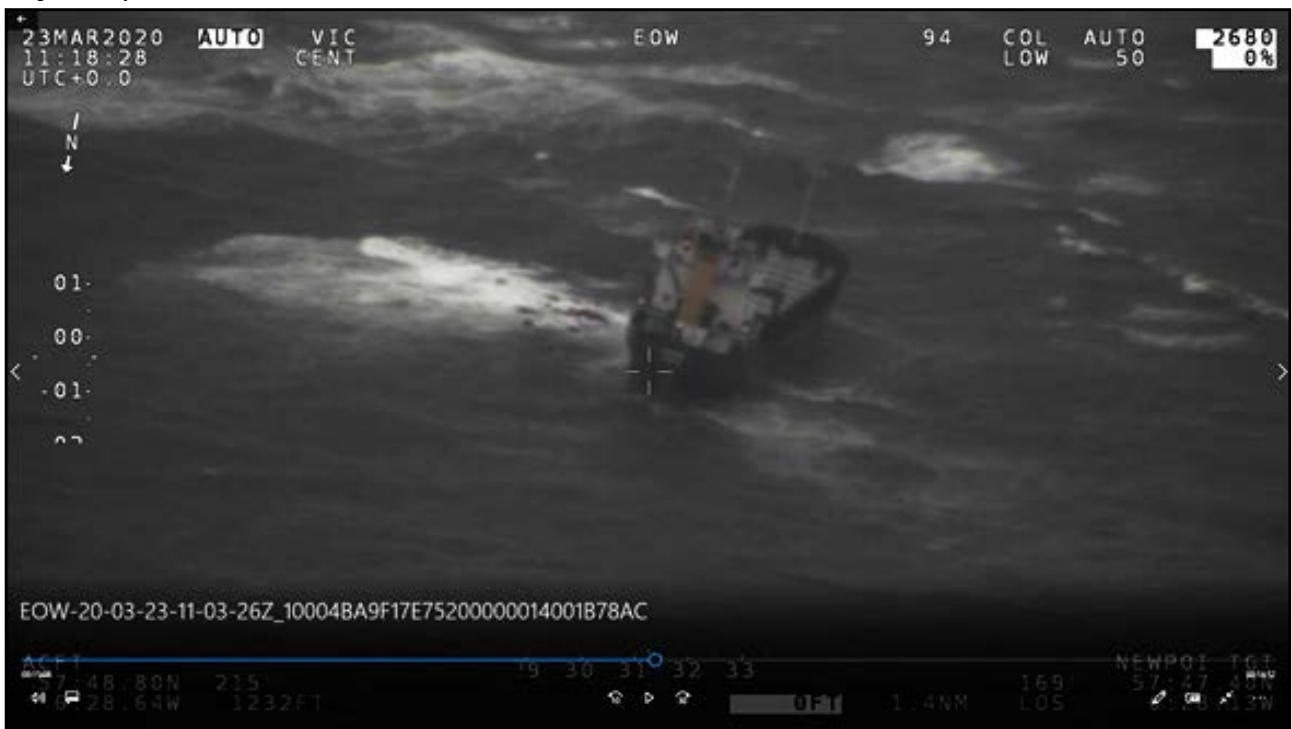
Figure 4: Kaami aground on Sgeir Graidach

The forepeak tank was sounded and a water level of 3.5m was returned. The tank was empty on departure from Drogheda, which indicated that it had been breached. The C/O could also hear the movement of water from the sounding pipes connected to the bow thruster space and he believed that this space was also breached.

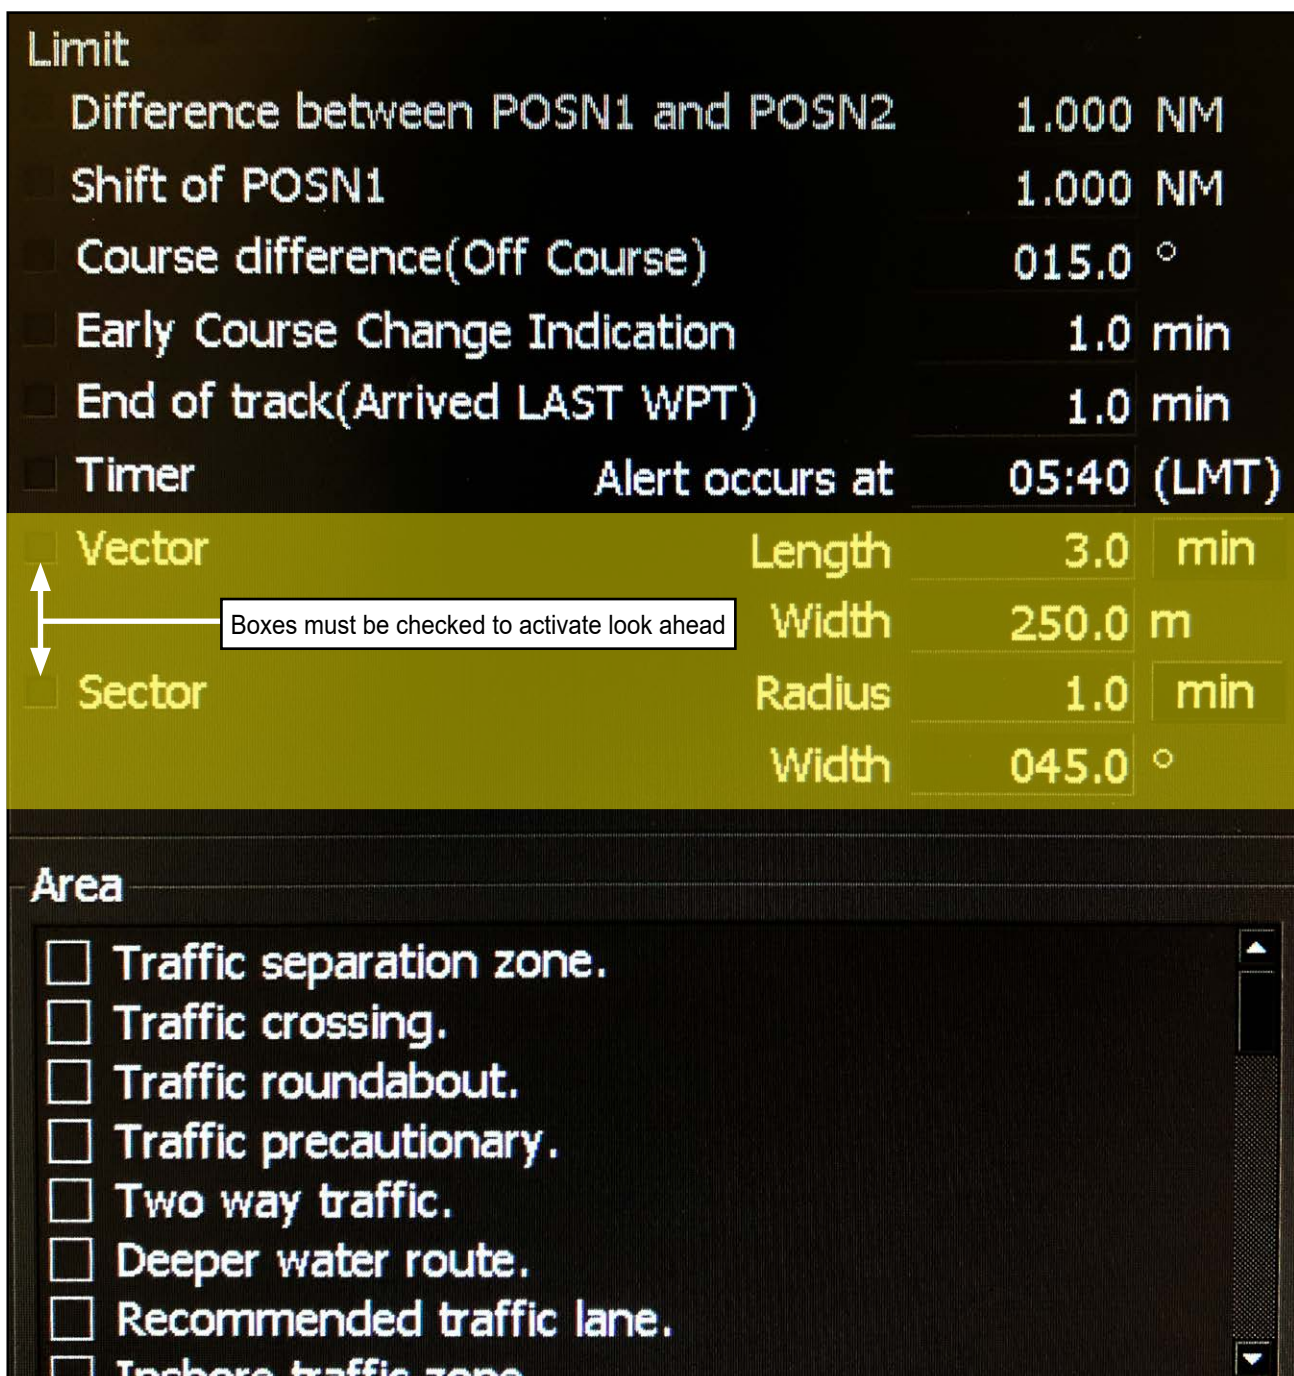
Figure 9: Look ahead options on Kaami's JRC JAN 2000 ECDIS

- All available information was selected to be displayed on screen.
- The look ahead vector was set to length 3.0 minutes<sup>5</sup> x width 250.0m but was not activated (Figure 9).

- The look ahead sector was set to radius 1.0 minute x width 045.0° but was not activated (**Figure 9**).
- A two-colour palette had been selected<sup>6</sup>.
- XTD was set to 0.1nm (**Figure 8**). The isolated danger symbols and area where *Kaami* crossed the safety contour fell within this safety corridor.
- The ENC cell (*GB 302210*) (**Figure 12**) that covered the IMO recommended route to the north of the Isle of Skye was not loaded on *Kaami*'s ECDIS system.

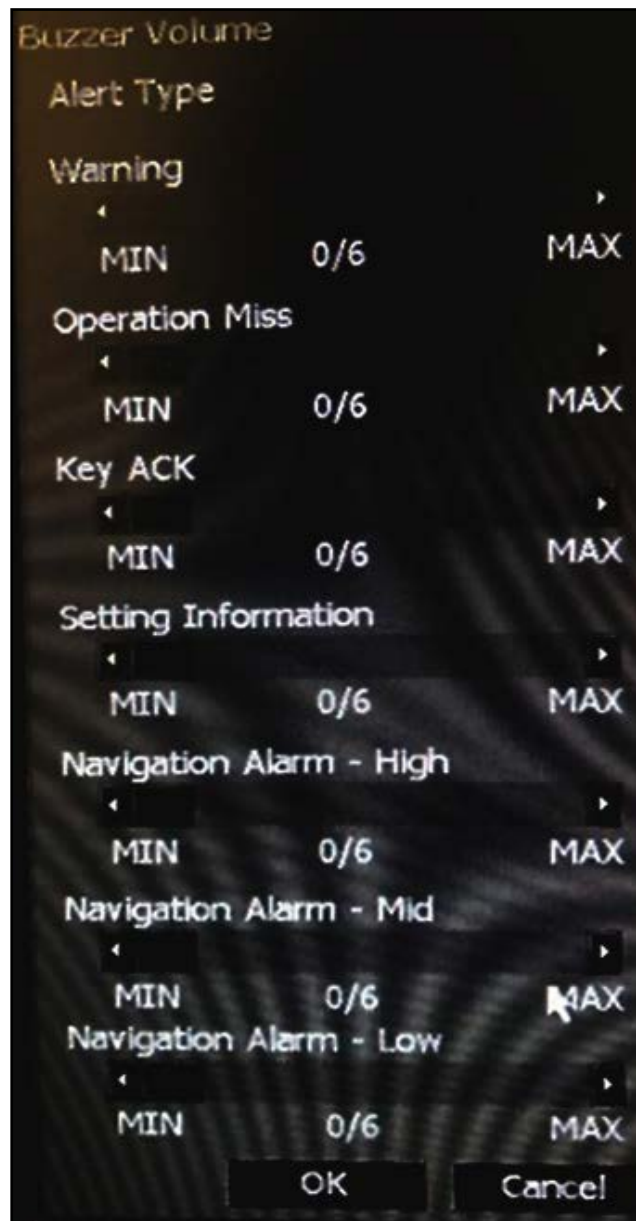
- The alarm audio buzzers were all set to level 0 (no sound) (**Figure 10**).

**Figure 10:** Alert buzzer settings all set to zero

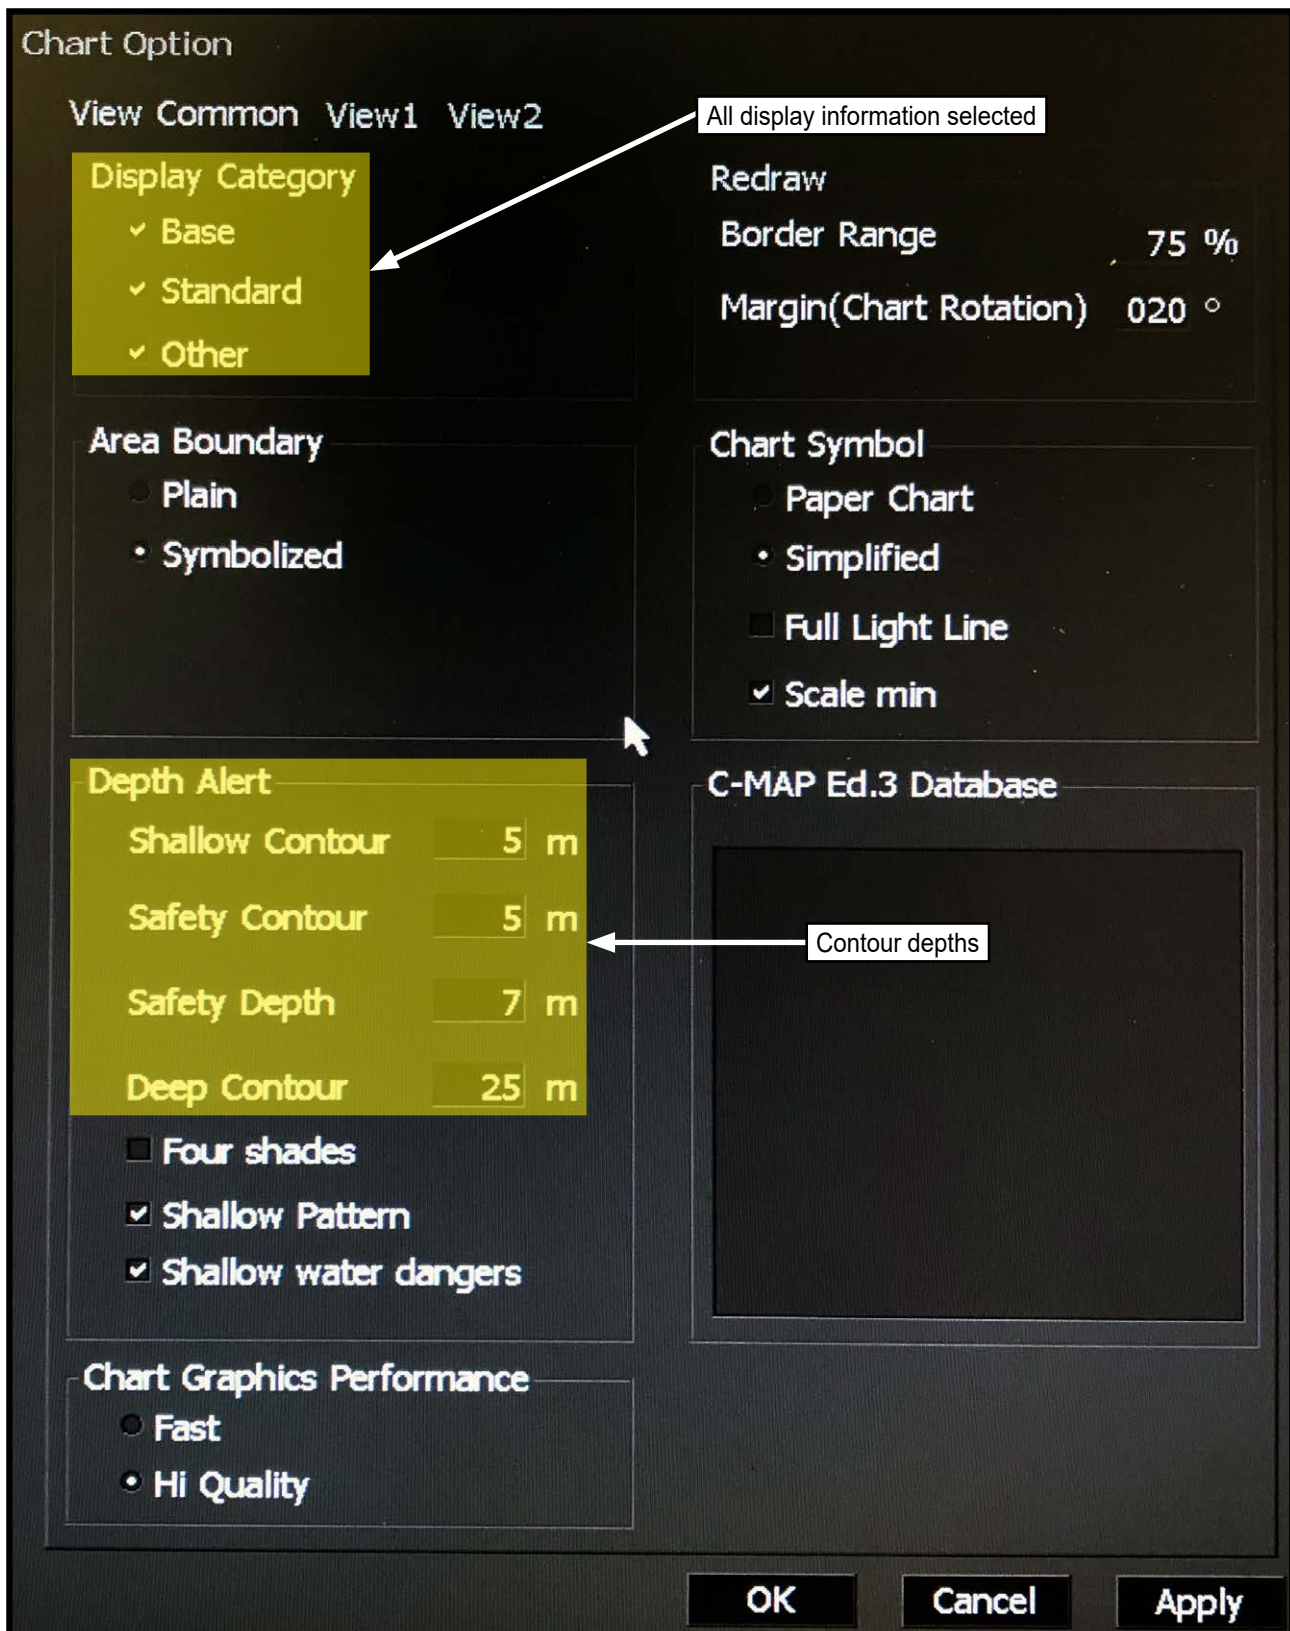
Figure 11: Depth contour settings

- The depth settings (**Figure 11**) were:
  - Shallow contour: 5m
  - Safety contour: 5m
  - Safety depth: 7m
  - Deep contour: 25m

The correct setting of safety contours and safety depth are fundamental aspects of ECDIS use. Whether using a two or four colour palette, the setting of the safety contour will present an ENC to the navigator with clearly defined safe and unsafe water. *Kaami* departed Drogheda with a deepest draught of 5.40m and yet the safety contour was set to 5.00m and had not been changed since the current crew joined the vessel a month previously. This indicates a significant lack of understanding of the practical use of ECDIS.

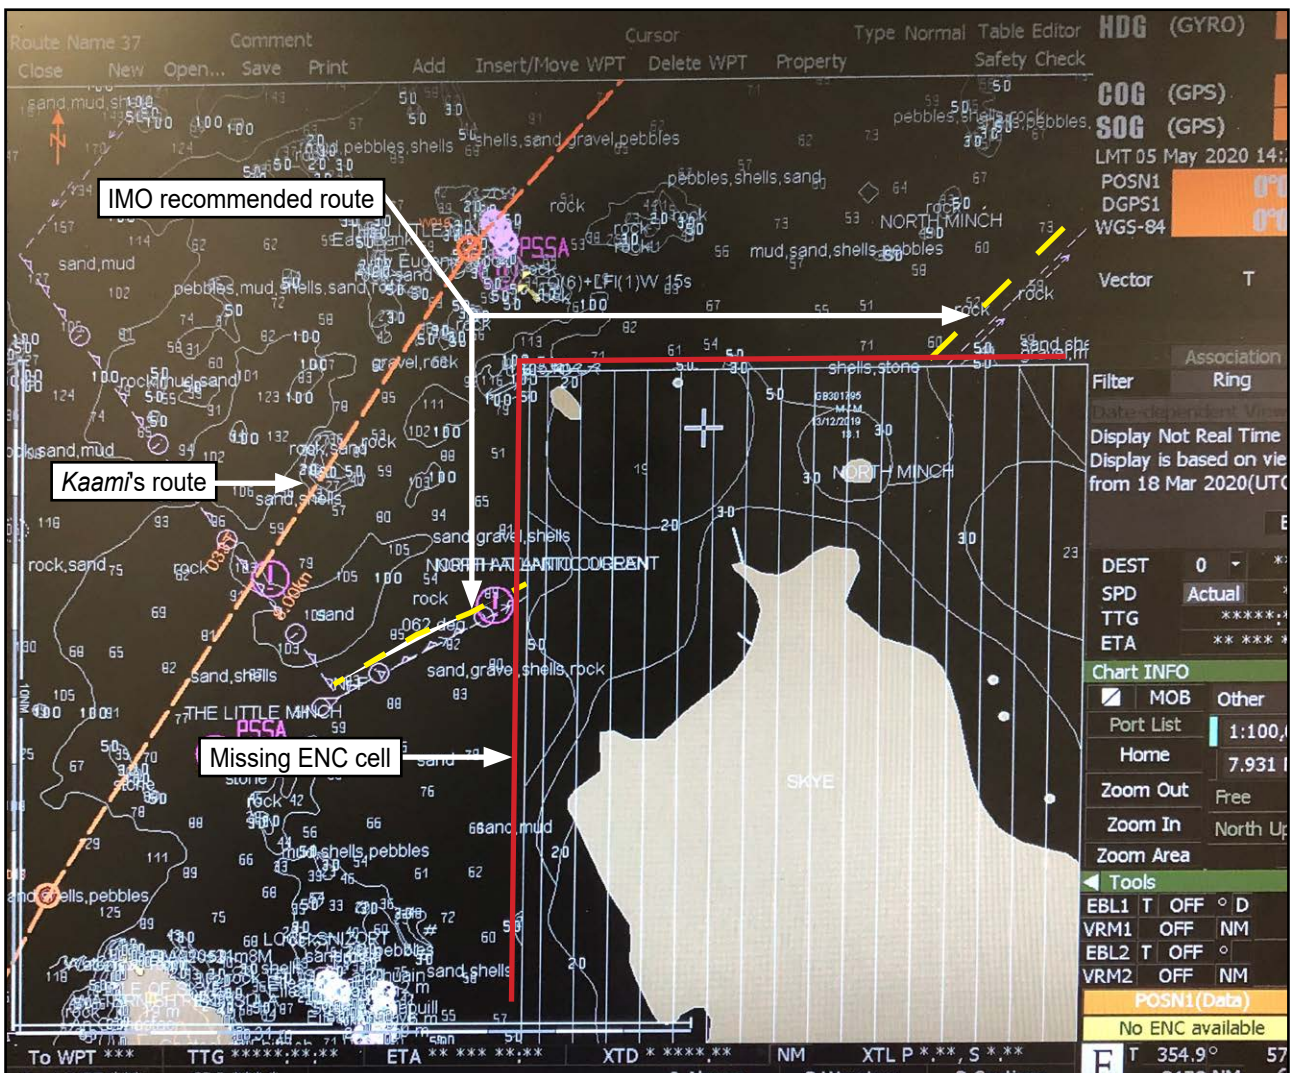
**Figure 12:** ECDIS with missing electronic navigation chart cell indicated by vertical bars

For example, the ENC cell (*GB 302210*) (**Figure 12**) that covered the IMO recommended route to the north of the Isle of Skye was not on *Kaami's* ECDIS system. This, and that the ENC cells for the voyage were not ordered until the day of departure from Drogheda, indicate that a full and proper appraisal of the intended voyage had not taken place.

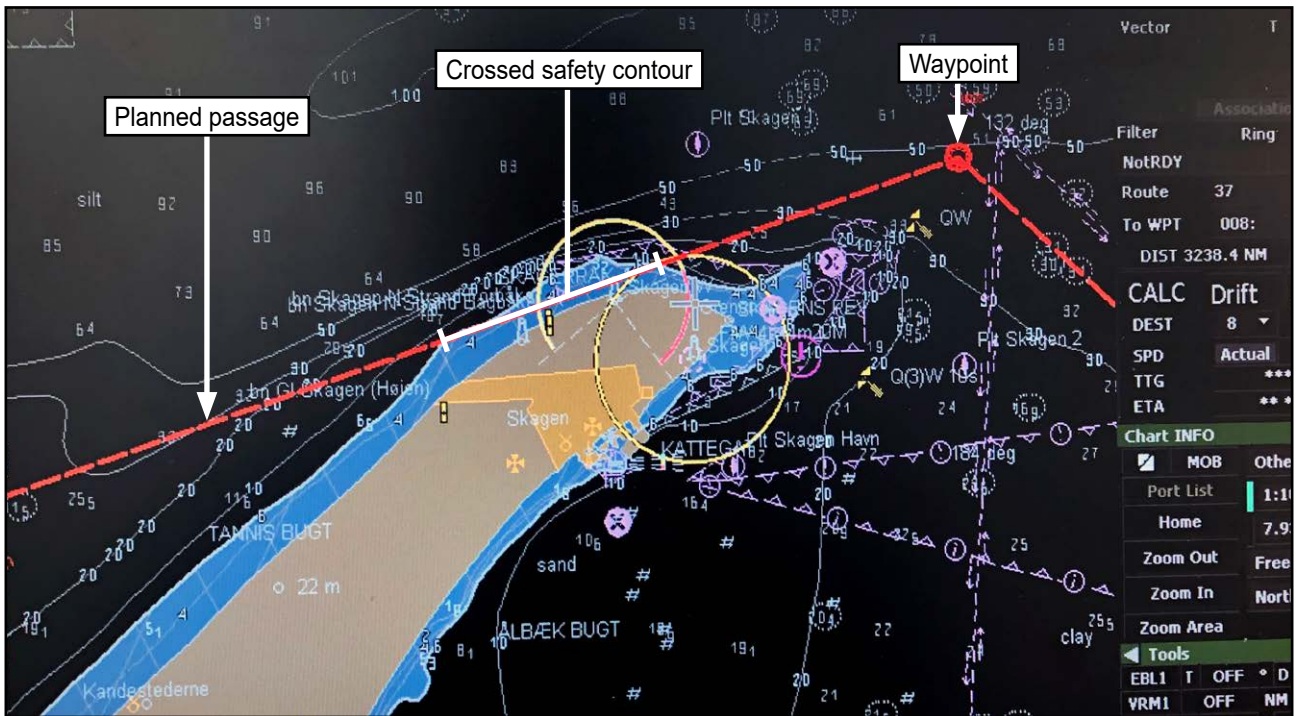
**Figure 16:** Route 37 crossing the safety contour before the Kattegat waypoint
