Fumigation of cargo on board ships: the invisible killer

Following the tragedy of a seaman's death in his cabin on a vessel with a fumigated cargo on board, Gard News presents an analysis of similar cases.

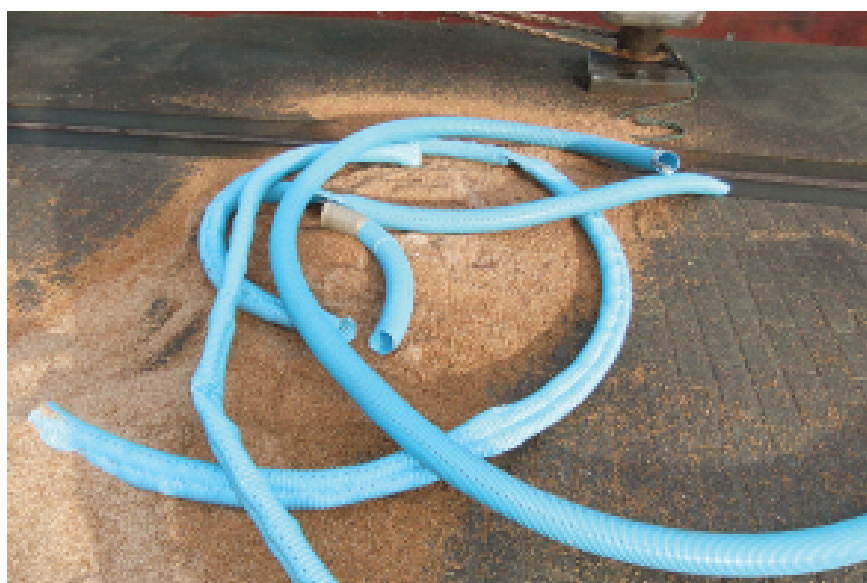
Plastic tubes used for aluminium phosphide tablets, pulled out after discharge of the cargo holds.

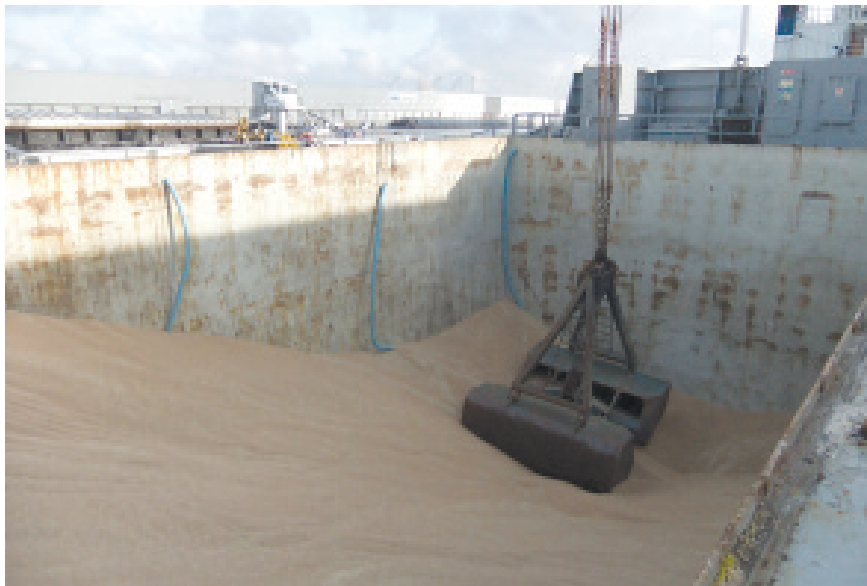
Following the death of the seaman, there was of course an investigation, and the level of gas in the cargo holds was measured regularly, every day. The process should have been completed after five days, but it took a full month before the gassing stopped. The reason for the slow process must have been the dry weather and the temperature of -10°C at the time of loading. There must have been insufficient moisture in the cargo for the aluminium phosphide tablets to react faster. The small holes of the tubes arranged in the cargo holds may also have provided insufficient contact with the cargo. When pulling out the tubes, several aluminium phosphide tablets were found still intact. It was noted that the distinct odour, which should have made people aware of the presence of hydrogen phosphide gas, had already disappeared after three or four days. When the vessel was finally discharged, the cargo was placed into barges for further transportation on inland waterways. Workers informed that it was not uncommon to see aluminium phosphide tablets still being active in the transshipment of such cargo.

Grain being unloaded from cargo hold. Three out of six vertical plastic tubes can be seen. The aluminium phosphide tablets were placed into these tubes after loading. The tubes had small holes, but contact between cargo and tablets was probably insufficient so it took a full month for the fumigation to be completed in this case.

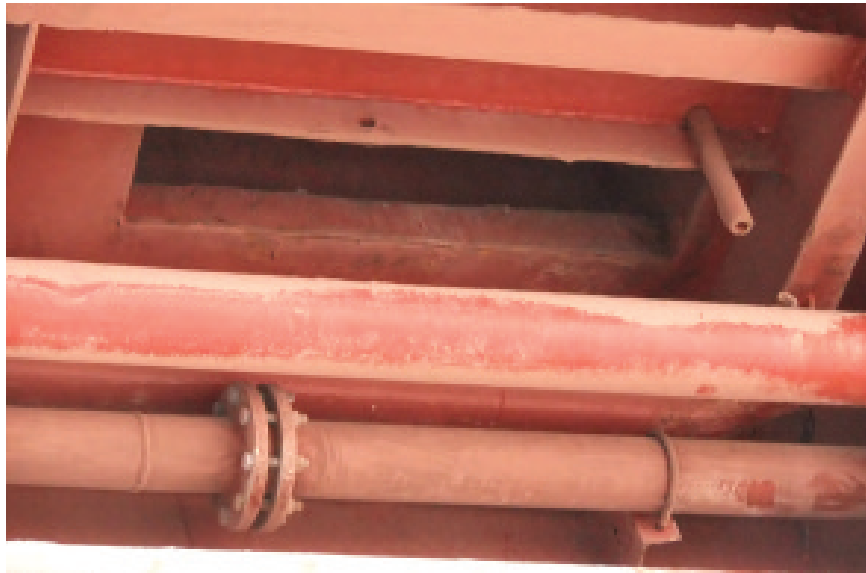
The deceased seaman's cabin was on main deck level, in front of the accommodation and next to the captain's office. When the lining of the office was pulled down, a small corroded hole was found in the front bulkhead. That steel plate was the common boundary with the aft ventilator from the aft cargo hold. Corrosion within the ventilator over many years had made a small opening for the gas in the cargo hold to pass to the insulation of the accommodation walls. The extraction fans from the toilets created a slight under-pressure, sufficient to draw the gas, which escaped to the cabins wherever there was an opening. The sad truth is that the seaman would most probably have survived if he had not been told to rest in his cabin, and had instead been placed in fresh air.

Ventilator opening in deck at the aft bulkhead of cargo hold No. 3. The steel bulkhead is the common boundary between the accommodation and the cargo hold ventilator.

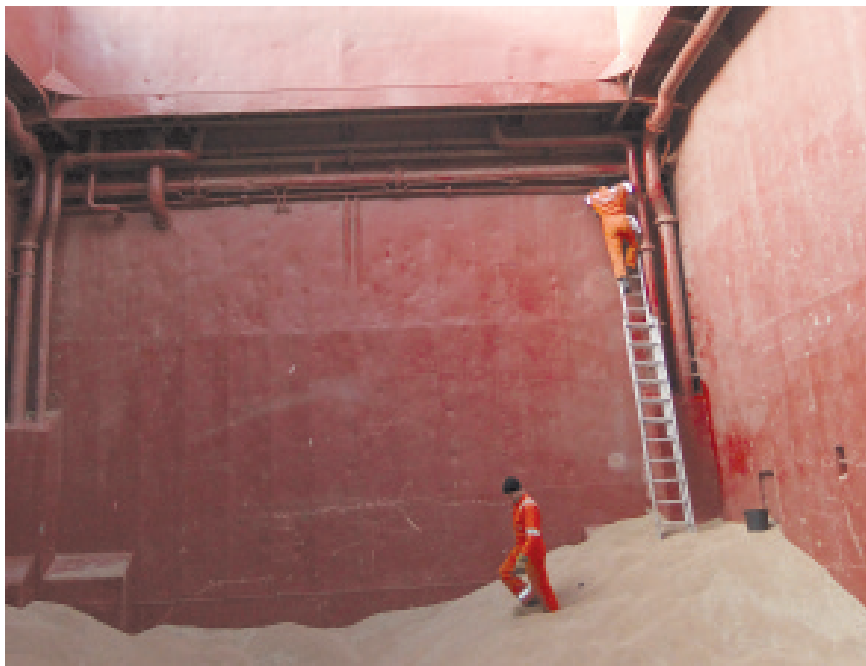
Aft bulkhead of cargo hold No. 3. The ventilator opening is in the corner, above the ladder. Access is difficult, as it is behind pipes under deck.
