Loss of containers overboard involving *APL England*

46 NM south-east of Sydney, New South Wales, on 24 May 2020

ATSB Transport Safety Report

351-MO-2020-002

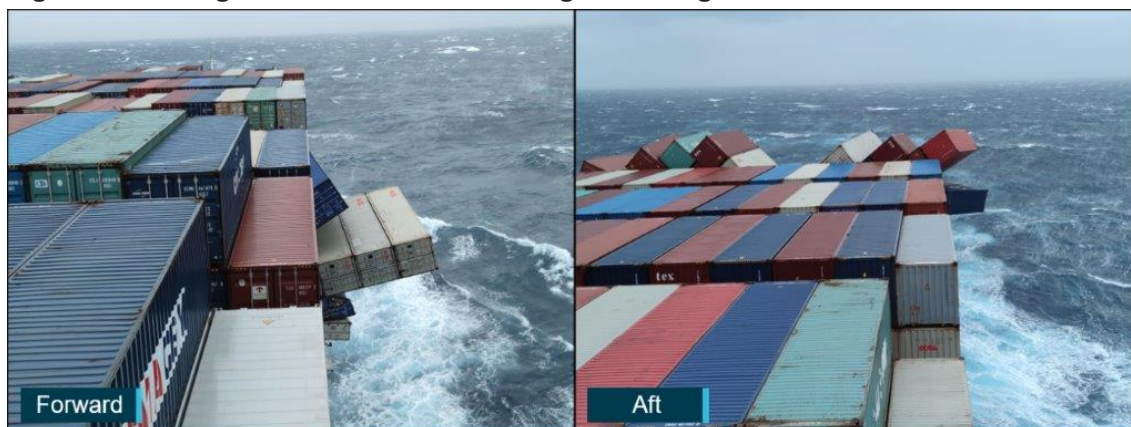
Figure 3: Looking forward and aft from navigation bridge at about 0700

As the skies lightened (sunrise was at 0647), the chief officer noticed fallen stacks of containers aft (bay 62) (Figure 3). The master notified the company of the incident. Upon returning to the bridge about 10 minutes later, the master was notified by the chief officer of the damage and loss of containers forward (bay 30).

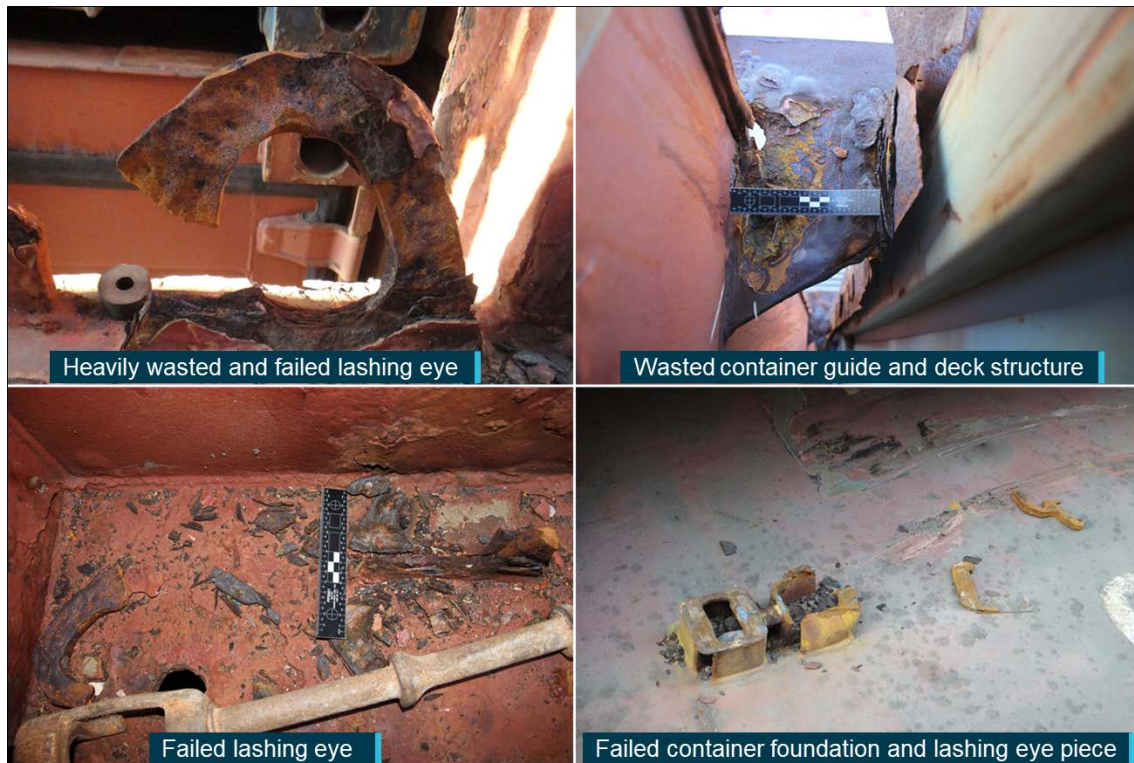
Figure 4: Examples of condition of cargo securings and ship structure

The ATSB onsite investigation examined securing arrangements and lashing equipment in use on the ship. The lashing equipment appeared in generally good condition. However, many of the ship fittings (lashing eyes, lashing bridges and deck structures) were not found in good condition, as evidenced by the examples shown in Figure 4.

The ATSB inspection of the bay 62 (aft) arrangement and damage revealed similar structural and securing conditions as shown in Figure 4. However, in addition to this, examination of the stowage arrangement showed that the security of the stow above the container cell guides used in bay 62 was affected by the use of high cube (2.9m (9'6") high) as opposed to standard height (2.6 m (8'6")) containers.

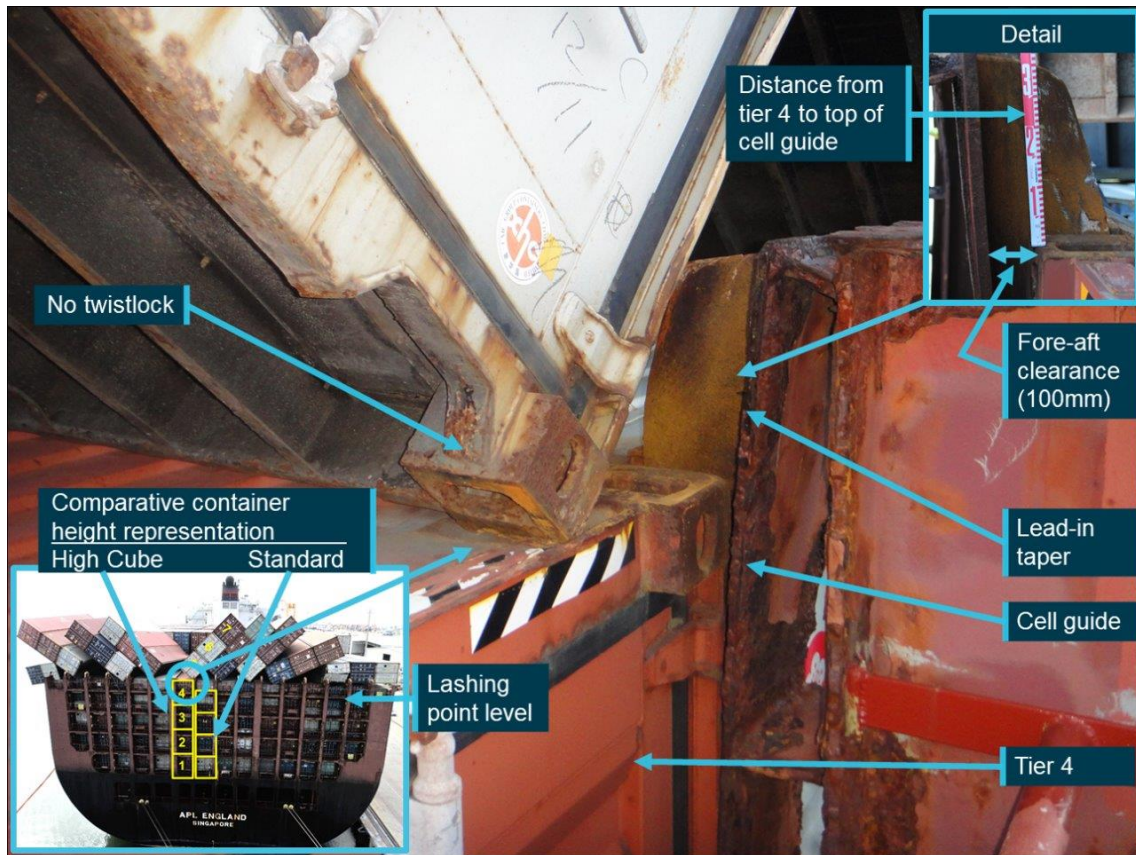
Figure 5: Bay 62 container stowage versus cell guide arrangement

Containers loaded on deck into bay 62 were secured as per the CSM. The CSM allowed for 8 tiers of 40' containers to be loaded with the lower 4 tiers held within the cell guide structure. Containers in these tiers were not secured to each other or the deck via twistlocks or other securing arrangement. Atop tier 4, the lower part of tier 5 containers were within the cell guides and, due to access reasons, not secured to tier 4 containers by twistlocks. Tier 5, 6, 7 and 8 containers were secured together by twistlocks and lashing rods secured these stacks to the ship as per the CSM—lashing rods connected from lashing eyes (mounted to the cell guide structure) to the lower foot of tier 5 containers.

In this arrangement, when loading standard height containers, the top of tier 4 was about 1,550 mm (5'1") below the top of the cell guides. However, high cube containers are 300 mm (1') higher than the standard height container. Therefore, when loading high cube containers into bay 62, the top of tier 4 was 1.2 m (4') higher than when loading standard height containers. In these circumstances, the bottom of tier 5 containers would be about 300 mm below the top of the cell guides, and within the tapered (fore-aft) lead-in section of the guide (Figure 5).

For the voyage to Australia, bay 62 was loaded with predominantly high cube containers to 7 tiers. The loading computer lashing and forces checks did not show any conflicts for this arrangement.
