SAFETY INVESTIGATION REPORT

REPORT NO.: 02/2022

MV FABIO DUO' **Serious injury to a crew member,** **during crane operations** **in the port Santa Margherita Ligure, Italy** **11 January 2021**

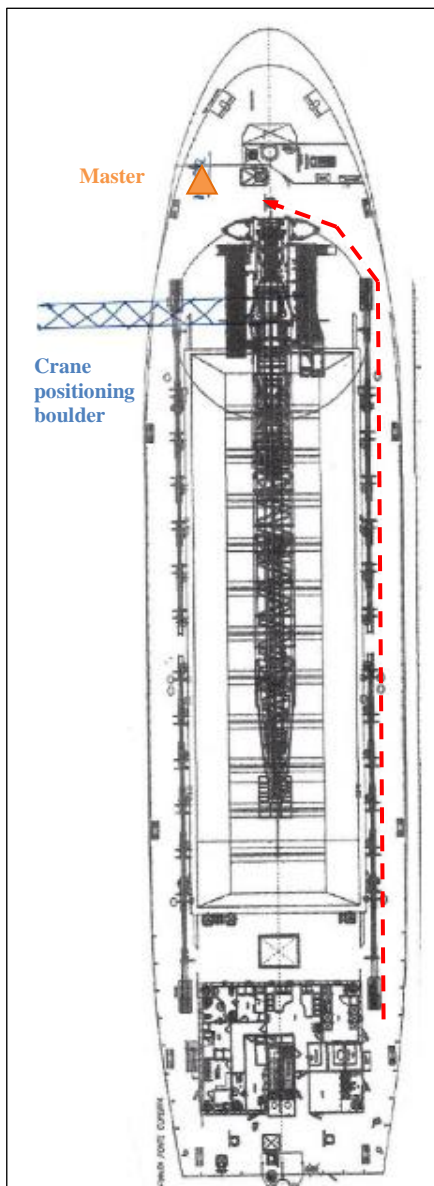
The master took the access way on starboard side of the cargo hold to reach the forecastle (Figure 2), since the port side access way had been cordoned off. During this time, the crane operator, who was placing one boulder in position at the breakwater, noticed the master in proximity of the paint locker (Figure 2).

Figure 2: The route taken by the master to access the forecastle is indicated in red. The master's position when the crane operator saw him before the accident is marked in a triangle

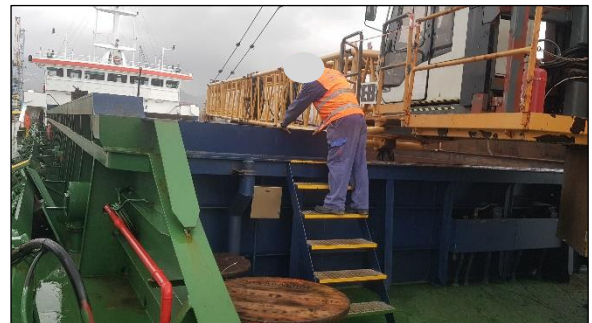
After checking on the maintenance, the master made his way to the accommodation block but decided to check the status of the boulders in the cargo hold. The master climbed the starboard stairs to the cargo hold and looked inside the cargo hold (Figure 3).

At this time, the crane operator had the crane's boom in line with the cargo hold and was picking up one of the boulders from the hold. Within a matter of seconds, the crane turned in a clockwise direction, towards the breakwater, entrapping the master between the body of the crane and the cargo hold coaming.

Figure 3: A simulation of the master on the stairs

At the time of the accident, the master had just climbed the stairs leading to the cargo hold to check its status. The crane operator, having picked up one boulder from the cargo hold, turned the crane towards the breakwater. While doing so, the sudden movements of the crane caught the master off guard and trapped him in between the body of the crane and the cargo hold coaming.

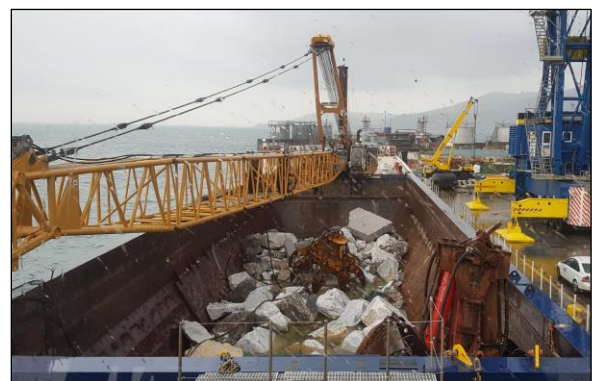
At this time, while the crane operator was placing one of the boulders in position, he heard a scream and turned the crane back towards the cargo hold. He immediately noticed the master lying on deck from the crane's side mirror. He alerted the bridge and switched off the crane. The cargo operation was suspended at 1514 (Figure 4).

Figure 4: The status of the cargo hold, as viewed from the bridge, after the cargo operation was suspended

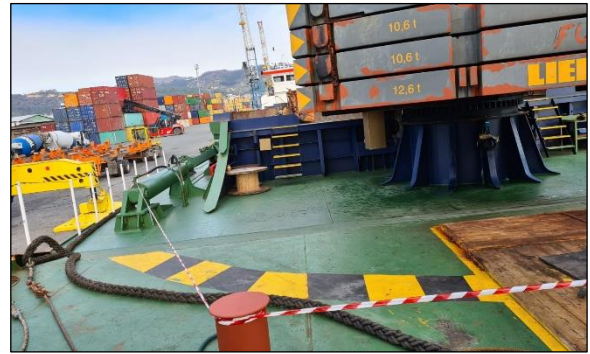
As indicated elsewhere, the free access to the main deck was restricted. In fact, due to the ongoing operations, access to the forecastle from the port side of the cargo hold had been cordoned off by means of a chain (*i.e.*, a physical barrier system). However, access to the forecastle (from the accommodation block) was possible from the starboard side of the cargo hold. Black and yellow markings were painted in a semi-circle on the deck around the crane, extending from port to starboard (Figure 5). The paint marked the hazardous area for the crane operations.

Figure 5: Black/yellow markings on the deck (starboard side only)

Paint markings are classified as a symbolic barrier system and therefore require one's interpretation to be effective (as opposed to a physical barrier system). After the accident, the master could not recall these markings on deck and his impression was that the deck was easily accessible.

The safety investigation concluded that the (symbolic) barriers in place at the time of the accident did not serve their intent and purpose.

- 02/2022_R1** Install physical barriers systems to all deck accesses and around the crane prior to the commencement of crane operations.
- 02/2022_R2** Ensure that joining officers do not find themselves in a situation where they are expected to assume responsibility without getting a detailed handover and prior knowledge of critical aspects of the ship's operations.
- 02/2022_R3** Assess the risks related to access to the crane's cabin from starboard side, taking into consideration the open cargo hold.
- 02/2022_R4** Ensure that crew employed on board, with special reference to officers, can communicate in English, and that all crew members can communicate in the determined working language.

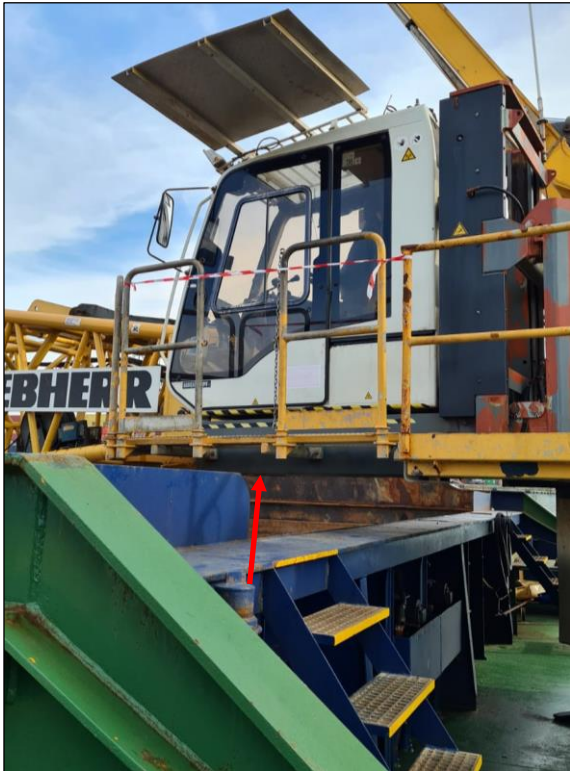
It was possible for the crane driver to step inside the crane cabin either from port or starboard side. However, if access was made from the starboard side through the stairs on the deck (Figure 5), it necessitated the crane

driver to step onto the coaming, leap into the cabin, and in so doing, exposing himself to the hazard of a fall from a height⁷ (Figure 6).

Figure 6: Access to the crane from starboard side
