The causes and prevention of human error contributing to maritime accidents in Tanzania

Gerson Japhet Fumbuka
WMU

A dissertation submitted to the World Maritime University in partial fulfilment of
the requirements for the Award of the Degree of

MARITIME SAFETY AND ENVIRONMENTAL PROTECTION

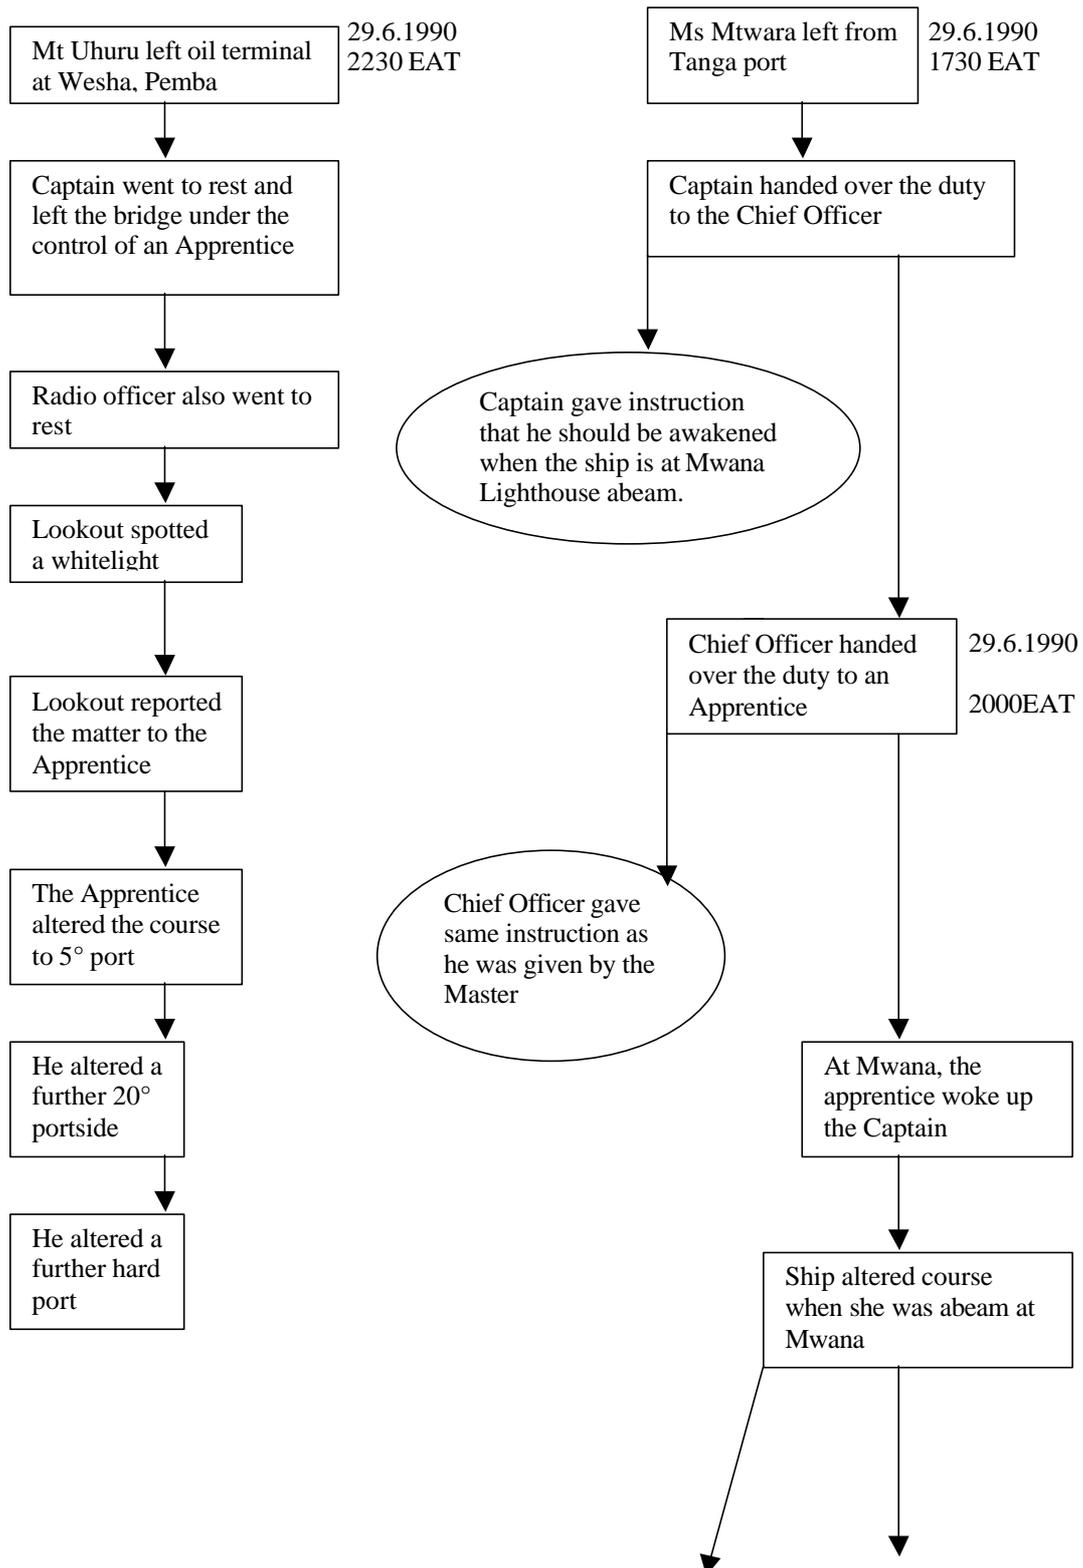
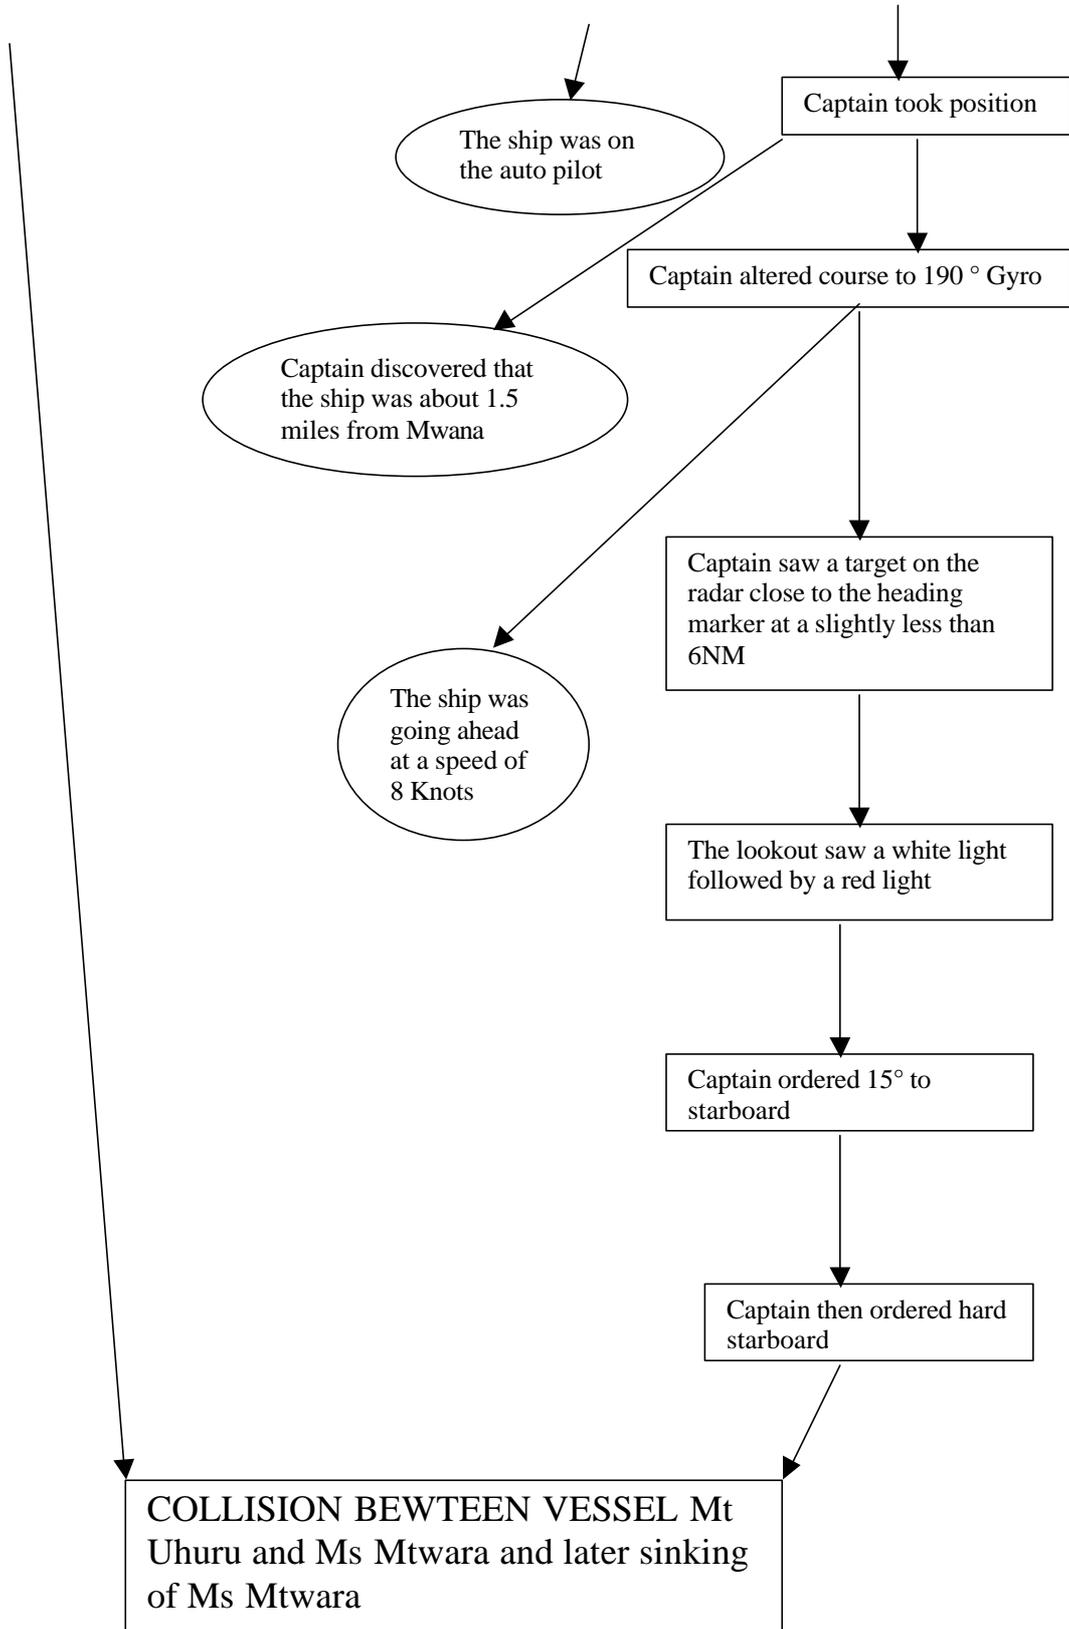
(Chart 1.0) Events and Causal Factors Analysis of the collision between tanker vessel Mt Uhuru and Passenger vessel Ms Mtwara

side of their intended courses. The MT Uhuru hit the MS Mtwara just aft of the portside door at the tween deck level. A few minutes later MT Uhuru substantial damage but did not sink.

The signal station failed to mention that MT Uhuru had left Zanzibar. The apprentice was unable to determine the location of the vessel MS Mtwara just before the collision. His lack of knowledge, training, and experience in commanding a vessel prevented him from making proper judgement in altering to port instead to starboard in accordance to COLREG 1972.

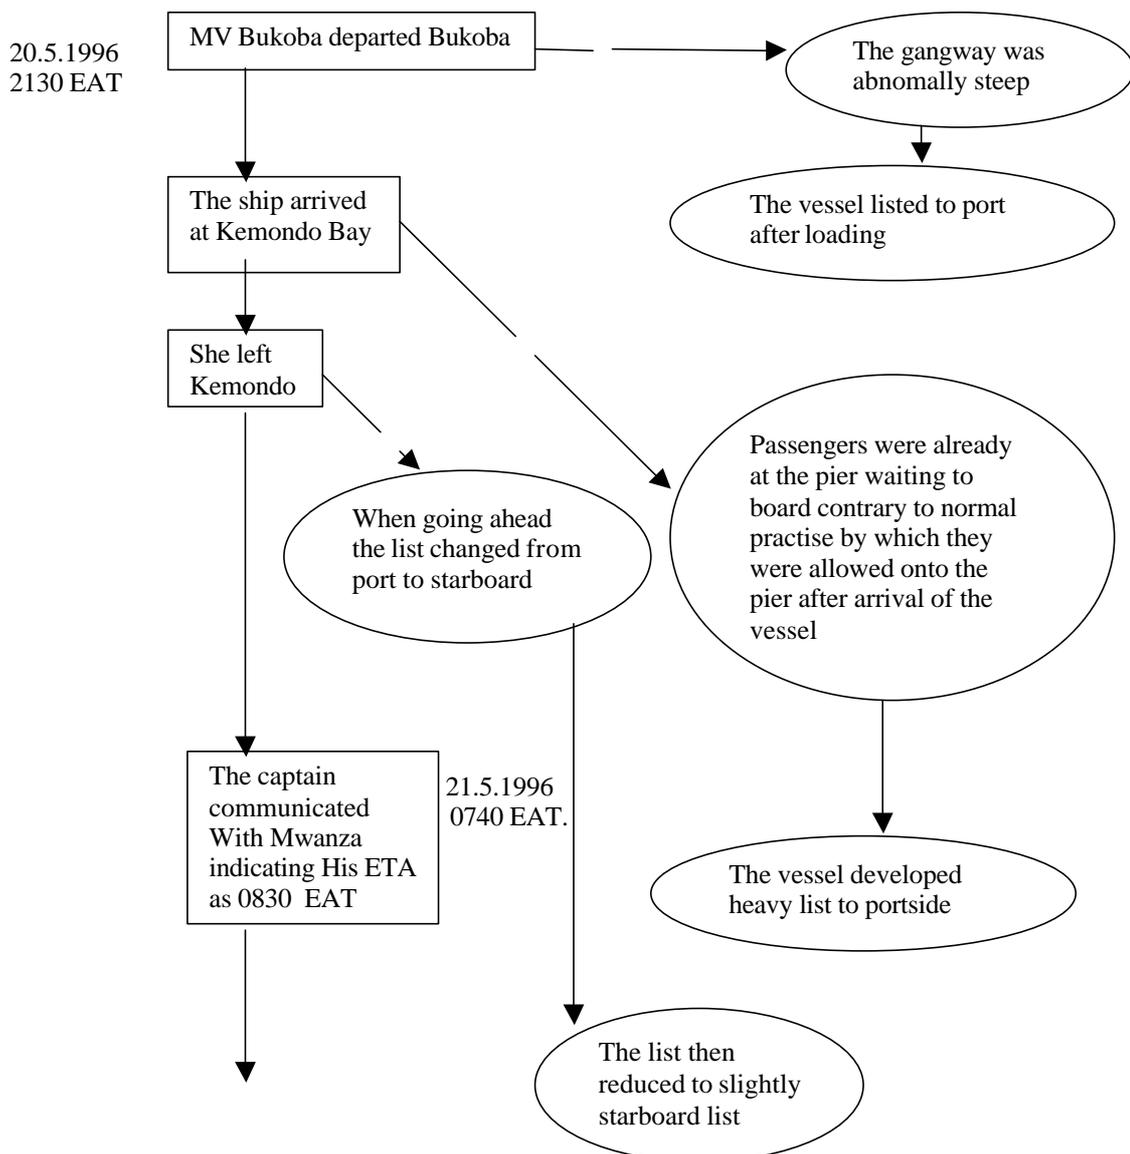
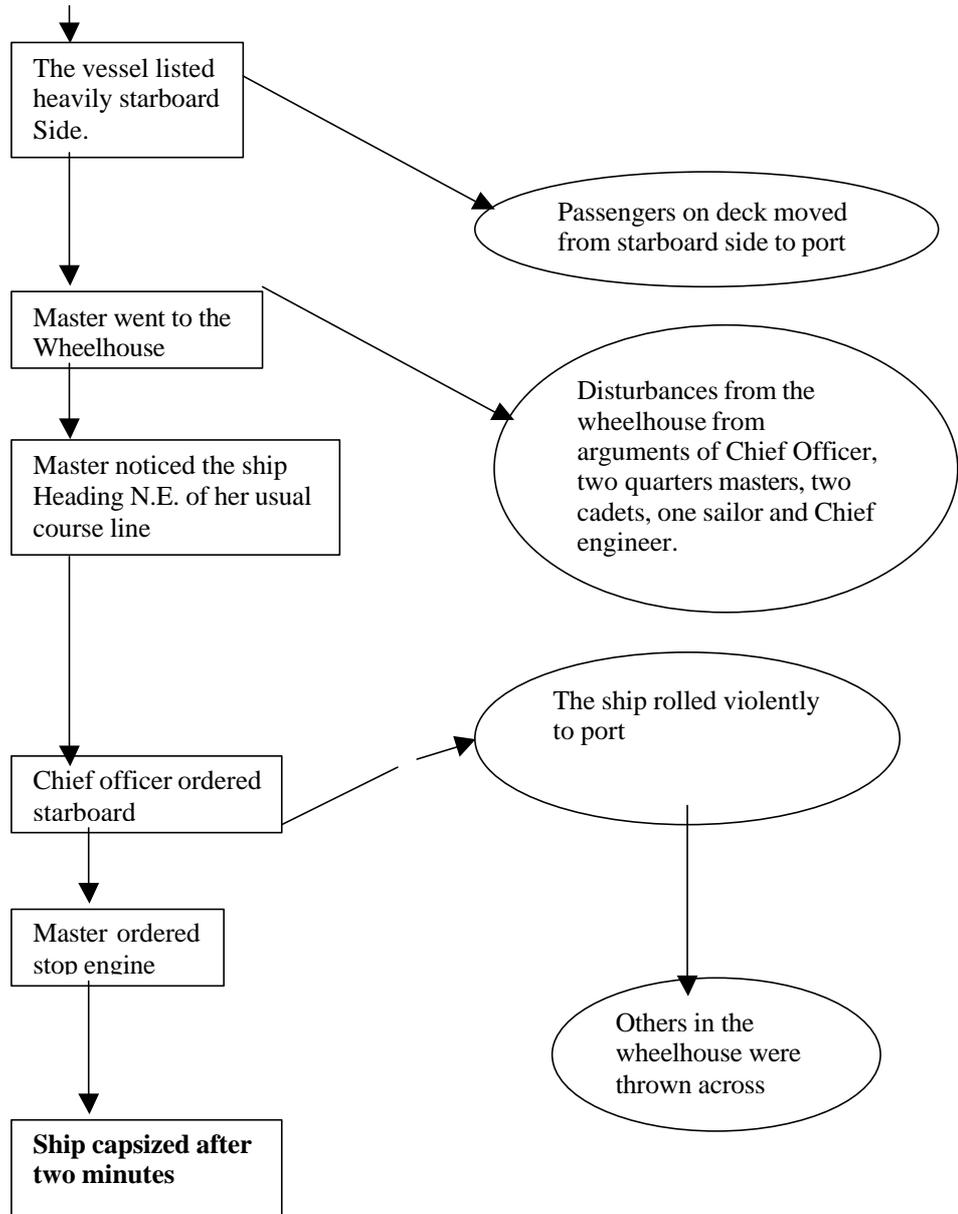
(Chart 2.0) Events and causal Factors Analysis of the Capsize of MV Bukoba

It was generally observed that MV Bukoba was listing slightly to port or starboard during her lifetime. Although the cause of list was not investigated on board the vessel, it is evident that it was either due to poor design or construction or both. Basically, TRC acquired a faulty ship from Belgium Shipbuilders Corporation (BSC) whose defects could not be detected for sometime until Danish expert came on the scene three years later. This problem originated from the contract itself which was drawn by the ship builders, and was heavily skewed in favour of the shipbuilders. The belgian party was adamantly reluctant to vary any of the terms in the contract inspite of numerous appeals from the Government of Tanzania. Due to the special circumstances prevailing at the time, especially the transportation crisis with the Government's financial weakness, the Tanzania Government apparently felt itself to have no option but to accept the unequal terms of the contract. Here are some of the contract articles which had serious anomalies:

1. MV Bukoba had a common tendency of listing to the portside or the starboard side.
2. The vessel had two shore communication systems both in good condition but internal communication between engine room and bridge was defective.

3. It was common practise to overload the vessel.
4. There was no stability booklet onboard.
5. Most of the senior officers onboard had no knowledge of ballasting conditions requiring permanent ballasting.

16. No safety drills were being conducted on board and the muster list was not posted as required.
17. It was observed that most life saving appliances were kept under lock.
18. Excess of 200 passengers and excess of 15.03 tonnes of cargo overloaded the vessel.
19. Ships log books and other documents were not being filled.
20. The vessel had steering problems after the stability test due to increased freeboard.

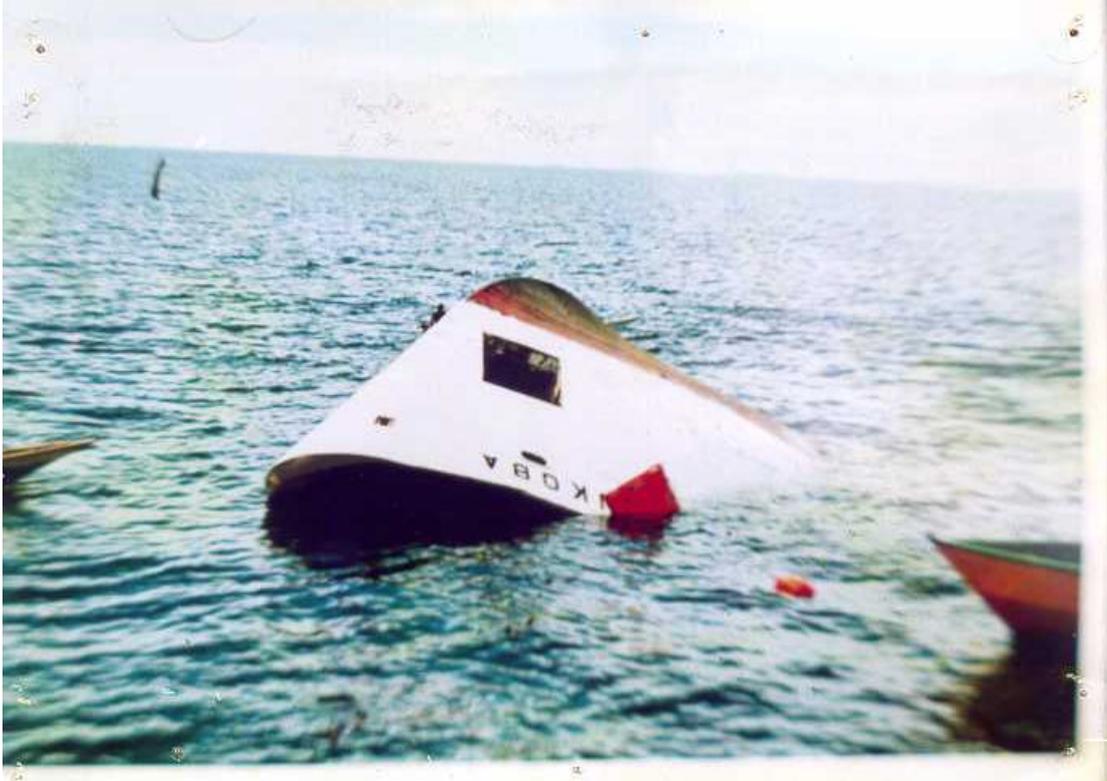
Picture 1.0: A hole cut by the TRC rescuers at the starboard bow

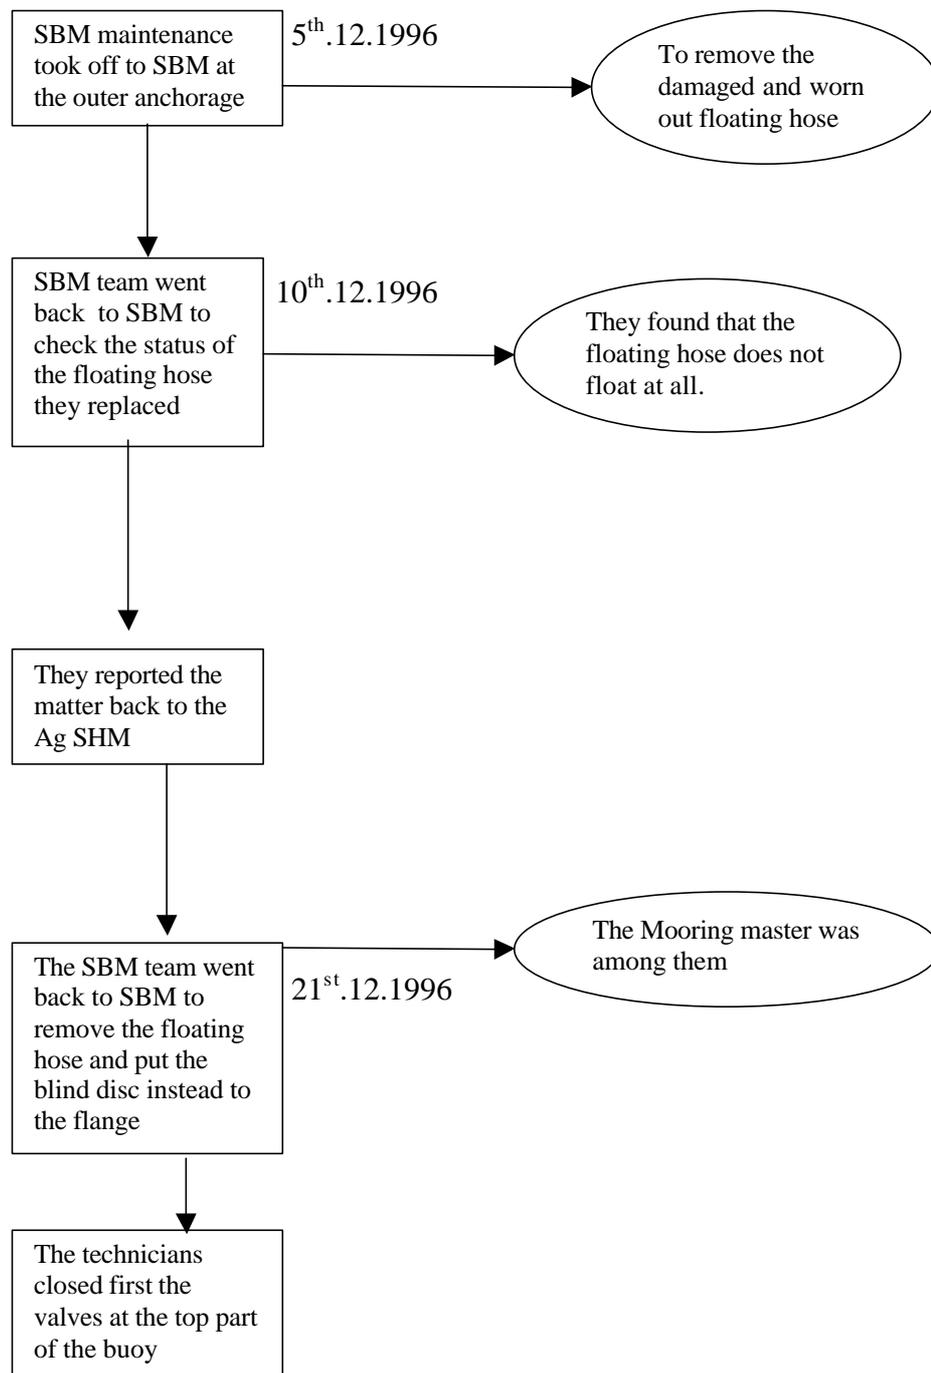
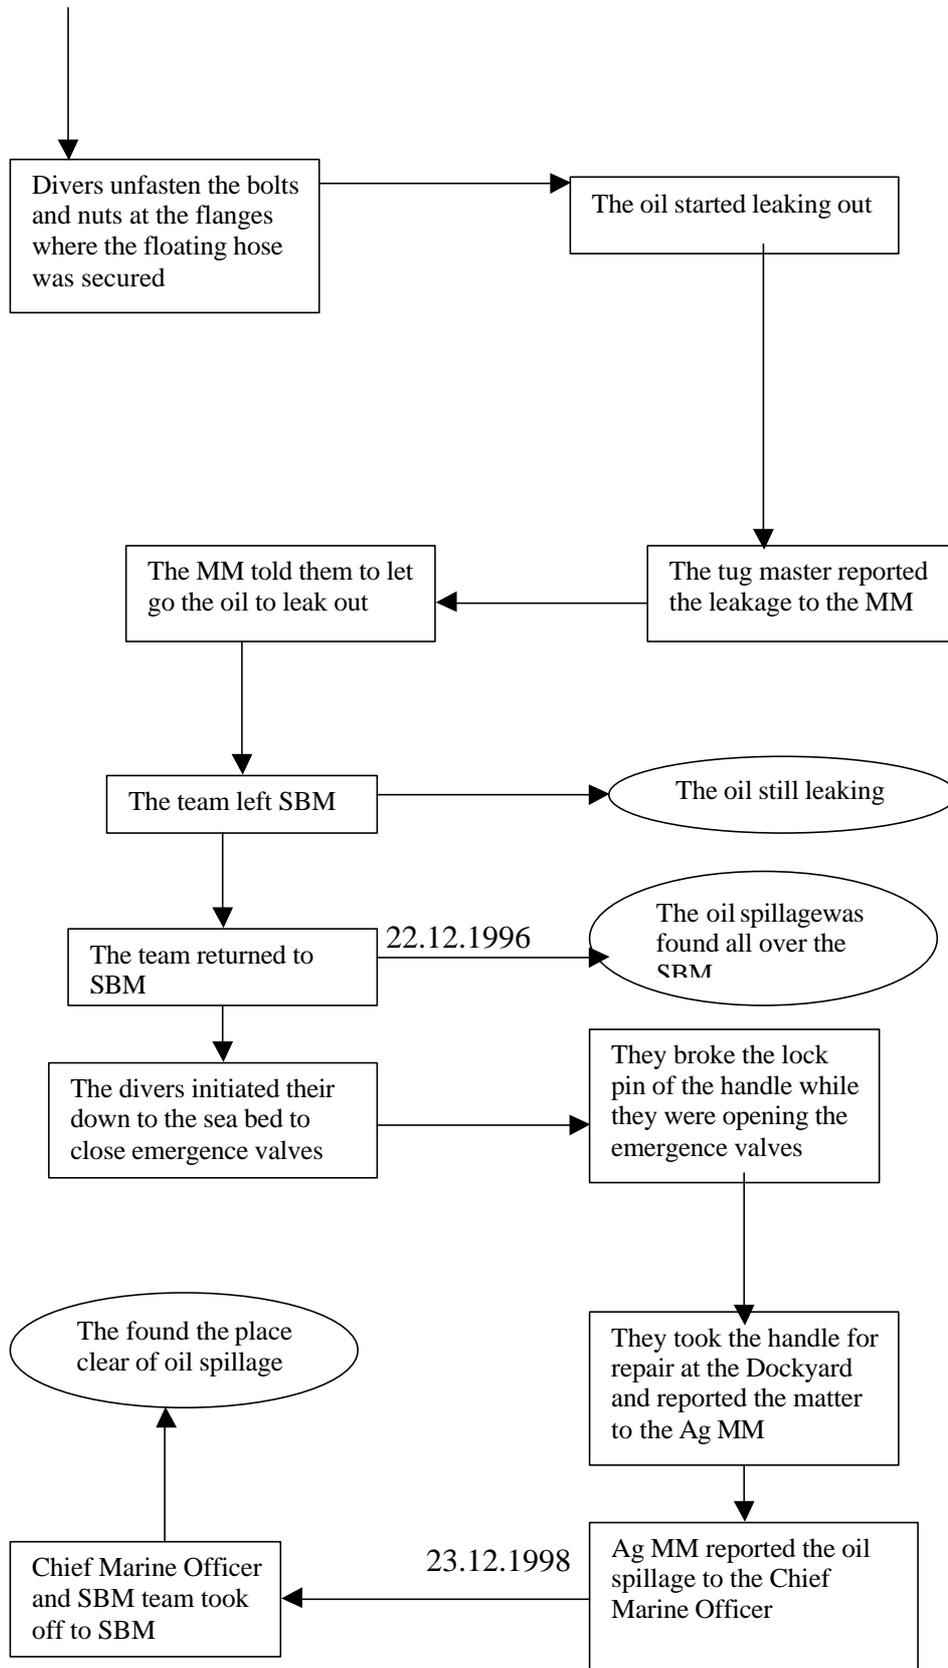
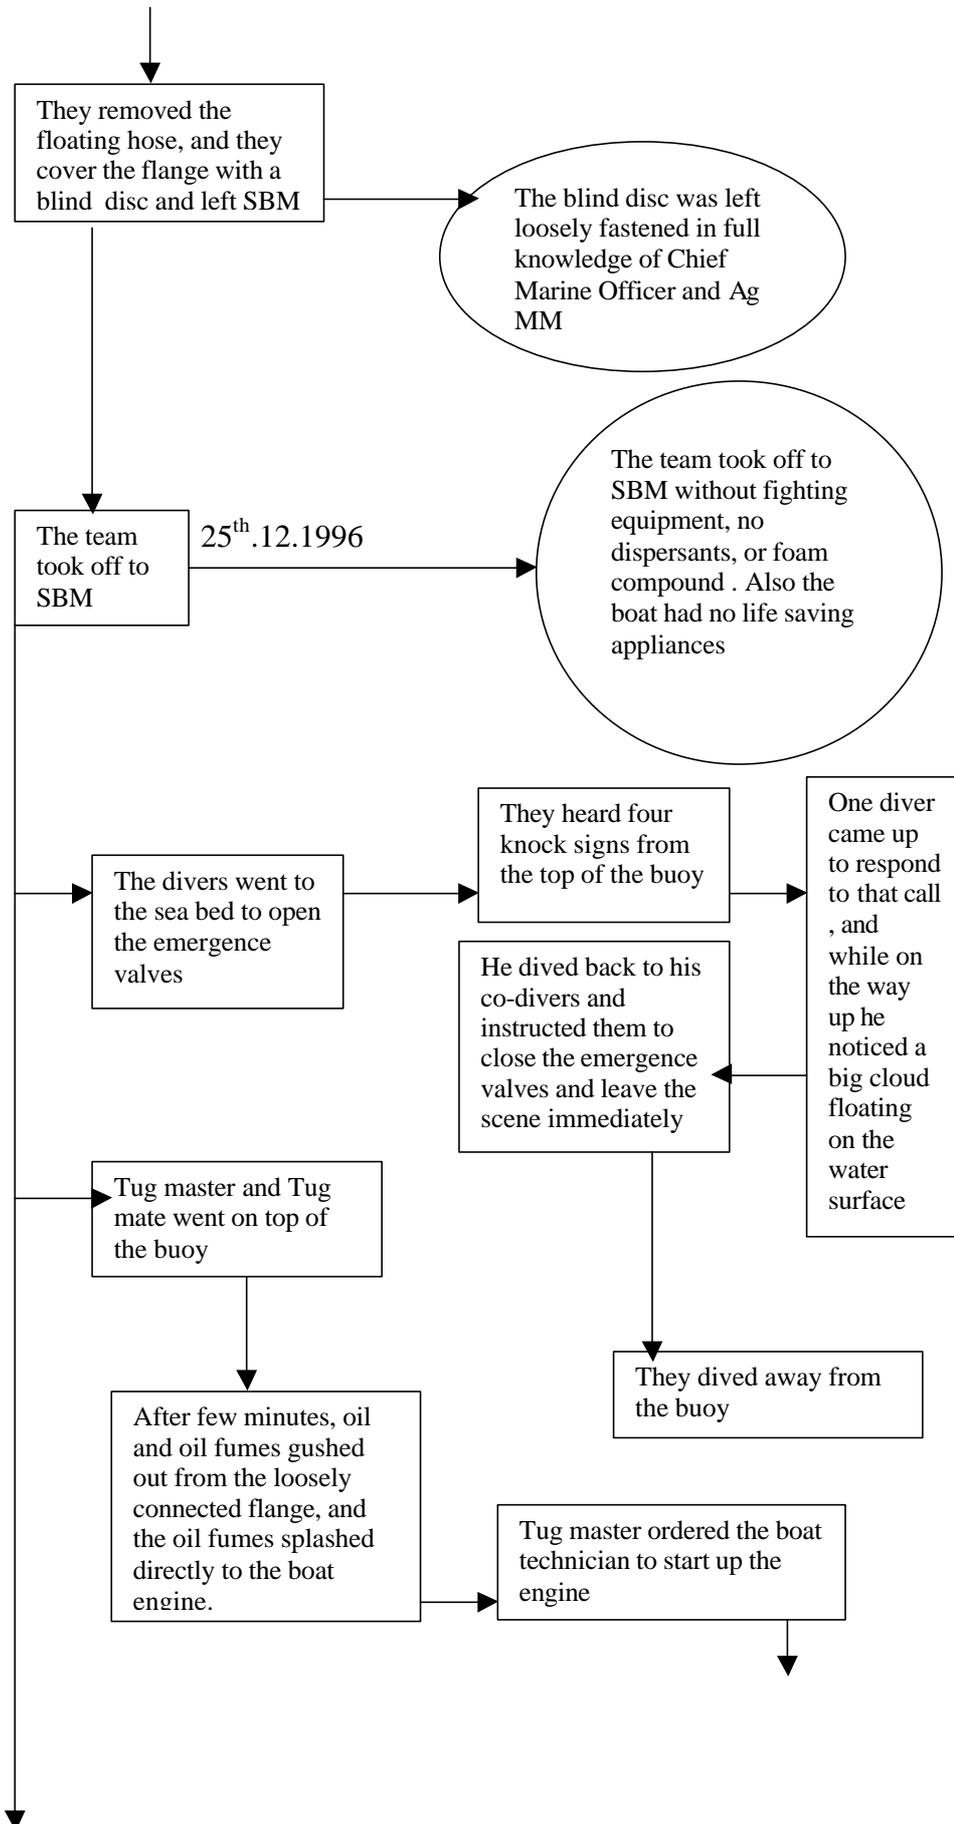
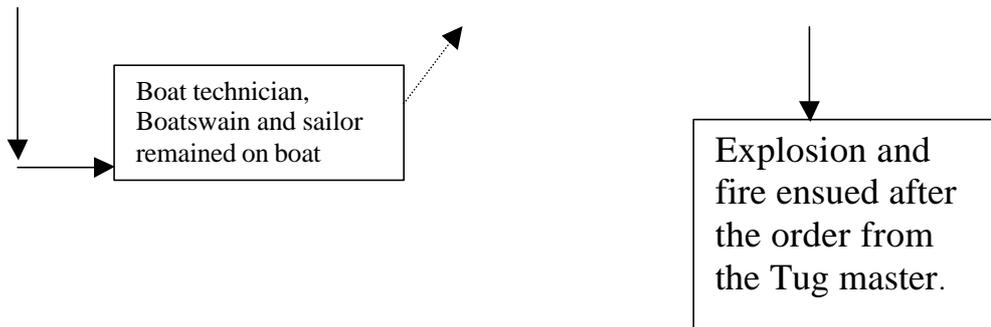
(Chart 3) Events and Causal Factors Analysis of the Fire/Explosion involving Mv INZI and SBM (Single Buoy Mooring)

The boat herself was not fit for that kind of job and not even recommended by the IOCMF which deals with oil safety precautions at oil terminals and was operating the SBM without complying IOCMF regulations for about more than 10 years. The Tanzania Harbours Authority (THA) management is largely accountable for what has happened and contributed a lot to this fire accident.

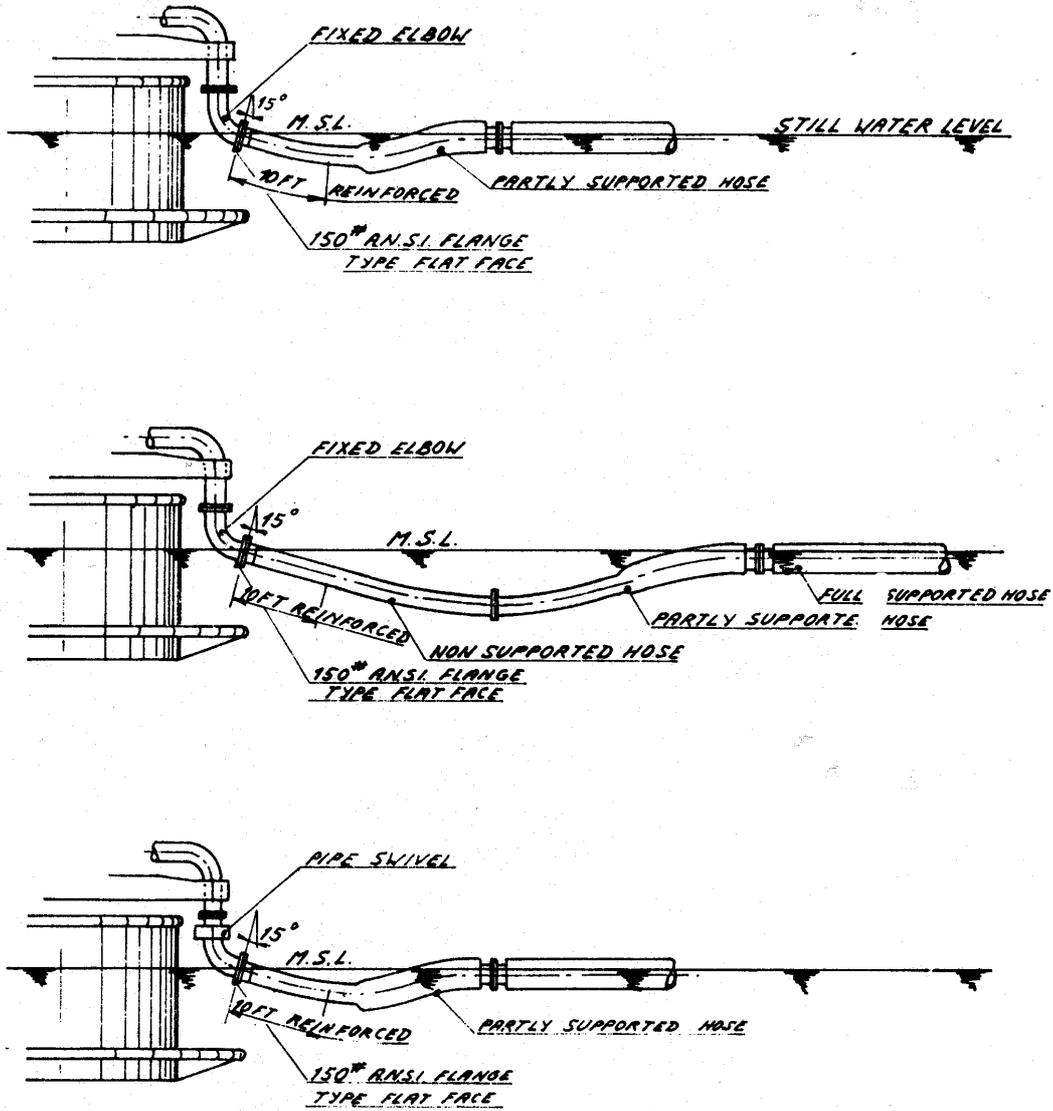
Mooring Master went on leave from 1st December 1996 until 30th December 1996. On 1st December 1996 he handed over his duties verbally to the Assistant Mooring Master on front of Harbour Master and Senior Harbour Master. The Mooring Master left the following assignment to be done on the SBM that is to repair the damaged and worn out floating hose, which was losing ability to float (Figure 3.0).

Figure 3.0 Different arrangements of floating hose

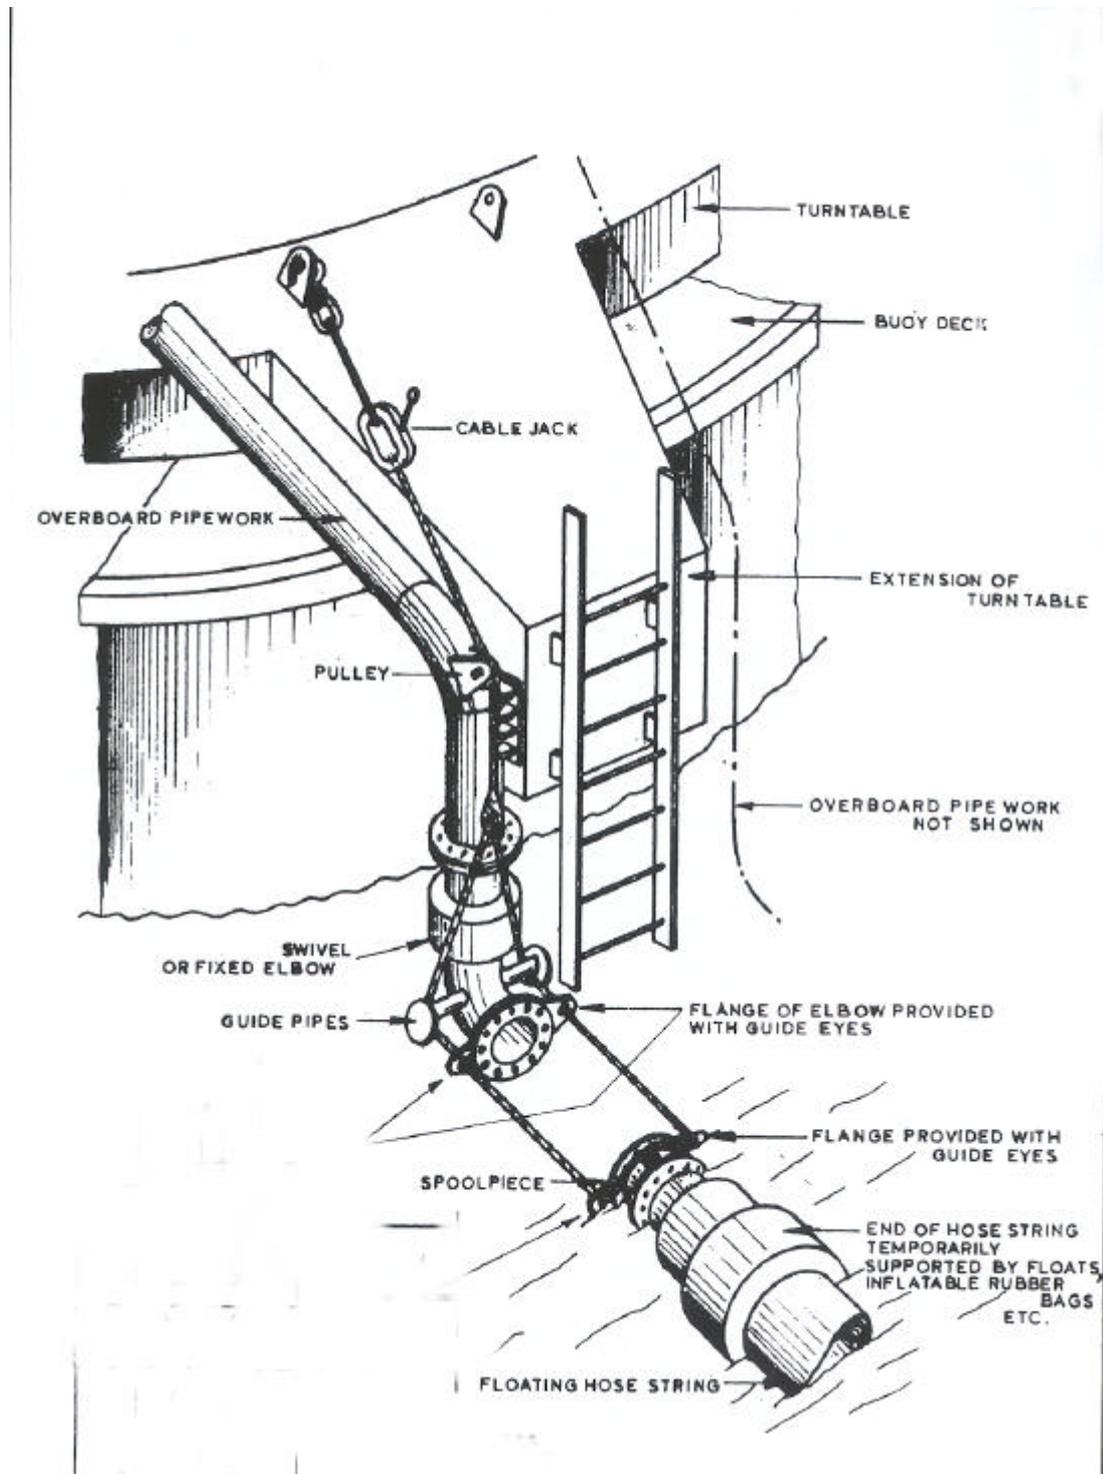
Figure 3.1 Flange where oil started leaking out
