SAFETY INVESTIGATION REPORT

REPORT NO.: 13/2022

MY SIEMPRE **Fire on board,** **whilst moored in the port of Olbia, Italy** **06 September 2021**

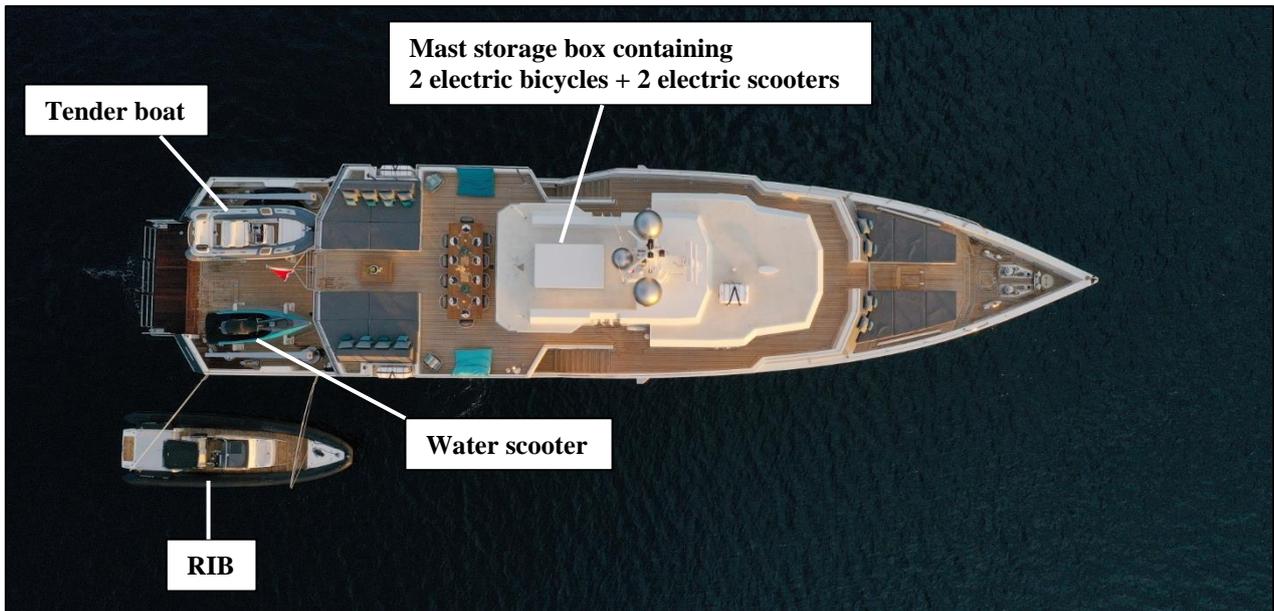
Figure 1: Location of some of the leisure equipment on *Siempre*

As seen in **Figures 1** and **2**, *Siempre* was equipped with several leisure equipment, most of which were electrical and powered by Li-ion batteries. Except for the electrical bicycles and scooters, which were stored in the mast box, all the other leisure equipment was stored on the open aft deck.

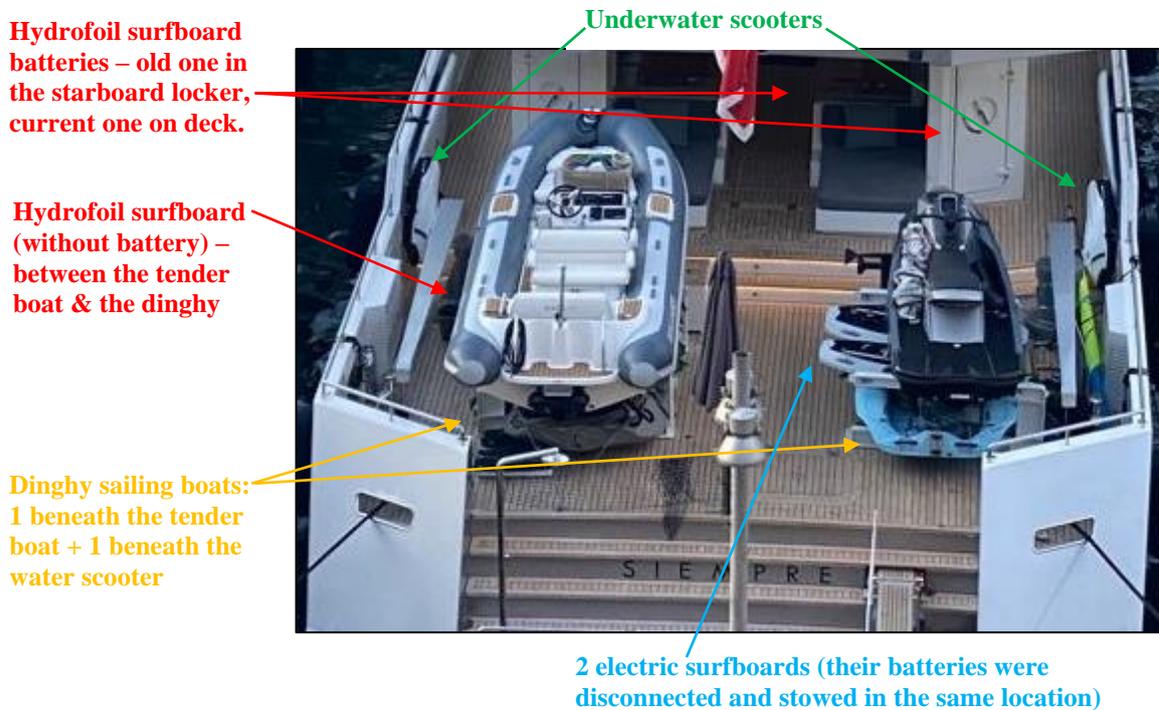
Figure 2: Location of the rest of the leisure equipment on *Siempre*'s aft deck

While most of the leisure equipment on board had integrated, rechargeable, Lithium ion (Li-ion) batteries, the hydrofoil surfboard and electric surfboards had removable, rechargeable Li-ion batteries. The electric surfboards' batteries were stowed in proximity of the surfboards, while an old (dead) battery of the hydrofoil surfboard was stowed in the starboard locker. The one in use was stowed on the deck in the cockpit area (**Figure 2**).

60 °C, before it failed. The dead battery was kept on deck for several days and later placed in the starboard locker, on the aft deck (**Figure 2**), where the yacht's fender hooks² were being stored.

However, there was only space for the removable rechargeable Li-ion batteries to be stored on the aft deck. Thus, even if these Li-ion batteries remained intact, they would still be susceptible to hazards, such as a fire originating elsewhere in its vicinity. Furthermore, considering that the crew members were advised to store the dead battery in a safe location (and since the disposal or the transportation of a faulty Li-ion battery requires certified professional services), the crew members did not have a choice, but to place it in the starboard locker.

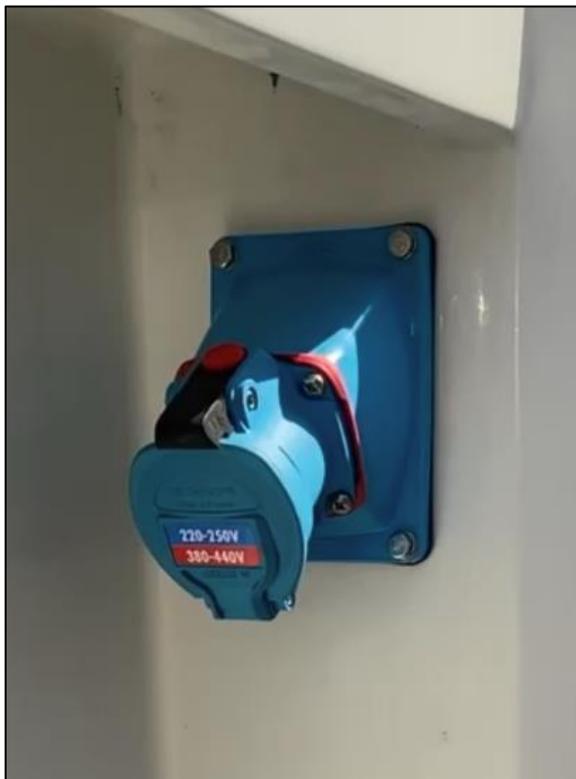
The water scooter was recharged through a 380 V - 400 V power socket, while the other equipment (or their removable batteries) was recharged through 220 V power sockets. The 220 V power sockets were fitted at various locations, around the aft deck of the yacht. The 380 V - 400 V power socket for the water scooter was fitted in June 2021. It was fitted on the starboard bulwark, near the water scooter (**Figure 3**). The wiring schematic diagram for this socket is shown in **Figure 4**.

Figure 3: Water scooter charging socket (fitted by the crew members in June 2021)

Since the exact seat of the fire could not be established, the safety investigation did not exclude a third possibility that the fire may have been caused by an electrical short circuit in the charging socket of *Siempre's* water scooter. In its consideration, the MSIU considered that about two weeks prior to the fire, the power socket had malfunctioned.

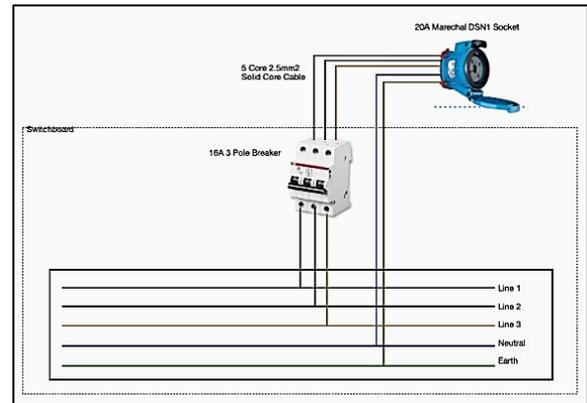
Figure 4: Wiring of the water scooter charging socket

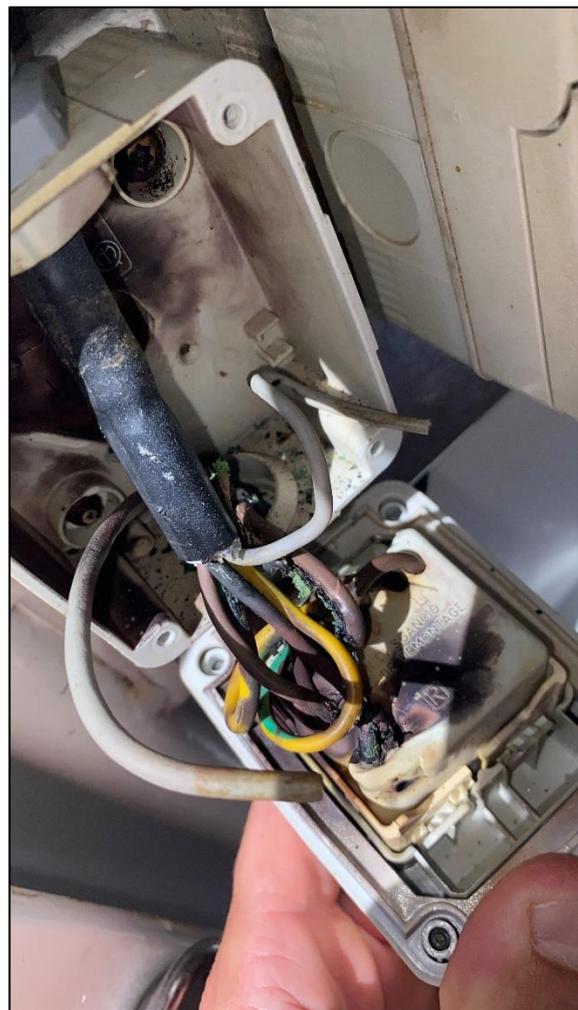
Around two weeks prior to the accident, the crew members noticed that the power outlet fitted on the bulwark near the tender boat, was not functioning properly. On dismantling the unit, the chief engineer observed electrical damages inside (**Figure 5**).

The chief engineer trimmed off the damages parts of the wires and connected the unaffected parts of the wires using connector clips.

Figure 5: Damages within the power socket fitted near the tender boat

The safety investigation was informed that this power outlet contained two sets of wires, one of which was connected to the water scooter's charging socket.

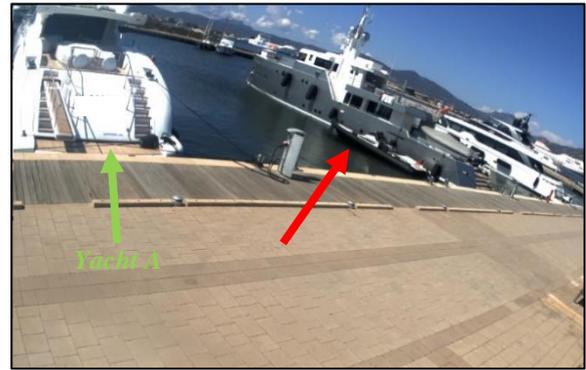
Figure 6: Still from the marina's CCTV footage, showing how *Siempre* was moored at Olbia (red arrow: *Siempre*, with her RIB moored to her port side)

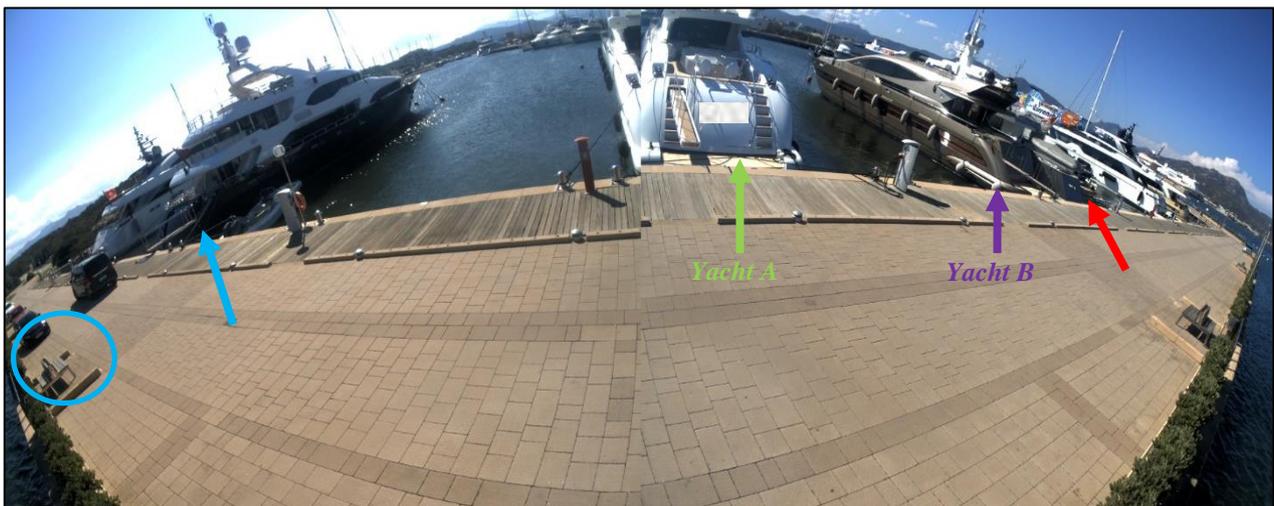
On 06 September, at 0128, the CCTV camera captured smoke escaping from *Siempre*'s aft deck, soon followed by intermittent bright flashes, resembling open flames. This caught the attention of the crew members of a third neighbouring yacht (MY *Blue Vision*), who were on the dock at that time (**Figure 7**).

Figure 7: Still from the marina's CCTV footage from the afternoon of 05 September 2021. Blue circle: location of *Blue Vision*'s crew, when the fire started; blue arrow: MY *Blue Vision*; red arrow: MY *Siempre*

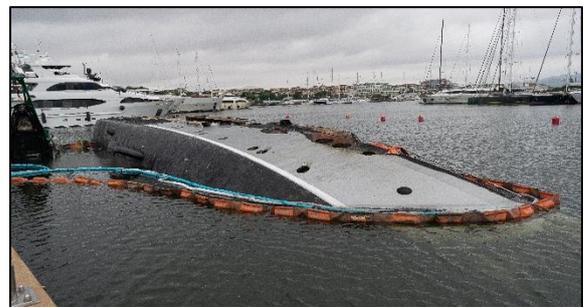
The shore fire brigade continued to fight the remaining flames, using water and foam. Subsequently, *Siempre* started to develop a port list. At around 0730, while the shore fire brigade was still fighting the fire, *Siempre* listed over to its port side (**Figure 8**). However, for the following two days, several interventions were still required by the shore fire brigade to tackle emerging flames and smoke from parts of the yacht that were above the water level.

Figure 8: *Siempre* on the morning after the fire

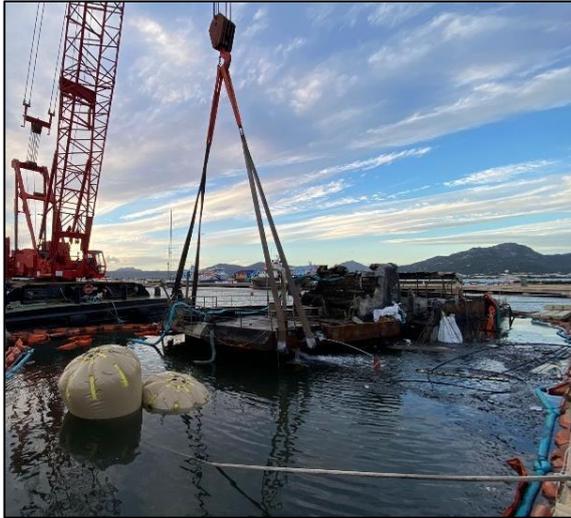
Siempre was declared a constructive total loss. The yacht was eventually re-floated on 02 November 2021 (**Figure 9**).

Figure 9: Re-floating of *Siempre* at Olbia

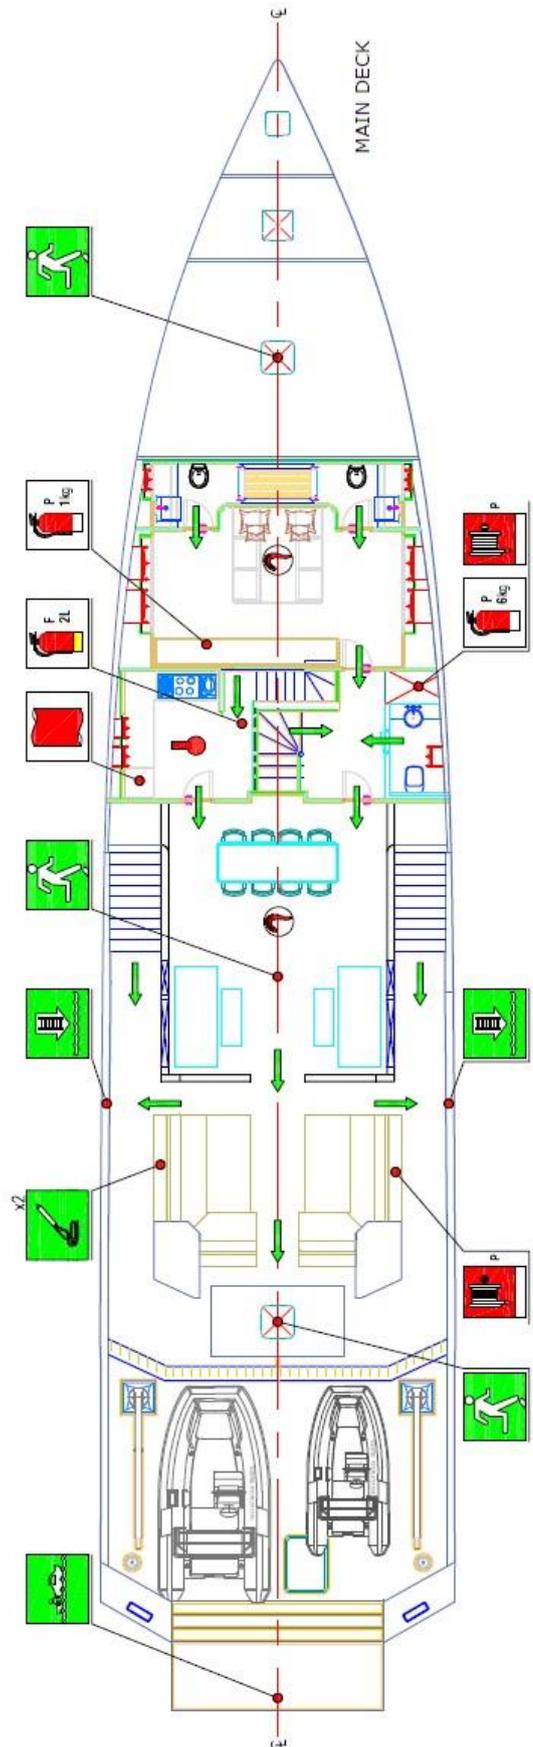
Figure 10: Extract of *Siempre*'s Fire Safety Plan

The main deck, where the fire started, was fitted with two smoke detectors, a heat detector, two portable fire extinguishers within the accommodation space, and two fire hose reels and a portable fire extinguisher on the external, starboard side of the accommodation (Figure 10).

fire detector was a smoke detector near the mid-length of the main deck (**Figure 10**). This indicated to the safety investigation that, within those two minutes, sufficient smoke had entered the accommodation area of the main deck, from the open aft deck, to reach the smoke detector and activate the fire alarm.
