# Collision involving the bulk carrier *Goliath* and tugs *York Cove* and *Campbell Cove*

Devonport, Tasmania on 28 January 2022

**ATSB Transport Safety Report**

MO-2022-002

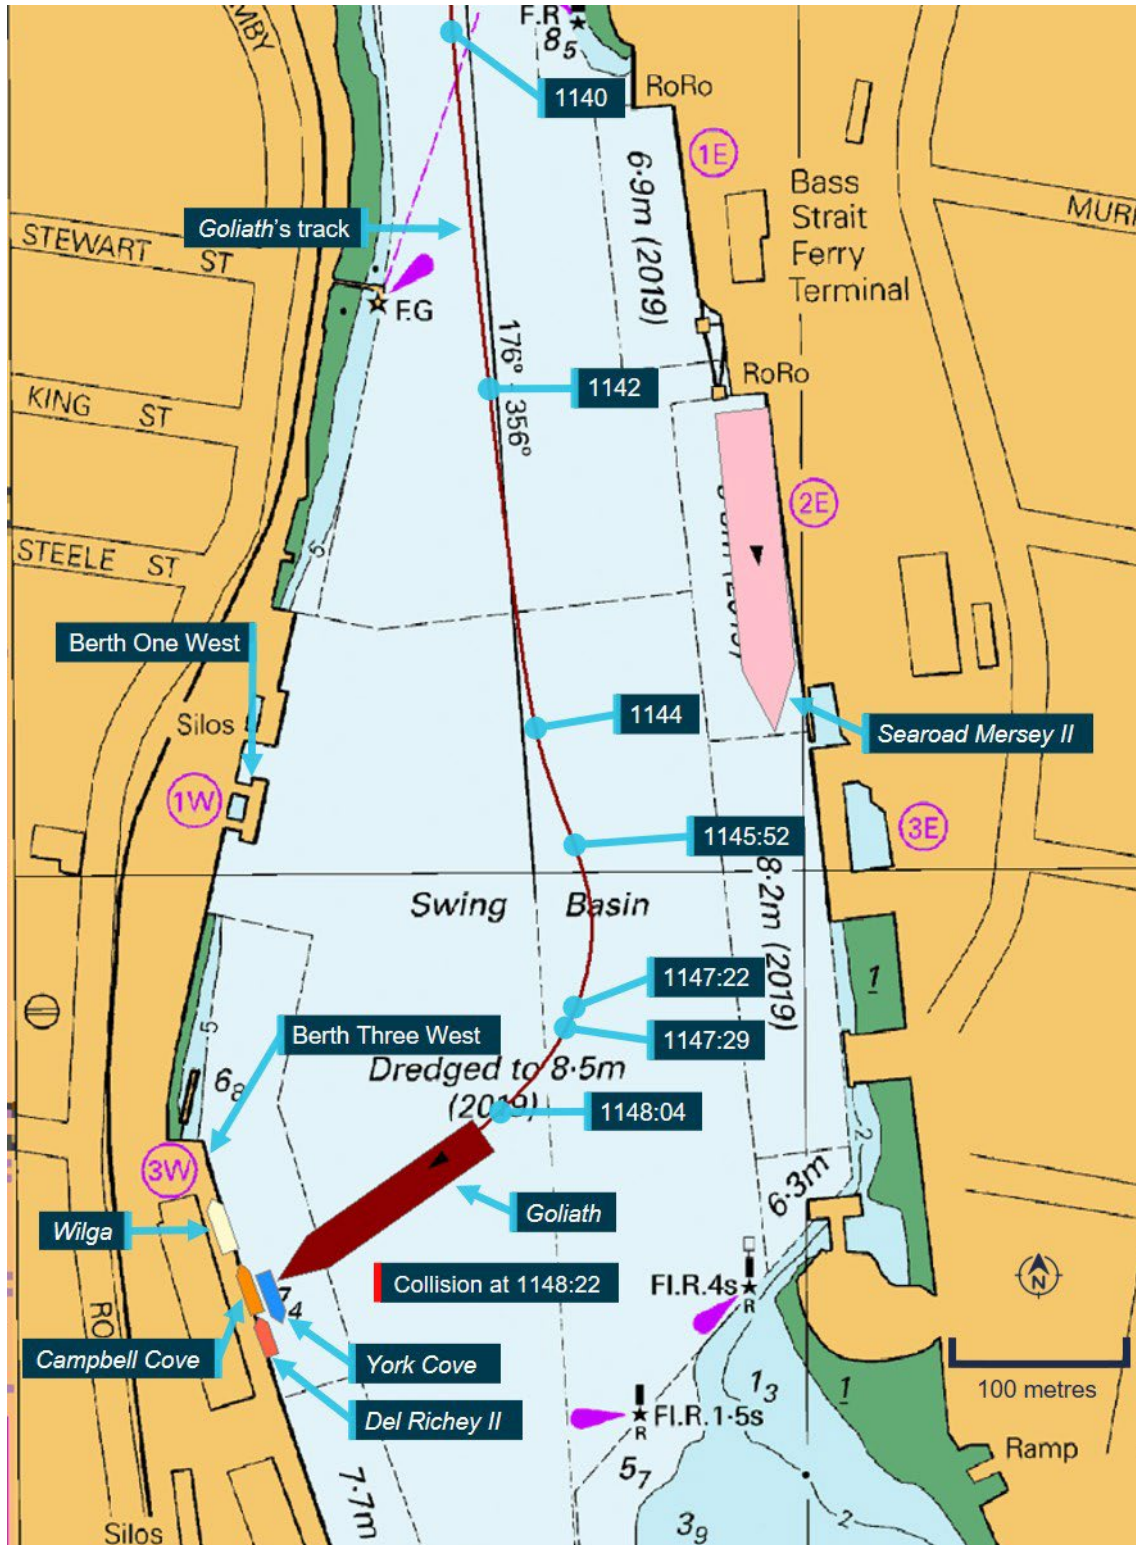
**Figure 6: Section of chart Aus 164 showing Goliath's track and sequence of collision**

As the manoeuvre progressed, the master felt that the ship was not swinging as expected and was closing with 2 tugs, which were moored at berth number Three West ahead. In an effort to

With the ship's speed still increasing, the master checked the rudder angle indicator located in front of the port wing console and then observed that both rudders were still amidships and not at the angles corresponding to the VecTwin joystick setting as expected. The master called out to the second mate that the steering was not in VecTwin steering mode and immediately brought the engine telegraph to 'slow ahead' and then to 'stop'.

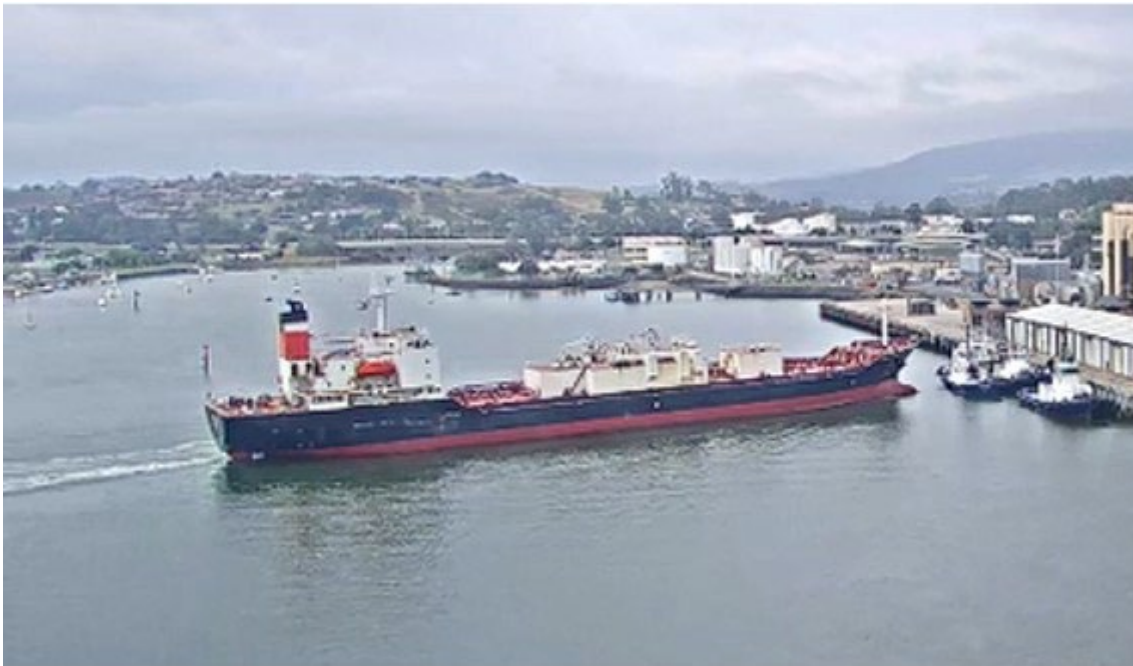
**Figure 7: *Goliath*, immediately before the collision with the tugs**

At about the same time (1148:22), *Goliath* collided with the two tugs ahead. (Figure 7). The ship's speed was 4.7 knots as it struck the port midships area of the tug *York Cove*, which was moored outboard, and alongside, of the tug *Campbell Cove*.<sup>11</sup> Both the tugs were severely damaged and began taking on water almost immediately. The tug *Wilga* and the fishing vessel *Del Richey II*, berthed to the north and south of the two damaged tugs respectively, were not impacted.

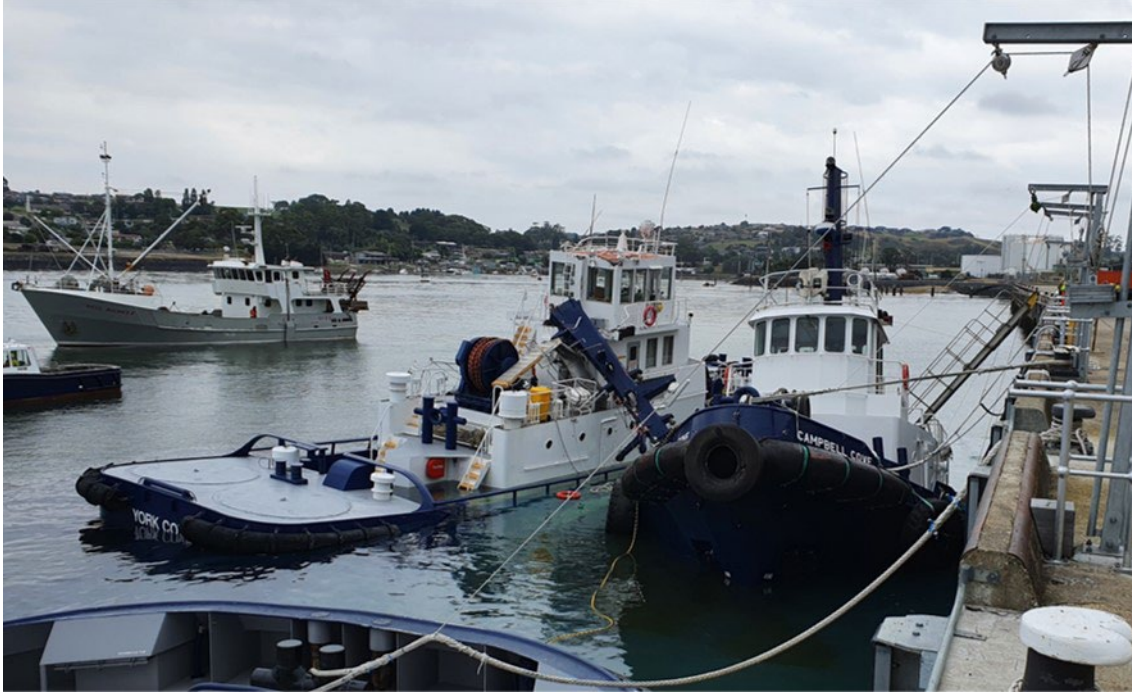
**Figure 8: York Cove and Campbell Cove about 20 minutes after the collision**

By about 1220, both damaged tugs had developed a list to starboard as they took on more water and oil began to escape (Figure 8). By this time, the fishing vessel *Del Richey II* had cast off from its berth and taken up station nearby to assist. The tug *Wilga* remained alongside the berth.

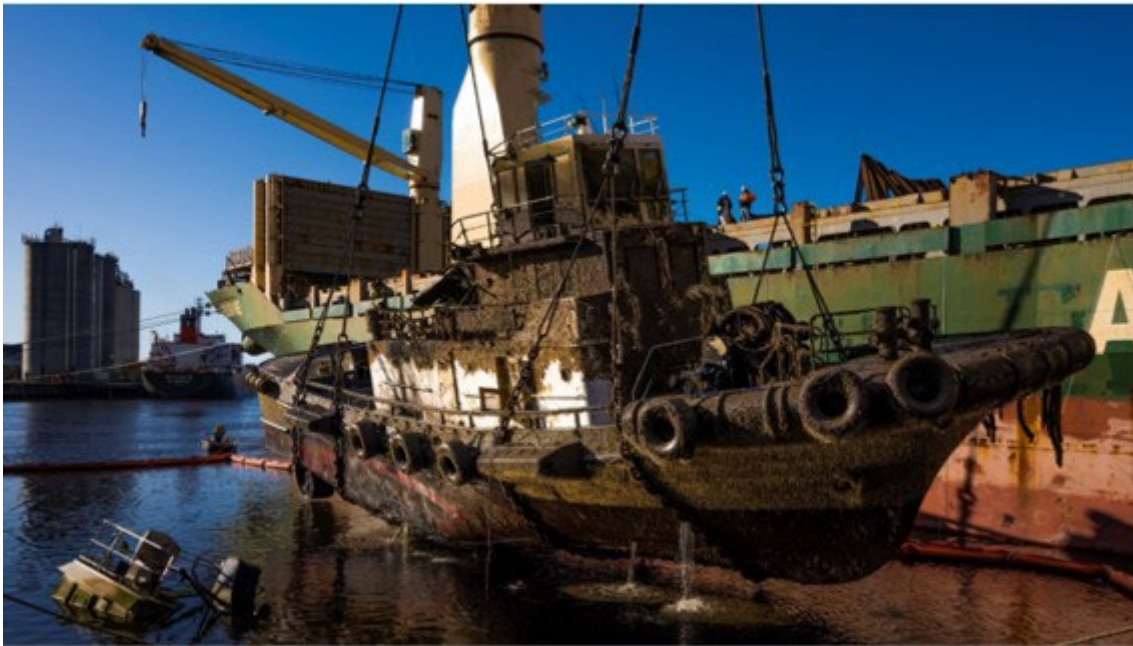
**Figure 10: *York Cove* being recovered**

Both *York Cove* and *Campbell Cove* were declared constructive total losses. On 11 March 2022, United Salvage were awarded the tender for removal of the wrecks of the sunken tugs. In July 2022, the heavy-lift ship *AAL Melbourne* was engaged to lift and remove the tugs' wrecks. The ship arrived in Devonport on 7 August and recovered *York Cove*'s wreck (Figure 10). *Campbell Cove*'s wreck was also recovered by 12 August. During the recovery operation, an unknown quantity of oil escaped the containment area although EPA surveys of the shoreline and water did not detect any affected wildlife. *AAL Melbourne* departed Devonport on 16 August for Brisbane, Queensland where the tugs were to be scrapped (recycled).

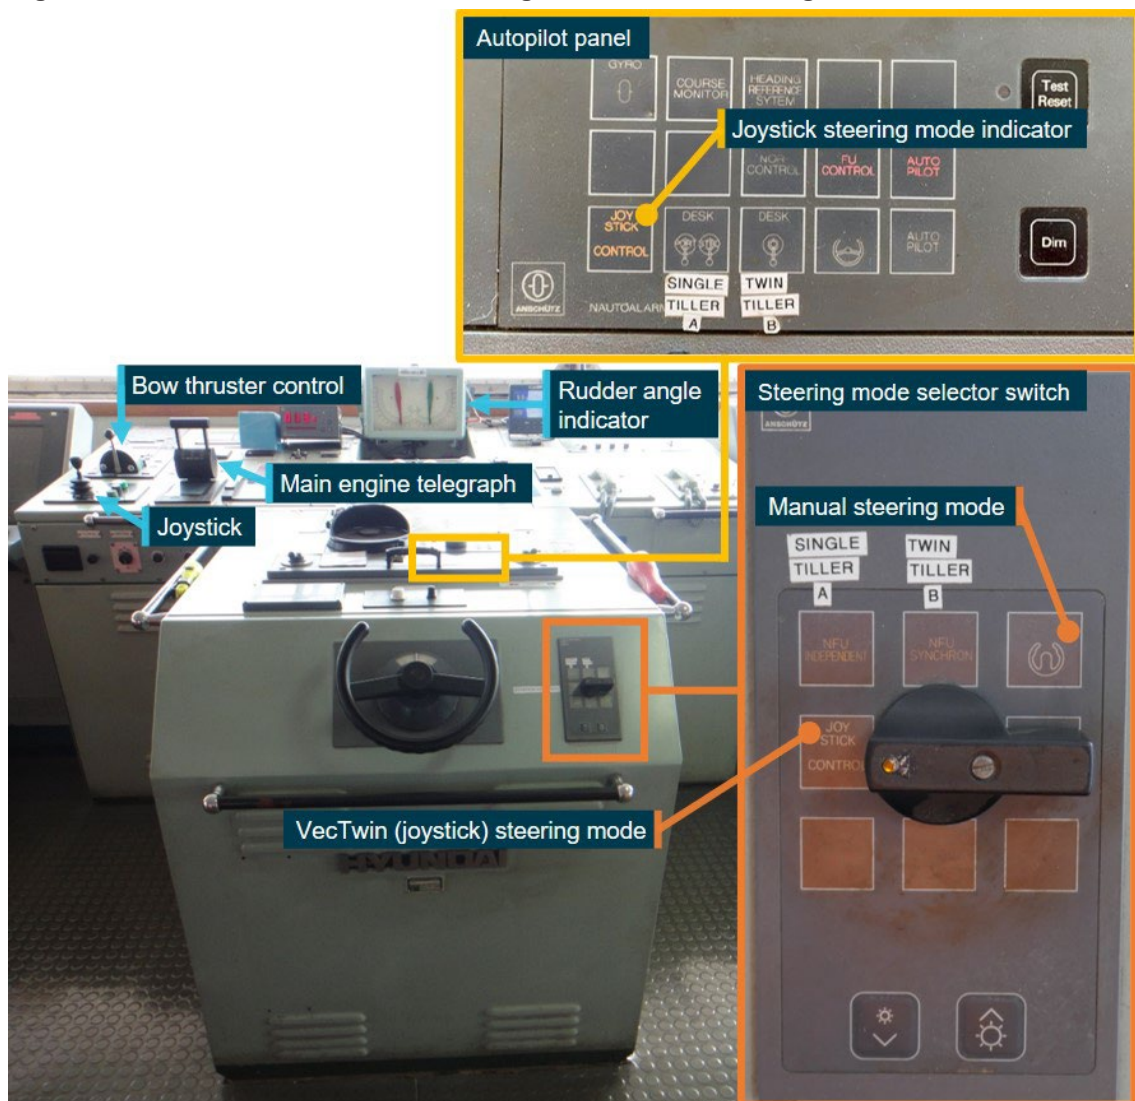
**Figure 11: Goliath's wheelhouse, steering console, and steering mode selector switch**

On board *Goliath*, the second mate had run into the wheelhouse, checked the steering mode selector switch on the steering console and realised that it was still in manual steering mode. The second mate immediately switched it over to VecTwin (joystick) steering mode while the master placed the engine at 'half astern' followed by 'full astern' and, by 1148:31, at 'emergency astern'.

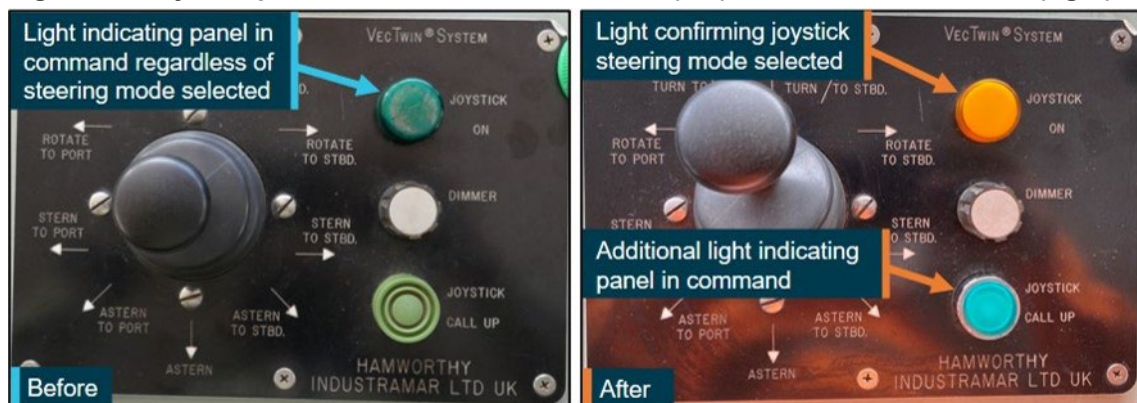
**Figure 13: Joystick panel at the time of the accident (left) and after modifications (right)**

The investigation found that neither the master nor the second mate had undertaken the required bridge resource management (BRM) training and that BRM on board was ineffective. The design of the ship's joystick system was also identified as having increased the risk as it was misleading and did not provide a positive visual confirmation that the correct steering mode had been selected.

*Goliath's* VecTwin joystick panels were modified to incorporate a positive visual indication that joystick steering mode was selected, and the transfer of control checklist modified accordingly. The company's standing orders, bridge checklists and the ship's procedures on navigation, watchkeeping and passage planning were amended to specify the conditions under which the relief of watchkeeping officers could take place during pilotages or during extended manoeuvres.

Following the accident, CSL Australia arranged for modification of the joystick control panels to provide affirmative visual confirmation that the correct steering mode had been selected and that the panel was selected for command (Figure 13). The modification was completed in April 2022.
