SAFETY DIGEST

Lessons from Marine Accident Reports

1/2023

MARINE ACCIDENT INVESTIGATION BRANCH

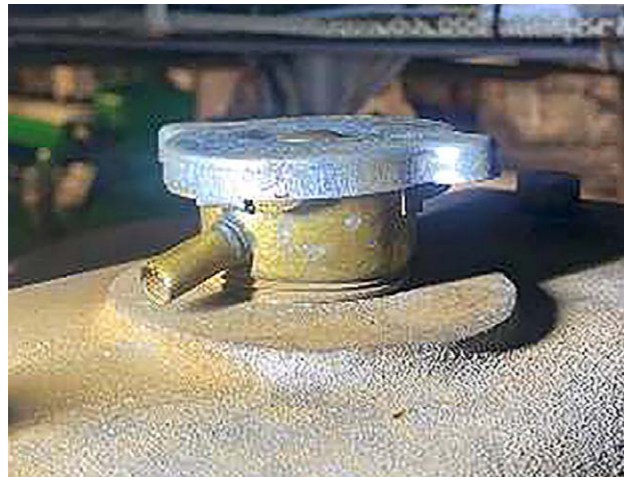
The propulsion engine of a small coastal passenger vessel began to overheat while on passage to its next port. One of the vessel's engineers stopped the engine and cleaned the sea water strainer, which had become clogged with debris and was restricting the flow of cooling water to the engine. The engineer also noticed that the engine's cooling system expansion cap (Figure 1) looked loose; he protected his hand with a rag and attempted to tighten the cap, which suddenly blew off. The engineer responded by instinctively turning his back to the unit but was sprayed with scalding hot water from the engine's pressurised cooling system.

Figure 1: Expansion cap in the fully closed position

1. **Observe** → Always allow an engine to cool down before attempting to conduct maintenance on a pressurised cooling system.
2. **Risk** → Ensure you refer to the risk assessments. These exist to alert operators to potential hazards and the mitigation measures that should be implemented before the task is undertaken. The risk assessment method statement is a clear explanation of how you are going to manage the identified risks.
3. **Procedure** → The company issued a safety flash that highlighted the dangers identified in this case. Familiarise yourself with manufacturers' manuals and ensure that you know how to complete a task correctly and safely.

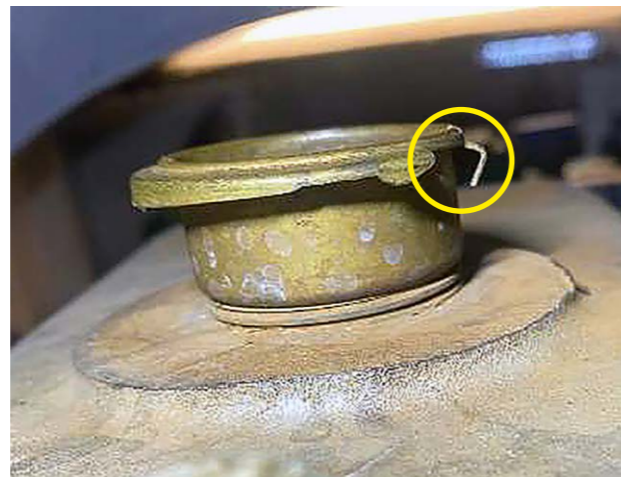
It was later found that the securing lugs for the engine cooling system expansion cap were bent (Figure 2), which had possibly prevented the cap from sealing correctly.

Figure 2: The bent securing lug

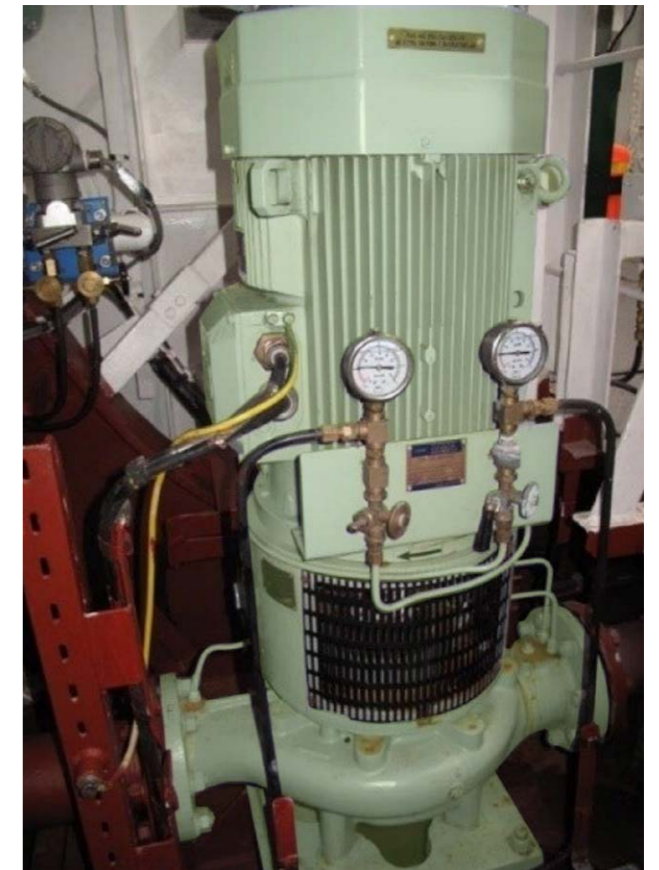
An oil tanker was anchored off the south coast of the UK when an auxiliary room fire alarm activated. The ship's firefighting team went to the engine room to investigate and discovered smoke emanating from an overheating sea water pump (see figure); they stopped the pump, allowed it to cool down and found that there was little damage.

The cooling water had nowhere to go when the valves were closed and there was no flow through the cooling pump, which caused its mechanical seal to gradually overheat and generate smoke.

Figure: The sea water pump

1. **Communicate** → Maintenance should be effectively planned and communicated. It is vital to consider the effects of isolation on running equipment that may not be directly related to the job in hand. The use of isolation logs and lock-out/tag-out notices can help engineers monitor the status of their systems and prevent mishaps.
2. **Aware** → All of the human senses play a part in the detection of issues that electronic or mechanical sensors may fail to pick up. The application of touch, smell, sight and sound while moving through a space are powerful tools in the armoury of a watchkeeping engineer and provide early warning of a developing problem.

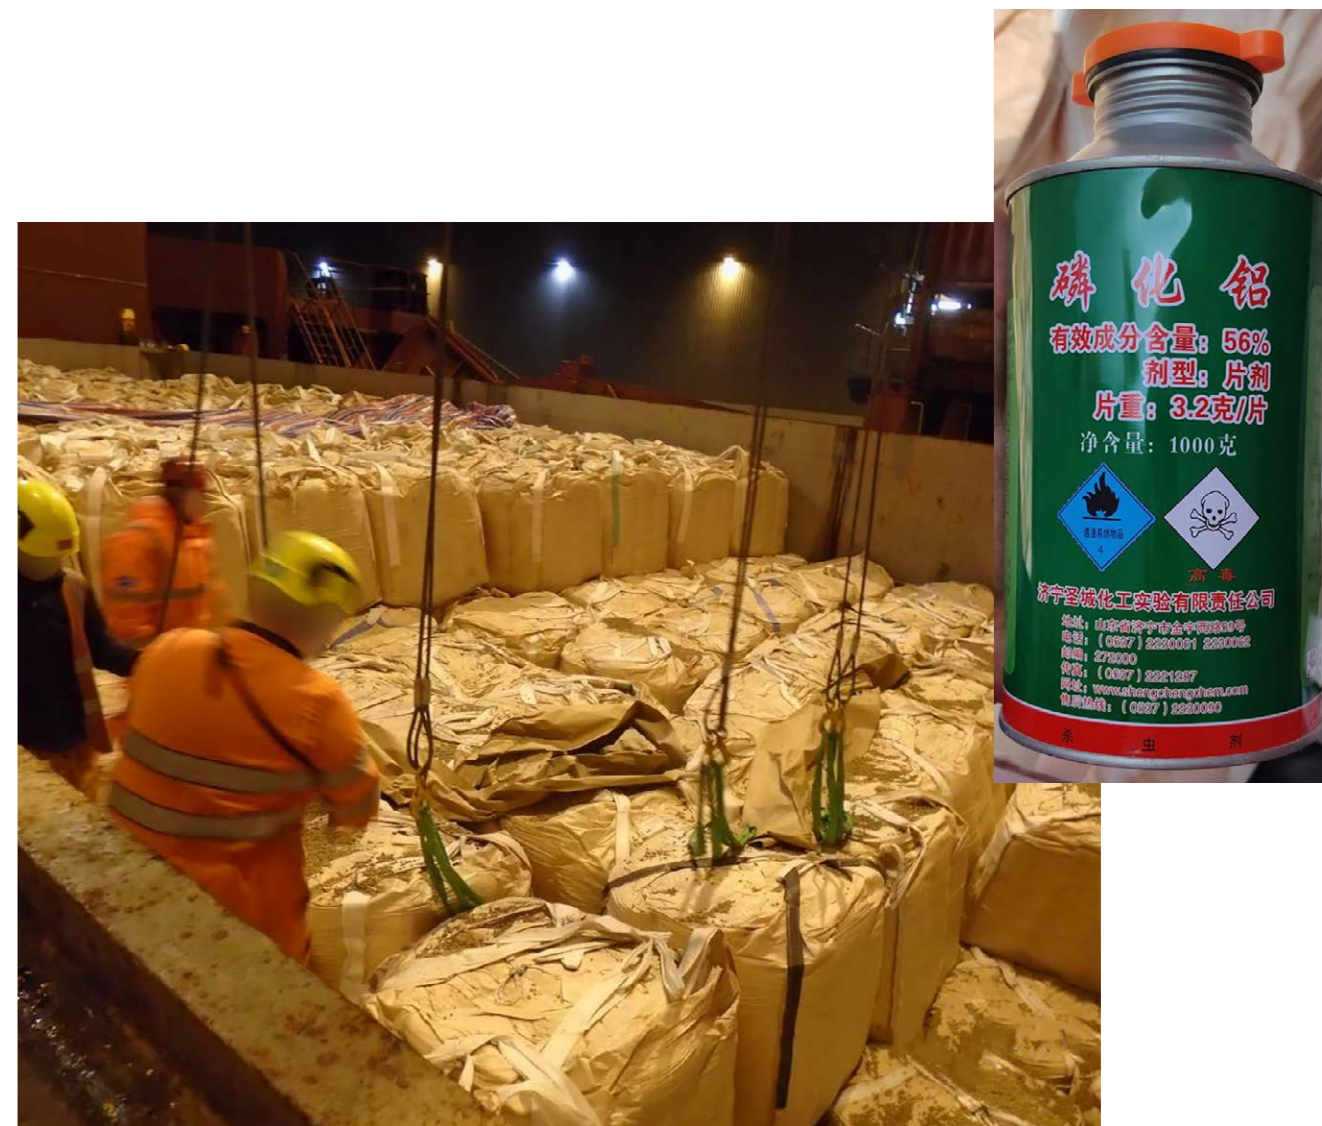
explosive limit before the stevedores discharged the cargo. When the stevedores started working in the holds they soon began to find the cans of fumigant among the bags of sweet potato pellets (see figure). The cans were marked with hazard symbols and the stevedores showed them to their supervisor; however, the cargo work was not suspended for several hours, by which time some of the stevedores had been in contact with the aluminium phosphide. The next morning one of the stevedores became unwell and required hospital treatment for sickness, disorientation and nerve damage to his hand.

Figure: Stevedores unloading the bags of sweet potato pellets and (inset) a can of fumigant

- Hazard** → Cargo holds can be a hazardous environment; stop work if you find something unusual and check if it is safe to proceed.
- Equipment** → Appropriate personal protective equipment (PPE), including coveralls, gloves, face masks and respirators, must be worn when handling fumigants.

- Procedure** → Masters, owners and charterers are reminded of the contents of IMO Circular MSC.1/Circular.1264 – *Recommendations on the Safe Use of Pesticides in Ships Applicable to the Fumigation of Cargo Holds*, which details the safe use of fumigants, measurement of fumigant levels on board ships and the responsibility to notify port authorities of the potential presence of fumigants on board.

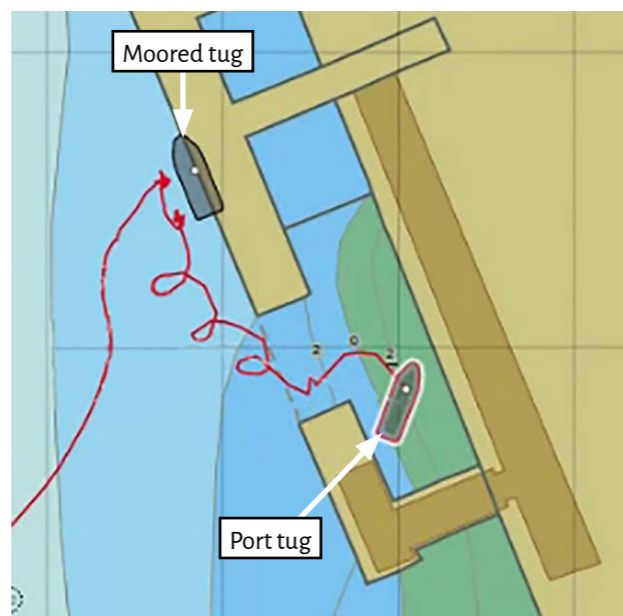
After accepting propulsion control from the engineer in the engine room, the master struggled to break clear due to the strong tidal stream. To prevent a collision with the other tug, full astern was being used on both engines when the port propulsion unit alarm sounded and the tug began to spin clockwise to starboard, narrowly missing both the moored tug and the floating pontoon (Figure 1).

Figure 1: Uncontrolled track and final position of the port tug

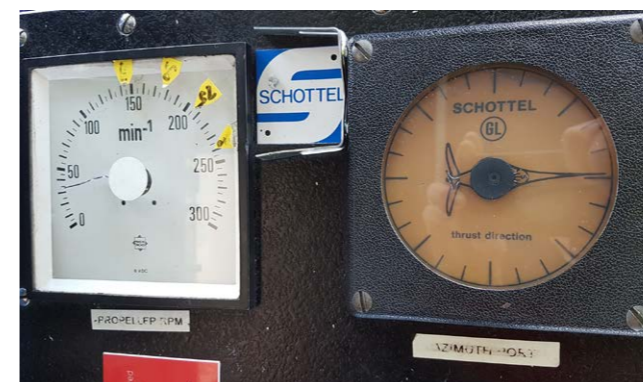
Figure 2: The azimuth direction indicators

- Risk** → The azimuth directional indicators were hard to read due to the glass covers becoming less transparent with age. The port shaft indicator had failed a day earlier after an attempt to replace the internal lamps resulted in a broken indicator needle. A temporary needle repair was unsuccessful and the master, unable to adjust the brightness of the new lamps, resorted to covering the indicator with a piece of paper. A defect report submitted on the same day stated: *(Still) able to operate equipment and requires repair asap*. As a result, the master relied on the starboard shaft indicator for both shafts. Risk assessments are essential to identify the potential hazards arising from inoperative or ineffective propulsion controls and indicators and when to keep the vessel in operation or withdraw it from service for repairs.

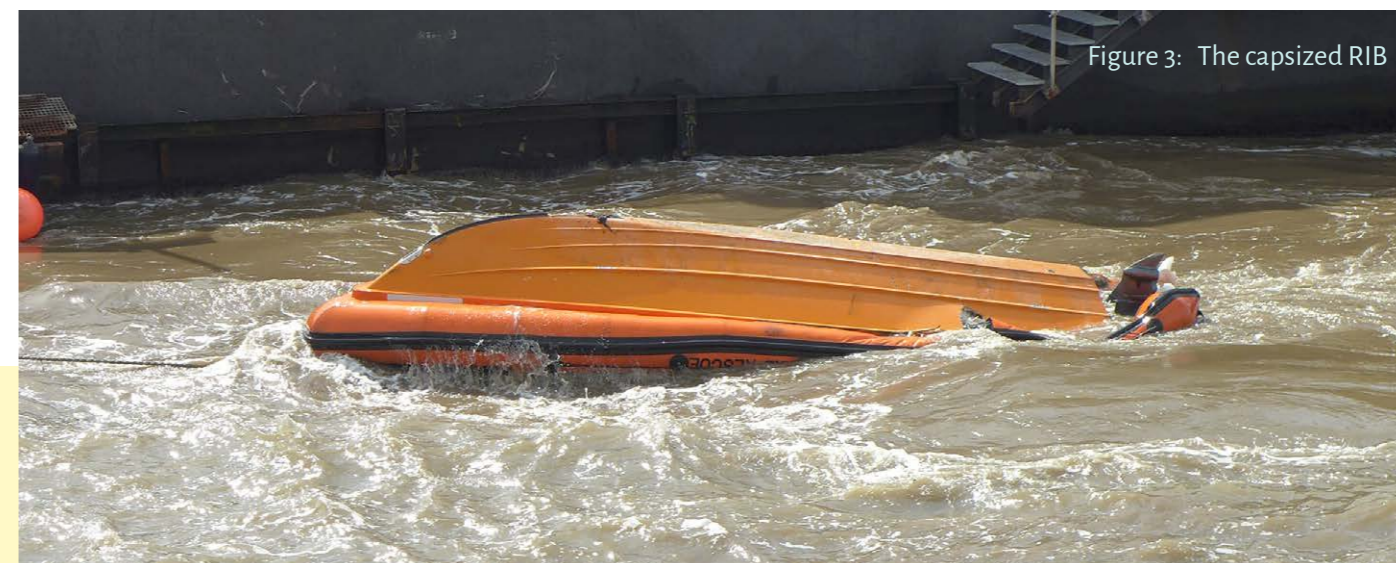
The tug's bow made hard contact with an adjacent floating pontoon's handrails and pontoon air tank. Its port quarter then made heavy contact with a moored rigid inflatable boat (RIB), the impact of which caused the RIB to capsize and its landing stage to sink (Figure 3). The tug's stern and starboard side then rotated close to the shore before full propulsion control was regained and the master manoeuvred the tug out into the river.

Figure 3: The capsized RIB

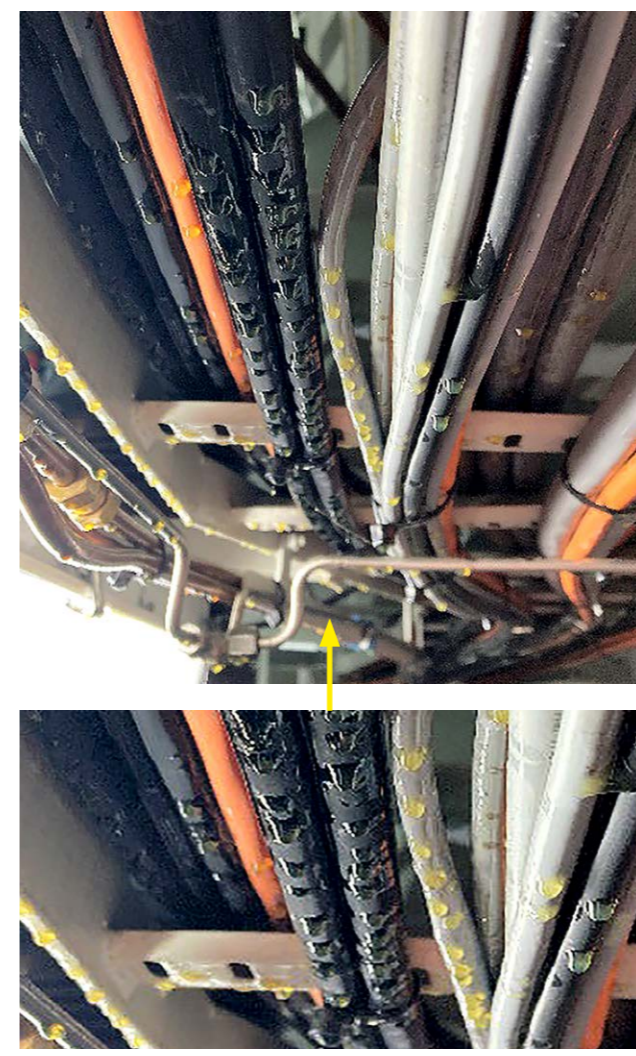
Figure 1: Oil dripping from engine room cables

The vessel was able to make its way to port, where an investigation was started that involved the shipbuilder and gearbox manufacturer. Before the vessel could leave port, the contaminated lagging was replaced, electrical cable trays and affected electrical connections were cleaned and checked, various electrical motors were overhauled and the engine room was washed down.

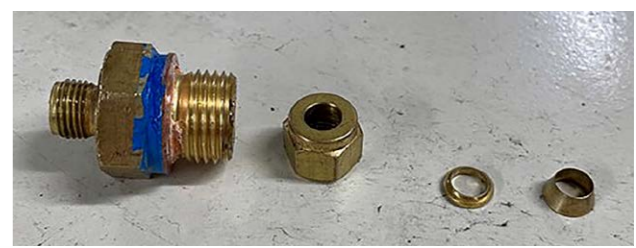
The investigation identified that the temperature probe was held in place by a pipe compression fitting (Figure 2) that had not been fully tightened during the vessel build. Once the fitting slacked further, there was nothing to stop the oil pressure forcing the probe out of the gearbox.

Figure 2: The original temperature probe fitting

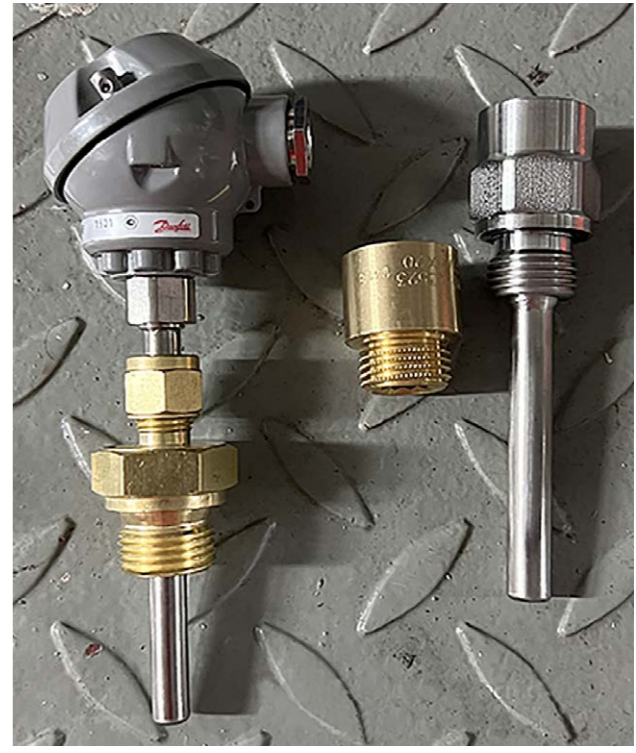
Figure 3: The new temperature probe fitting

- Equipment** → Although it was a marine gearbox, the design of the probe fitting was insubstantial in terms of the operating environment and the consequences of it coming loose. Poorly designed equipment increases the risk of injury to the crew and can force them into undesirable workarounds. In this case, the manufacturer produced a redesigned fitting and probe housing that would prevent reoccurrence and allow the probe to be changed while the propulsion system was working (Figure 3).

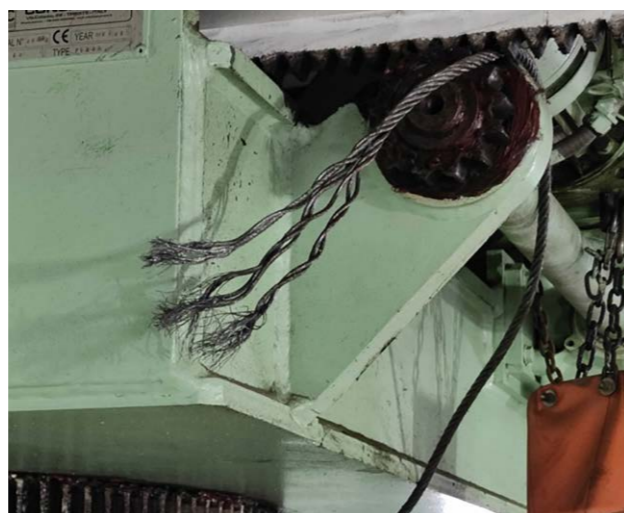
The failed hoisting wire had been renewed shortly before the engine maintenance work started but was 7m shorter than the wire length specified by the crane manufacturer in its technical manual. The shorter length wire affected the operation of the crane's hoist limit switch and prevented it from cutting power to the

winch electric motor when the hook was raised to the maximum lift height; the winch motor was therefore able to overload the wire and cause it to fail.

Figure 1: Failed crane hoisting wire

maintenance system (PMS) computer was found to be incorrect when compared with the manufacturer's specification. The cranes were taken out of service for repair and the ship's engineering team were instructed to conduct a

full inspection of engine room hoisting devices and take necessary steps to ensure that all equipment met manufacturer specifications; they were also reminded to test the hoist limit switches before operating the cranes.

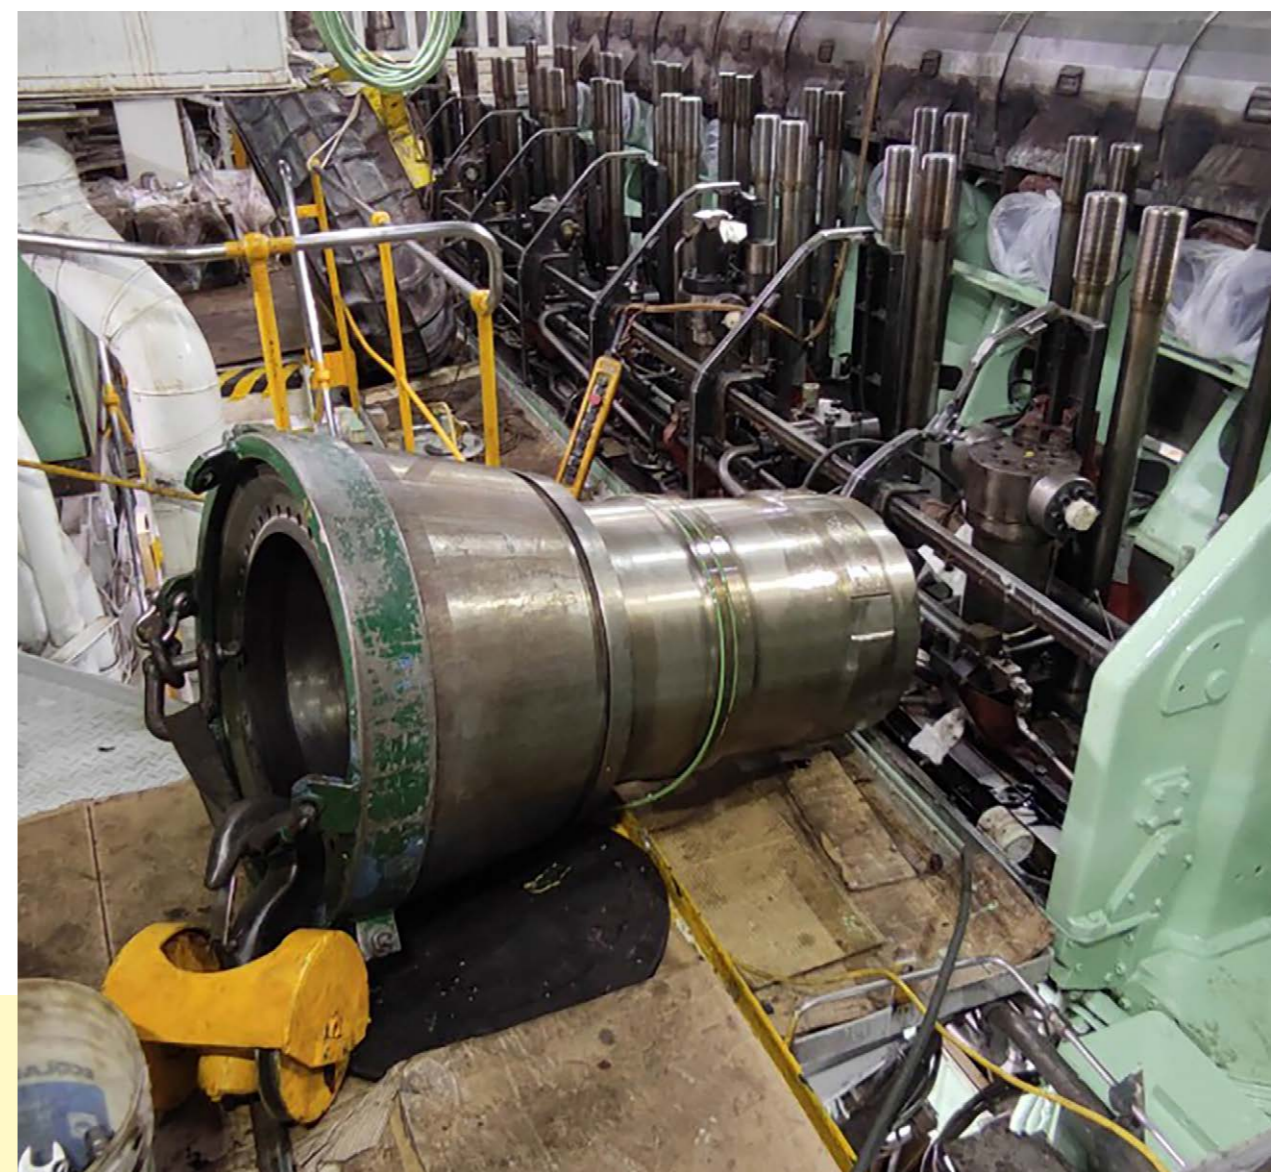
A cruise ship's engineering team were working with the engine manufacturer's technicians to overhaul a large diesel generator, using the engine room's overhead gantry crane to lift the heavy engine components. One of the 1200kg cylinder liners was being lifted into position above the engine, a process that required the electric winch motor to raise the crane hook to its maximum lift height, when the crane's hoisting wire suddenly snapped (Figure 1). The suspended cylinder liner fell onto the engine (Figure 2), causing damage to both pieces of equipment, and struck the left foot of an engine room fitter who was standing nearby. The crew member was treated in hospital for a broken toe and subsequently repatriated.

Figure 2: Position of cylinder liner after wire failure

1. **Hazard** → The crew member was lucky on this occasion but the first lesson here is to not stand under or near to suspended loads, regardless of whether the lifting equipment is new or has been recently overhauled. This incident is a reminder that equipment failure can occur at any time, potentially with severe consequences.
2. **Margin of safety** → It is unclear why the wire length documented in the PMS was incorrect. However, overreliance on hoist limit switches to cut power to the winch electric motor is risky, whether on cranes or lifeboat davits. A high torque electric winch motor has the potential to over-stress the hoist wire, causing it to fail. It is always safer to stop the lifting operation before overhead capacity is reached, even if the system is correctly set up and the limit switch has been tested.

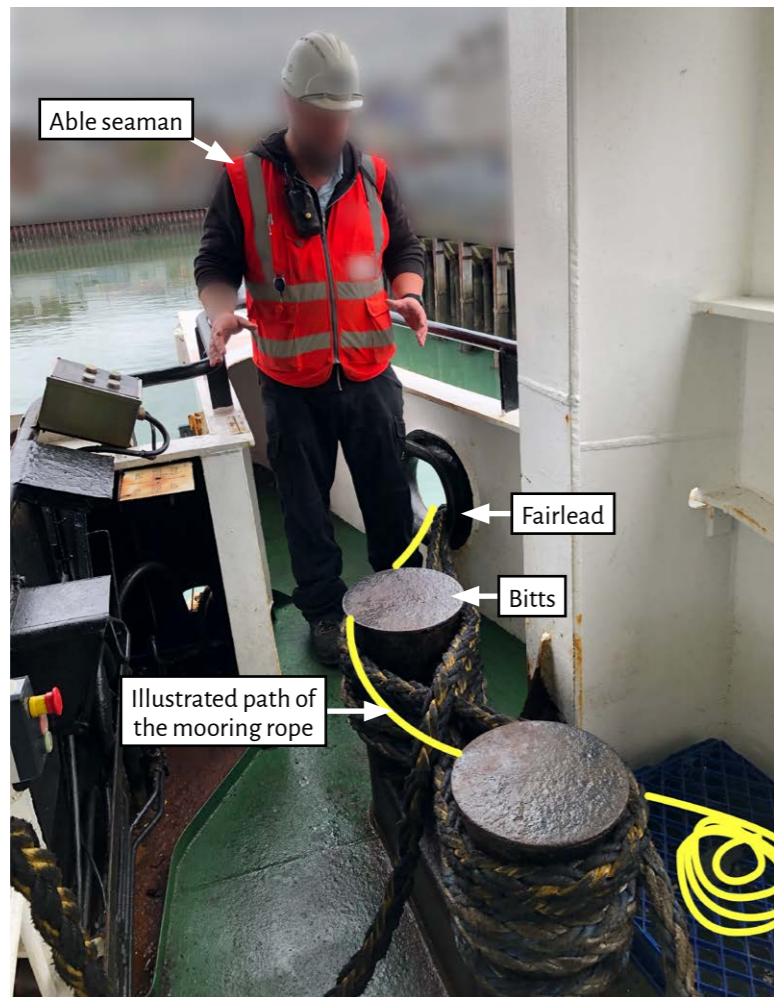
Figure 1: Reconstruction of the approximate position of the able seaman when he was struck by the mooring rope

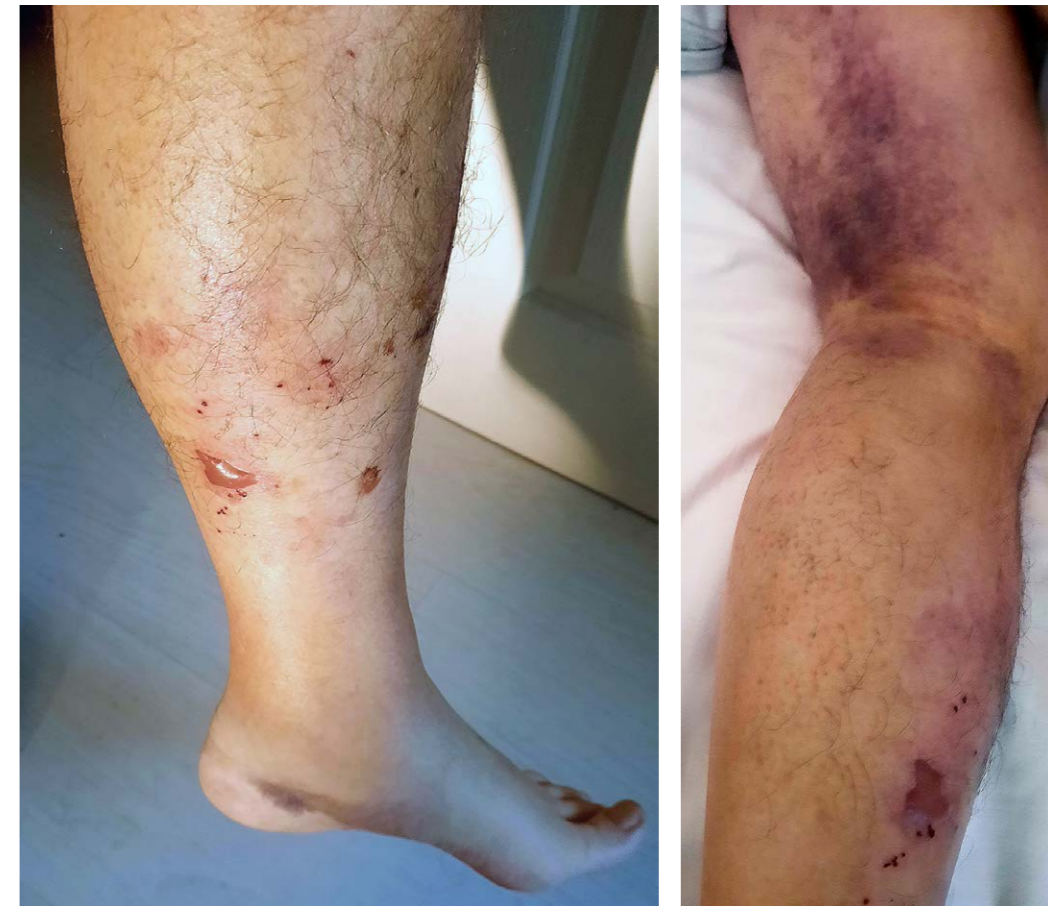
The AB suffered severe bruising and abrasions to his leg (Figure 2), but the injuries could have been much worse.

Figure 2: Leg injuries sustained by the able seaman

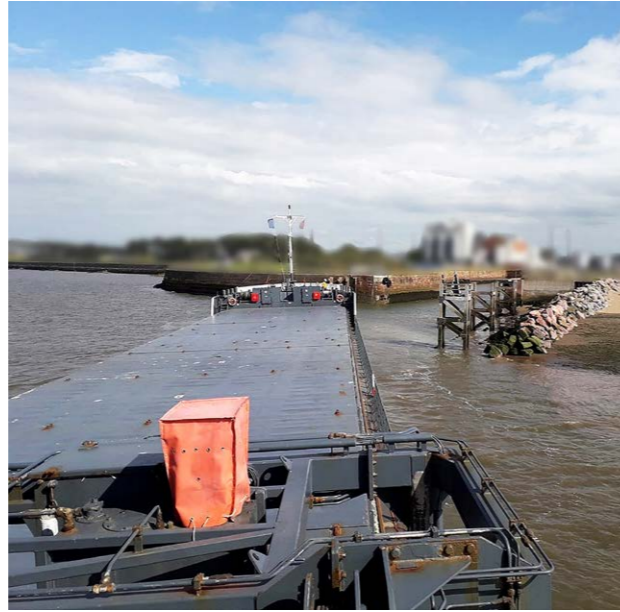
Figure 1: View from the starboard bridge wing towards the harbour entrance during the first grounding

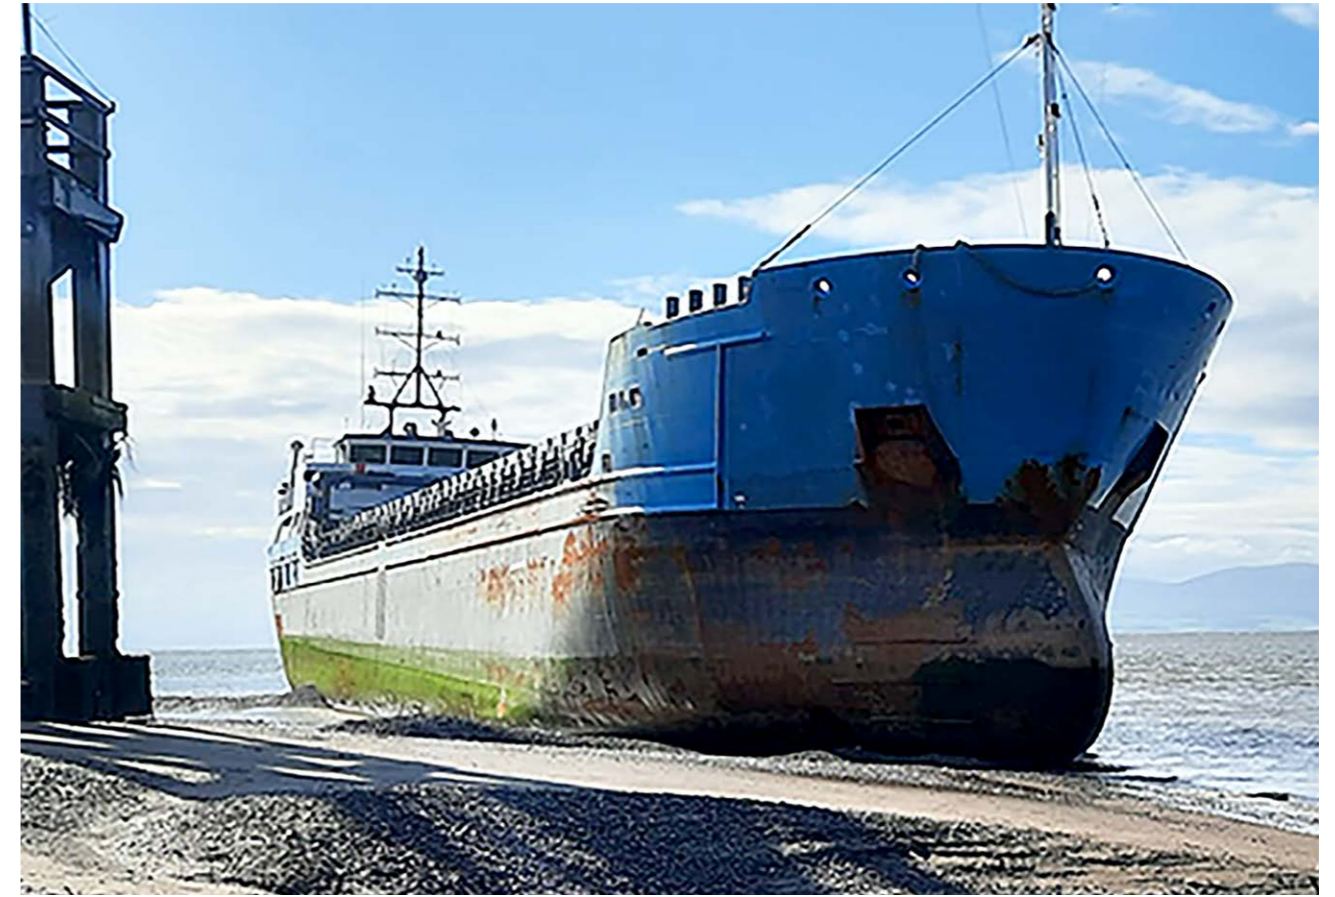
high tide to float off and eventually berthed 12.5 hours later than originally planned. The bulk carrier was undamaged but received a detention notice after a port state inspection, which delayed its departure.

Figure 2: Bulk carrier aground on the shoal in the approaches to the lock entrance

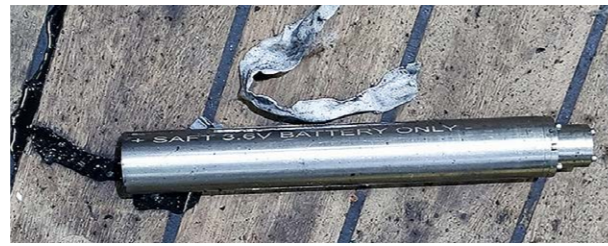
Seven hours later, the vessel's bridge team heard a loud bang followed by a fire detection system warning for the deepwater equipment storage area. The attending crew members discovered a scorched and damaged metal battery tube lying on the deck (Figure 1).

Figure 1: Damaged battery tube

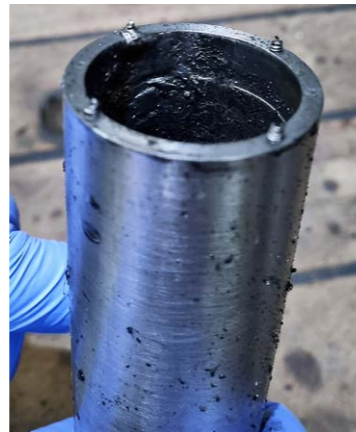
Examination of the battery tube indicated that sea water had leaked into the battery compartment (Figure 2) and contaminated the Li-ion battery, which caused pressurised gasses to build up and self-combust and resulted in a brief explosion. The remaining battery tubes were removed to a secure storage area for further checks.

Figure 2: Water ingress and damage

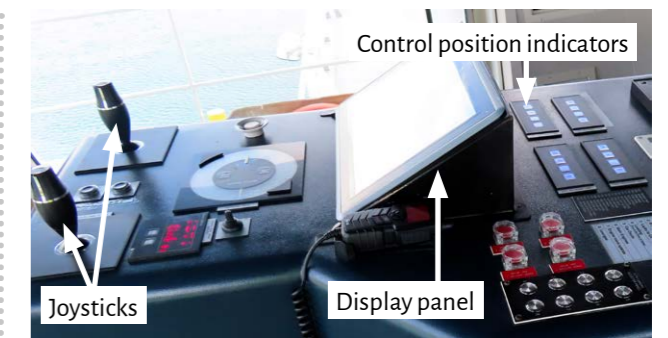
The master was using the starboard console (see figure) to manoeuvre the ferry out of port on the morning of the incident. The helmsman pressed the *command* button on the centre console to request control as normal and the audible tone sounded. The master, believing control had been passed, set the starboard console's joystick to the *zero* position. However, the VSP audible tone continued.

Figure: Voith Schneider Propeller control console

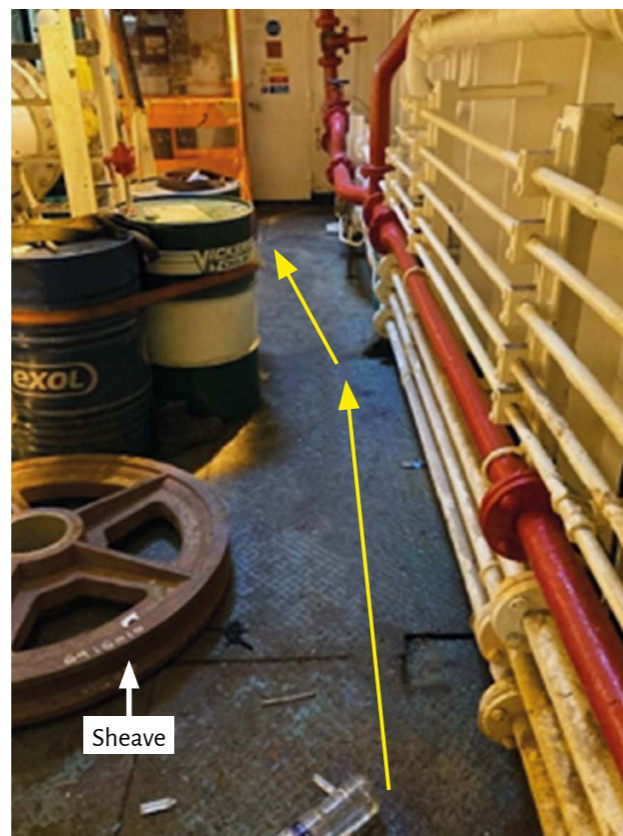
Figure 1: Planned route to move the sheave across the void space

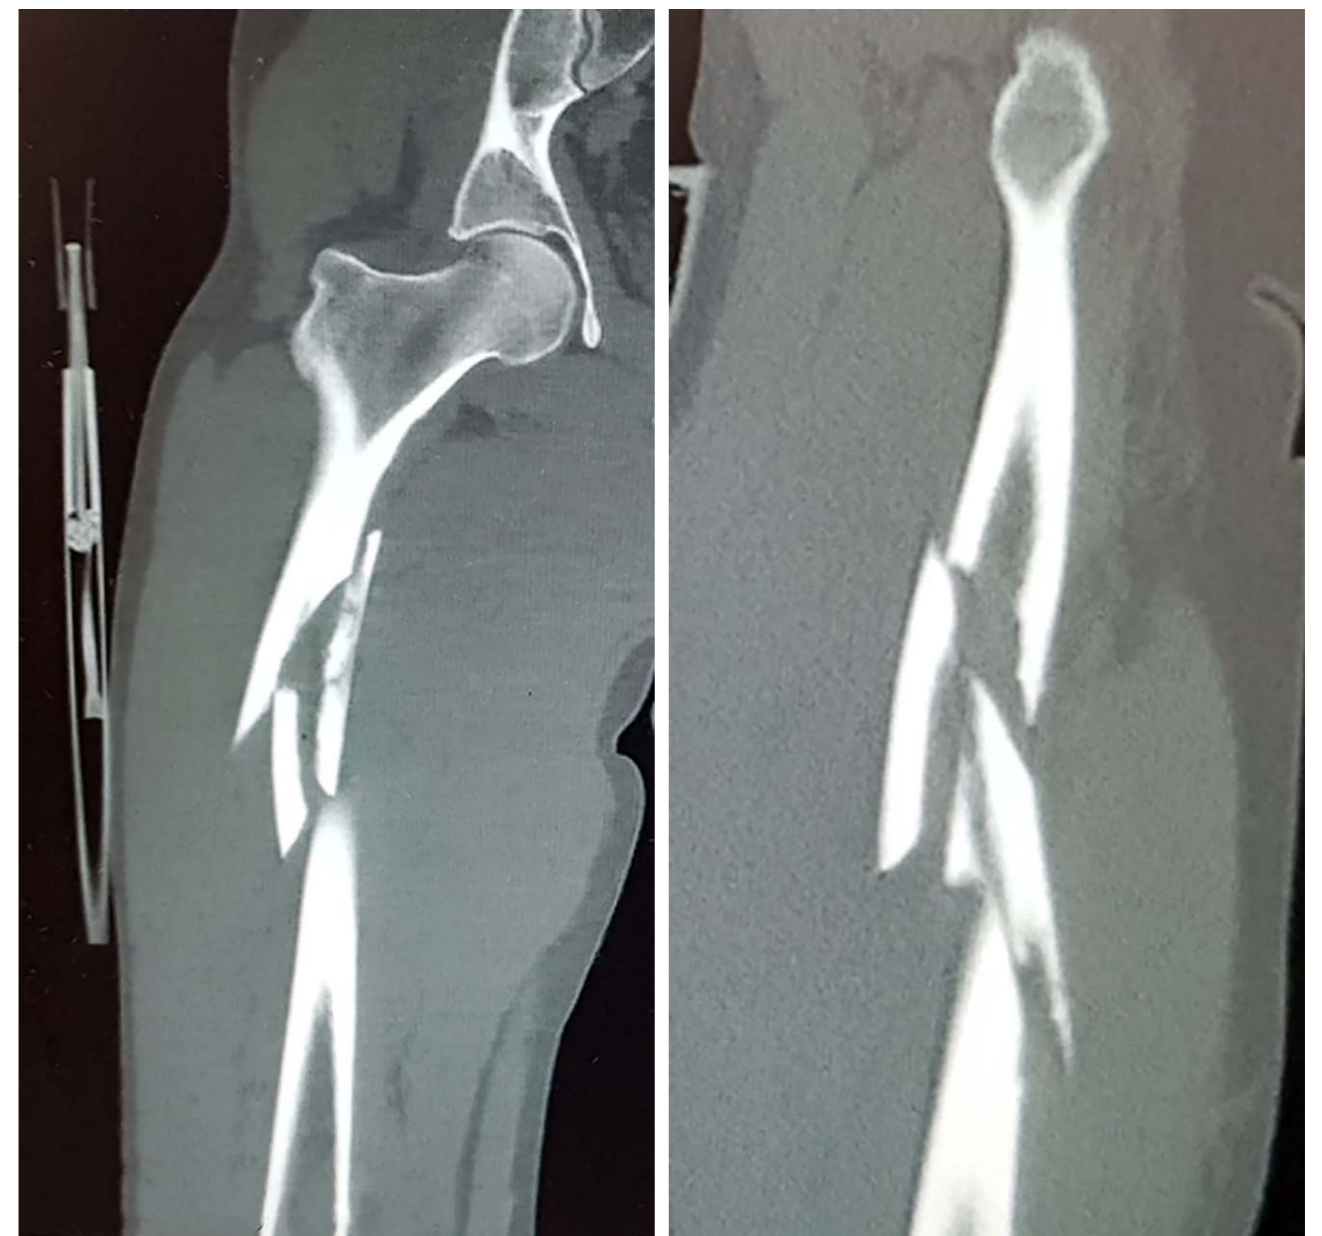
In considerable pain, the bosun managed to raise the alarm using his handheld radio. The crew mustered quickly, lifted the sheave off his leg and administered first aid. The dredger arrived at its berth and the bosun was transferred by ambulance to hospital, where he received treatment for multiple fractures to his leg (Figure 2). He was unable to return to work for several months.

Figure 2: X-ray images of the bosun's broken leg

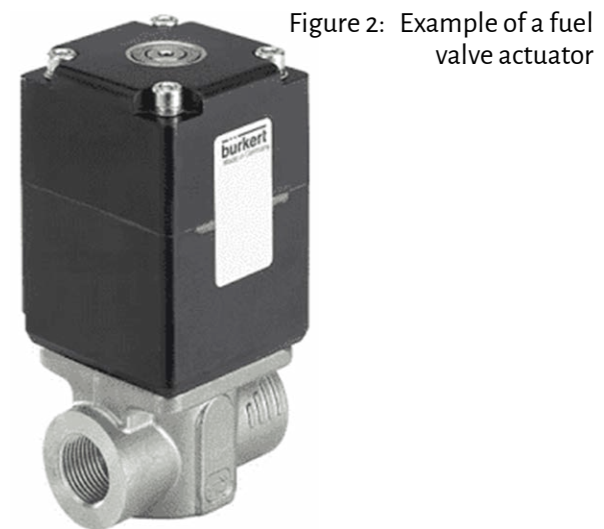
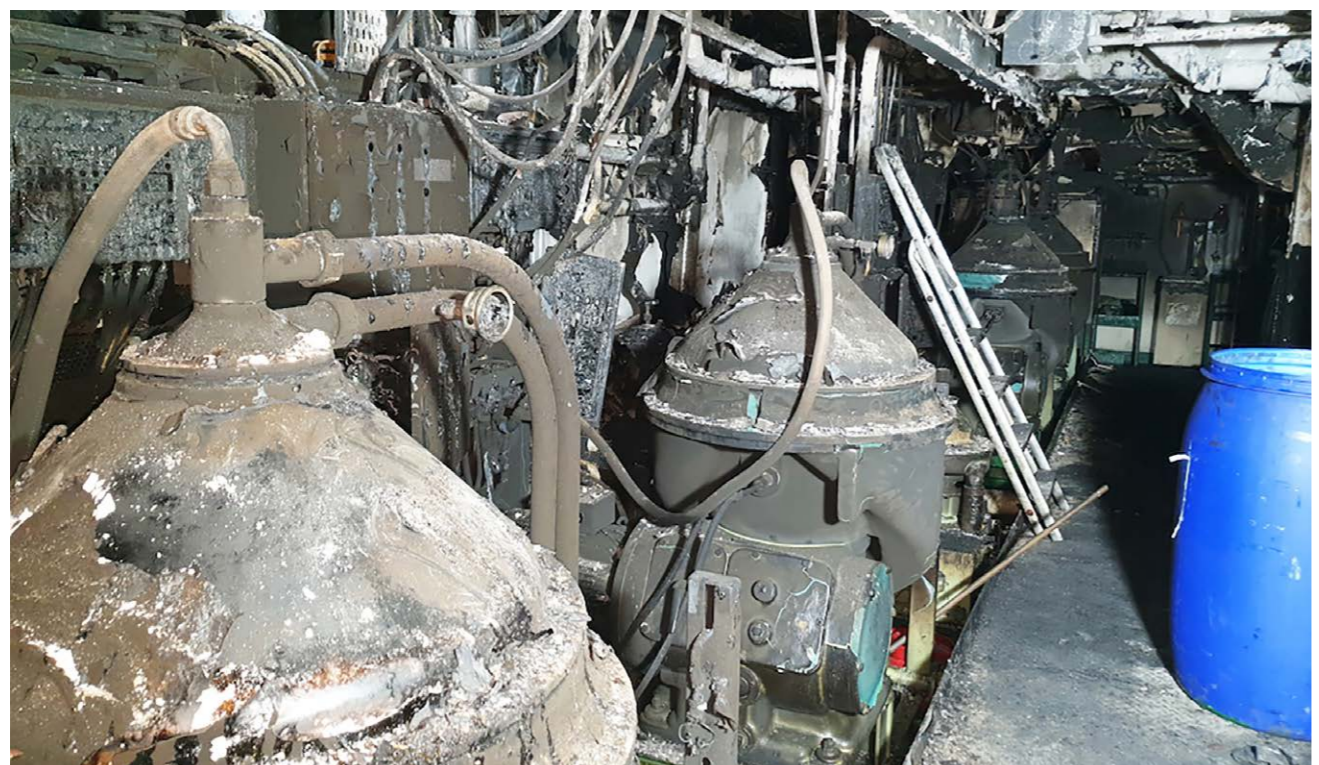
Figure 1: Fire-damaged fuel purifier room

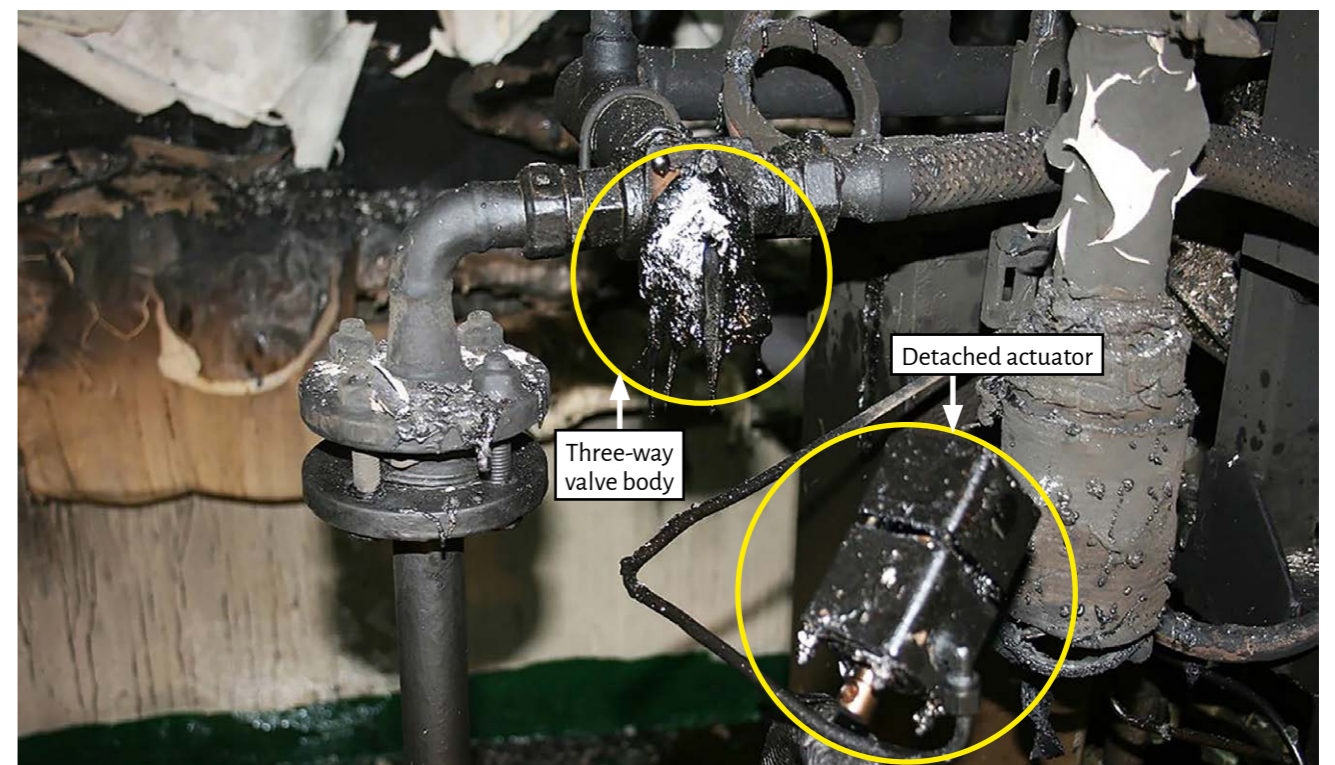
Examination of the equipment indicated that the fire had likely broken out due to gas oil spray emitted from a gas oil purifier system three-way

inlet fuel valve actuator (Figure 2). The actuator had become detached from the valve body and the whole assembly was severely damaged by fire and heat (Figure 3). Separation of the actuator and valve actuator spindle from the valve body allowed the fuel, operating at 2 bar pressure, to escape and spray over nearby heating and electrical equipment. On closer examination, the screws that secured the two parts of the actuator to the valve body were found to be slack.

Figure 3: Fire-damaged fuel valve actuator

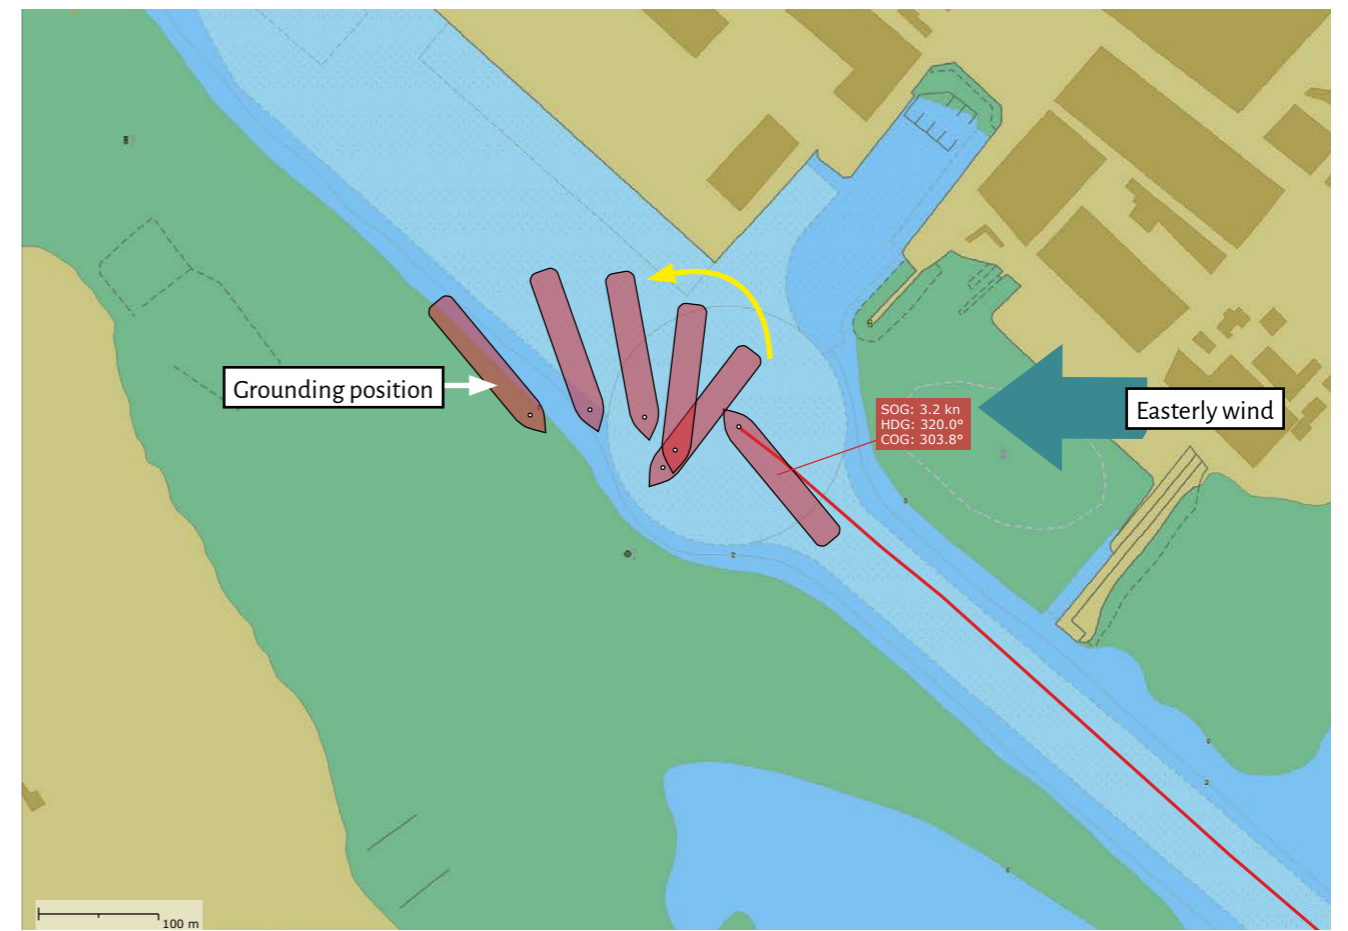
The master regained composure and manoeuvred the vessel off the mud and alongside the berth by paying out the anchor cable to help hold the bow against the wind. As a precaution, the intention was to have someone standing by the anchor's bitter end in case it needed to be let go; however, the crew could not find it and so this idea was dismissed. No damage was found when the vessel finally made it safely alongside and the anchor was recovered by tug later that day, without incident.

Figure: Cargo ferry's swing to port and subsequent grounding position

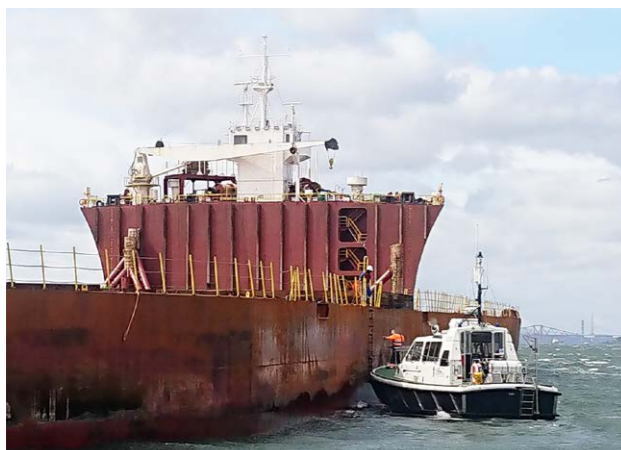
Figure 1: The transfer vessel alongside the cargo ship

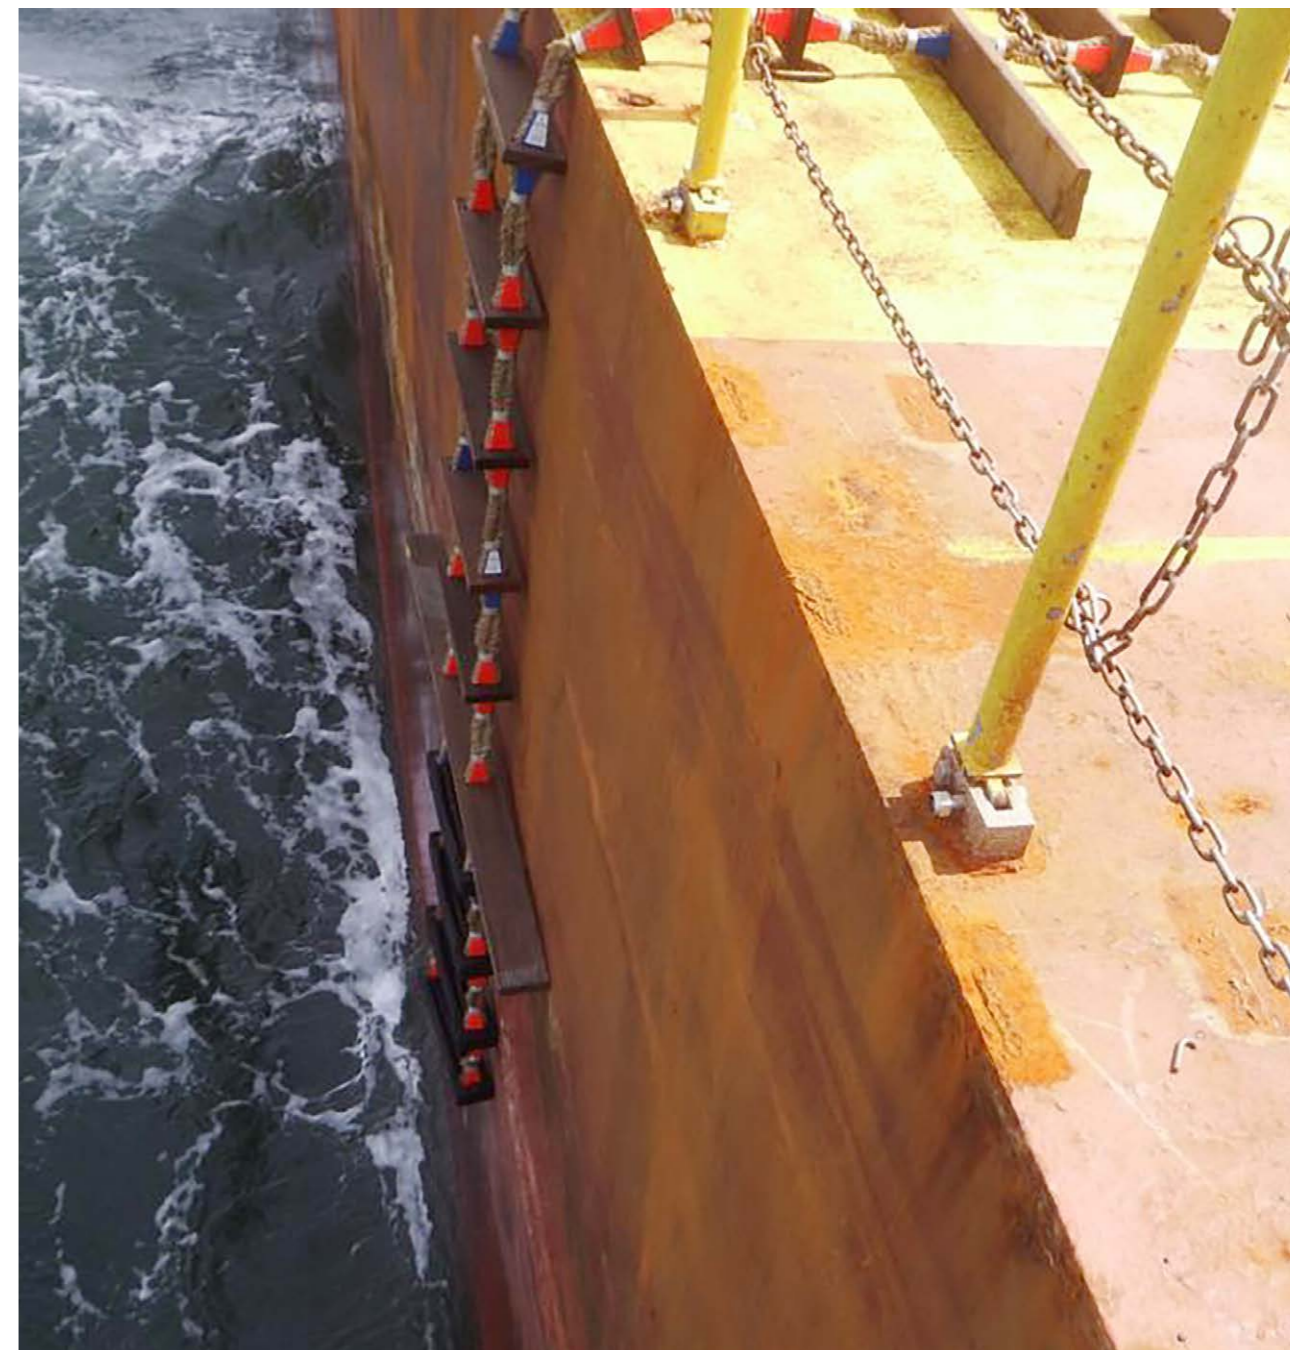
Figure 2: The cargo ship pilot ladder
