SAFETY DIGEST

Lessons from Marine Accident Reports

1/2023

MARINE ACCIDENT INVESTIGATION BRANCH

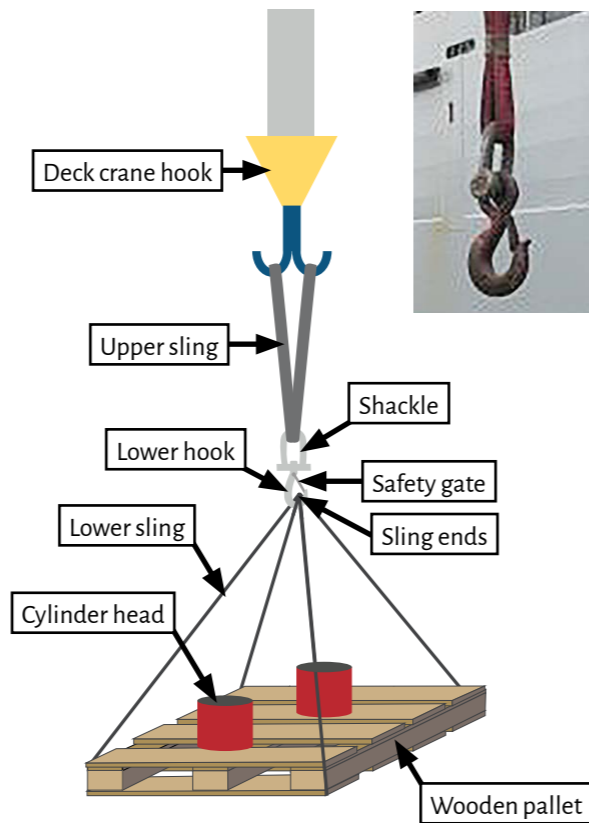
The initial lift of the wooden pallet was successful but when it was about 10m above the jetty the uppermost sling end slipped from the lower hook and flipped the pallet over, causing the cylinder heads to fall. Thankfully, the lifting operation plan ensured nobody was standing below the suspended load and damage was minimal; the falling cylinder heads caused a dent in both the jetty (Figure 2) and the operator's wallet.

Figure 1: Slinging arrangement and (inset) close-up of lower hook

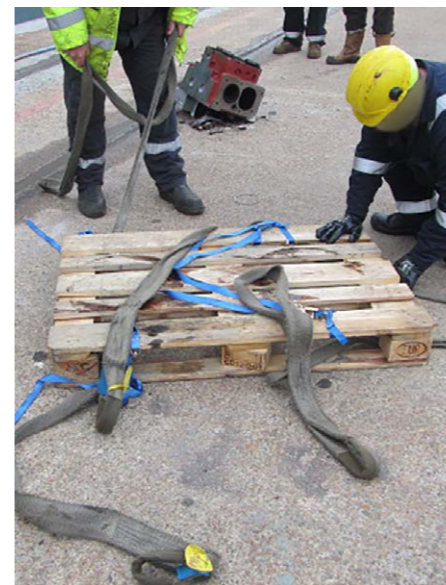
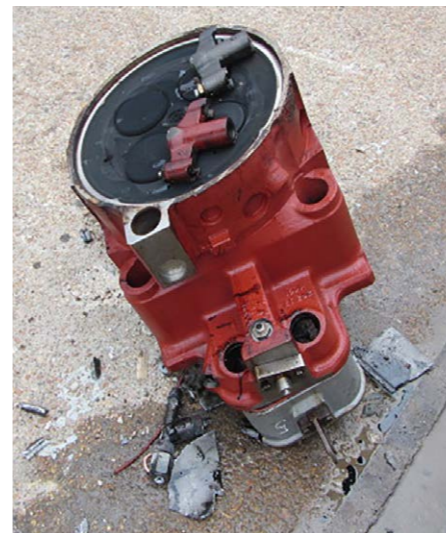
Figure 2: Wooden pallet and damaged cylinder head

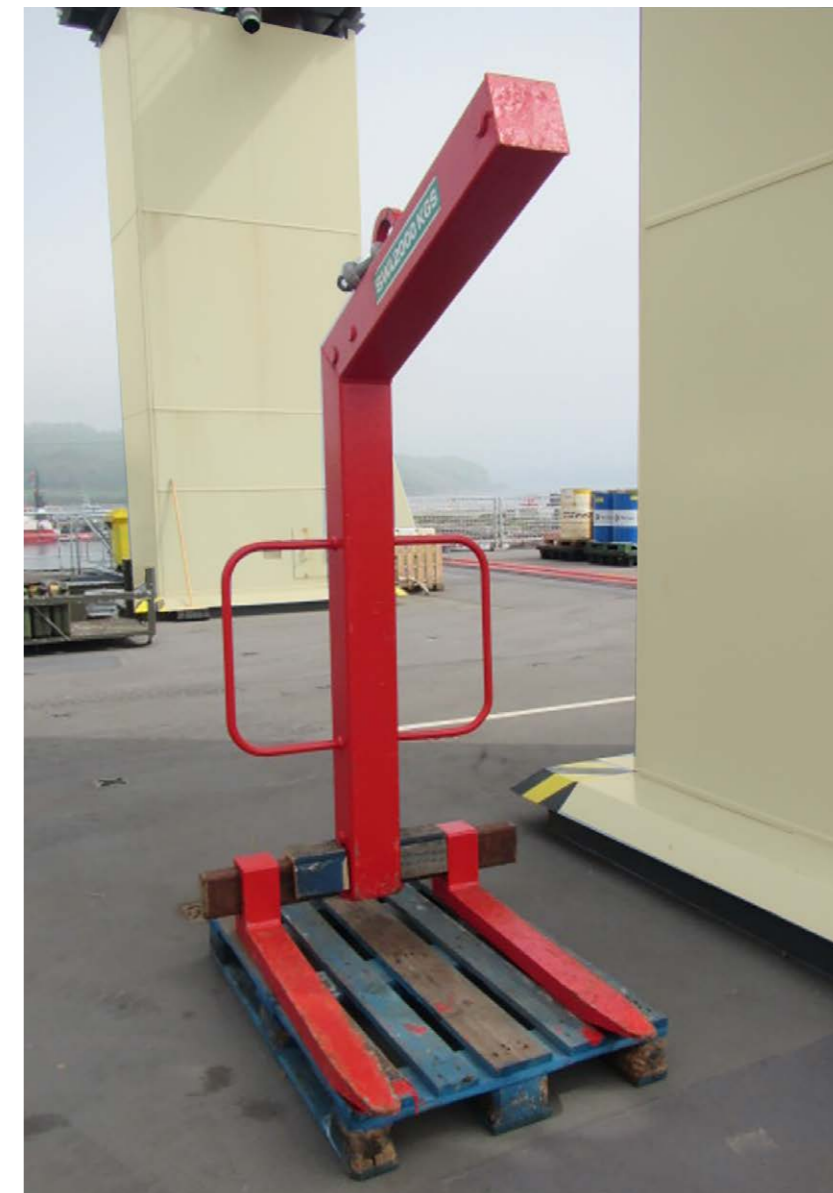
Figure 3: Wooden pallet fork-lift hook

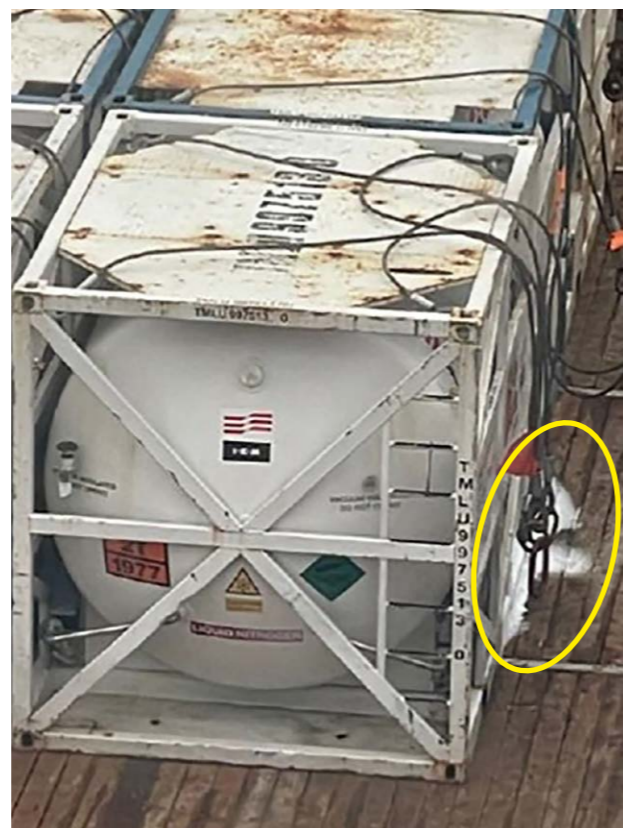
Figure 1: Icing of deck beneath nitrogen tank container

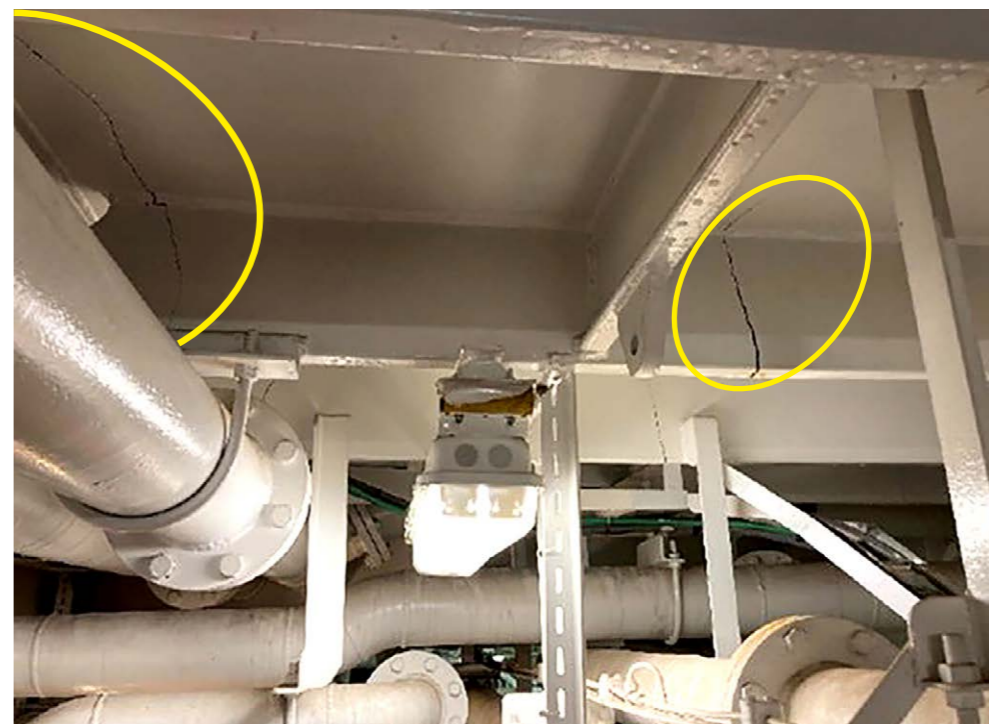
Figure 2: Cracks in the supporting steelwork

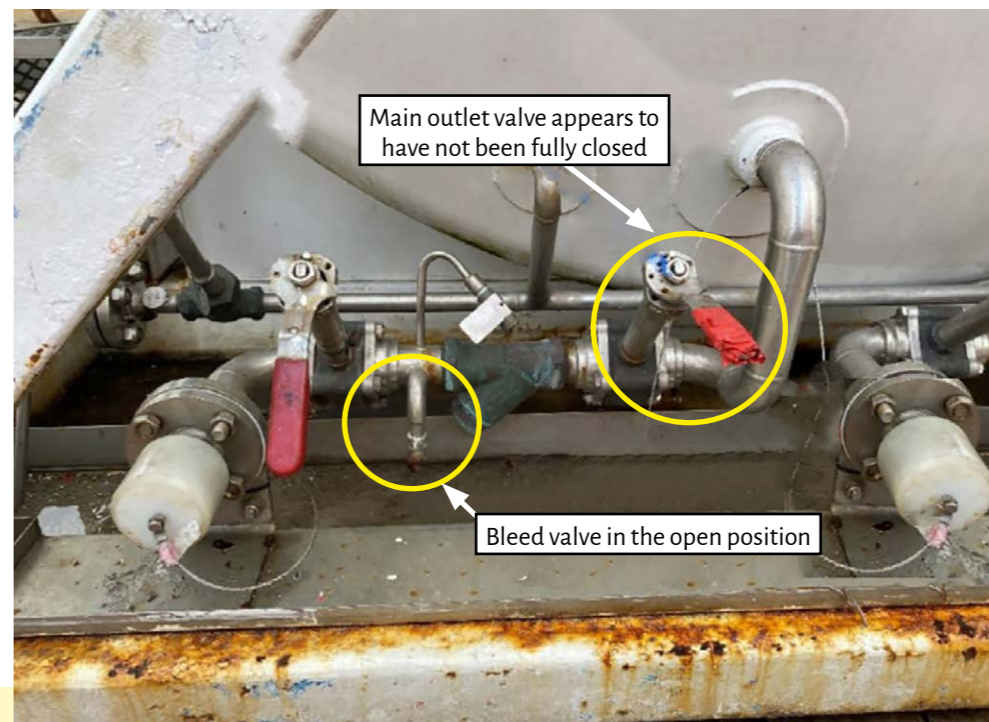
A post-incident inspection found that both the main outlet valve and the bleed valve on the nitrogen container, which was not locked, were slightly open and had allowed the nitrogen to leak out through the open bleed valve (Figure 3).

Figure 3: Tank outlet valves

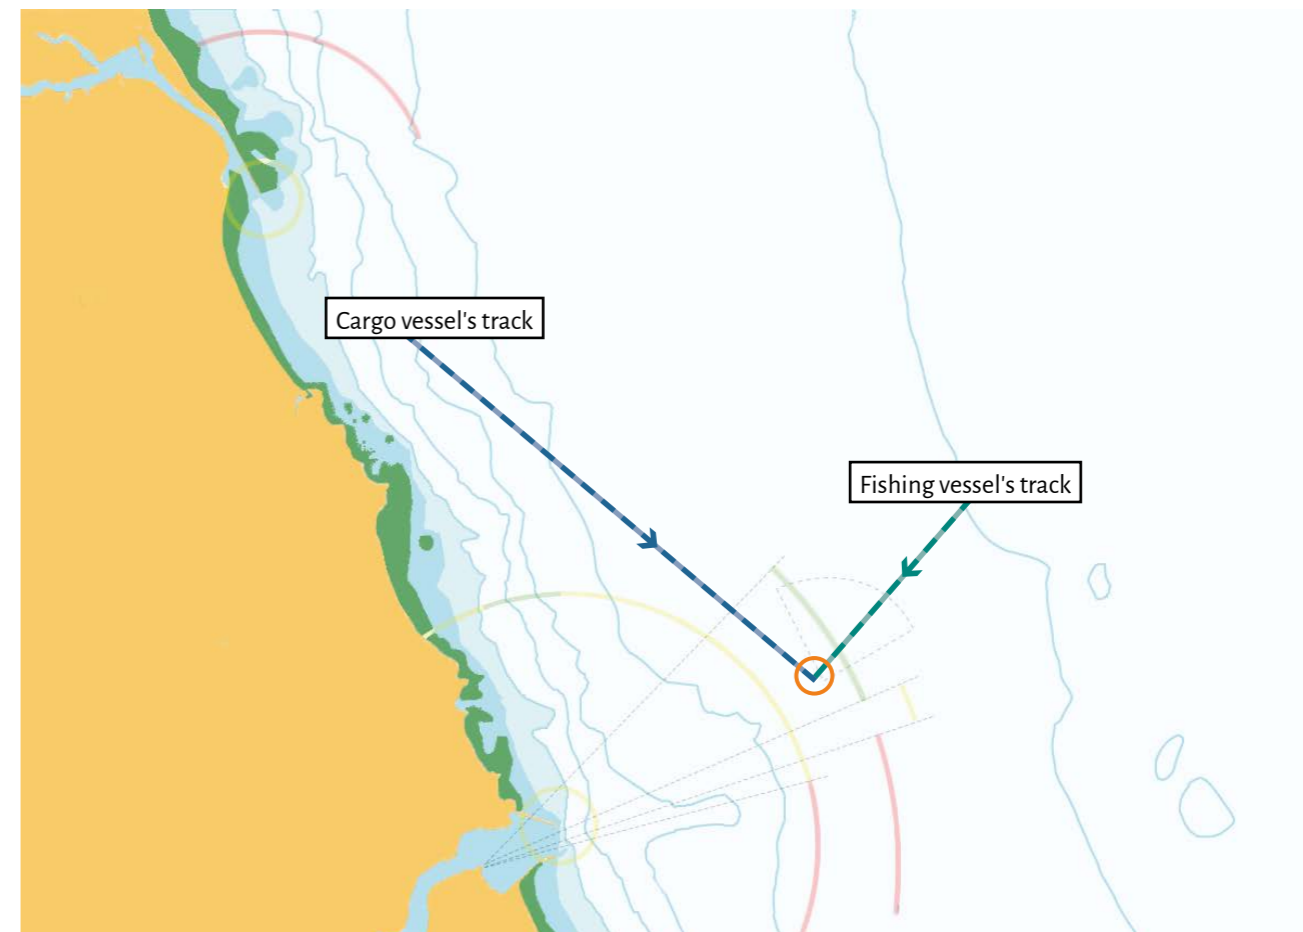
The fishing boat's bow was severely damaged and water flooded the forward space. Despite the efforts of the crew and local boats, it sank 2 hours later while being towed back into port. The crew were rescued without injury.

Figure: Tracks of both vessels up to point of collision

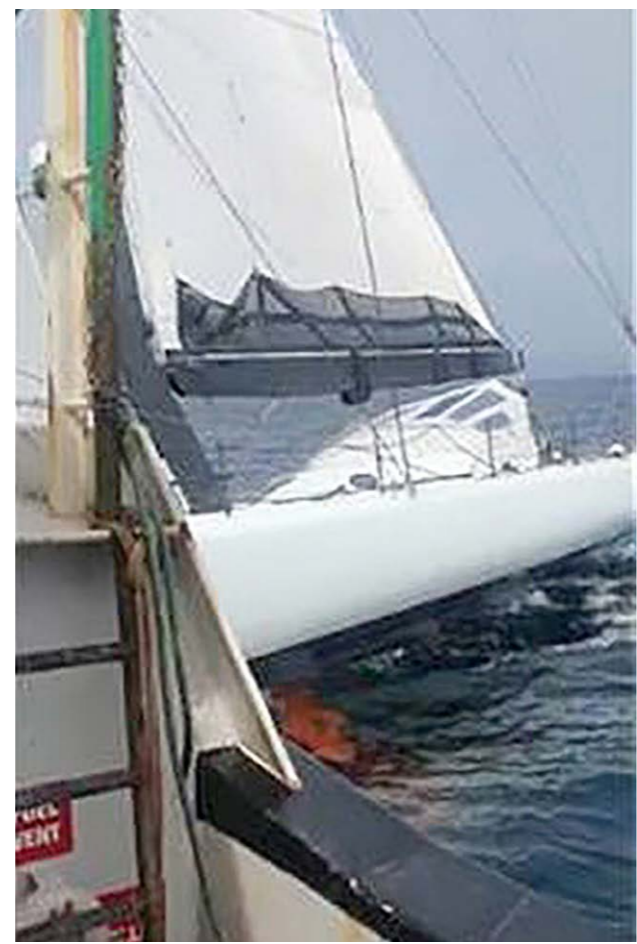
A few minutes later the 20m yacht passed about 1m ahead of the fishing vessel, travelling at about 8kts (see figure). The skipper and crew member on board the fishing vessel could see that neither the yacht's cockpit nor deck was manned as it passed them. The fishing vessel's skipper subsequently reported the incident to the coastguard.

Figure: The near miss

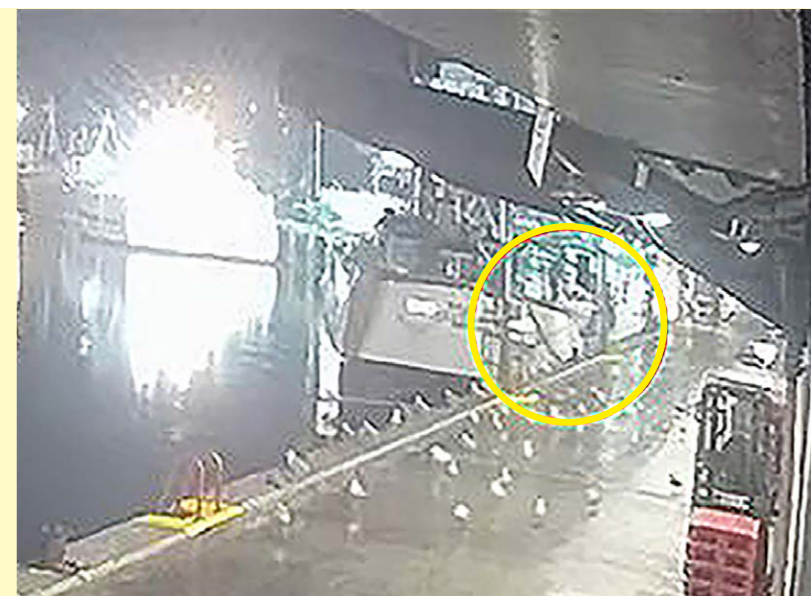
Figure 1: CCTV still of whelk trawler berthing

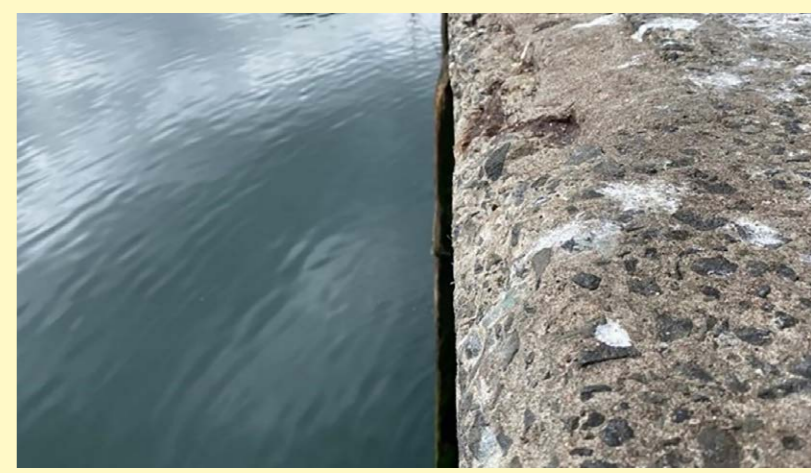
Figure 2: The sloping quayside

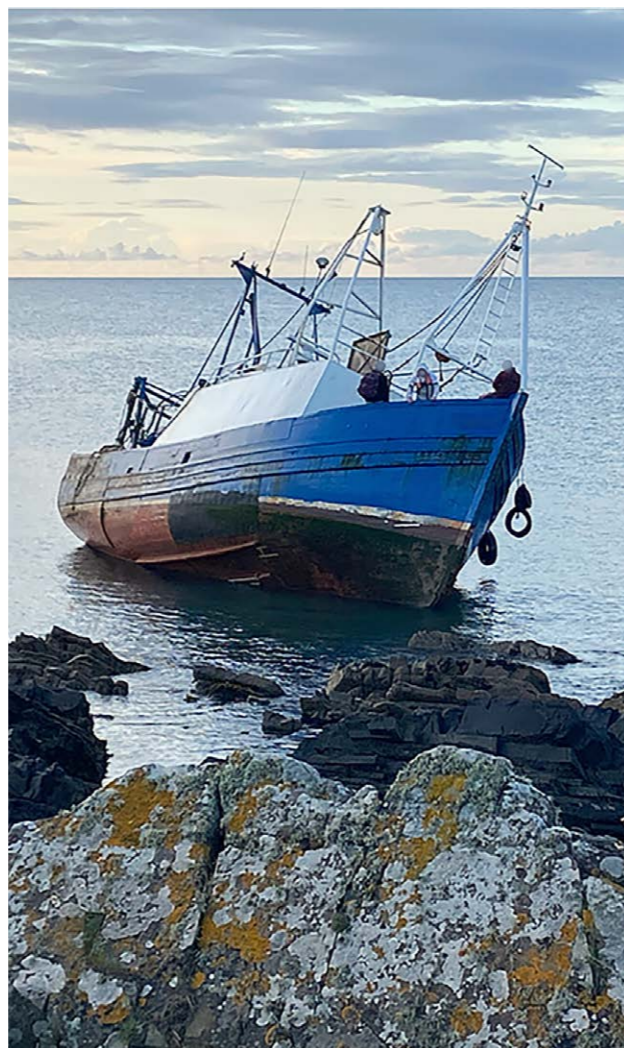
The skipper had been awake for about 20 hours at the time of the accident. Thankfully, the crew found only minor damage during an inspection of the hull and it was quickly repaired. The vessel was later refloated and returned to its home port under its own power.

Figure: The fishing vessel aground

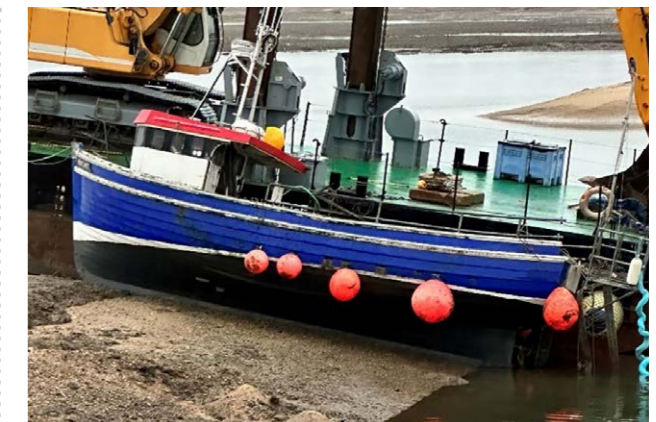
The wooden hull was fastened with nails, some of which the owner had identified in recent years as rusted below the waterline; these had been marked up and replaced when the vessel was lifted out of the water during its repair periods, although this had not taken place within the previous 12 months. The sunken vessel was eventually raised and the source of the leak was found to be failure of its hull due to a rusted and badly corroded nail.

Figure: The potting vessel

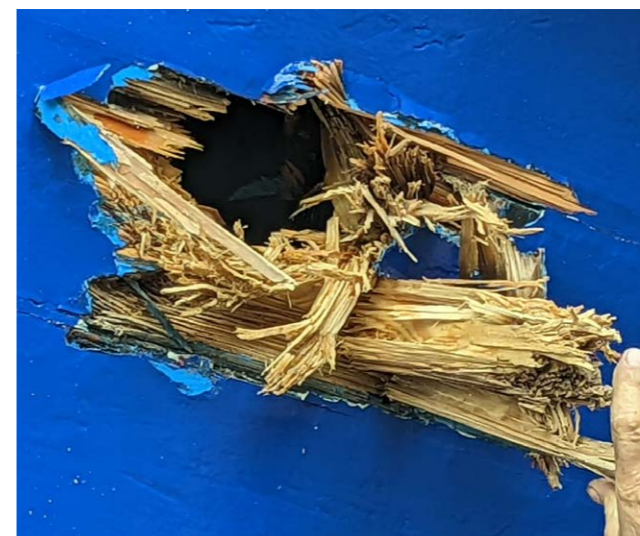
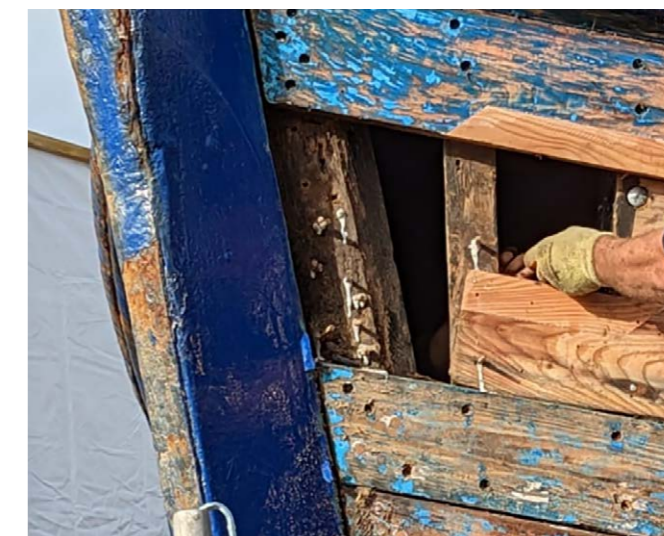
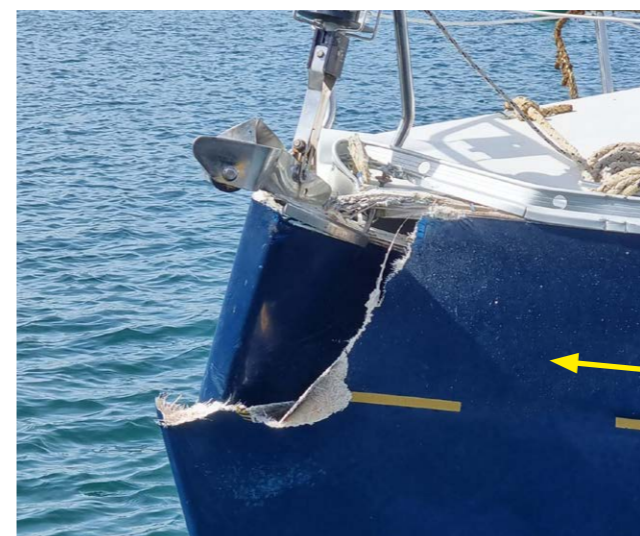
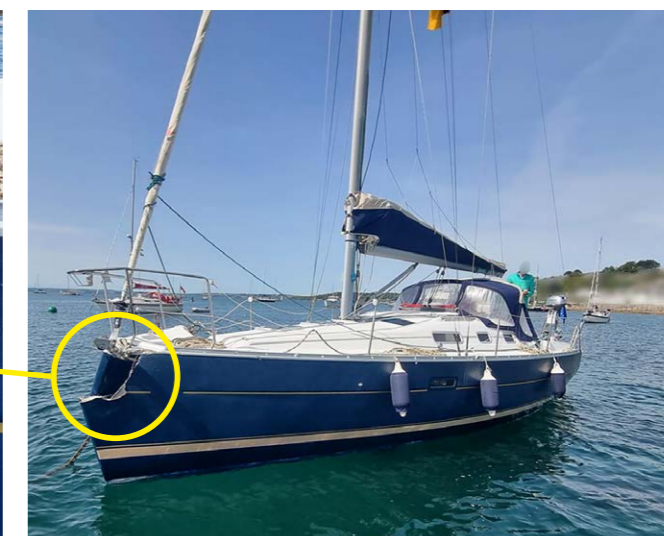
Although damaged (see figure) neither vessel was taking on water and both were able to return to port unaided to carry out necessary repairs.

Figure: The damaged fishing vessel (above) and yacht (below)

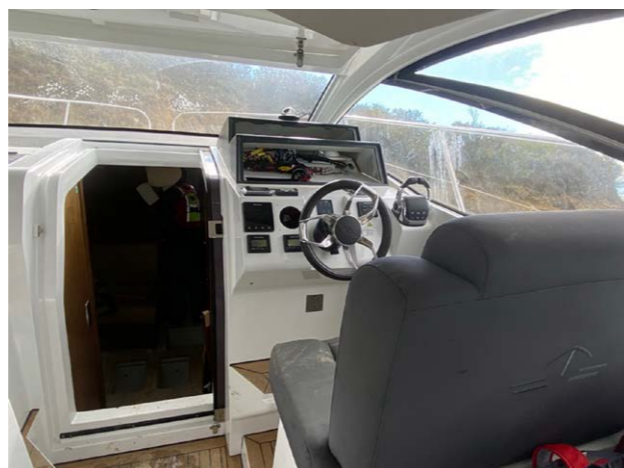
The mood on board was buoyant as the crew discussed their day. One crew member went to find a jumper and in doing so switched on all the lights in the forward cabin (Figure 1) and along the passageway. The skipper's night vision was compromised by a combination of the glare created by the bright cabin lights and spray on

Figure 1: View from inside main cabin

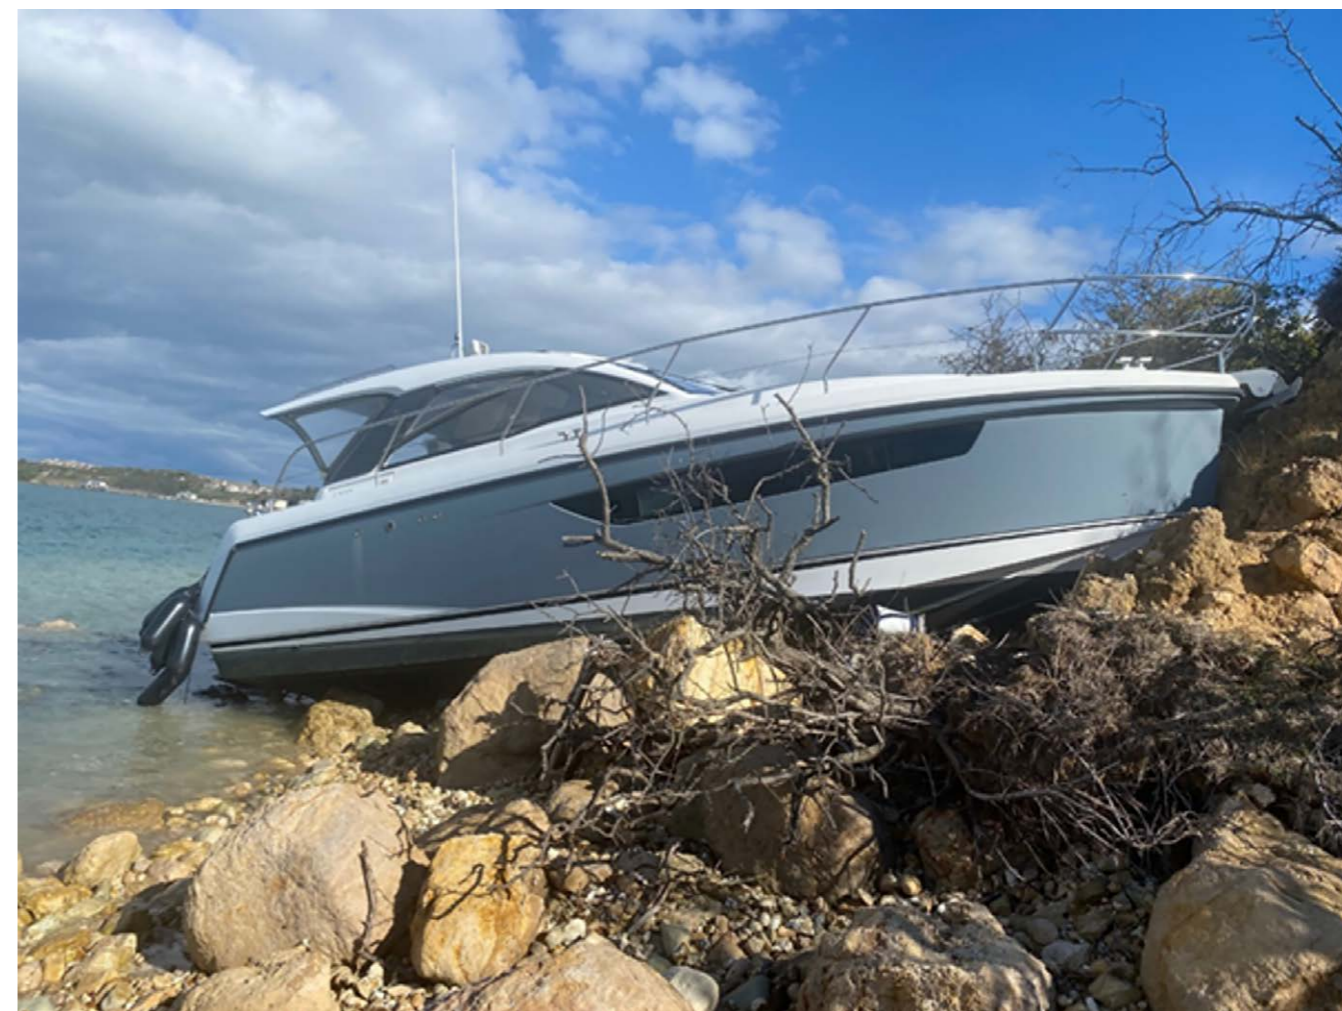
At least two crew members were found to need immediate medical attention when the group came to after the impact. Calls to the emergency services elicited a swift response and the two most seriously injured crew were airlifted to a specialist hospital for treatment. The remainder were taken to a nearby hospital for assessment. The motor cruiser was a write off.

Figure 2: Motor cruiser aground on rocky shoreline

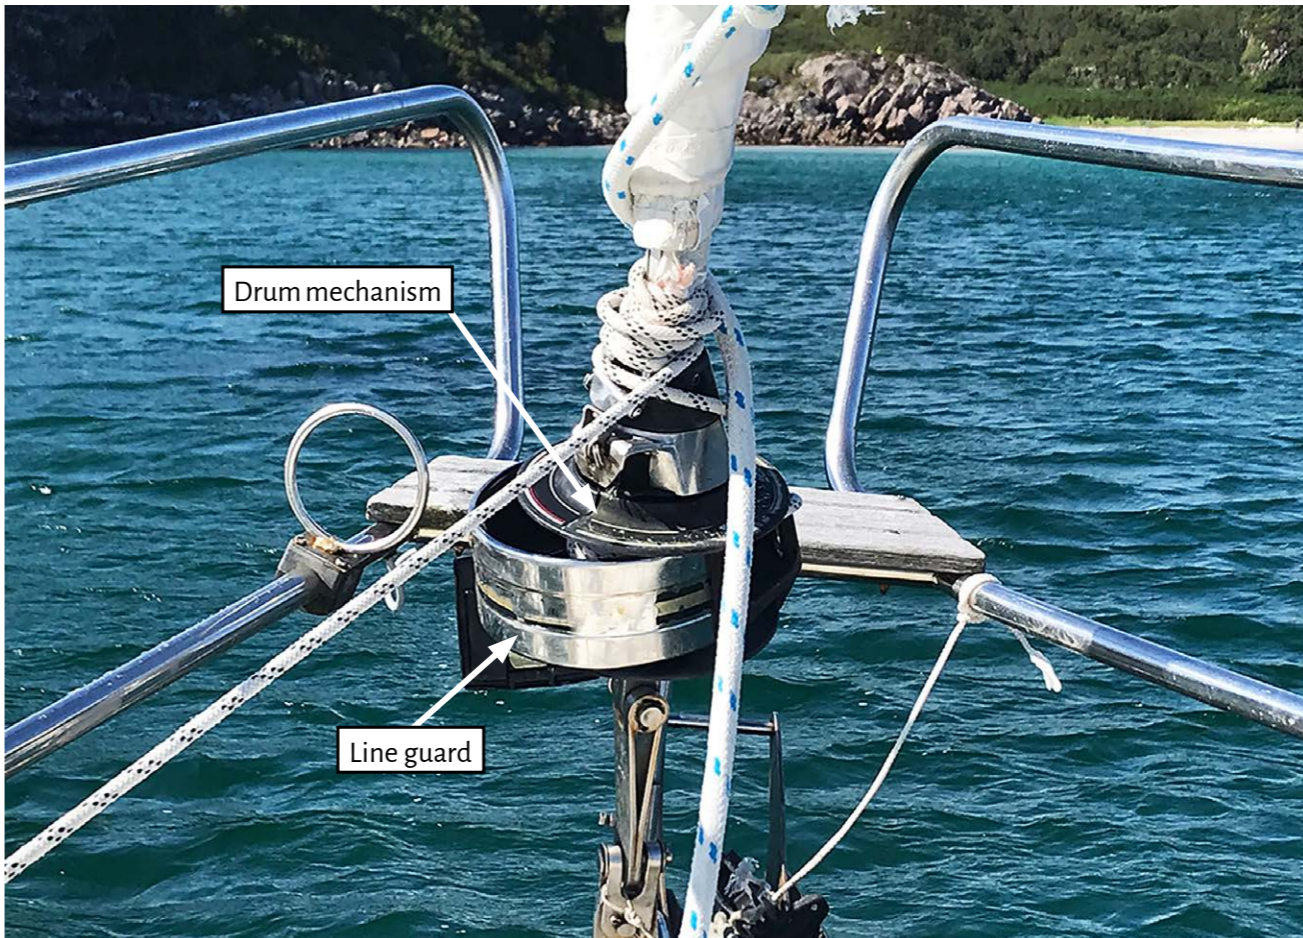
Figure: Defective furling gear with a gap between the line guard and the drum

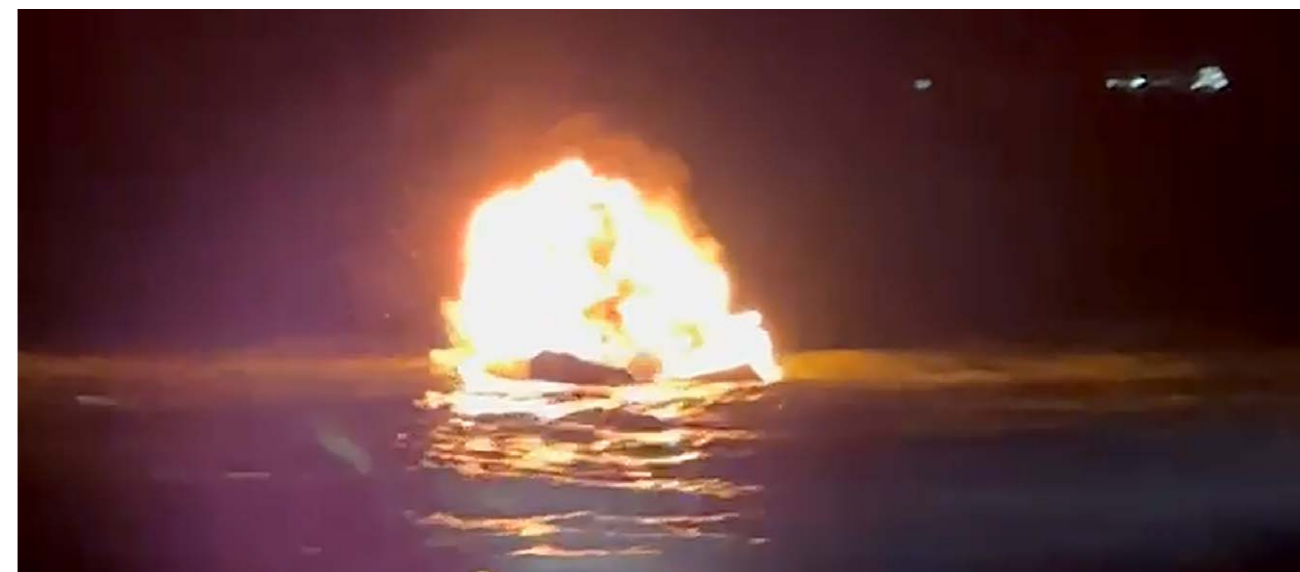
Figure 1: RNLi video still, showing cabin engulfed in flames

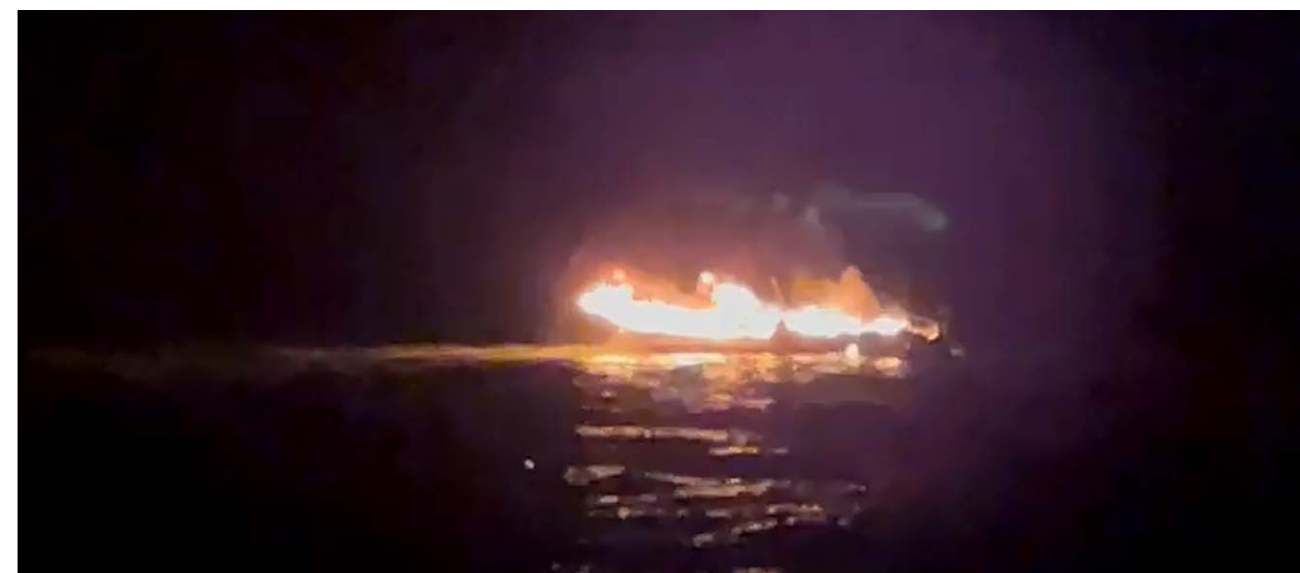
Once clear of the burning boat (Figure 1) the skipper called the coastguard on his handheld VHF radio and then attended to his crew member, who had badly twisted their ankle while scrambling to get into the liferaft. A nearby pilot boat diverted to attend the scene and was soon joined by the lifeboat. The skipper and crew member were recovered safe and well. The boat was lost (Figure 2).

Figure 2: RNLi video still, showing whole cabin destroyed by flames with only the hull remaining intact

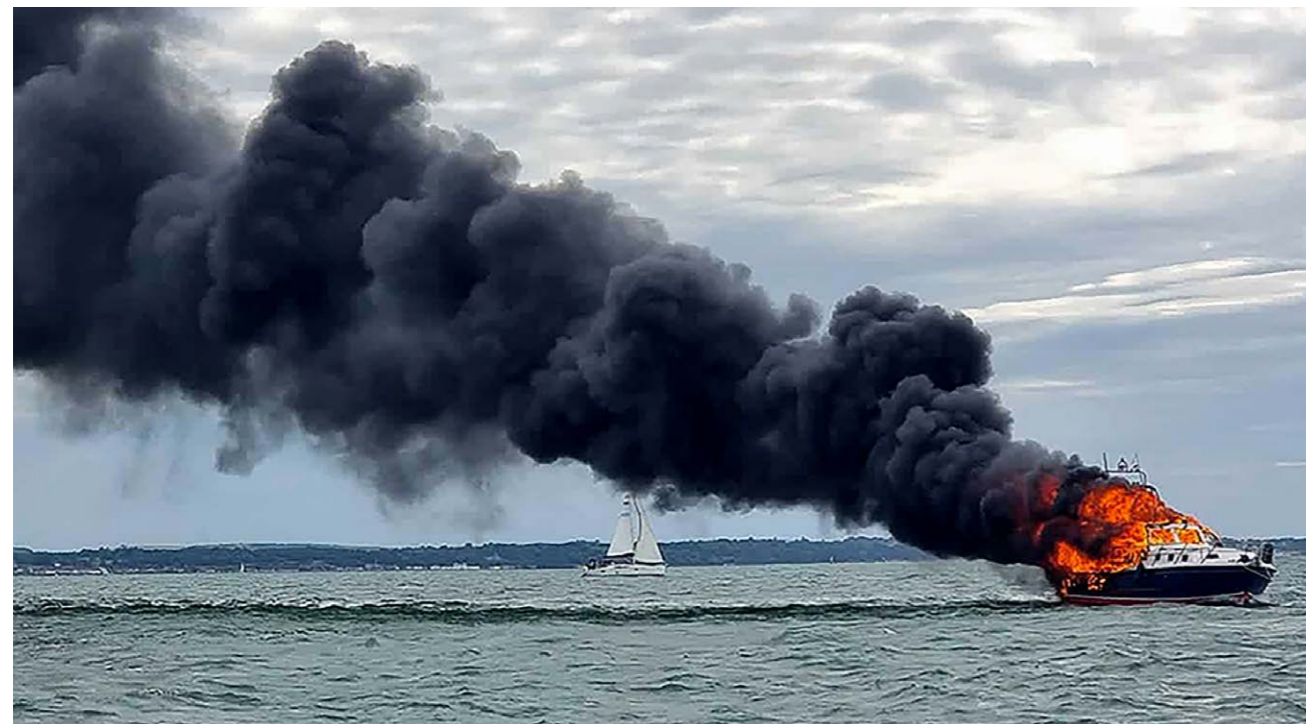
Figure 1: Motor cruiser after crew abandoned it

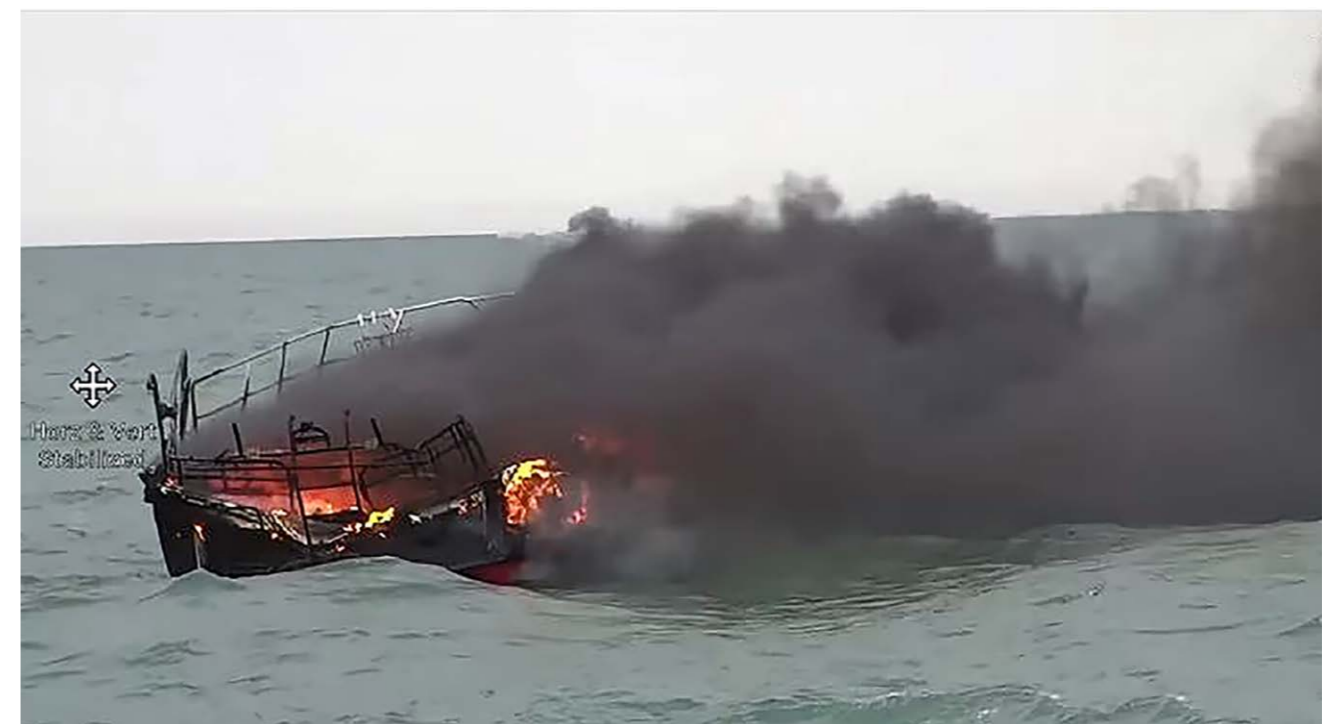
towline to set its anchor. A duty tug from the port also attended and attempted to extinguish the fire; however, this was unsuccessful and the vessel sank, extinguishing the fire and resulting in diesel fuel and debris entering the surrounding water (Figure 2).

Figure 2: Remains of motor cruiser before it sank

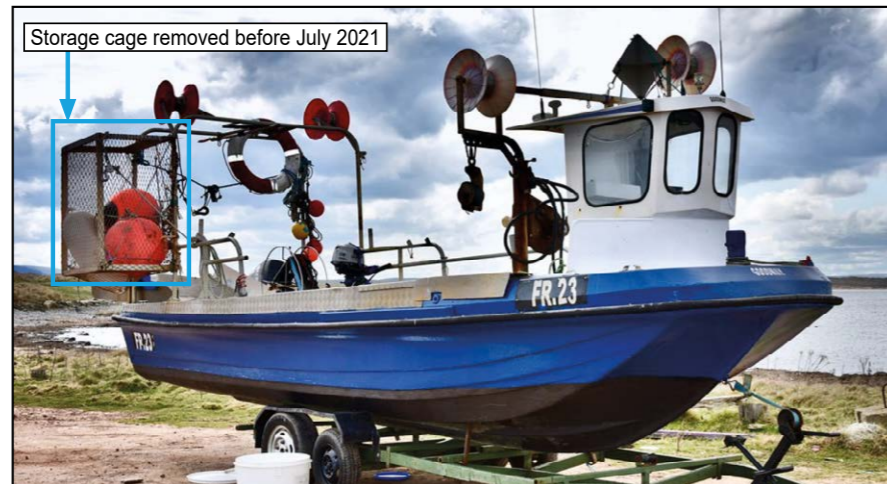
Figure 1: *Goodway*

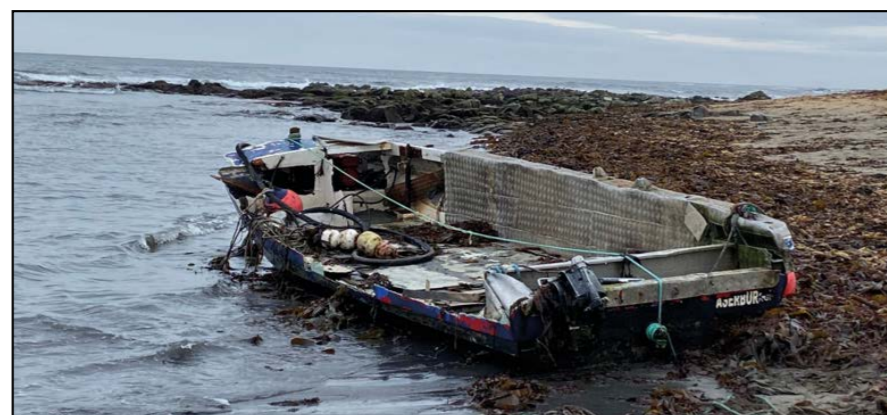
Figure 2: The wreck of *Goodway* washed ashore on Cairnbulg Point
