Issued May 22, 2023

MIR-23-09

Collision between Bulk Carrier *Bunun Queen* and Offshore Supply Vessel *Thunder*

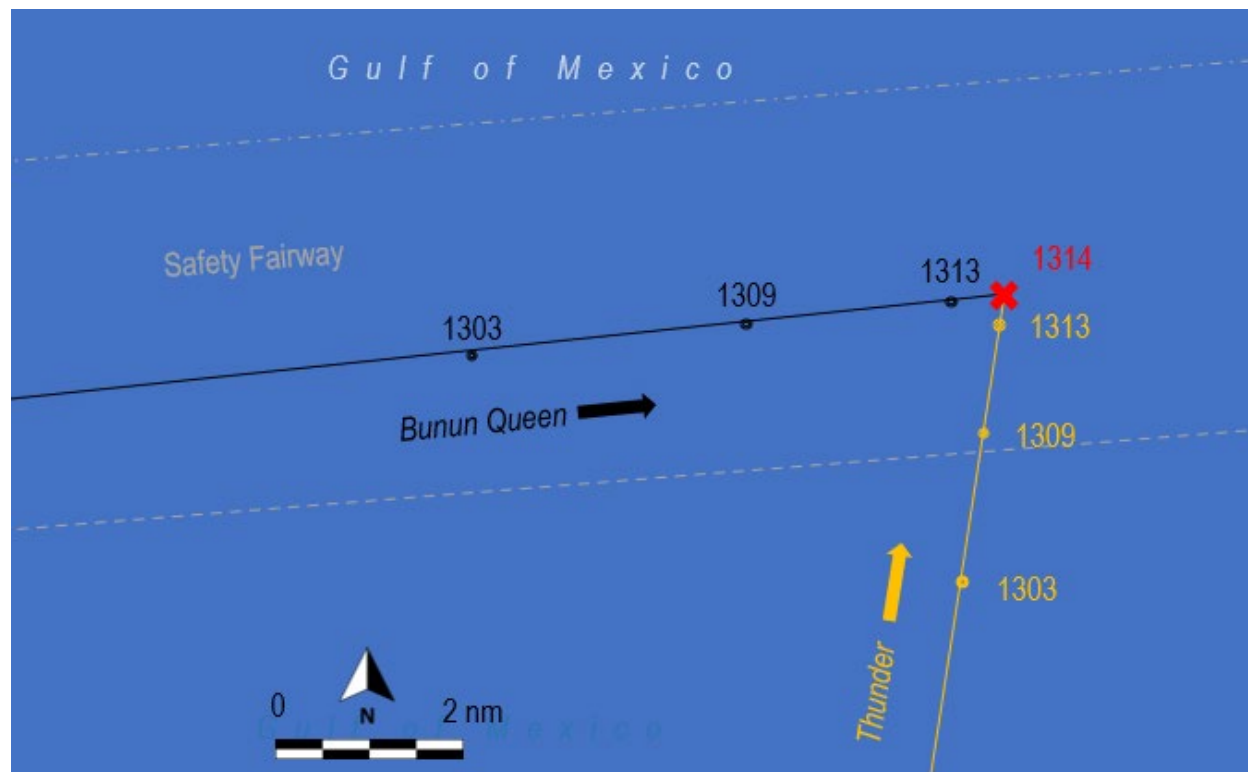
Figure 3. Tracklines of the *Bunun Queen* and *Thunder* leading up to the collision, based on VDR data.

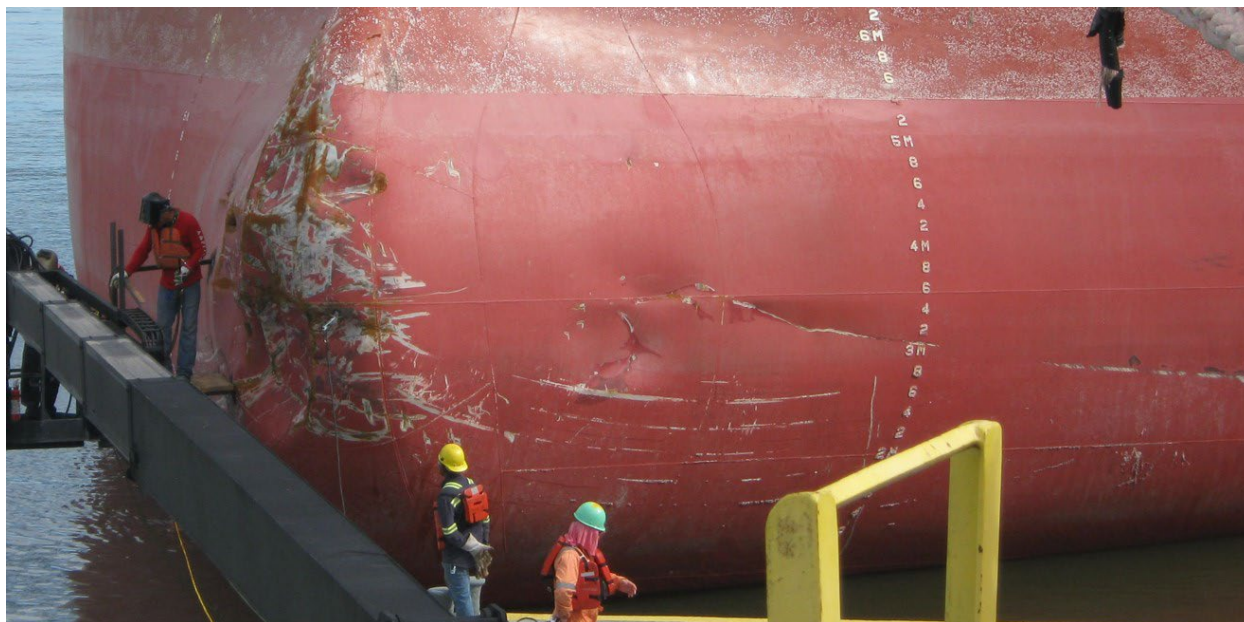
Damage to the *Bunun Queen's* port bow consisted of indentations and deformation of the shell plating above the waterline at water ballast tank no. 1 port. The vessel's bulbous bow sustained multiple dents, a crack, and a hull fracture of the shell plating, which caused water to enter the forepeak tank. The cost of repairs was about \$680,000.

Figure 4. Damage to the bulbous bow of the *Bunun Queen*. (Source: US Coast Guard)

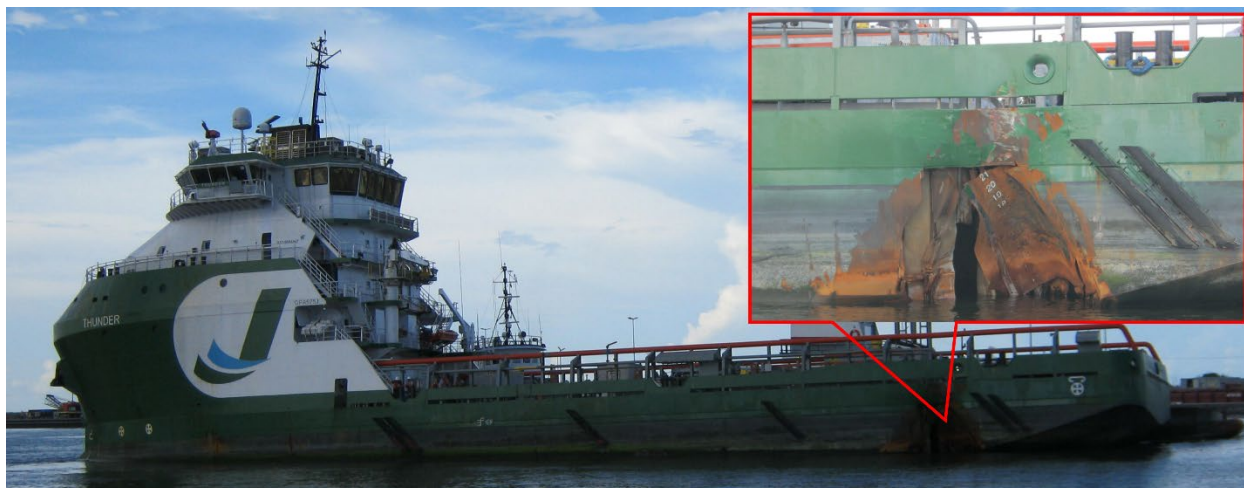
The *Thunder* sustained damage to its port side aft consisting of a large penetration above and below its waterline that caused flooding in the port side propulsion room, the port cargo tank (empty at the time), a void space, and the no. 7 port ballast tank. The cost of repairs was about \$11,598,078.

Figure 5. The *Thunder* being towed to a dock in Port Fourchon after the collision. The inset shows the damage to the aft port side of the vessel. (Source: Coast Guard)
