Fatal Accidents During Marine Transport of Wood Pellets Due to Off-Gassing: Experiences from Denmark

Frank Huess Hedlund and
Øssur Jarleivson Hilduberg

Keywords: wood pellets, off-gassing, confined space, accident investigation

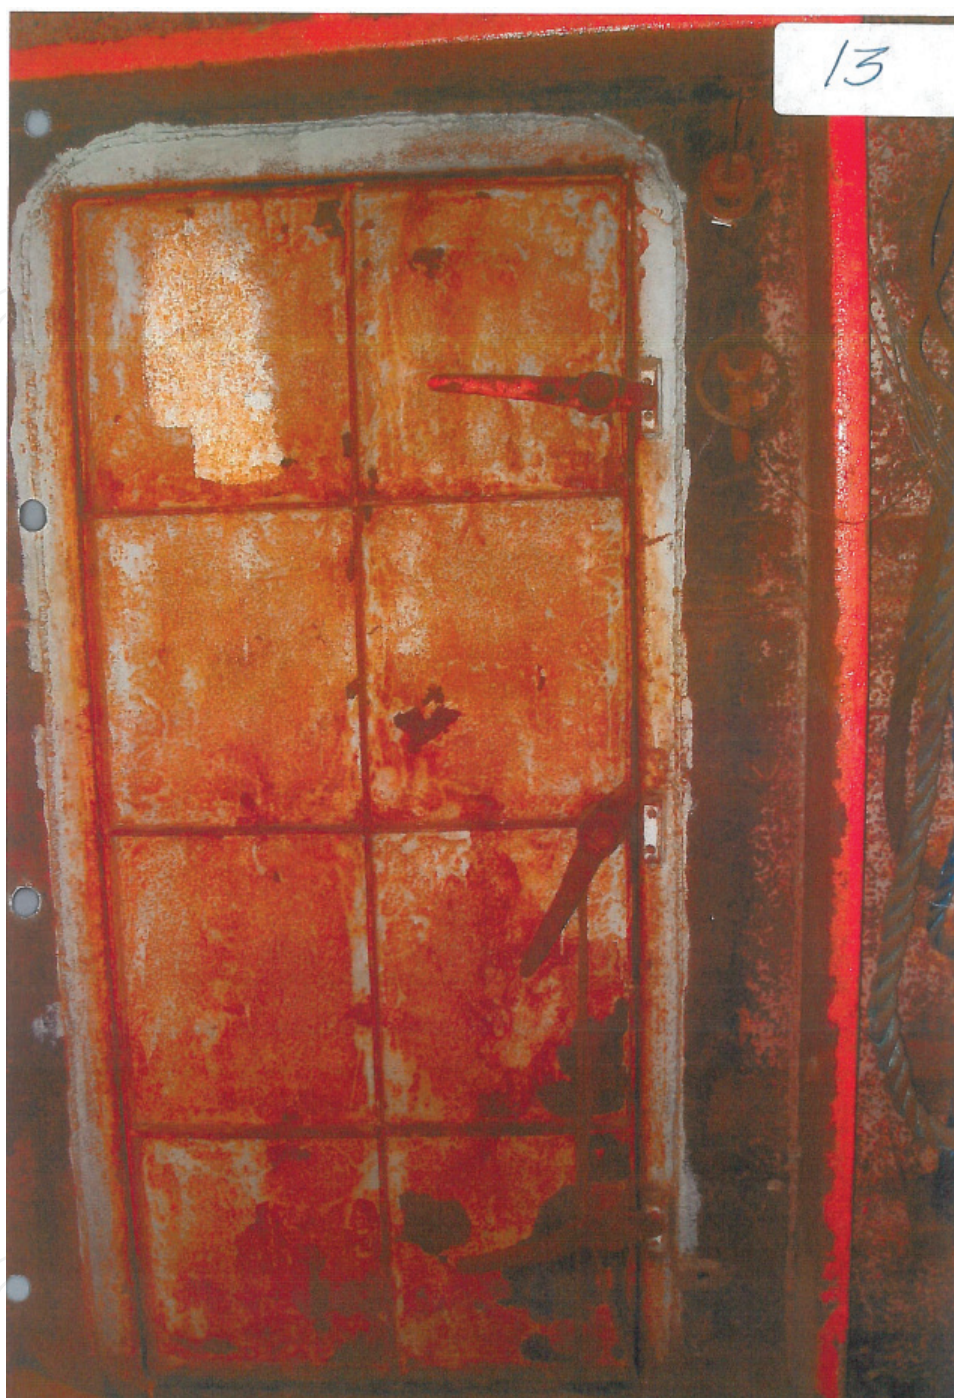
A door in the forepeak compartment allowed access to the front cargo hold. The door had three closing hinges but only two were engaged. It was speculated that gasses might travel from the cargo hold to the forepeak through a crevice in the door opening where the third hinge was not engaged (**Figure 1**).

Figure 1. The door in the forepeak compartment, which led the front cargo hold. The door had three closing hinges but only two were engaged. Gasses travelled from the cargo hold to the forepeak through a crevice where the third hinge was not engaged. (AMIRANTE). Source: Police photo file #13 [8].

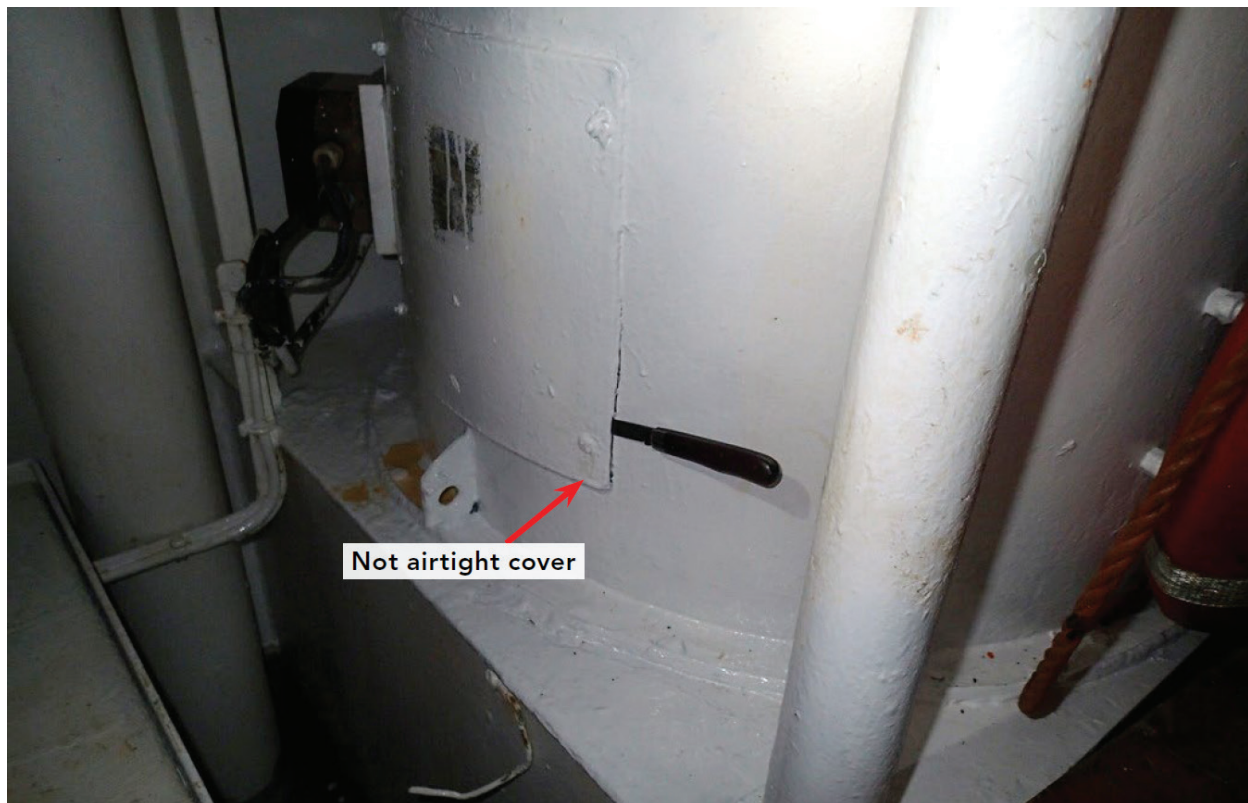
The CO₂ room, forecandle and bow thruster room are adjacent to each other and gasses might travel from one room to another through a number of connecting conduits. The shipping company contracted the classification society to investigate how carbon monoxide could have travelled from the cargo hold to the bow area. The investigation identified a minor gap in a section of the rim of an inspection cover on a ventilation duct that runs from the cargo hold through the forecandle as the most likely route (**Figure 2**).

Figure 2. The inspection hatch on a ventilation duct that ran from the cargo hold through the forecabin. A minor gap in a section of the rim (knife blade inserted) allowed gasses to travel from the cargo hold to the bow area. (LADY IRINA). Source: [13].

In response to the fatal accident, the shipping company acquired multi-gas meters and introduced a new work procedure mandating that the person making “First Entry” must carry an operational multi-gas meter. New warning placards with the instruction “ATTENTION—No first entry without use of multi-gas meter” were been put up on access doors.

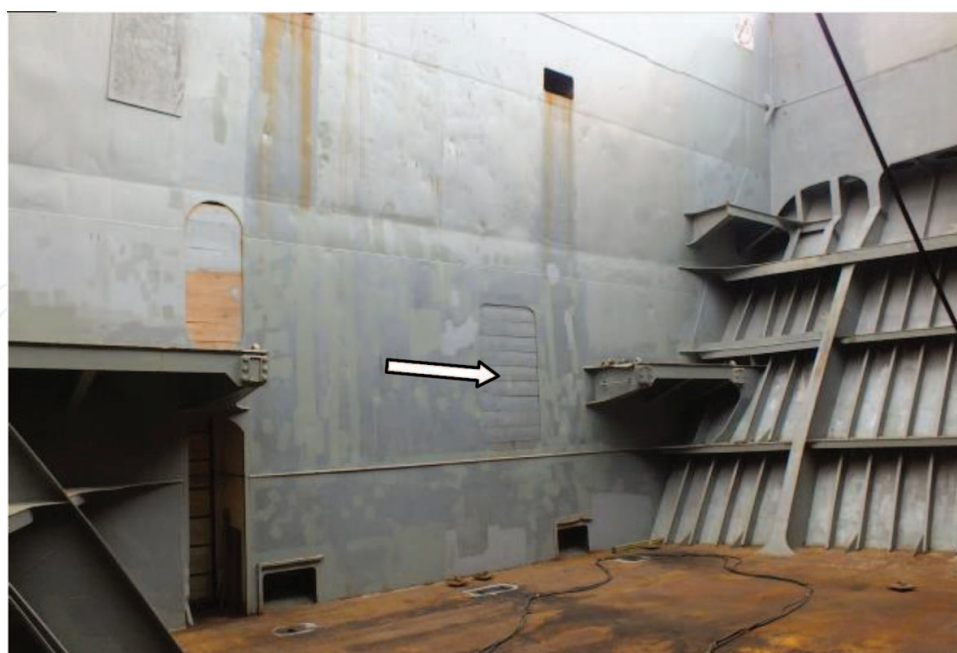
Figure 3. An opening in the front cargo hold allowed easy access to the lashing equipment room. When carrying bulk cargo, the opening was closed with planks of wood inserted into guide bars (CORINA). Source: [16].

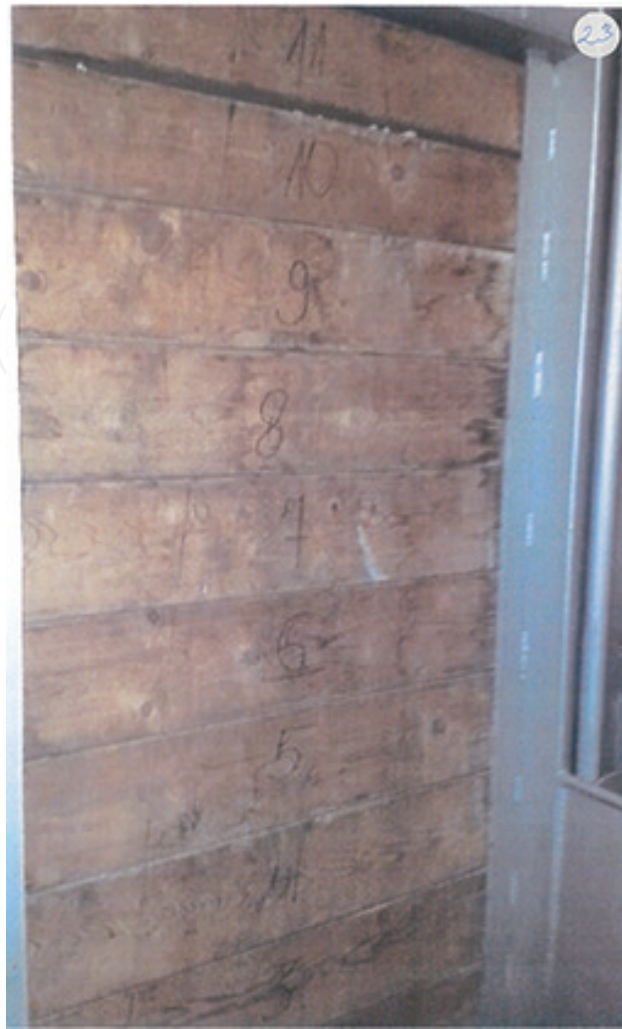
CORINA was general cargo multipurpose vessel adapted to transport of containers. Containers must be lashed, and in order to ease the handling and movement of lashing gear, the vessel was designed with a 2100 mm × 1150 mm opening in the forward bulkhead of cargo hold no. 1. The opening allowed easy access to the neighbouring storage room, where chains, stacking cones and other lashing equipment for containers were kept (**Figure 3**). When carrying bulk cargo, the opening was closed with planks inserted into guide bars. This barrier was not gas tight and gasses from the cargo hold could therefore travel to the fore-castle (**Figure 4**).

Figure 4. The plank barrier seen from the lashing equipment room. Wood pellets in the cargo hold are visible between planks 10 and 11. The barrier is evidently not gastight. (CORINA). Source: Police photo file #23 [8].
