MARINE SAFETY INVESTIGATION REPORT

Safety investigation into the collision between the
Maltese registered LNG carrier

ASEEM

SHINYO OCEAN

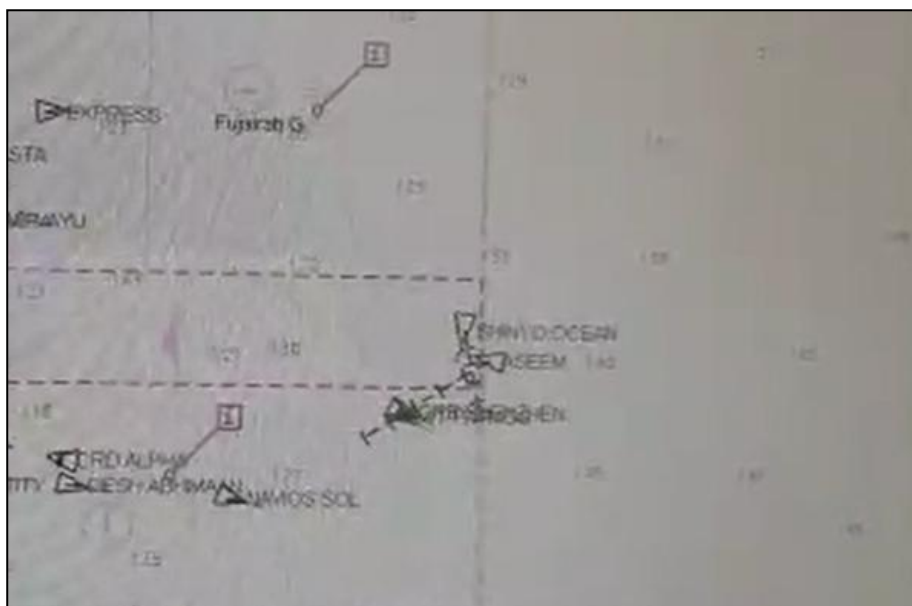
At around 0006, *Aseem* and *Shinyo Ocean* collided in (approx.) position 25° 15.0' N 056° 34.9' E, just within the passage channel of the Fujairah Offshore Anchorage Area (Figures 14 and 15). At that time, the heading of *Aseem* was 295° and her speed was 8.3 knots, while the heading of *Shinyo Ocean* was 173° and her speed was 7.3 knots. Contact was made head on, by *Aseem*, into the port bow of *Shinyo Ocean*, about 20 metres aft of her anchor windlass.

Figure 14: Extract of the ECDIS playback, showing the collision at around 0006
 (Source of the ECDIS playback: Federal Transport Authority – Land and Maritime, U.A.E.)

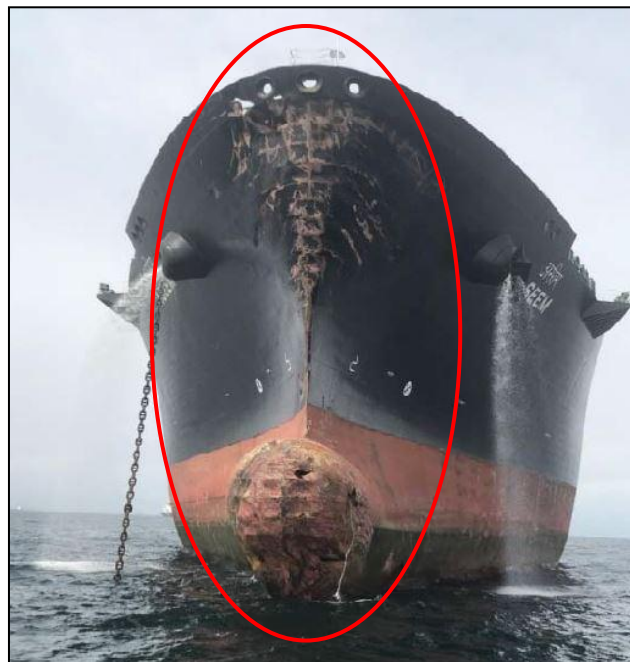
The damages sustained by *Aseem* were limited to the region around her stem, but above and below the water line (Figure 16). The shell plating in way of the bulbous bow (Figure 17) and the starboard bow (Figure 18), the stem plating, the forward bulwark (Figure 19) and the forecastle deck plating were distorted, fractured and perforated in several places. The internal strengthening members in these areas were also distorted, buckled and fractured.

Figure 16: Damages sustained by *Aseem*, which was restricted to the region around the stem

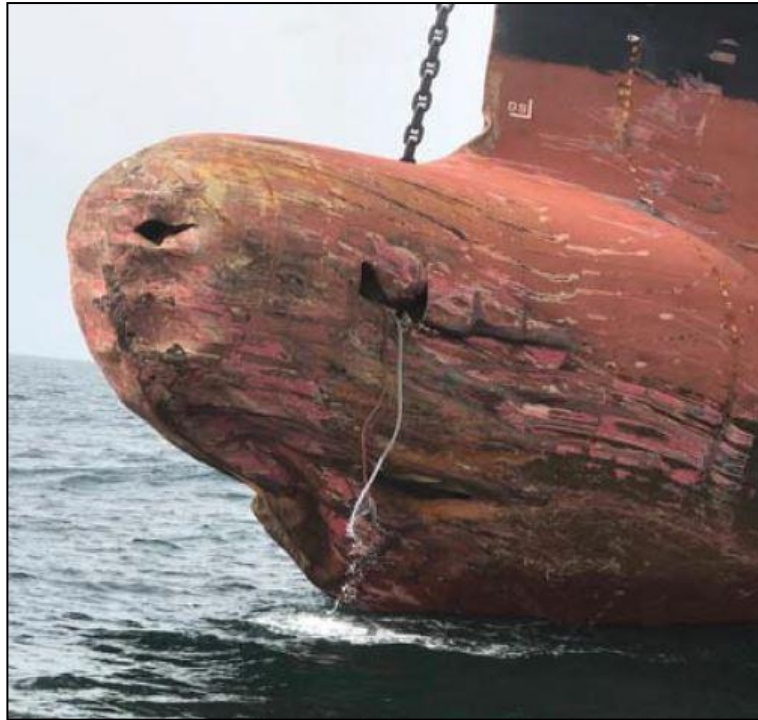
Figure 17: Holes and distortion in the bulbous bow plating

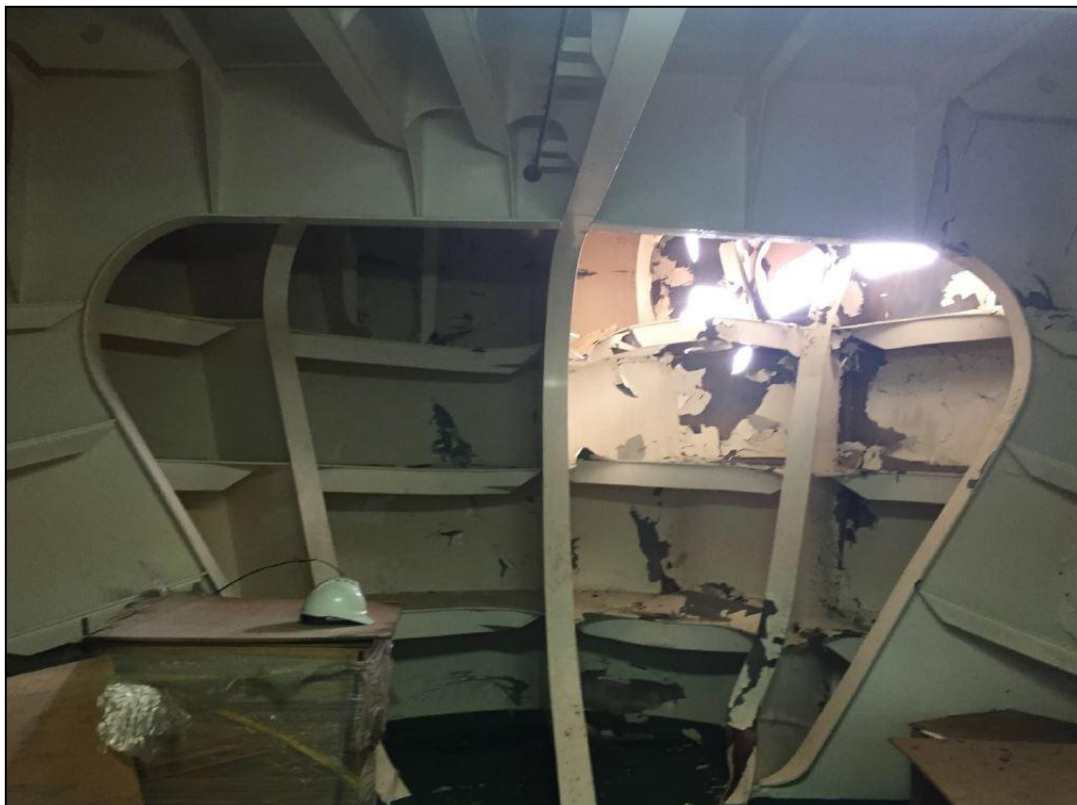
Figure 18: Internal view of damaged shell plating on the starboard bow

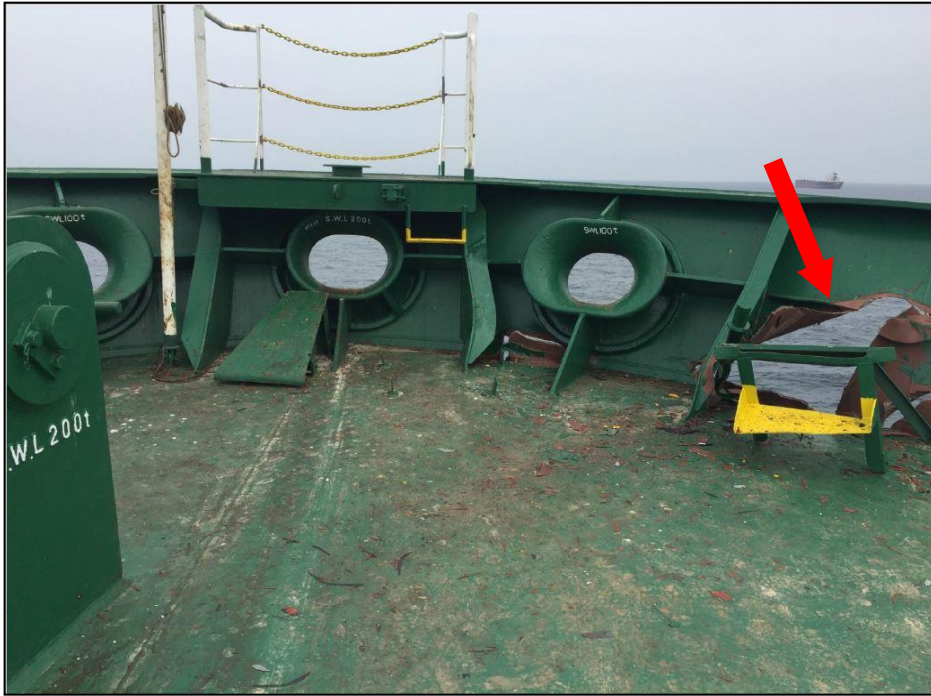
Figure 19: Damaged bulwark and stiffeners on the forecastle

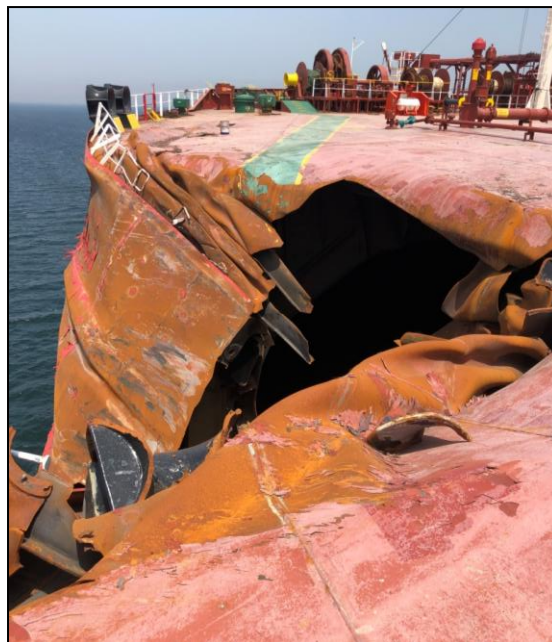
Shinyo Ocean sustained extensive damages to her deck plating and associated fittings (Figures 20 and 21), and her port side shell plating (Figure 22). Ballast tank no. 1 port and cargo tanks nos. 1 centre and 1 port were also reported to have been structurally damaged.

Figure 20: Damaged deck plating and fittings – as seen from aft to forward

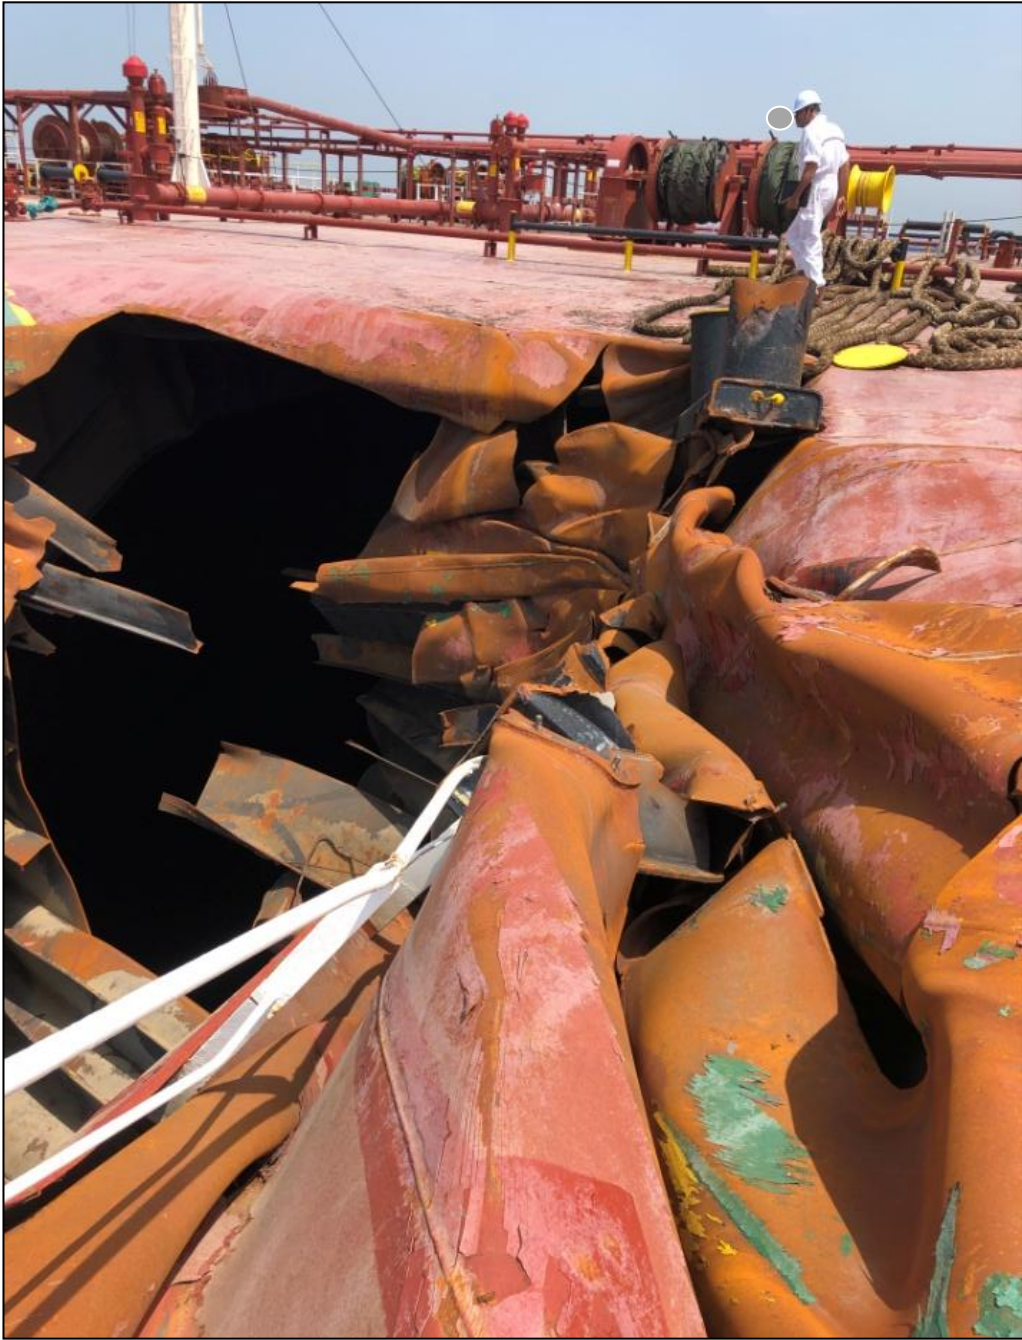
Figure 21: Damaged deck plating and fittings – as seen from the port side

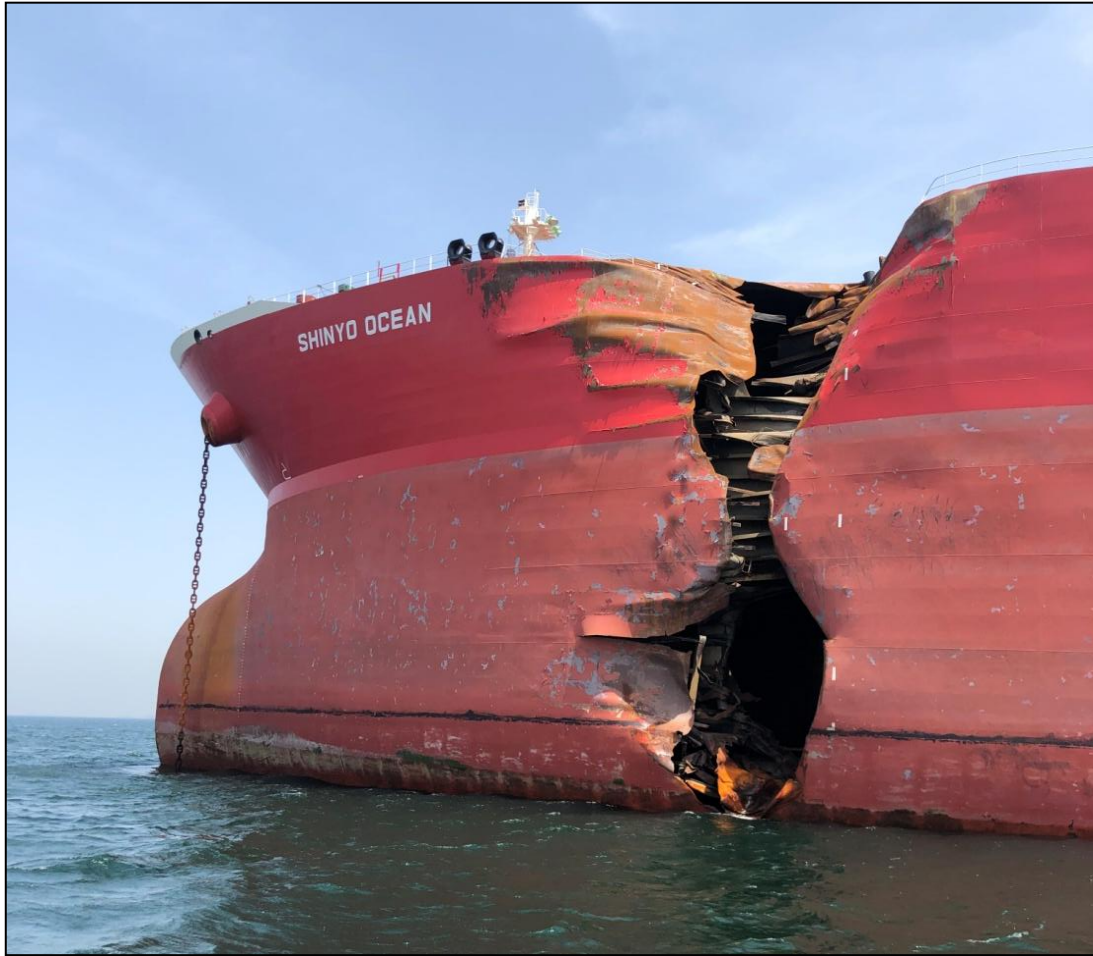
Figure 22: Penetrated hull plating
(Source: Federal Transport Authority – Land and Maritime, U.A.E.)
