Collision between *Huayang Endeavour* and *Seafreighter* approximately 5nm west of Sandettie Bank, English Channel 1 July 2017

SUMMARY

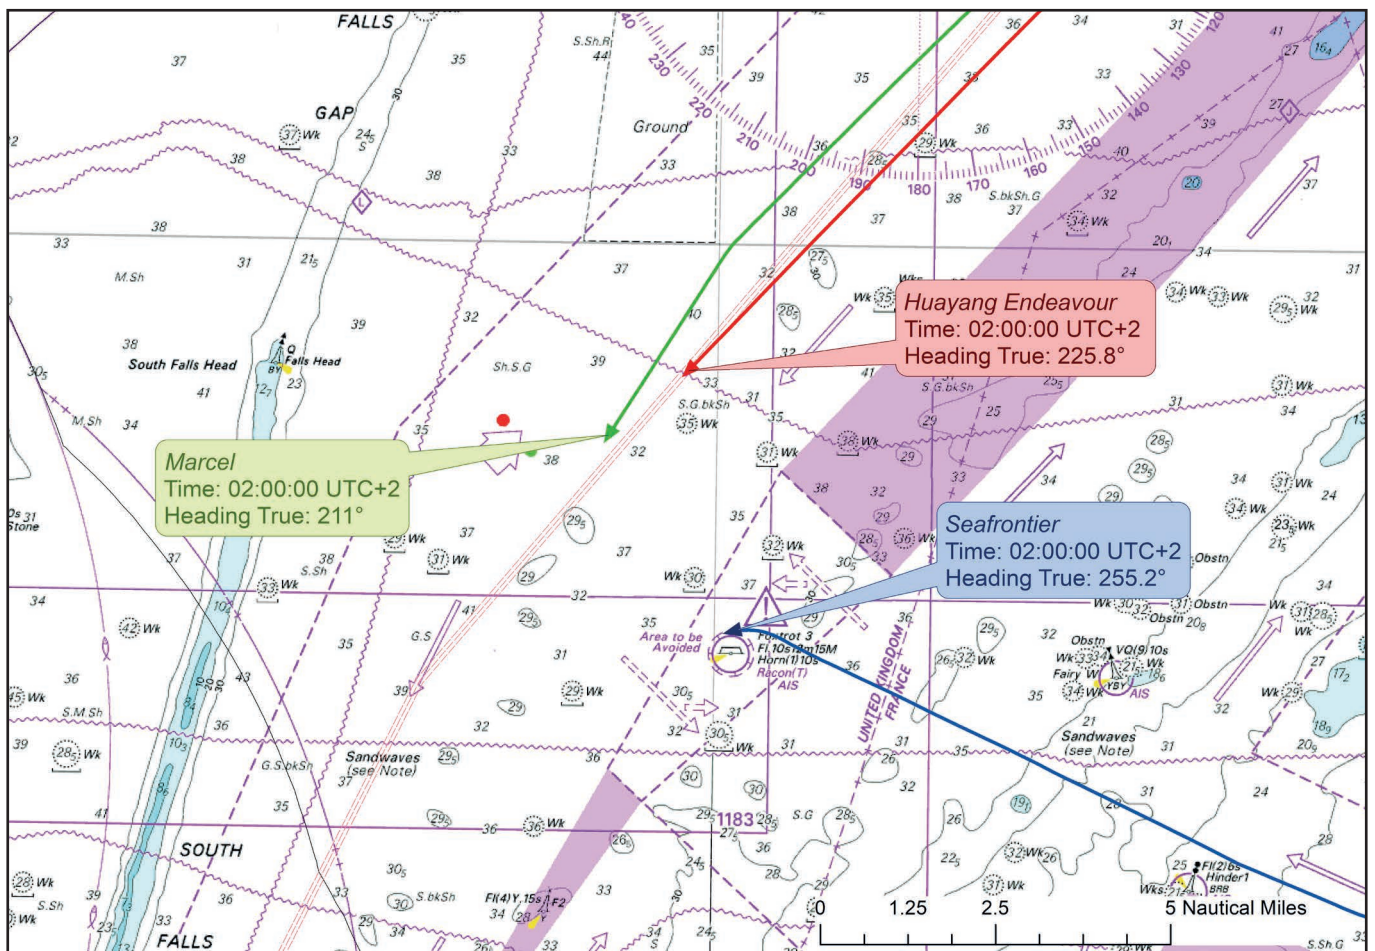
Figure 1: Position of *Seafreighter*, *Huayang Endeavour* and *Marcel* at 0200

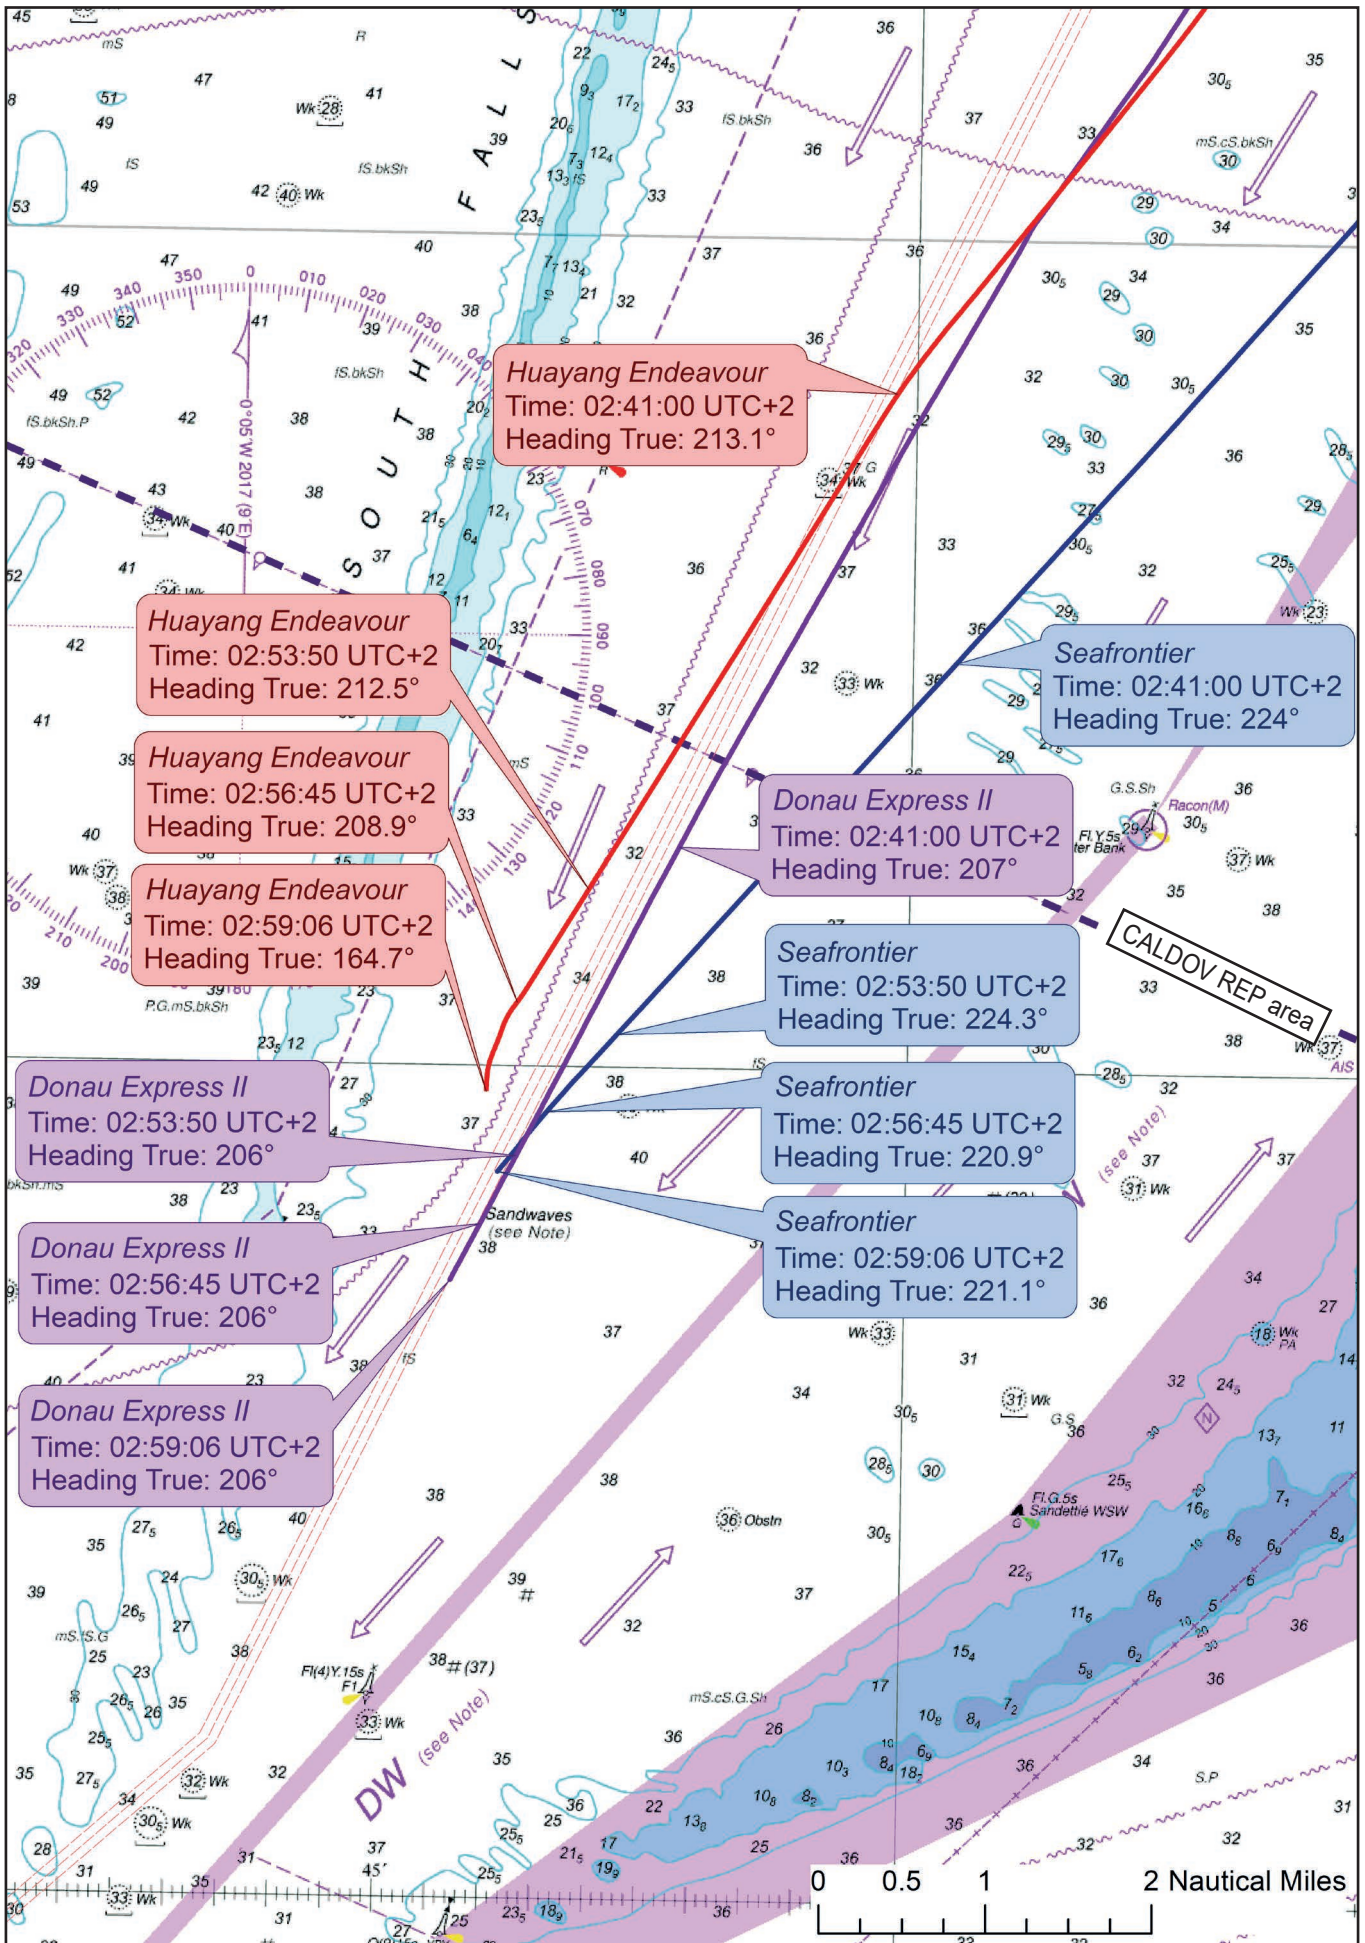
Seafrontier's own COG was 221° on a converging course with *Huayang Endeavour*. *Donau Express II* was on a COG of 207° and remained on *Seafrontier's* starboard bow (**Figure 2**).

Figure 2: The positions of *Seafrontier*, *Huayang Endeavour* and *Donau Express II* between 0241 and 0259

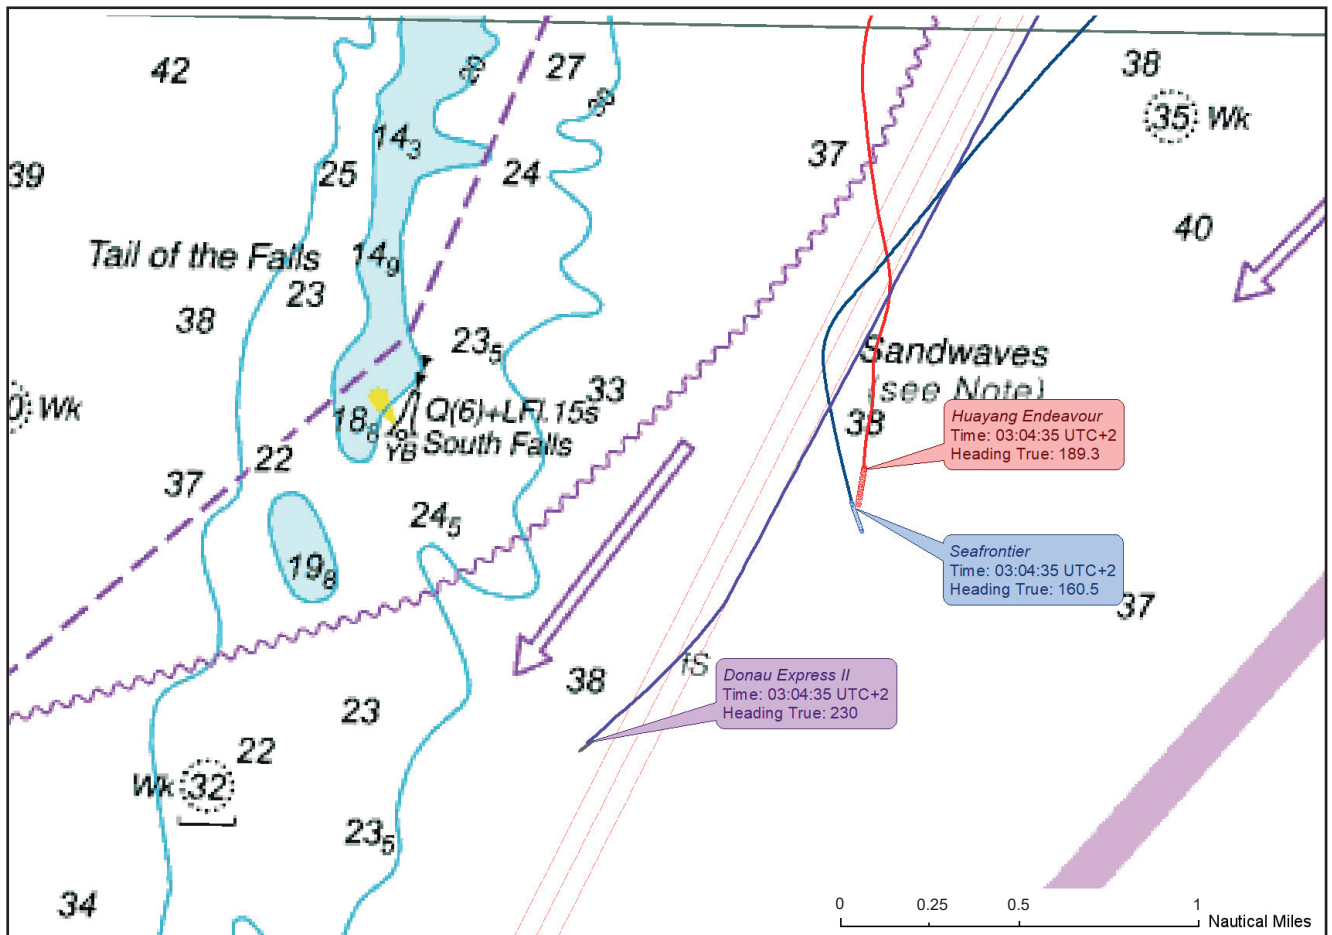
Huayang Endeavour's master, who was still visually monitoring *Seafrontier*, was equally alarmed to see that *Seafrontier* was altering rapidly to port and across his vessel's bow. The two vessels were just 655m apart when *Seafrontier* steadied on to a heading of 172° (**Figure 3**).

Figure 3: The collision

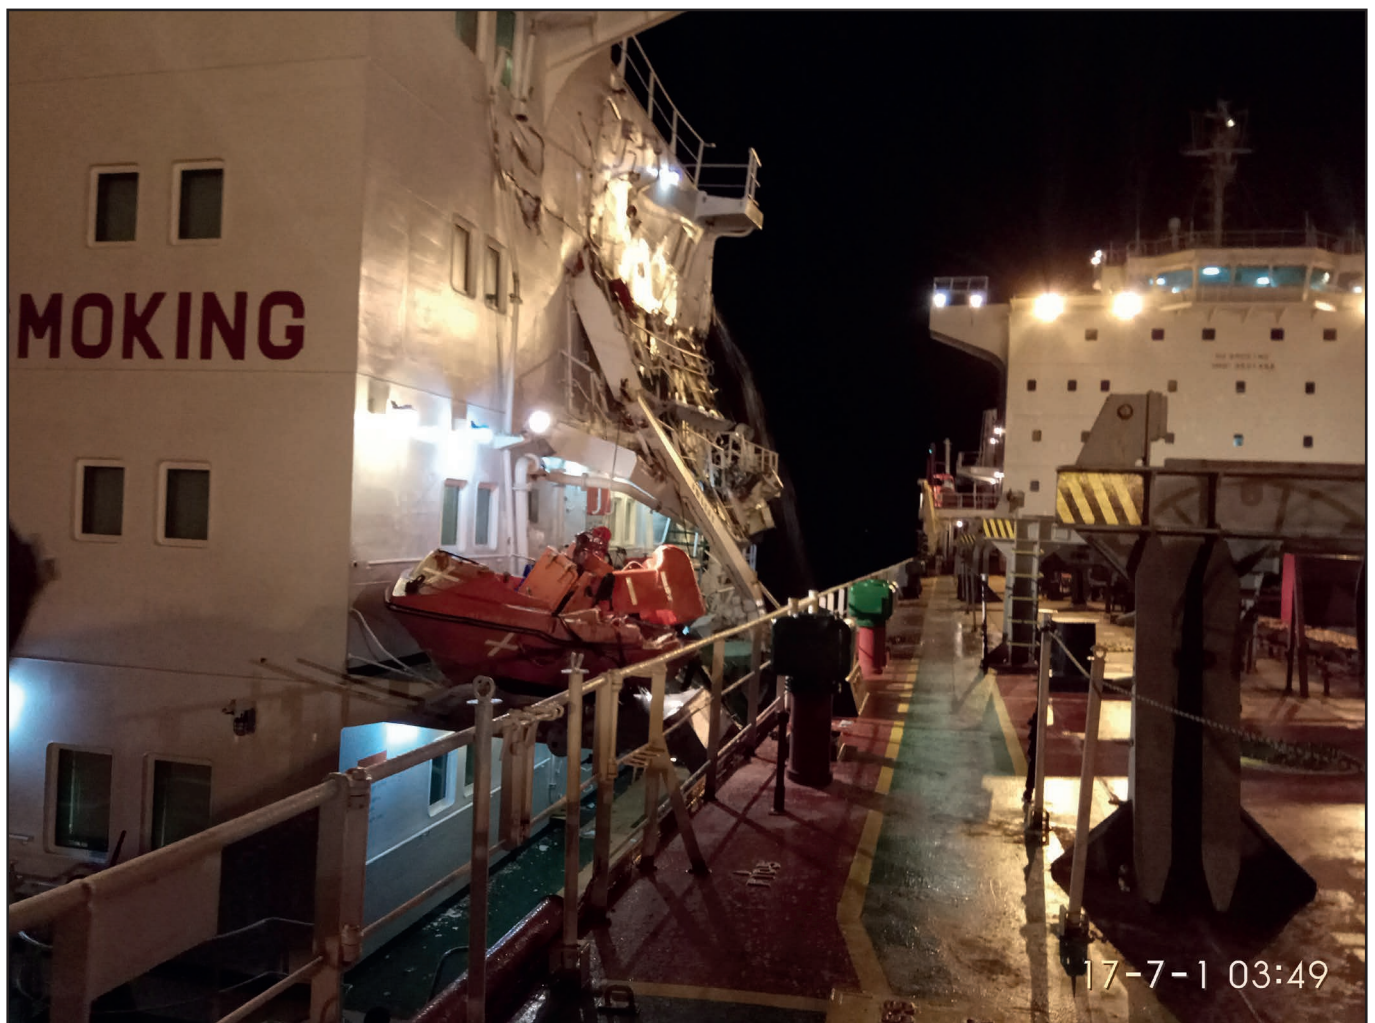
Just before impact, *Seafrontier*'s master changed the engine telegraph setting to dead slow astern. Seeing that collision was inevitable, the second officer changed the setting to emergency astern 5 seconds before *Huayang Endeavour*'s starboard bow struck *Seafrontier*'s port side in way of the accommodation housing and hull. *Seafrontier*'s second officer then set the engine telegraph to stop and the vessels remained in contact, with *Seafrontier* on *Huayang Endeavour*'s starboard side (**Figure 4**).

Figure 4: Seafrontier alongside Huayang Endeavour

Huayang Endeavour sustained damage to the hull plating on the starboard side of the bow, with penetrations into the forecastle store and forward void space. The starboard hull plating was indented along its entire length.

Seafrontier suffered significant damage to the port side accommodation, which was damaged over five decks. The port rescue boat and davit were extensively damaged, rendering them unusable, and one set of external stairs was totally removed. The internal structure was significantly damaged and it was fortunate that there were no injuries or pollution.
