MISLE Incident Investigation Report For

SLNC GOODWILL / Loss of Life

On 05Aug2020 00:42:00 EDT

Diesel Generator Failure Investigation

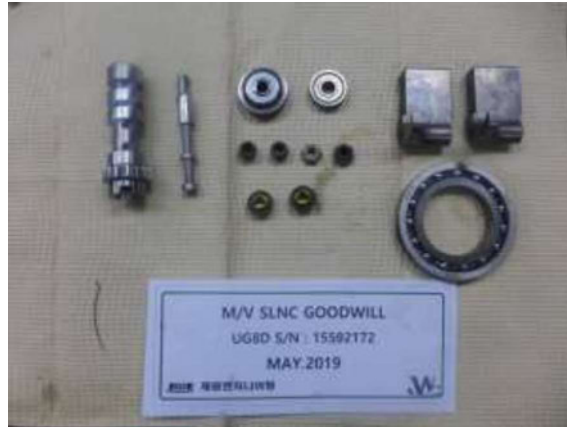
- a) P.V. PLUNGER & P.V. BUSHING : It was jiggling problem on test stand so replace P.V. PLUNGER & P.V. BUSHING (Control land wear)

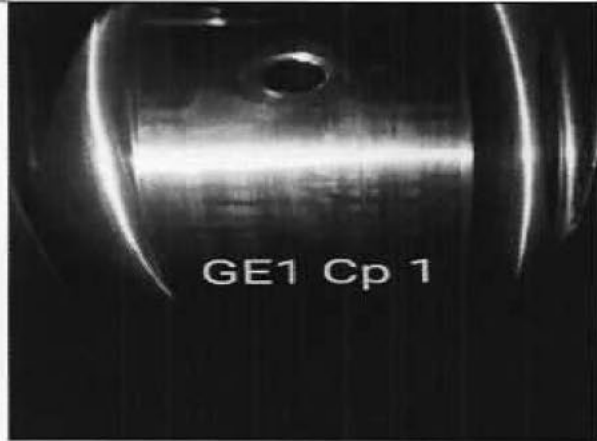
Crank pin Before polish condition

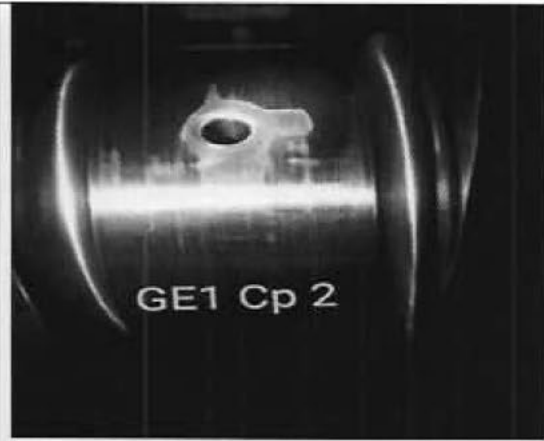
Crank pin with wear ridge condition

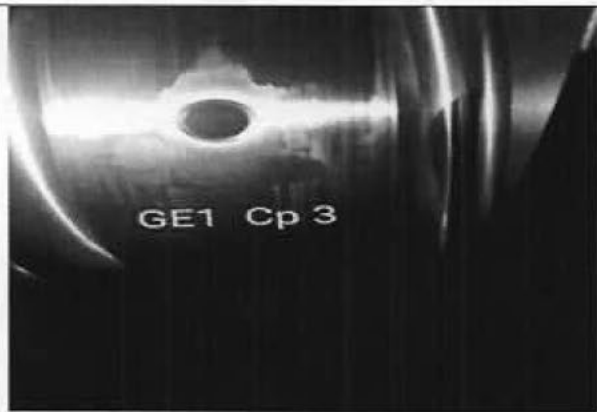
Crank pin found Wear ridge

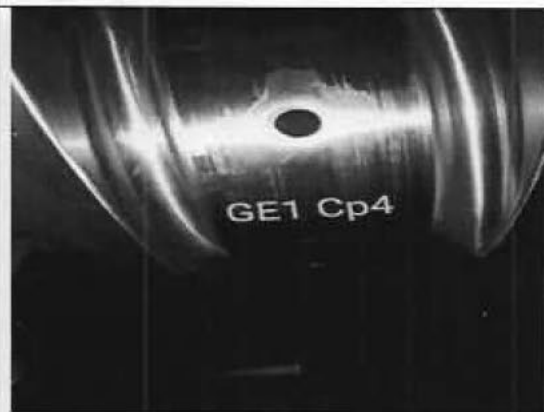
Crank pin found Wear ridge

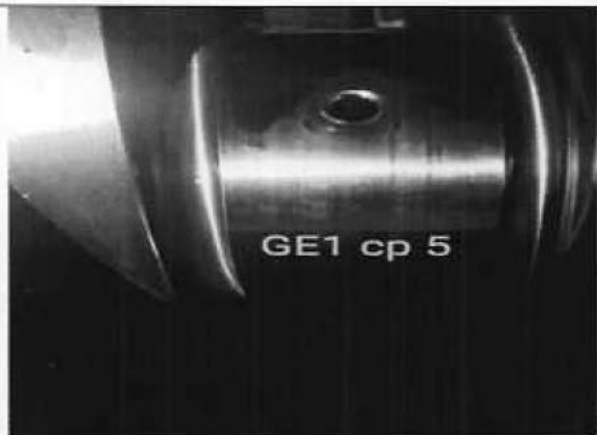
Crank pin found Wear ridge

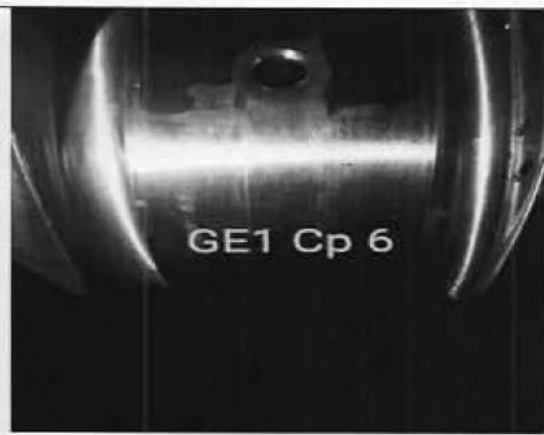
Crank pin found Wear ridge

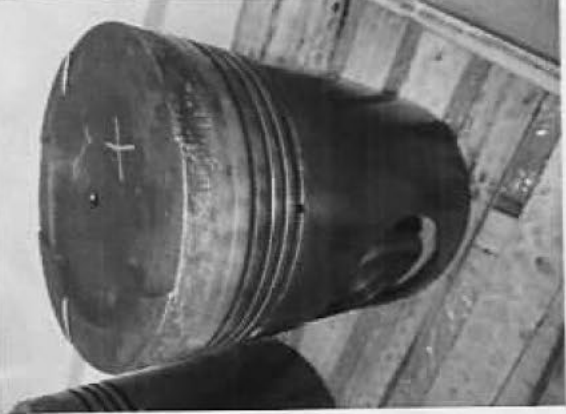
<p>Piston crown #4 condition (found cavitation)</p>	<p>Piston crown #6 condition (found cavitation)</p>

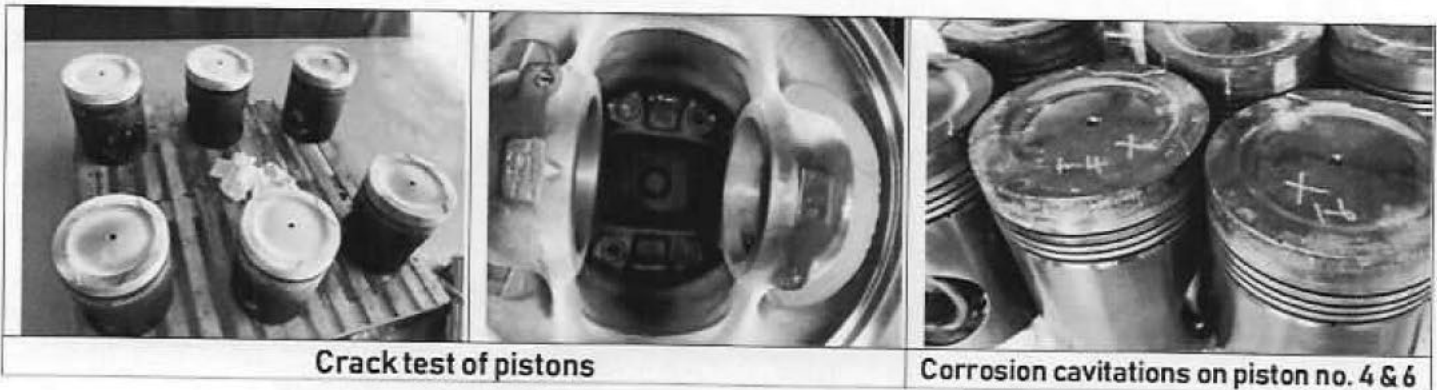
Corrosion cavitations on piston no. 4 & 6

Note: all 6 pcs connecting rod were renewed onboard with new spares.

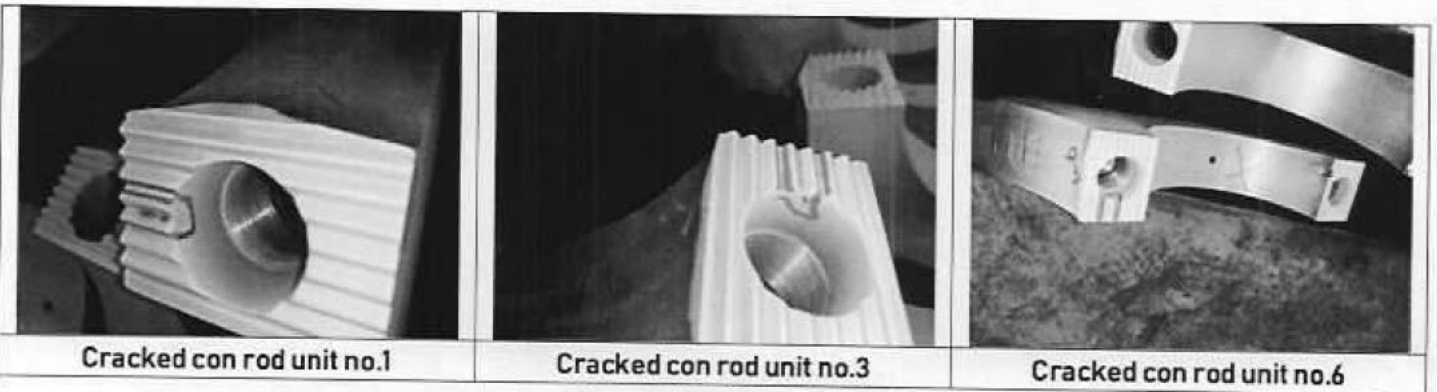
Cracked con rod unit no.1

Cracked con rod unit no.3

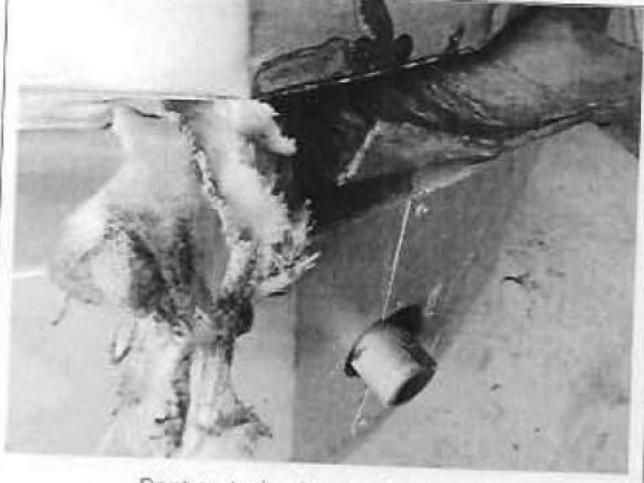
Dent on turbocharger foundation

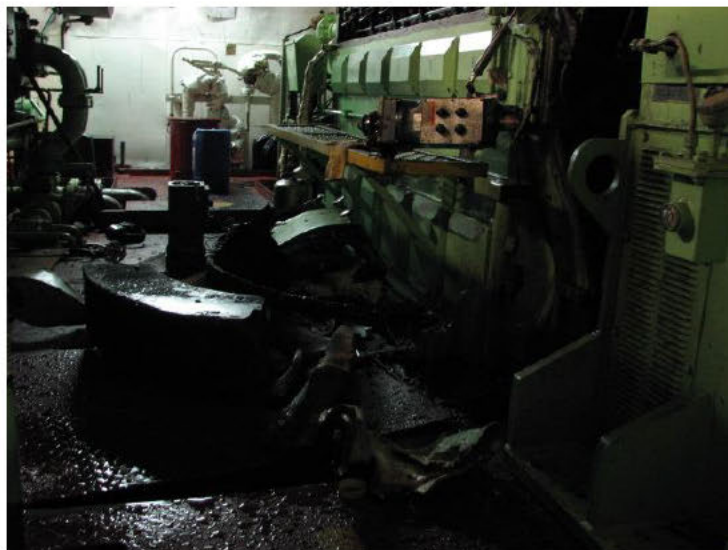
4.1.17. One large flywheel fragment struck the 3/AE, who was standing near the DG #1 governor, in the upper torso and neck; the impact caused significant blunt-force trauma and bleeding. The 3/AE was evacuated from the engine room and taken to the medical space where he received medical treatment for his injuries, but was unable to recover from the trauma. His death was recorded as having occurred at 1823; cause of death was listed as hemorrhagic shock.

Figure 4. Area where 3 A/E was standing at the time of the casualty

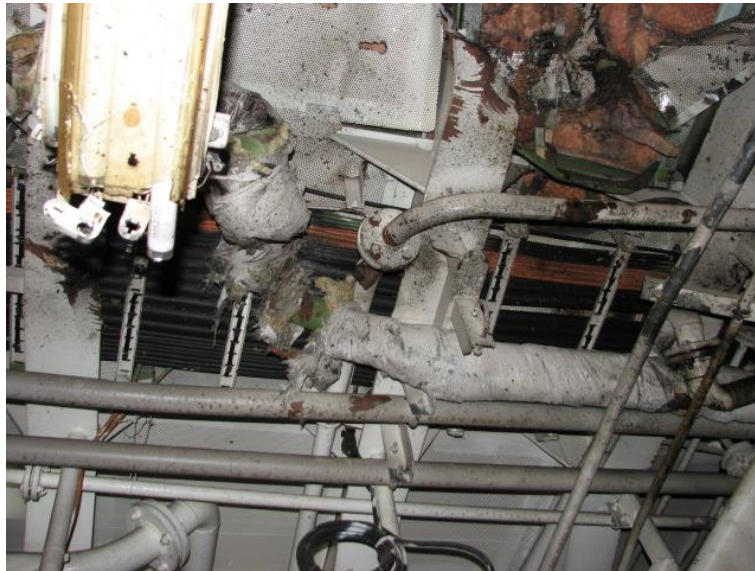
4.1.18. Other fragments of the flywheel struck piping that was vital to the vessel's electrical and propulsion systems to include air and cooling water distribution.

Figure 5. One area of damaged overhead/piping caused by a flywheel fragment

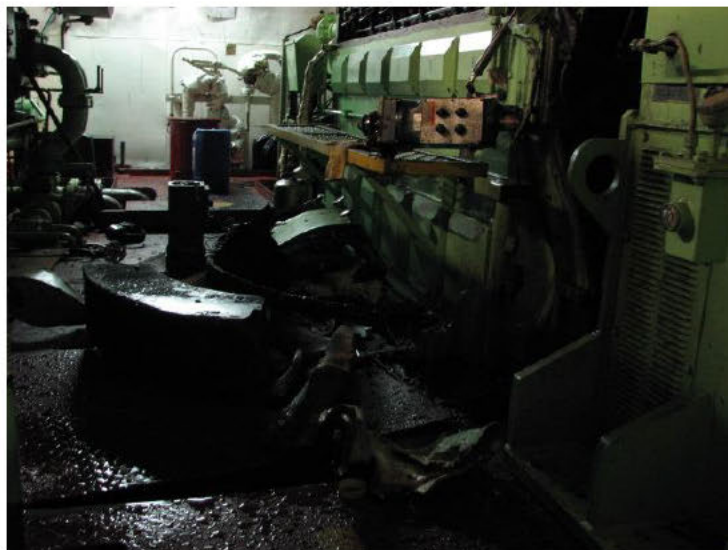
4.1.17. One large flywheel fragment struck the 3/AE, who was standing near the DG #1 governor, in the upper torso and neck; the impact caused significant blunt-force trauma and bleeding. The 3/AE was evacuated from the engine room and taken to the medical space where he received medical treatment for his injuries, but was unable to recover from the trauma. His death was recorded as having occurred at 1823; cause of death was listed as hemorrhagic shock.

Figure 4. Area where 3 A/E was standing at the time of the casualty

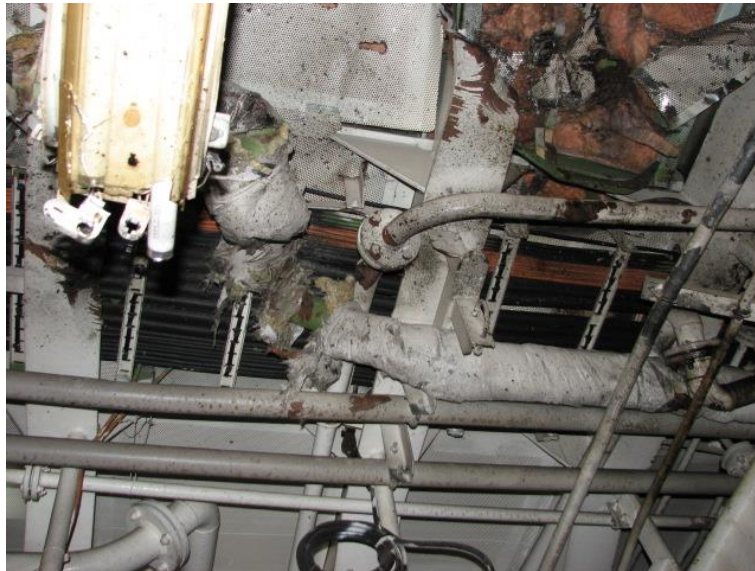
4.1.18. Other fragments of the flywheel struck piping that was vital to the vessel's electrical and propulsion systems to include air and cooling water distribution.

Figure 5. One area of damaged overhead/piping caused by a flywheel fragment

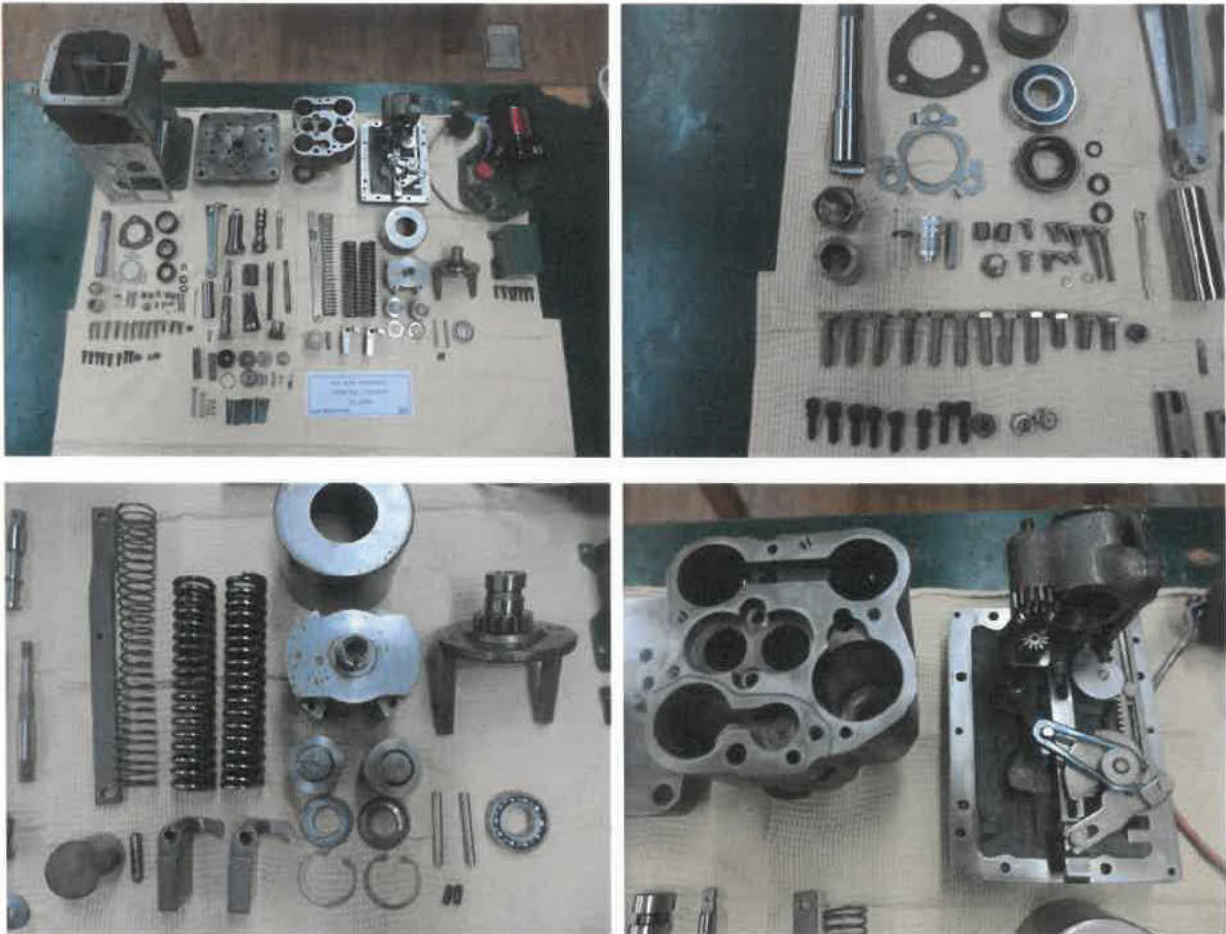
Part name	Part No.	Number	unit	Remark
DIAL PLATE	3099-935	1	EA	
BALLHEAD ASSEMBLY	31507	1	SET	Spare parts needed for modifying.
DIAL PANEL ASSEMBLY	34535	1	SET	
NEEDLE VALVE	30009	1	EA	Defective part.
